LANDSLIDES of the PANAMA CANAL

J. David Rogers, Ph.D., P.E., P.G.

2011 Pacific Section Meeting

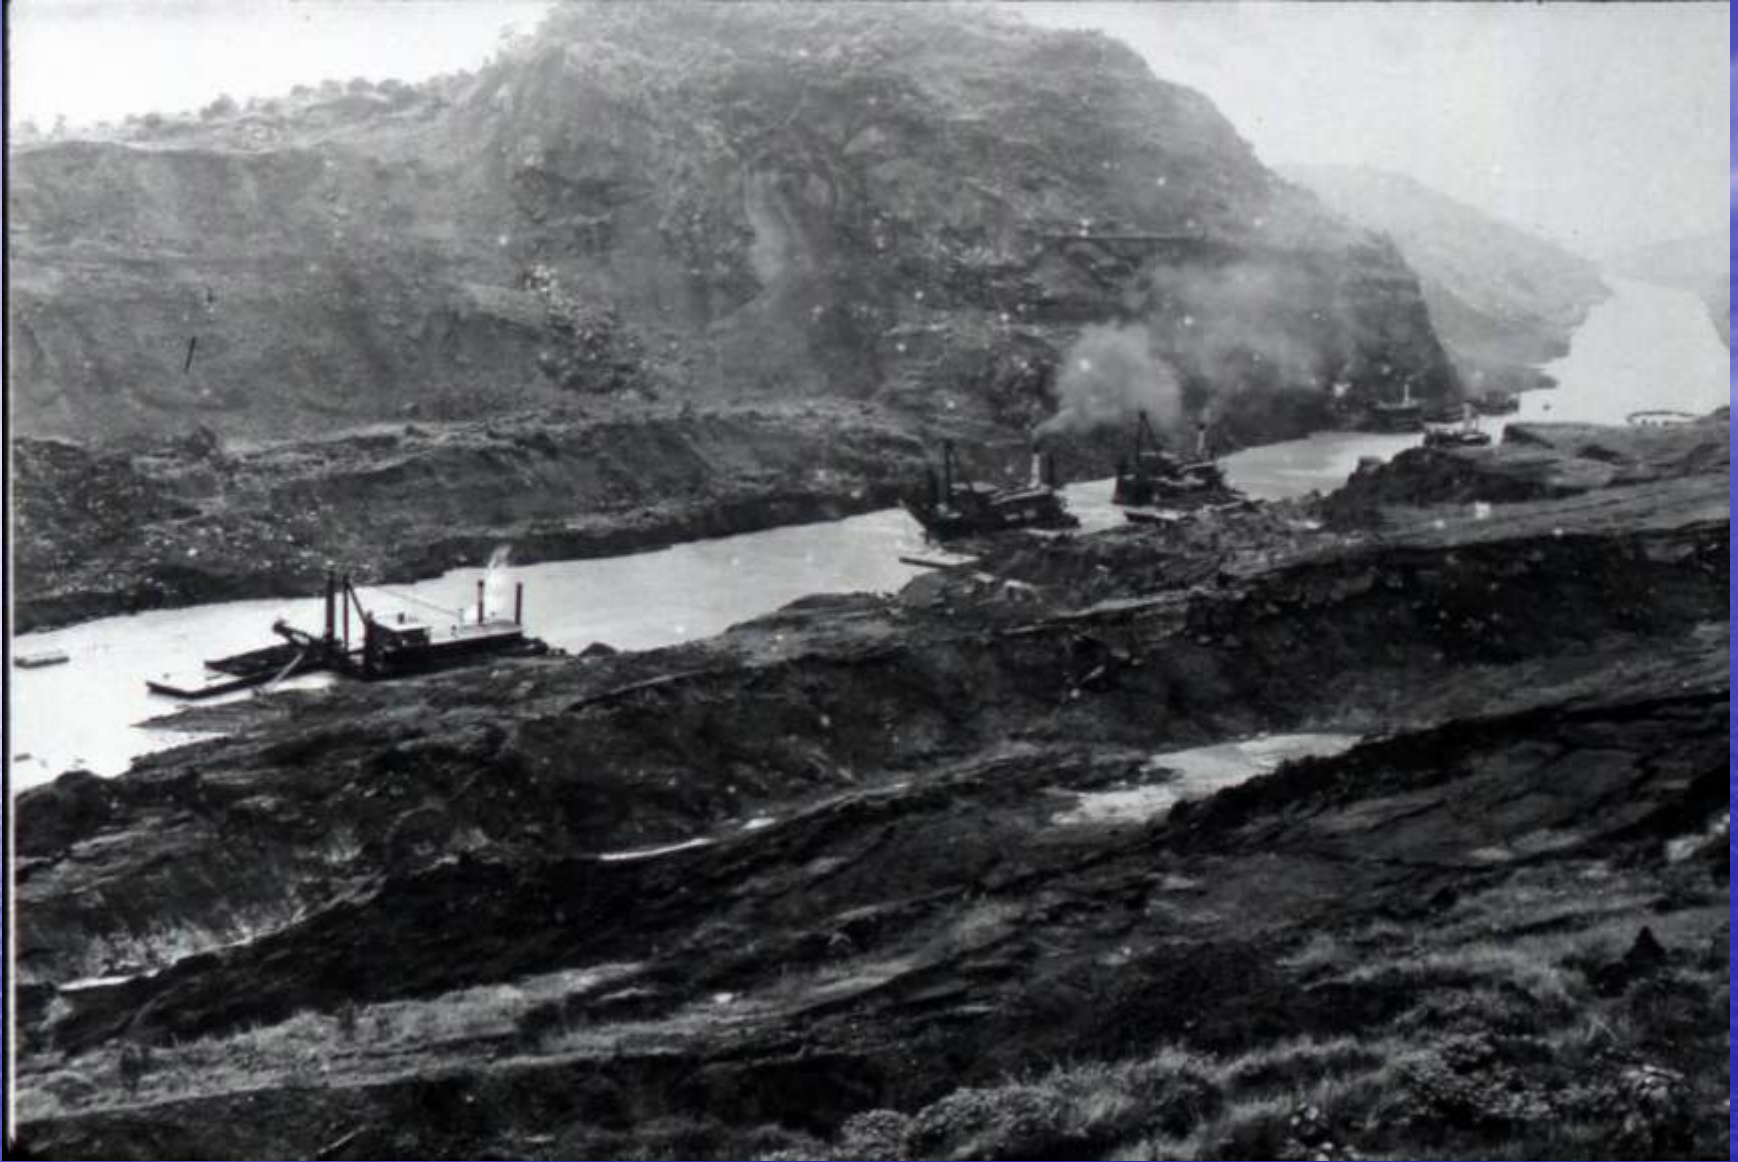
- **Goethals increased the number of dredges five-fold**

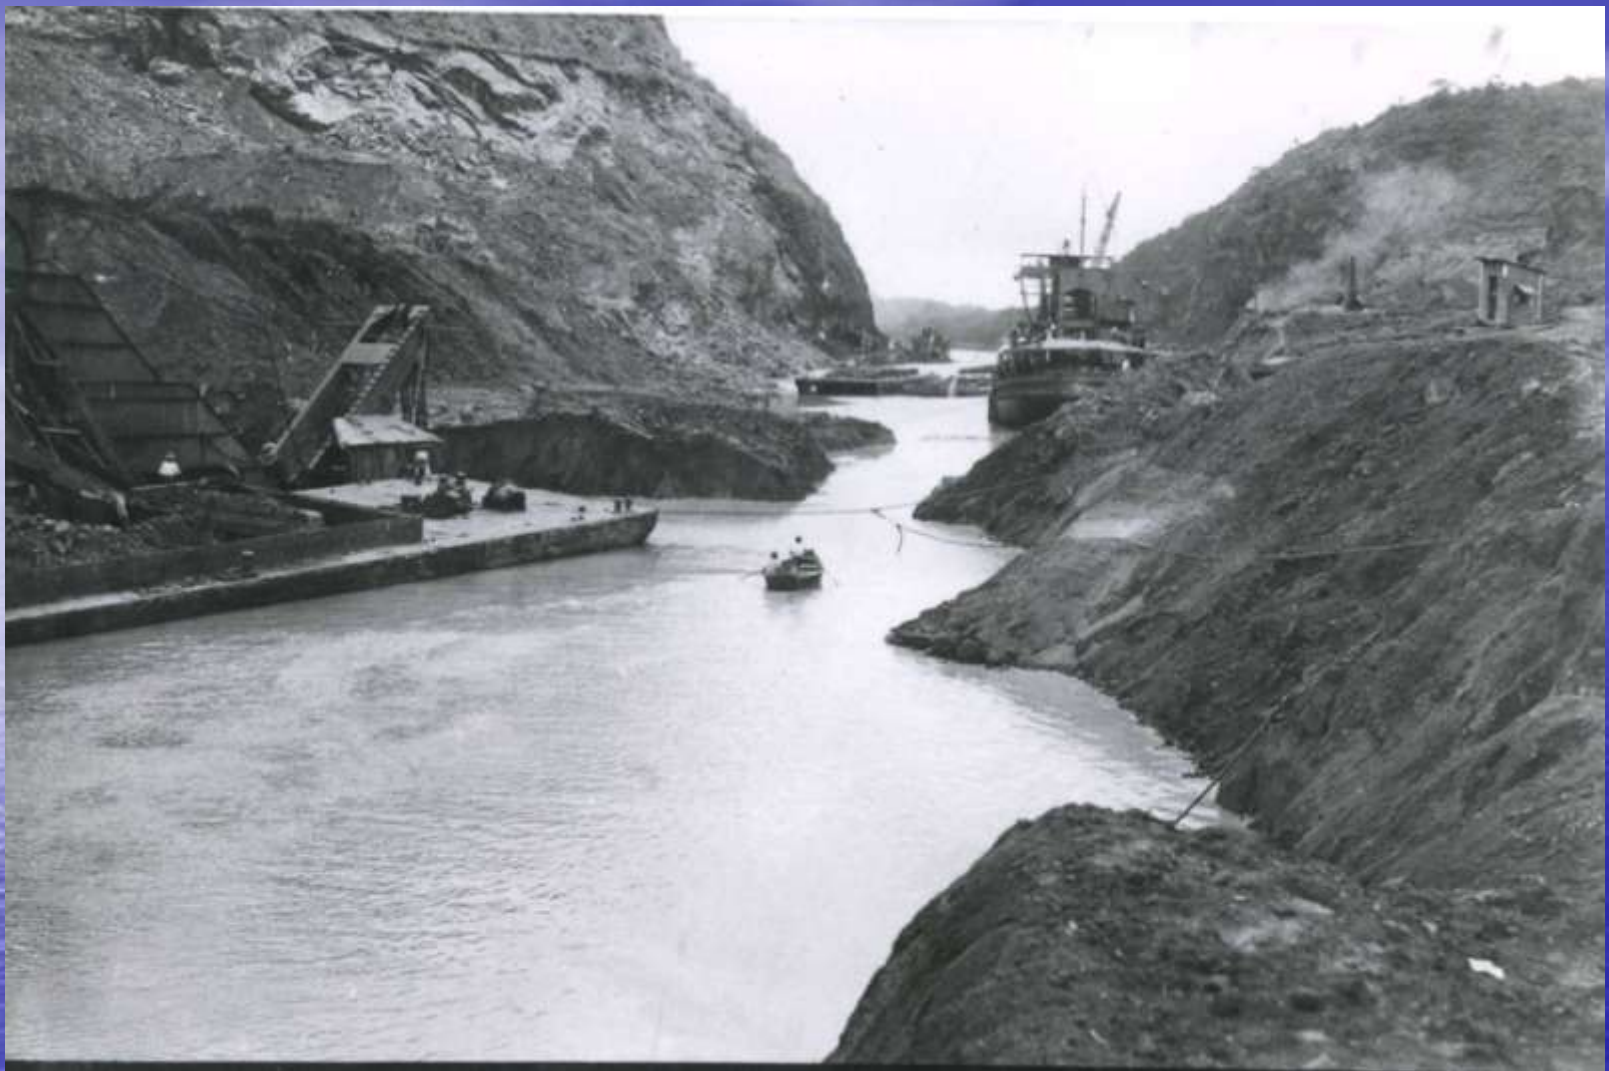
- Dredging the half-mile gap closed by landslides on September 18, 1915, which required excavation of 10 million cubic yards of slide debris over 9 months. This closure triggered the appointment of a commission drawn from the **National Academy of Sciences**, which reported to President Woodrow Wilson.

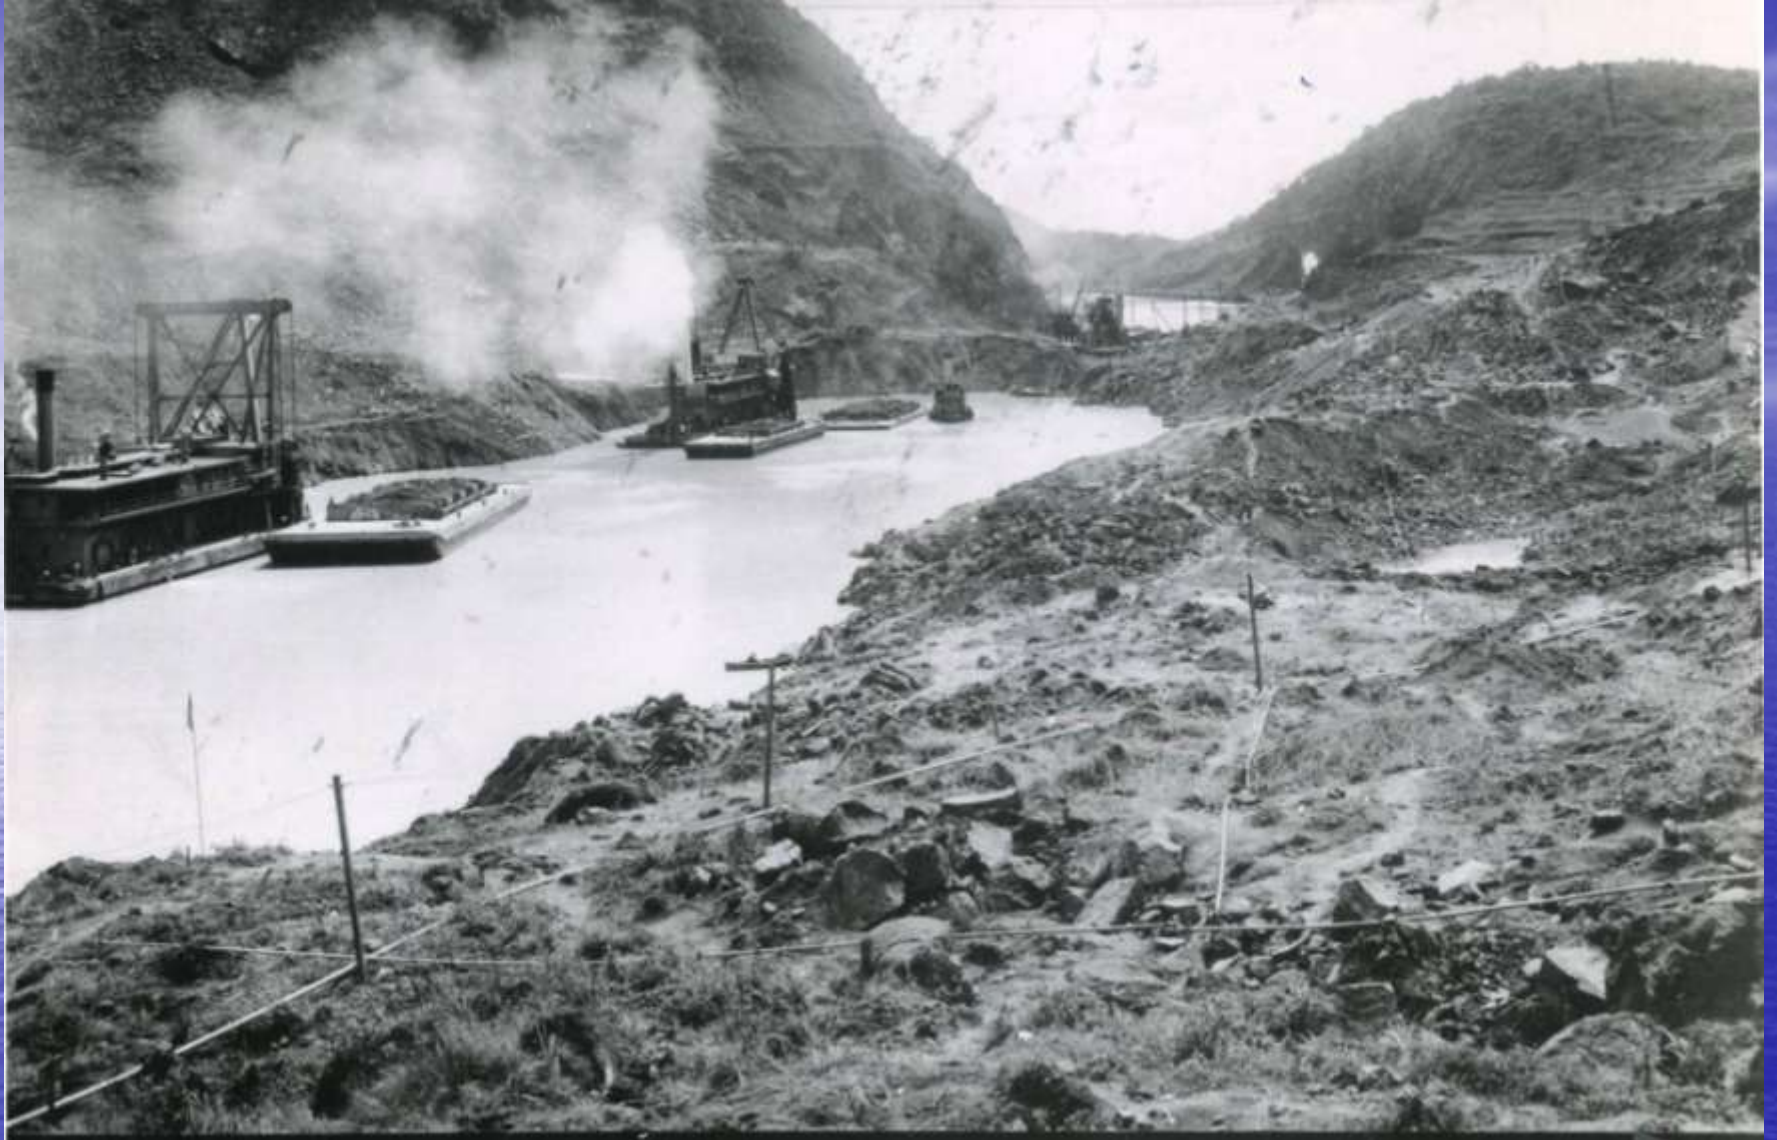
- **Dredges battling with the slides at Culebra on November 8, 1915**

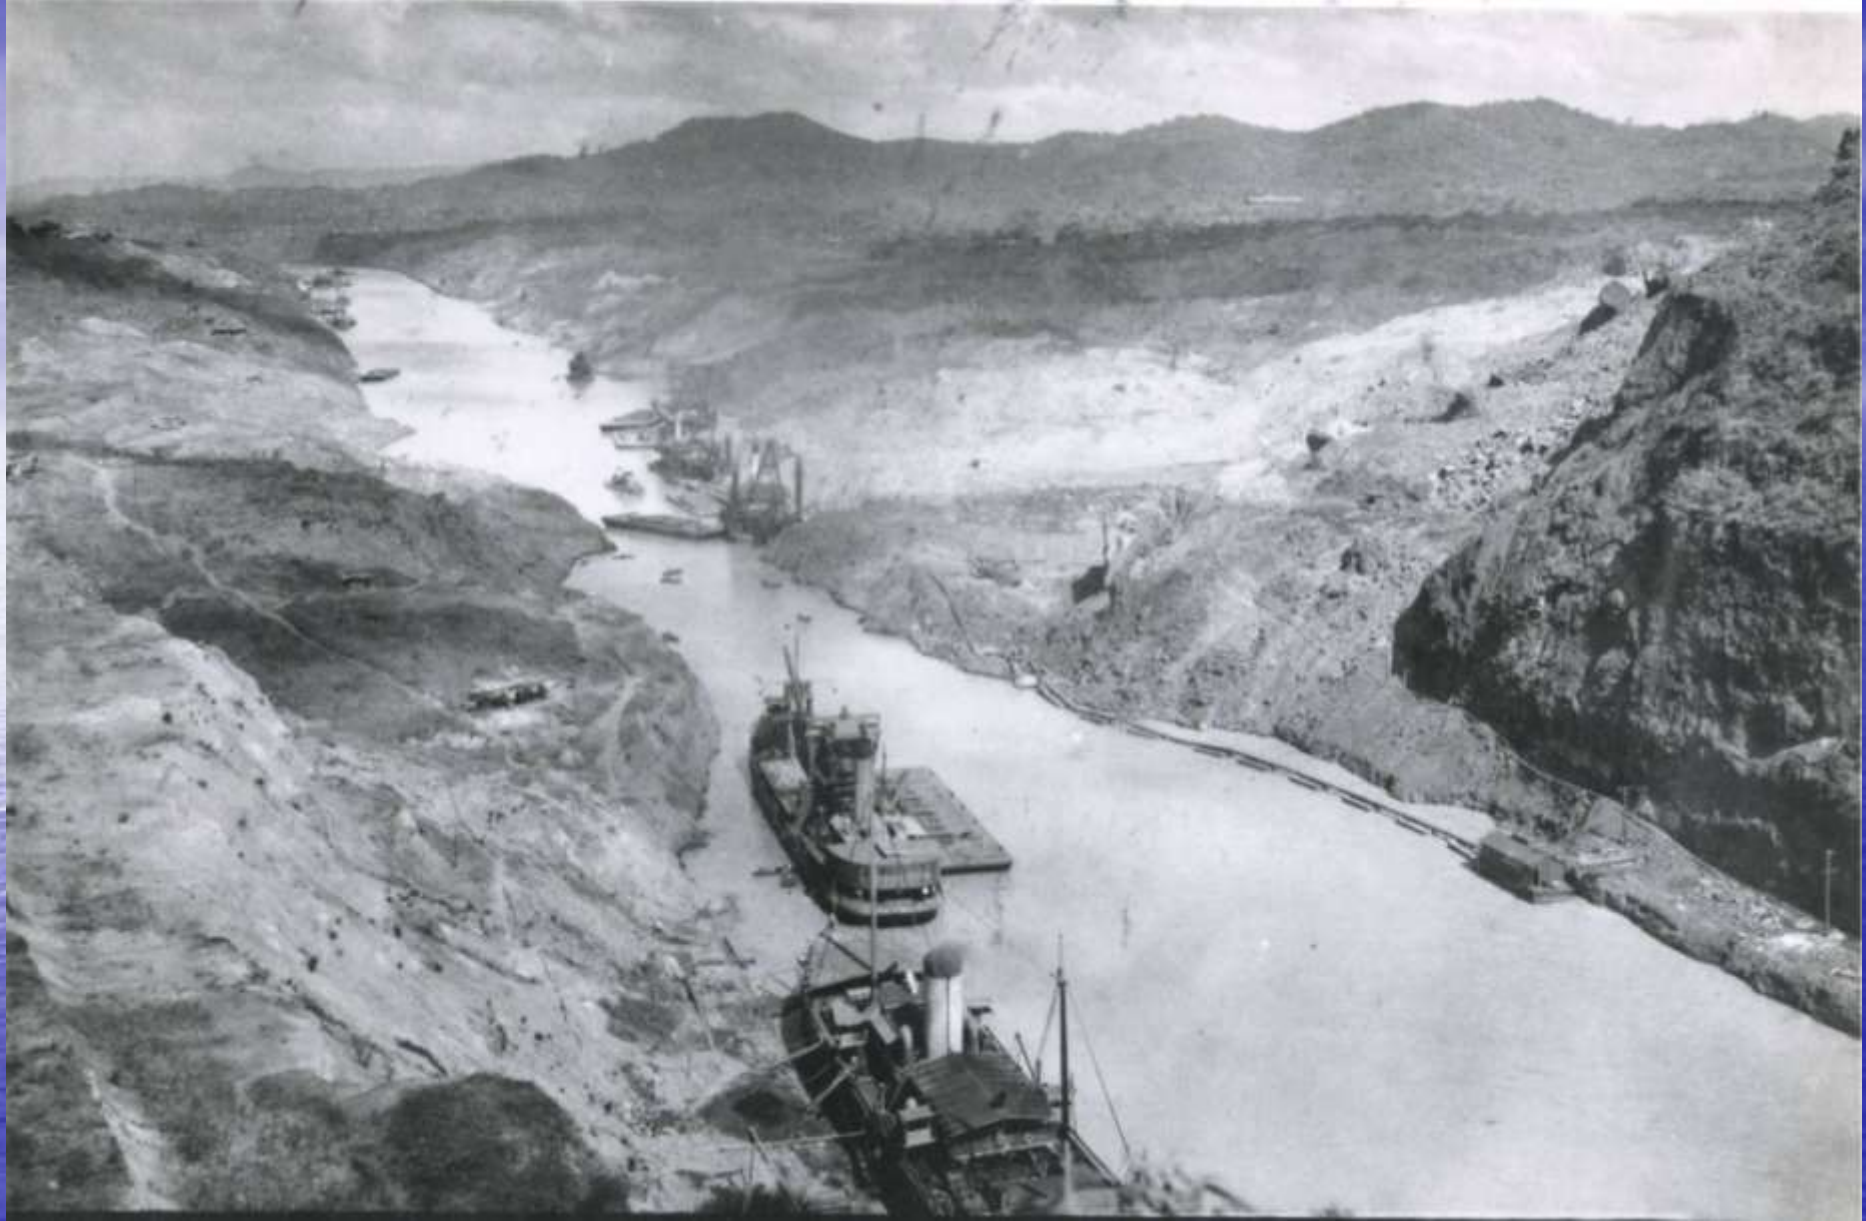
- **Still dredging at Culebra on December 20, 1915**

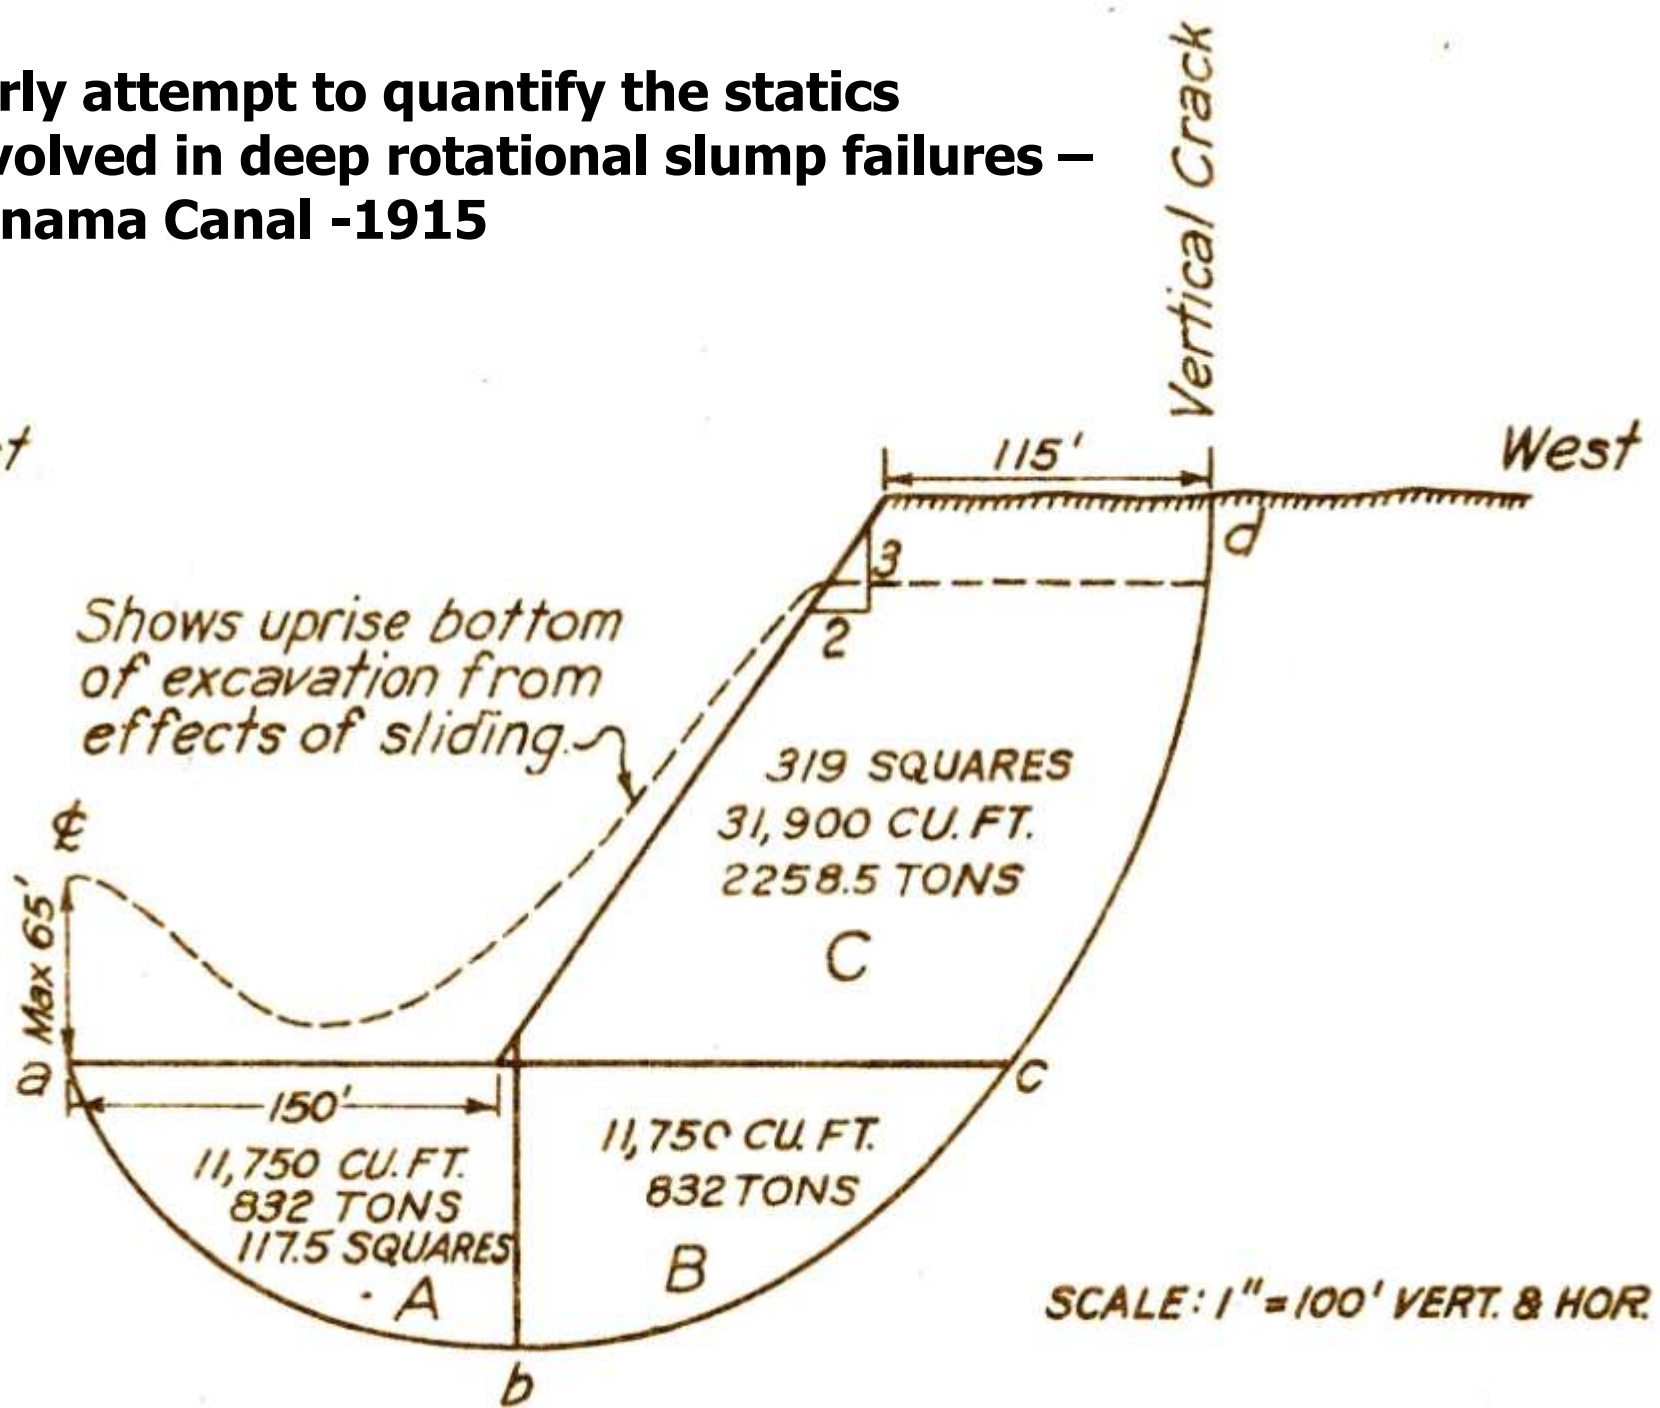
Early attempt to quantify the statics involved in deep rotational slump failures – Panama Canal -1915

East

West

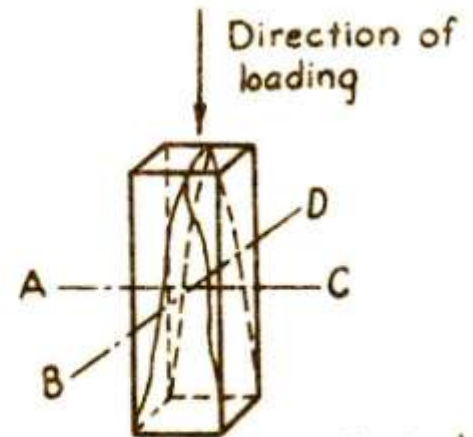
Diagram showing principal lines of rupture

Sample No. 11113-Y
 Ultimate load, 490 lbs. per sq. in.
 Elastic limit, 380 " " " "
 Modulus of elasticity 165000.

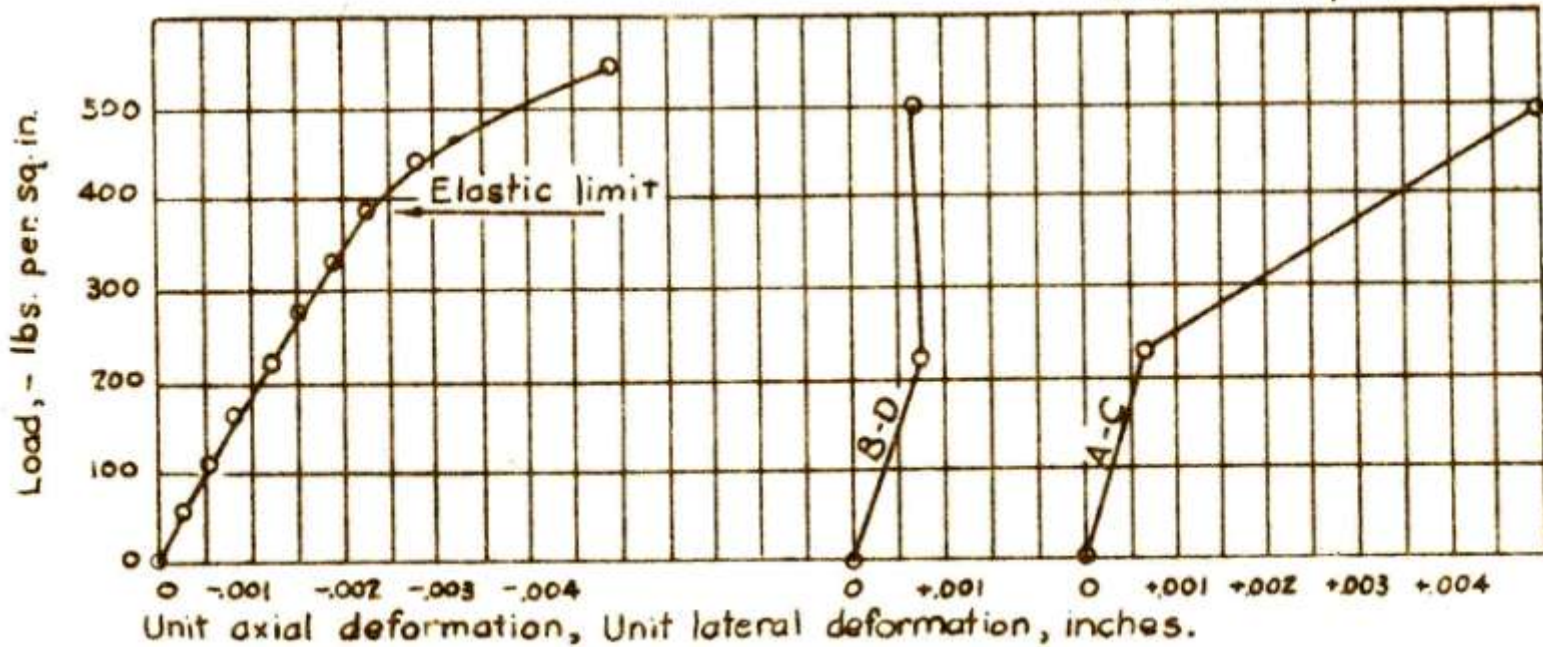
- Early compressive strength tests on the Culebra formation

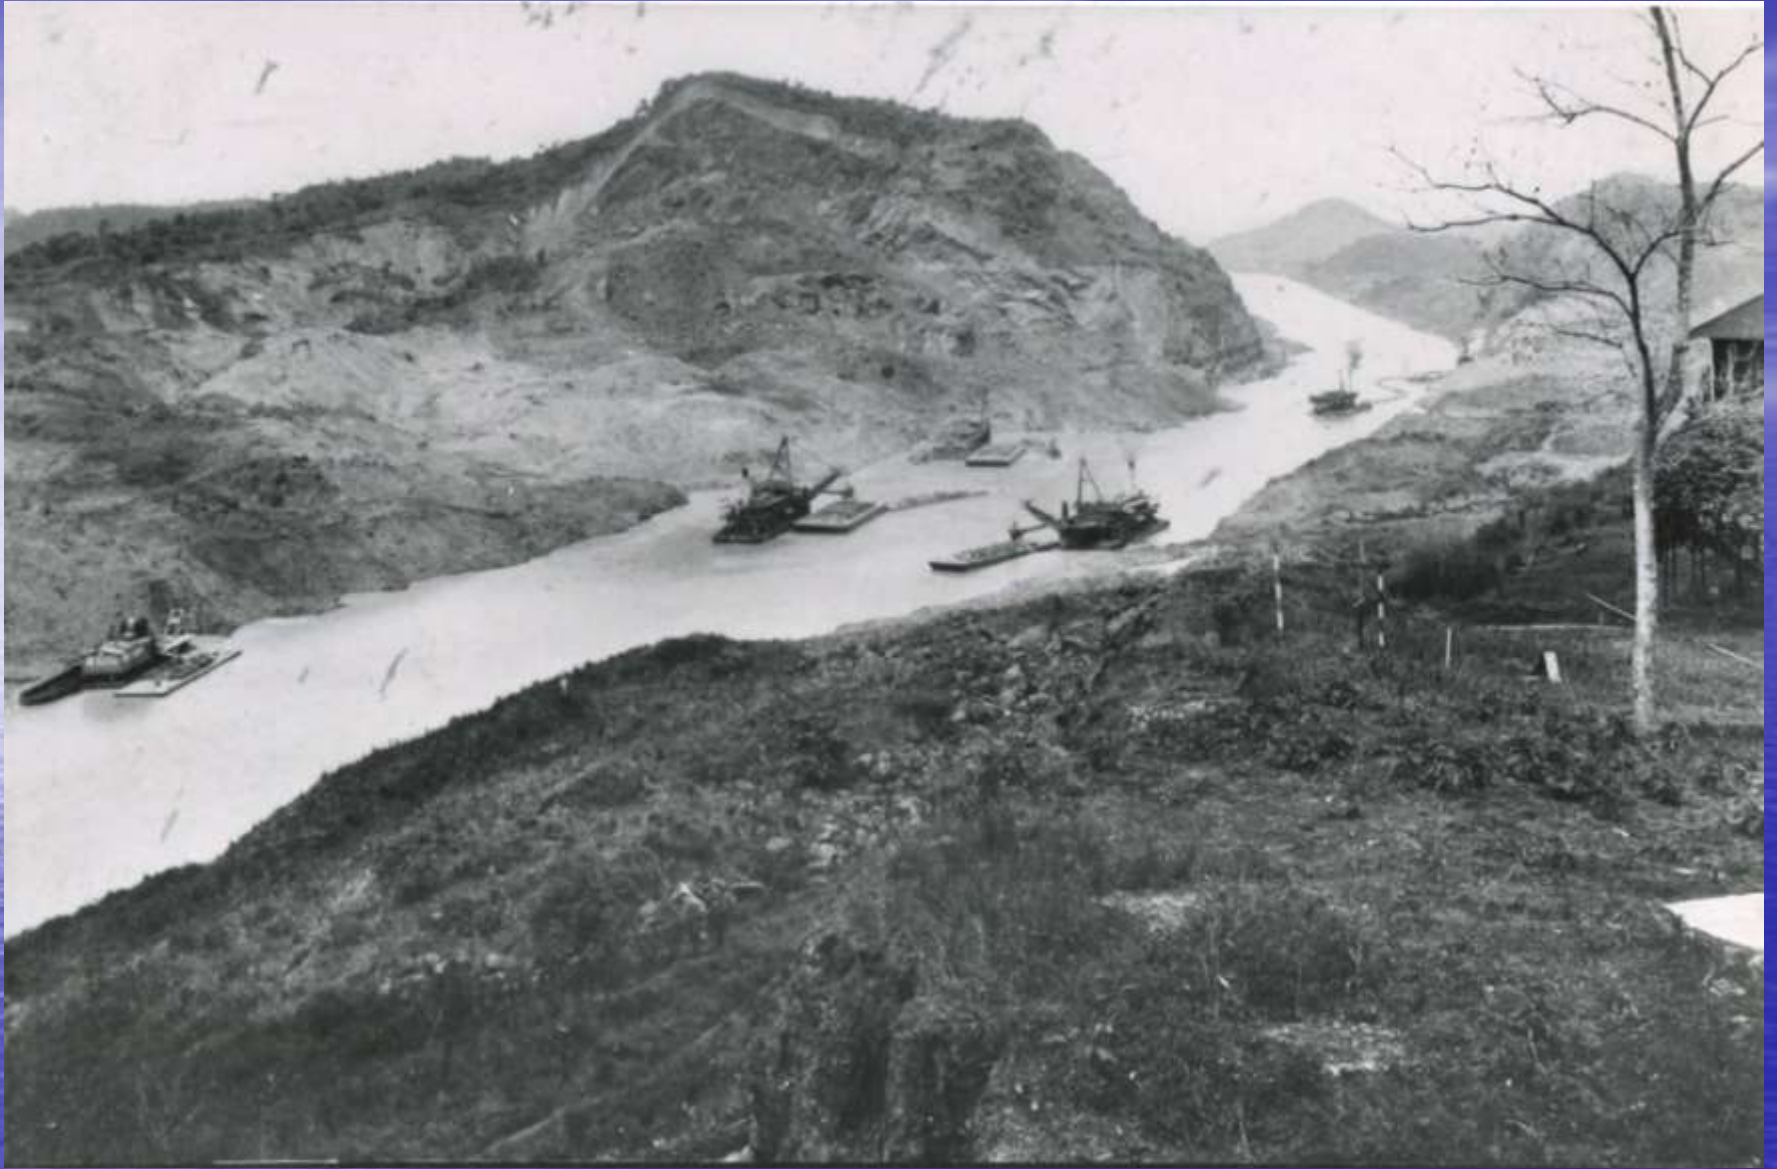
- **Barge shovels and suction dredges working the toe of the East Culebra Slide on July 3, 1916**

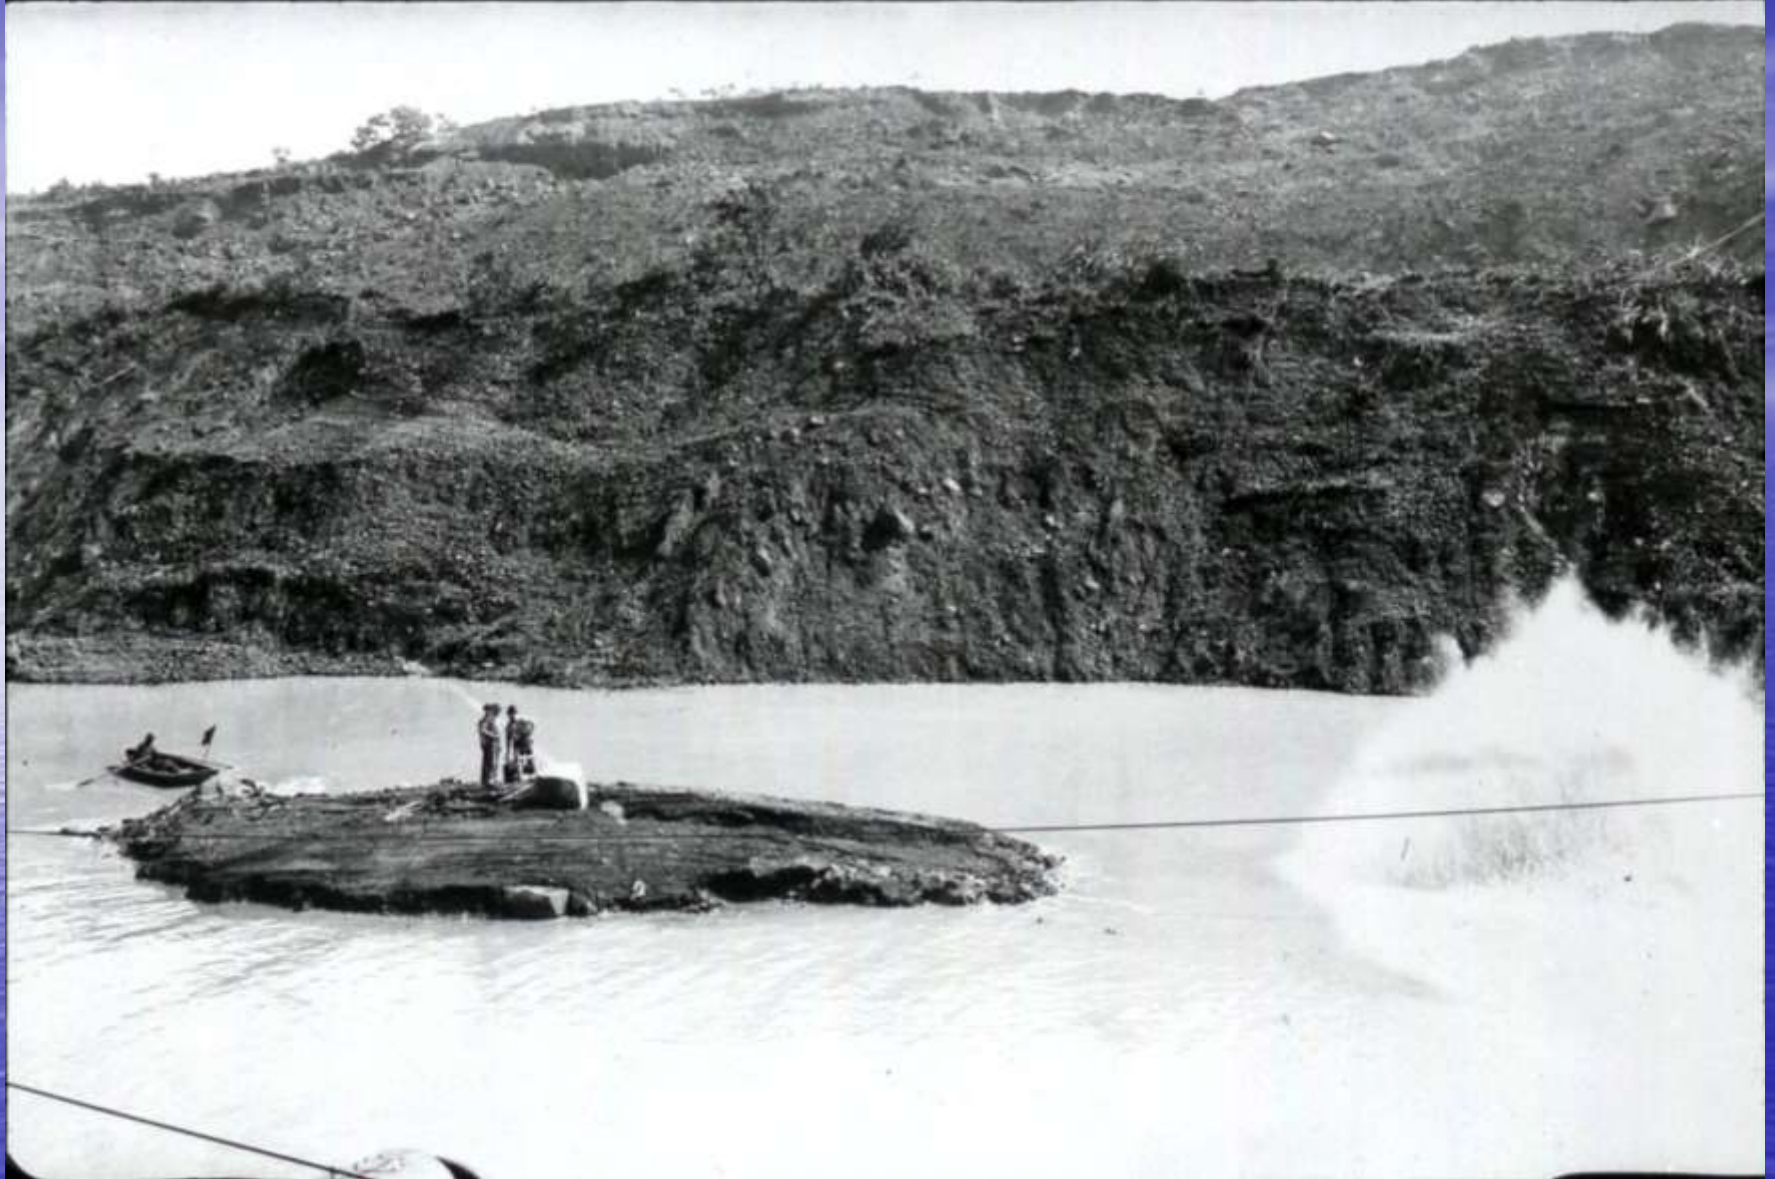
- **Toe heave that protruded upward through 30 feet of water on September 19, 1915.**

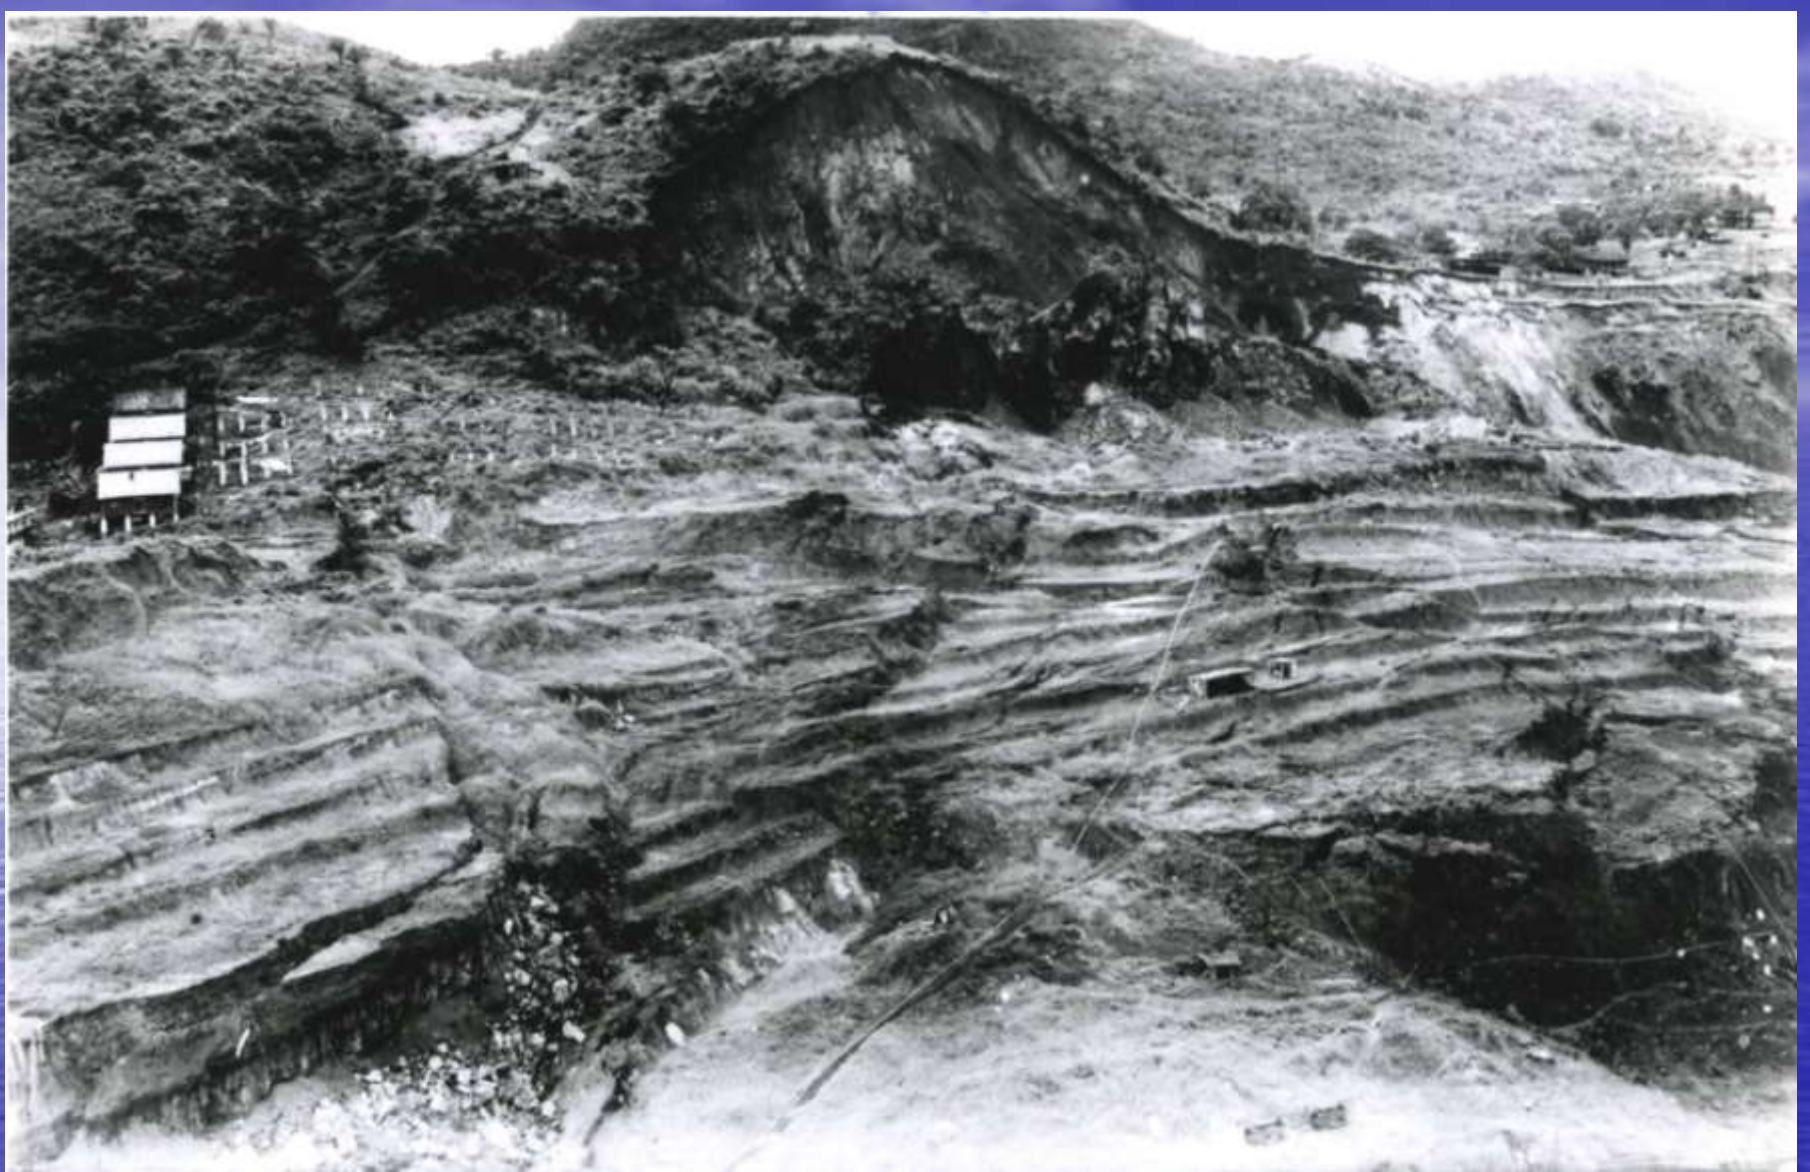
- **Zion Hill and the West Culebra Slide on October 24, 1915**

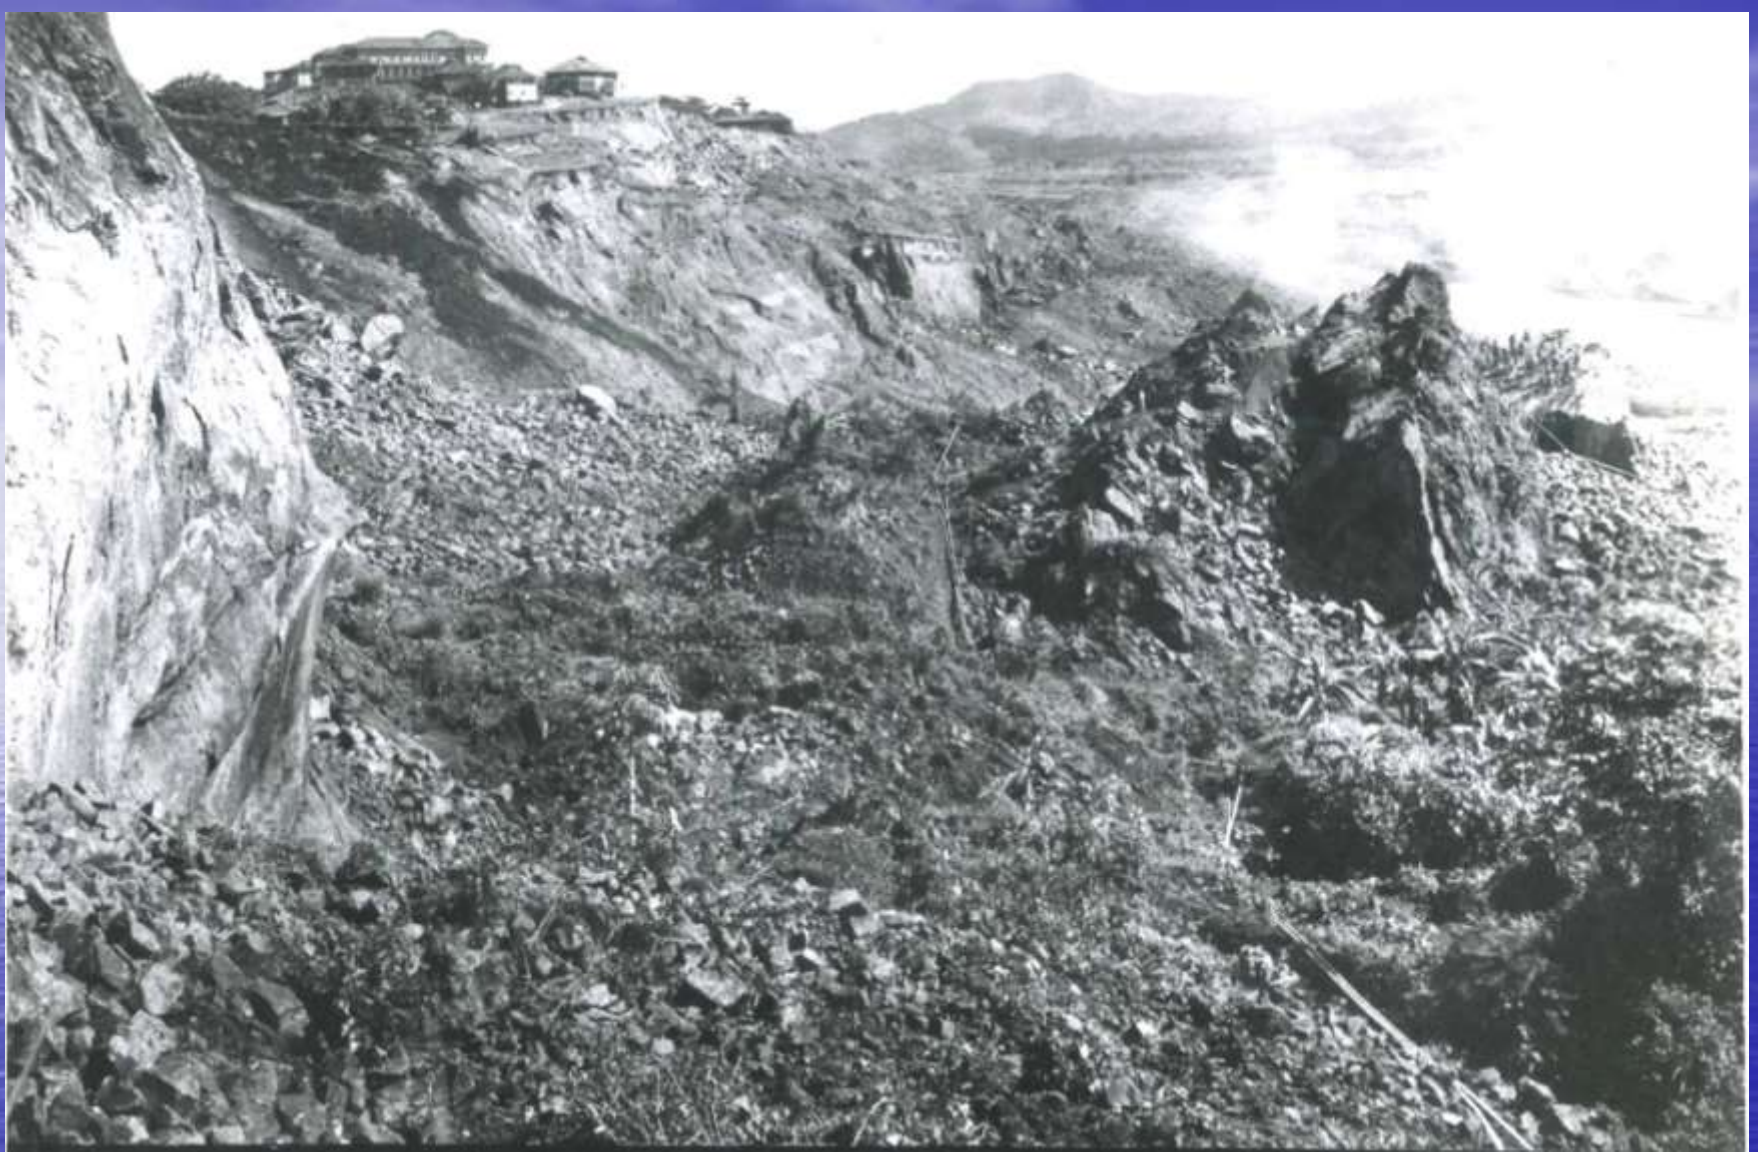
- **West Culebra slide activity viewed on July 3, 1916. Note emergence of 'Culebra Heights' in background.**

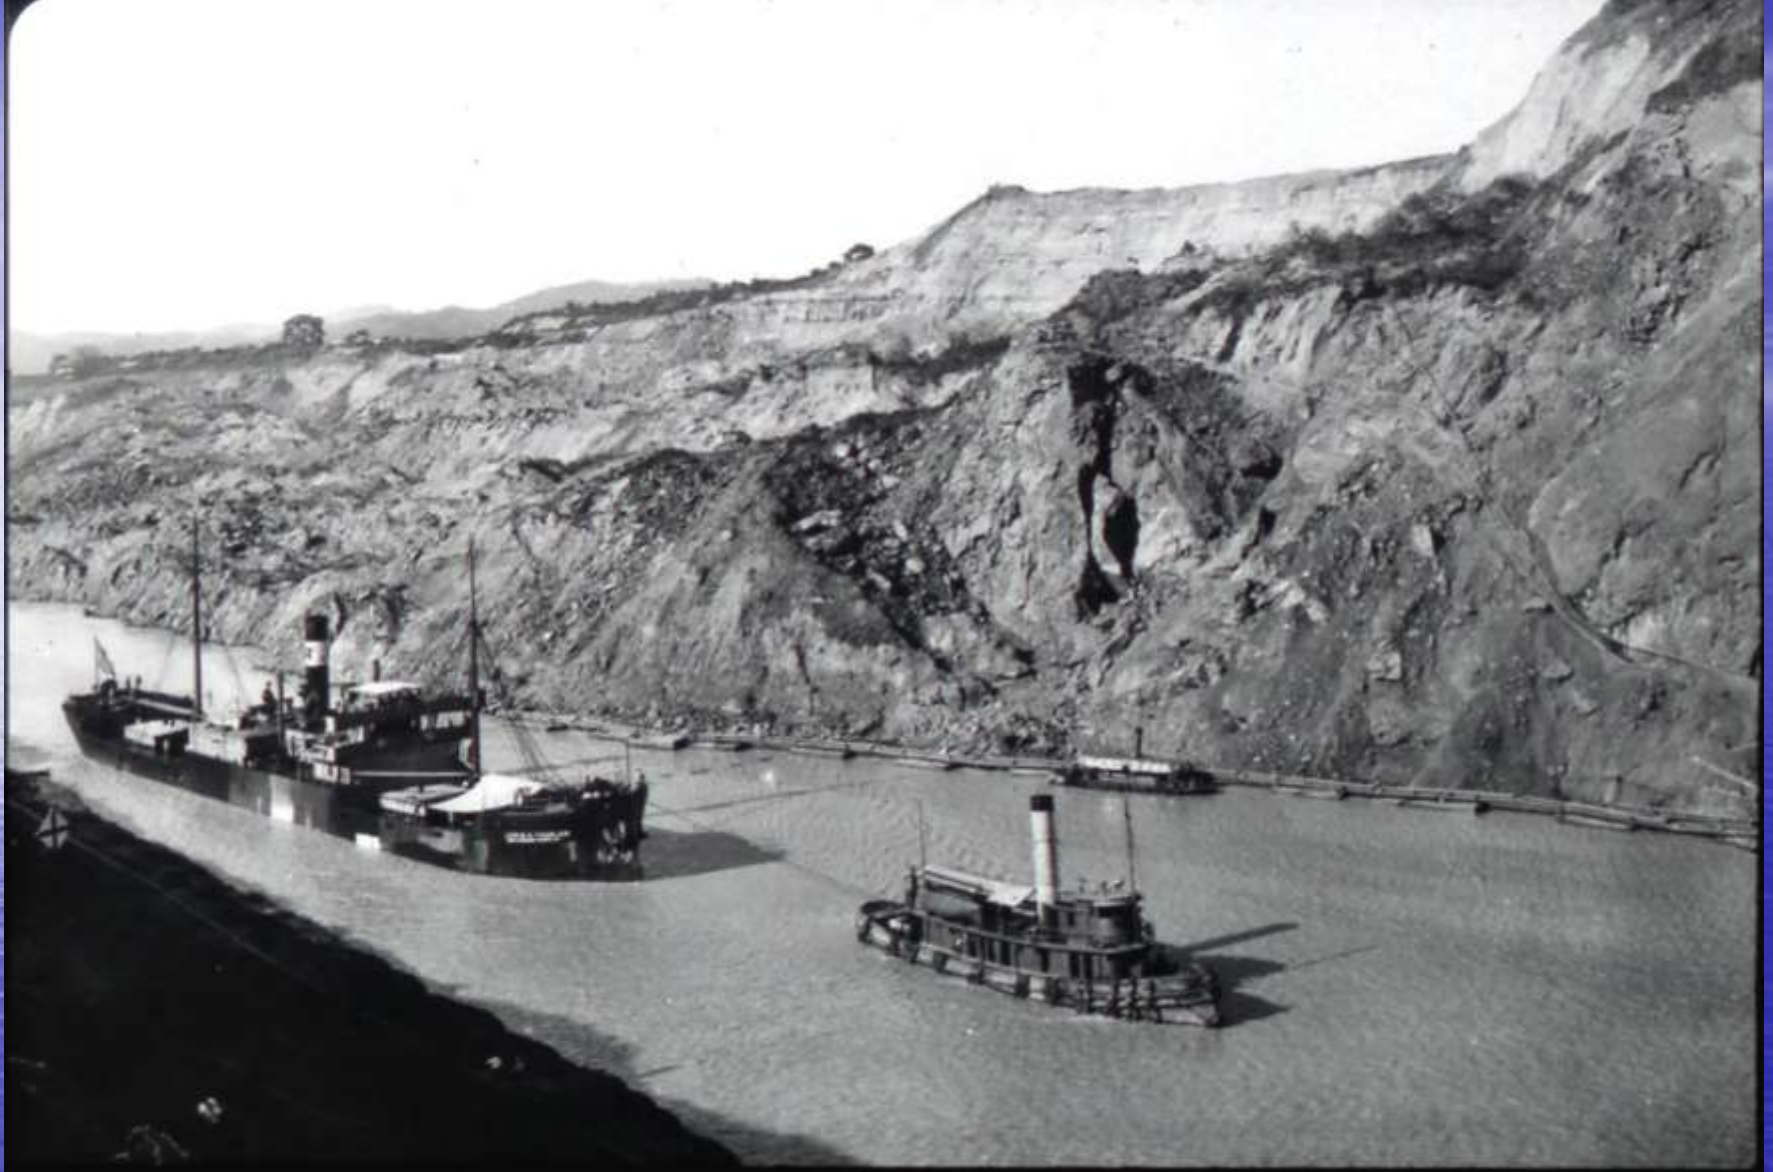
- **Landslides shut down the canal on 26 occasions between 1914 and 1986. This shows a tug assisting a coastal freighter passing through the canal in 1917.**
