LANDSLIDES of the PANAMA CANAL

J. David Rogers, Ph.D., P.E., P.G.

2011 Pacific Section Meeting

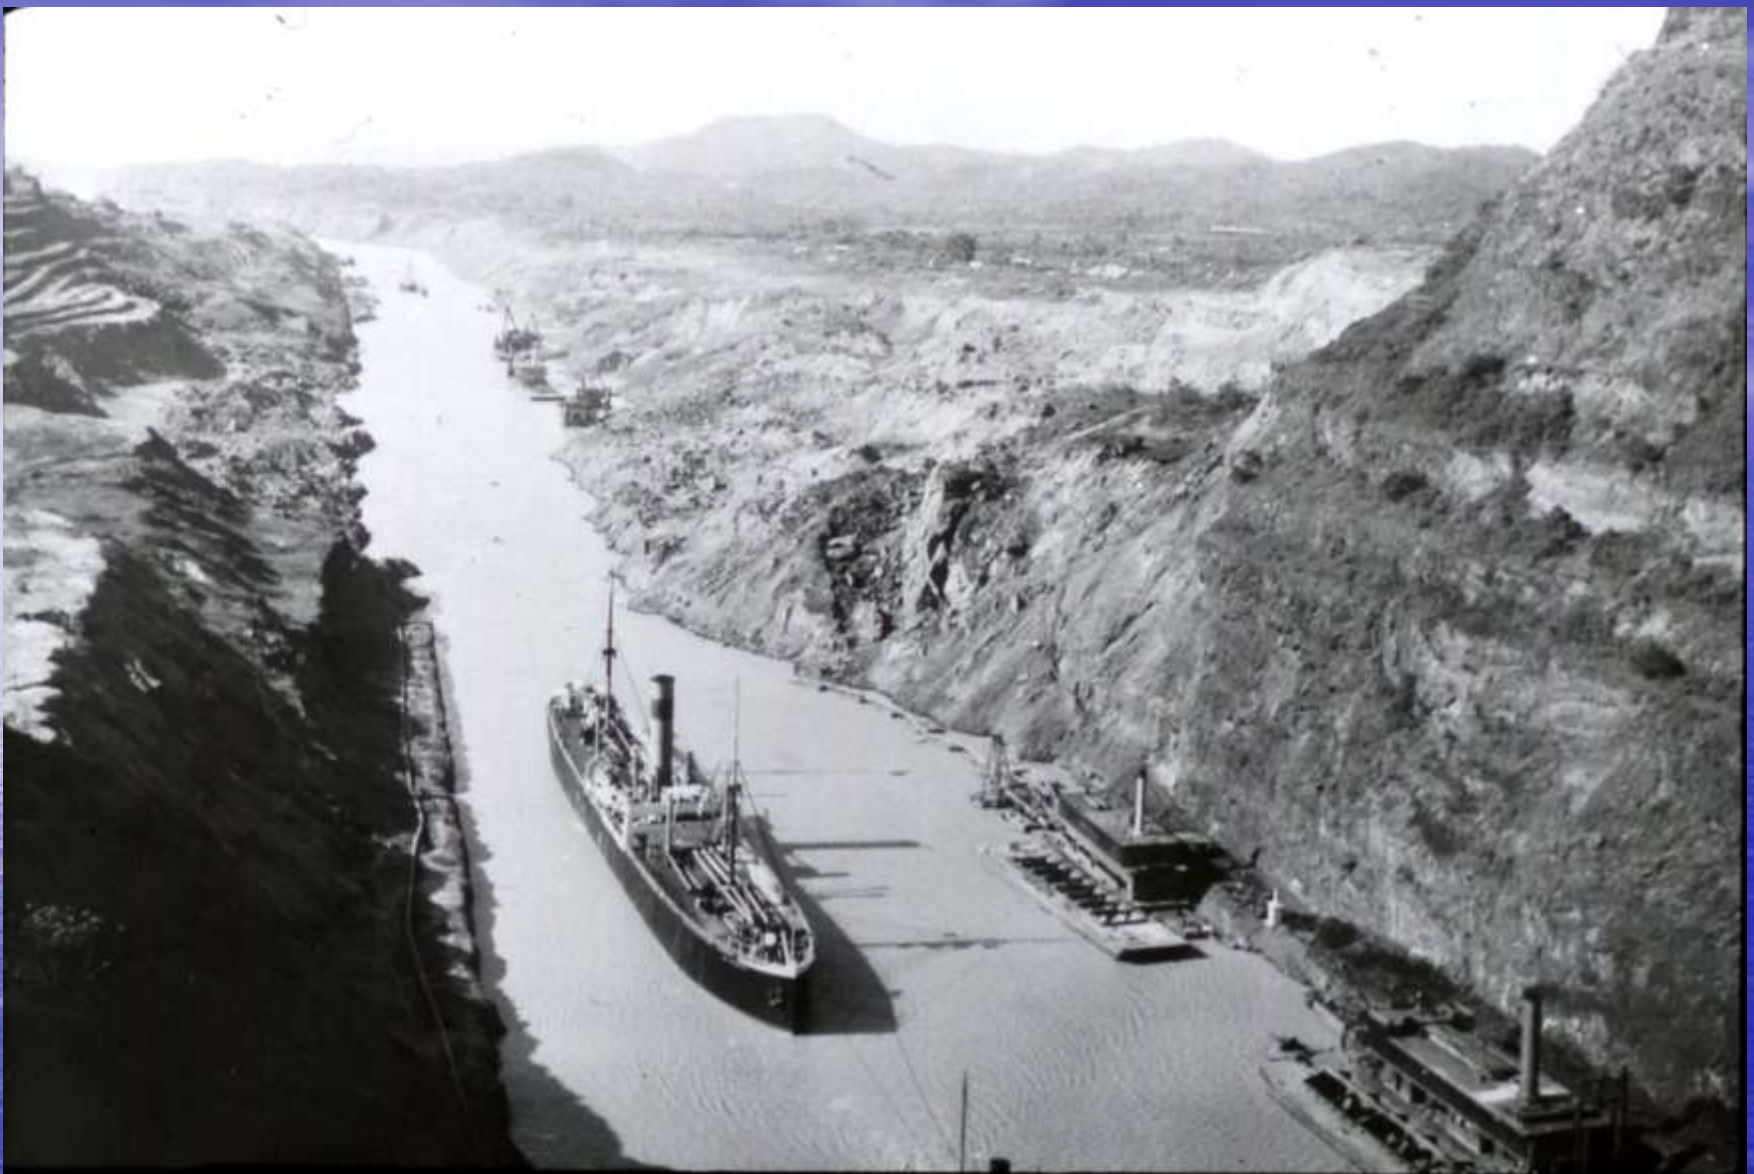
- **Ship transiting canal around the East Culebra Slide. Note dredges and muck barges**

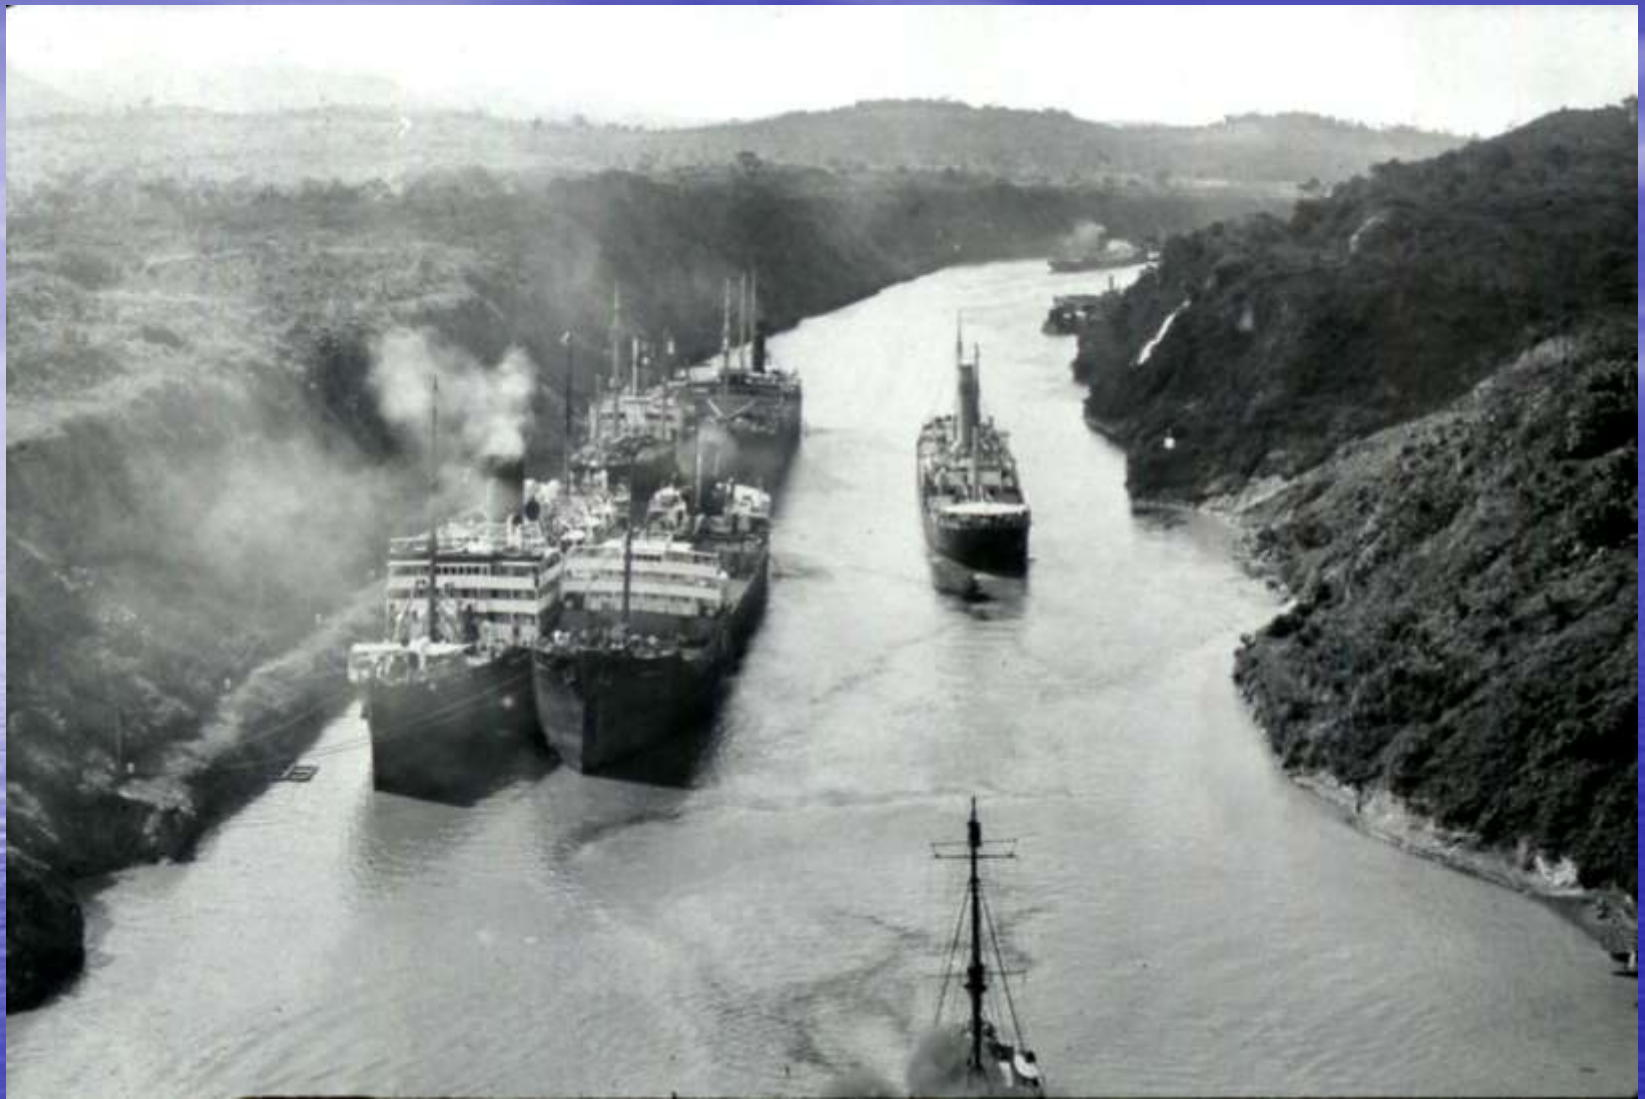
- **When landslides partially blocked the channel, ships were queued up on either side of the construction and escorted through the gap.**

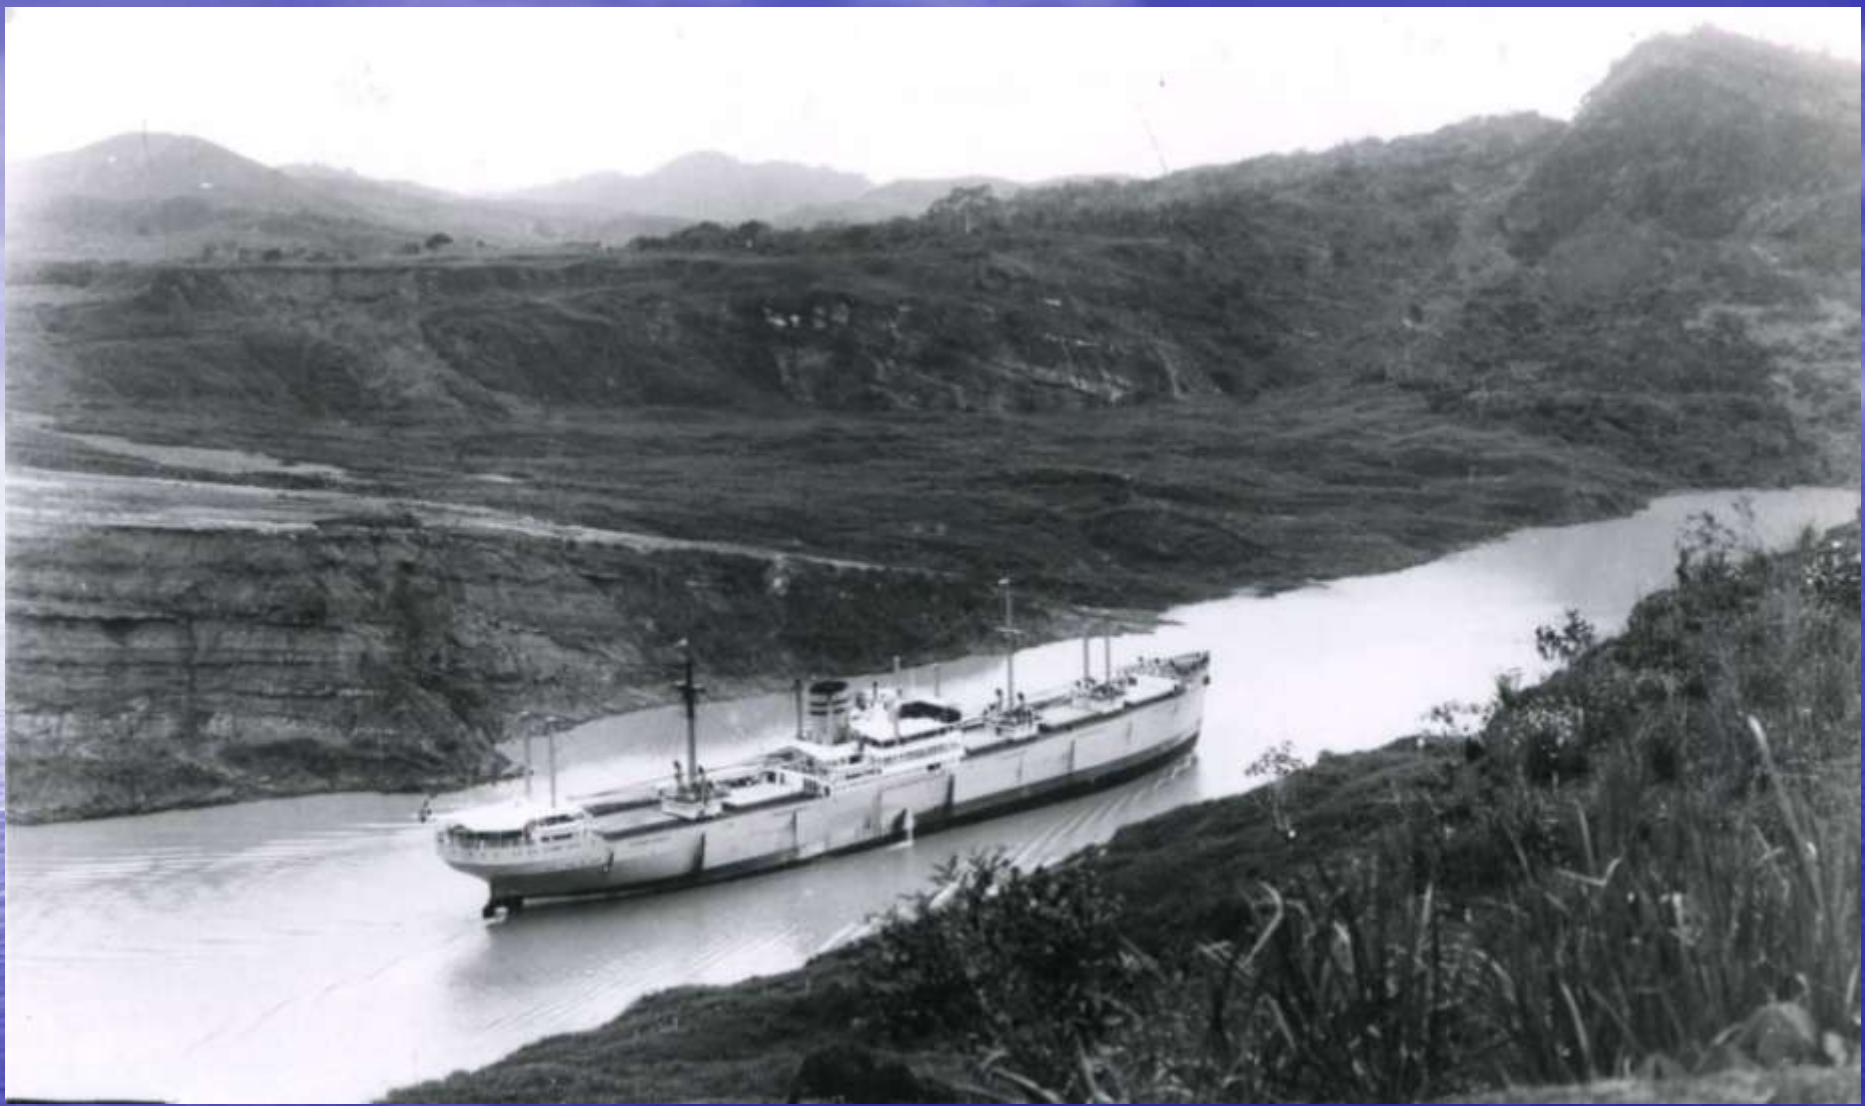
- **Still running one-way traffic on June 13, 1933-
passing the dormant East Culebra Slide**

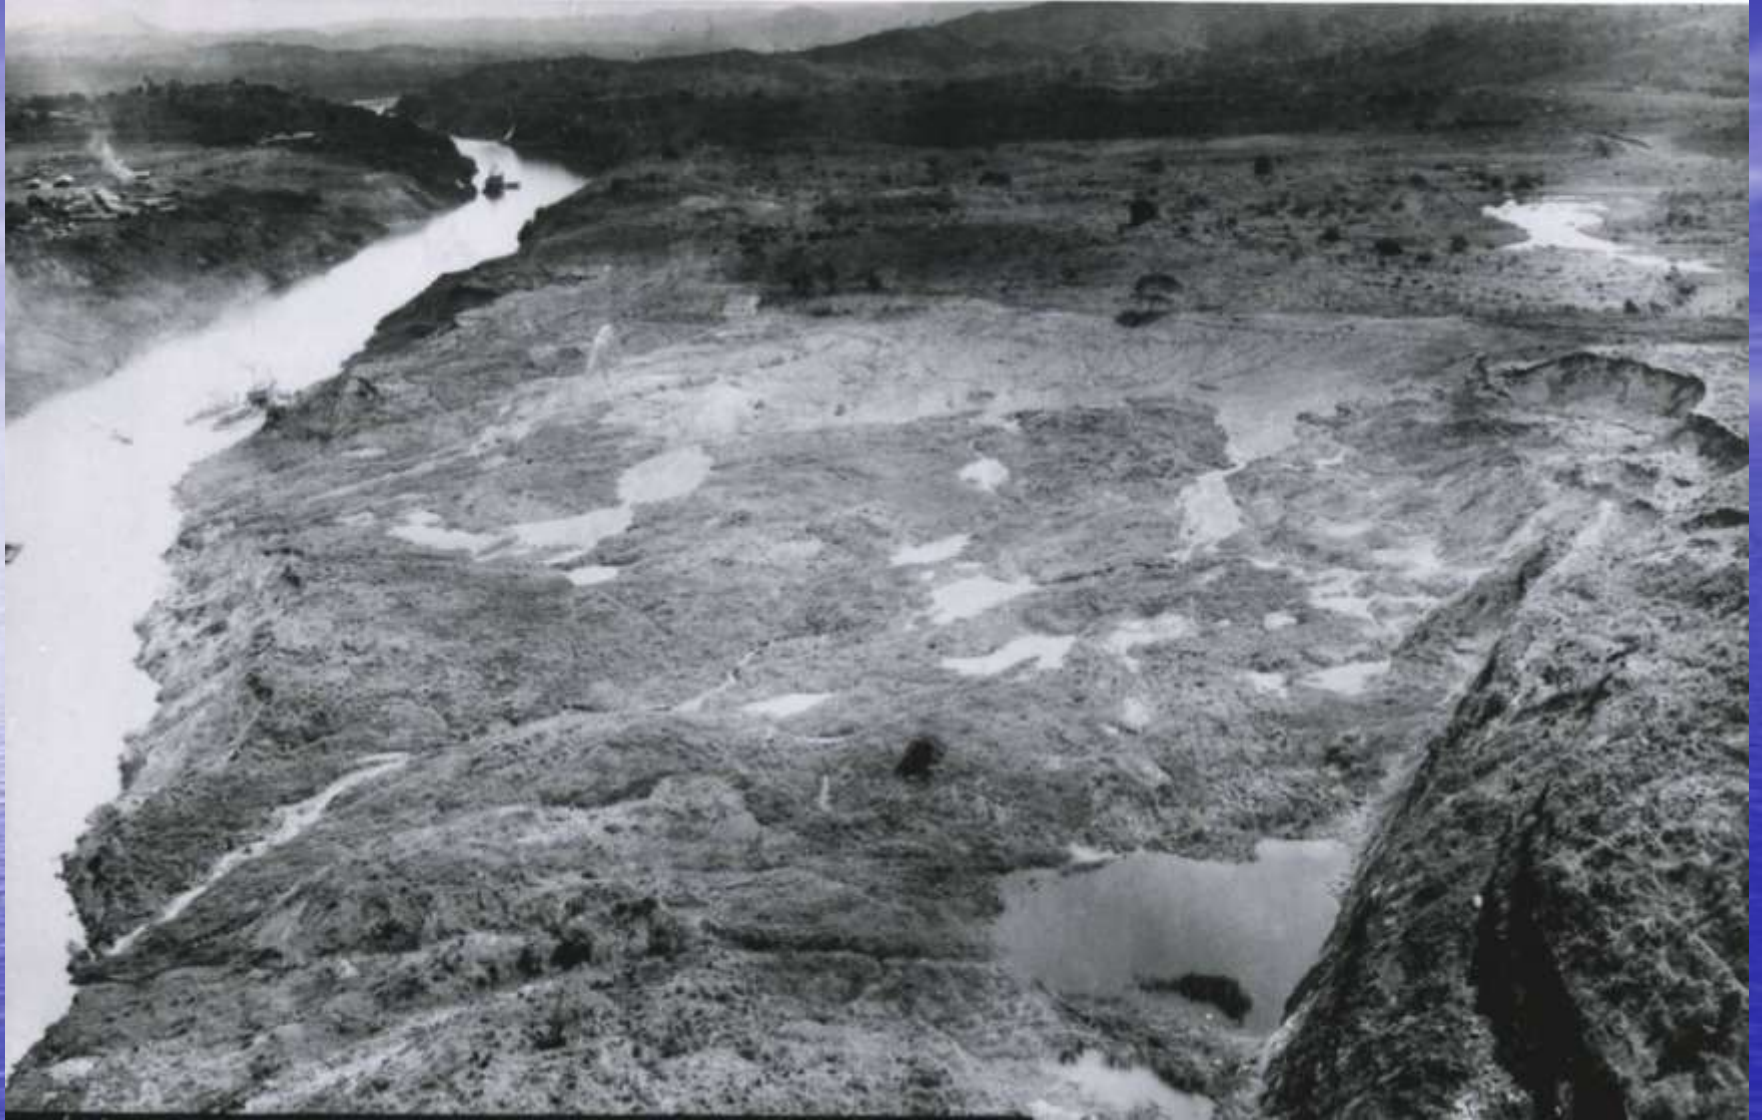
- **East Culebra Slide as seen from the crest of Gold Hill on June 19, 1923. The shear strength of the slide debris had obviously been transformed to a much lower value.**

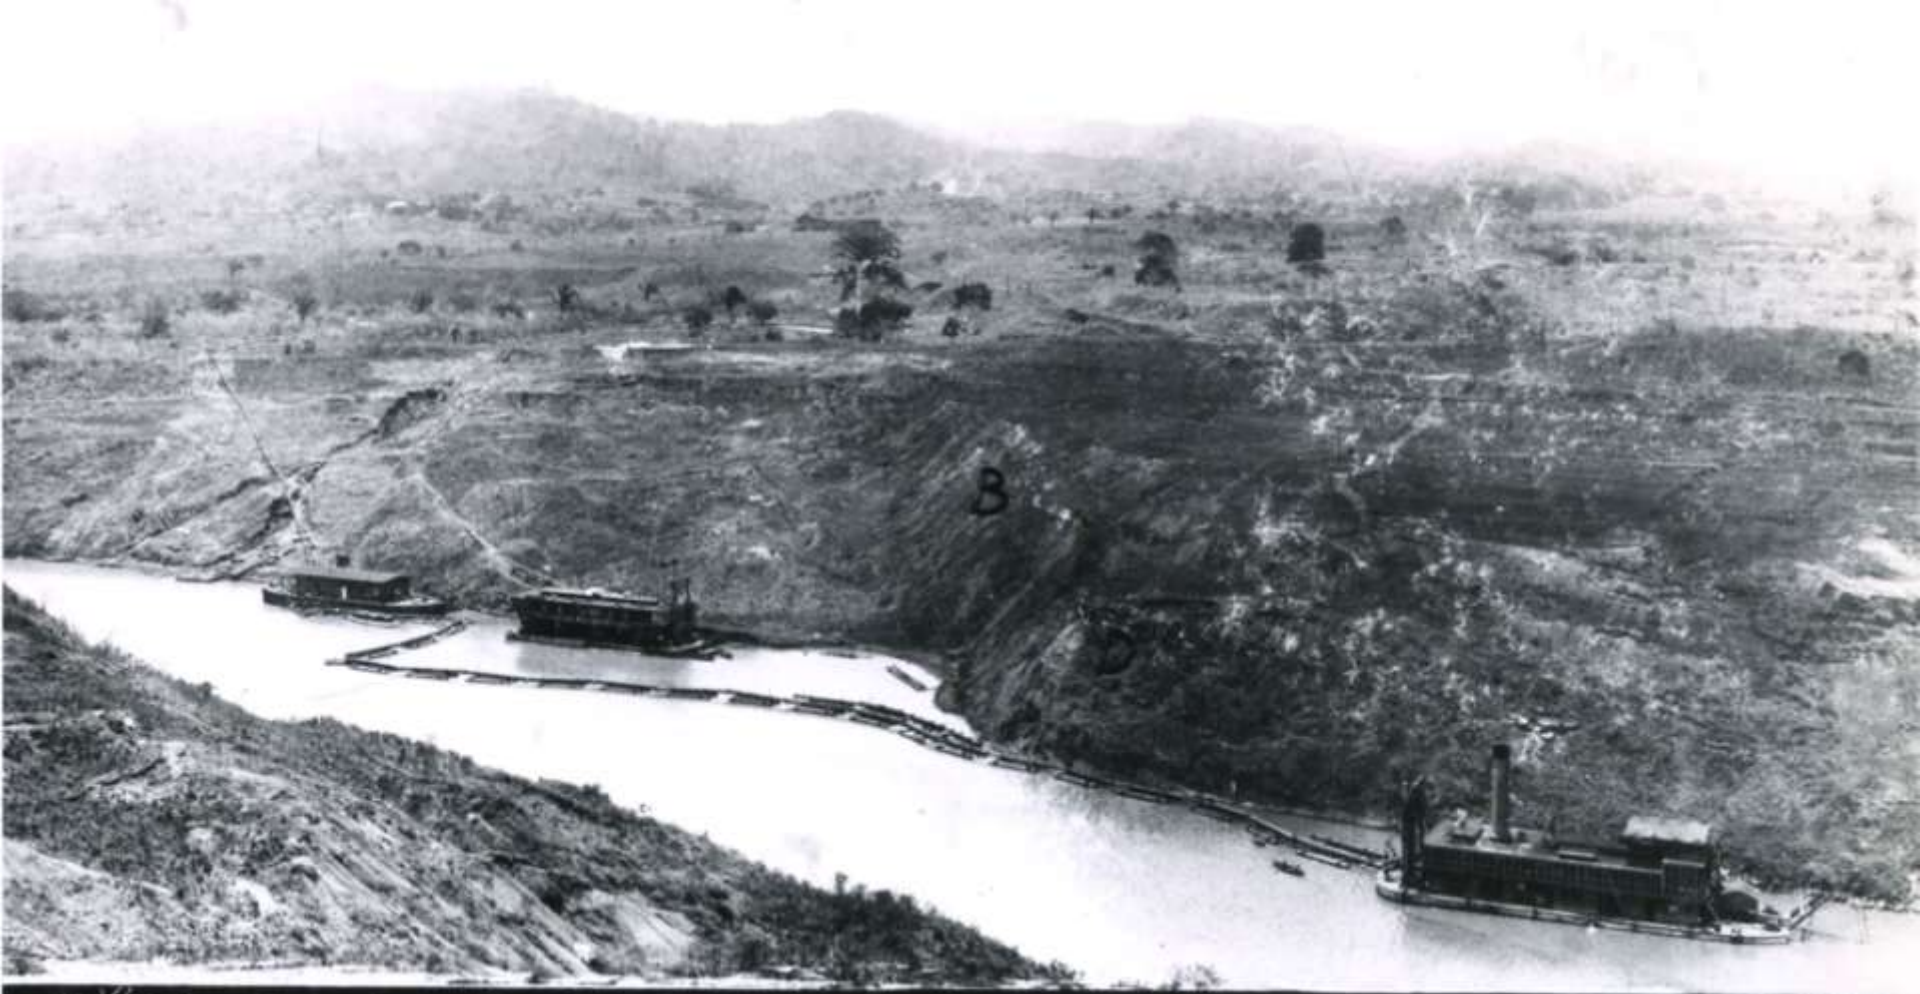
- **Dredges continue to work the zone between Obispo and East Culebra on April 25, 1924, ten years after the canal opened**

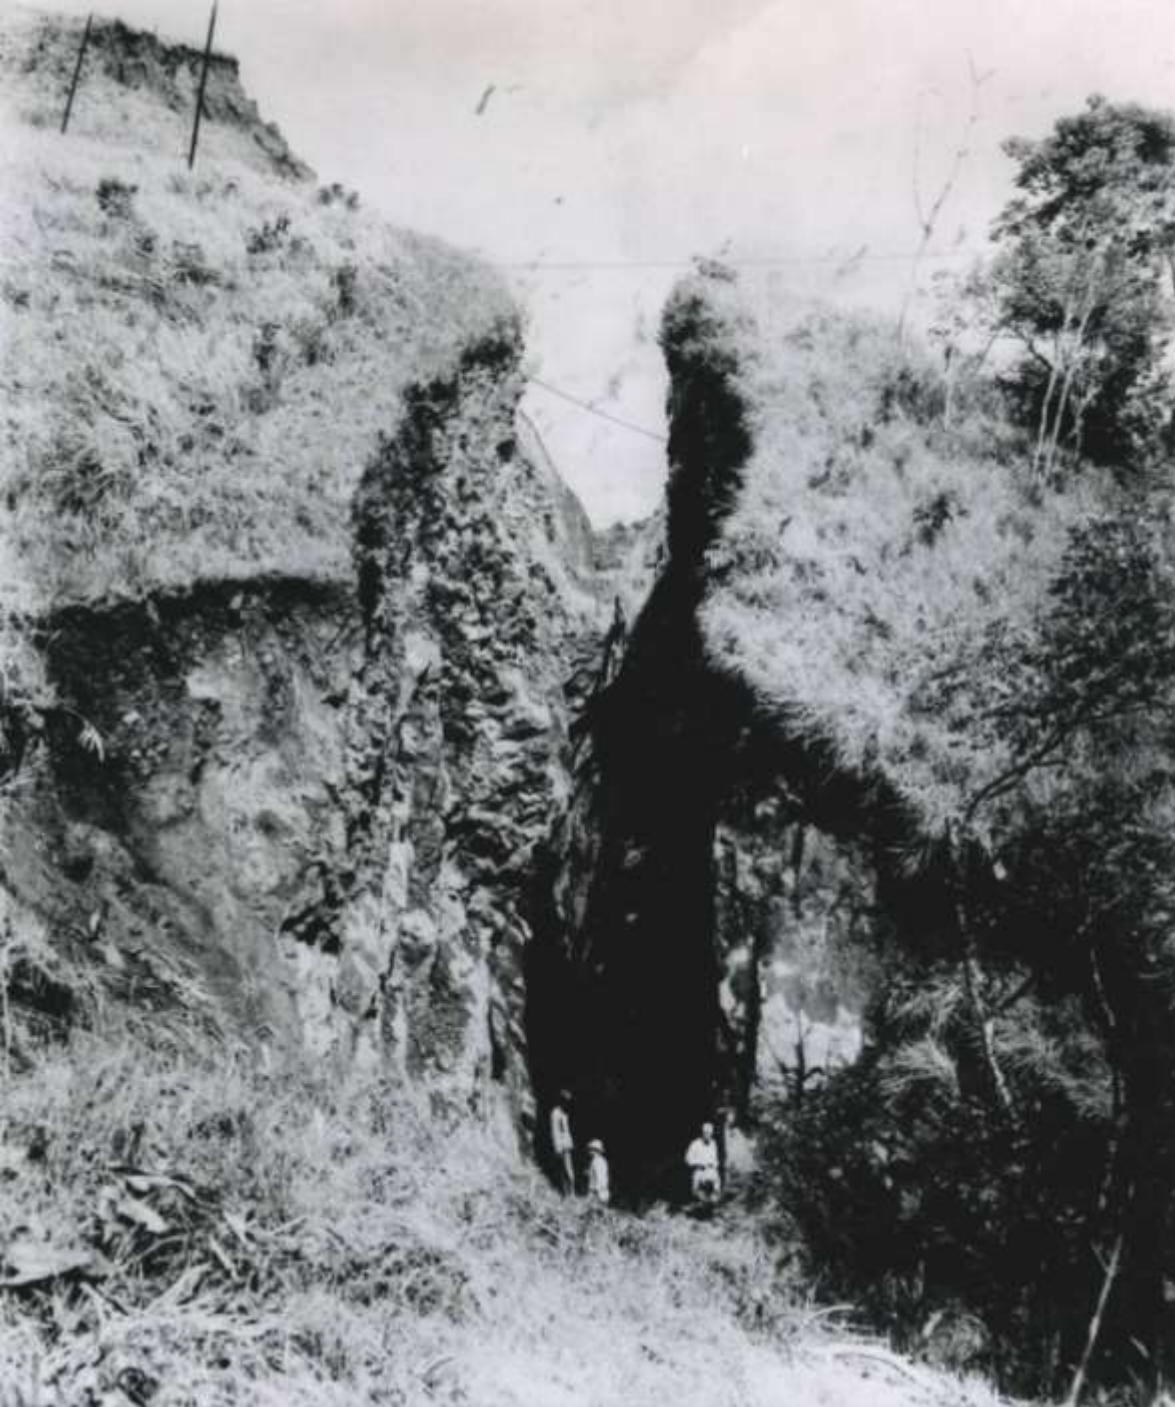
Tensile scarps

- **Massive tension crack opening above the West Culebra Landslide on October 22, 1936**

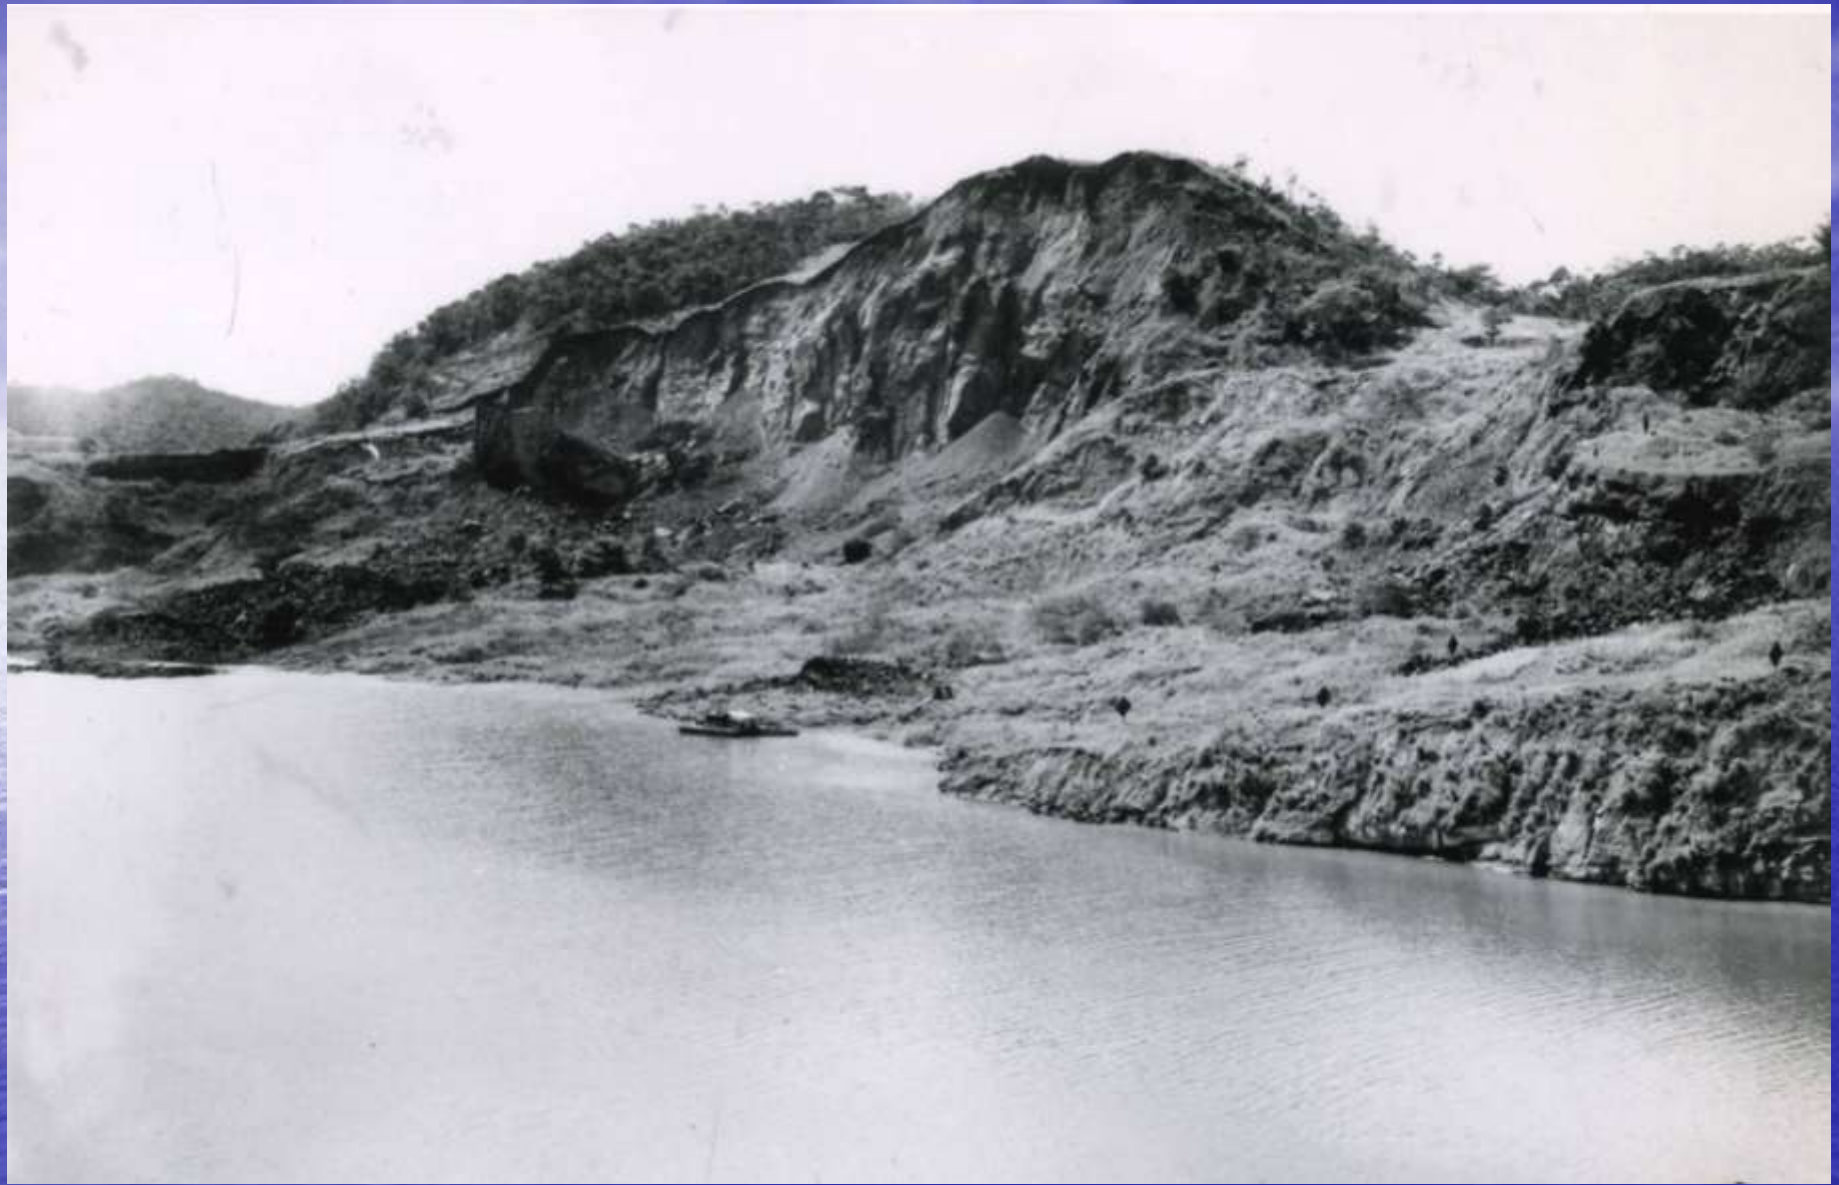
- **Head scarp of the West Culebra Slide, 25 years later, on January 26, 1937**

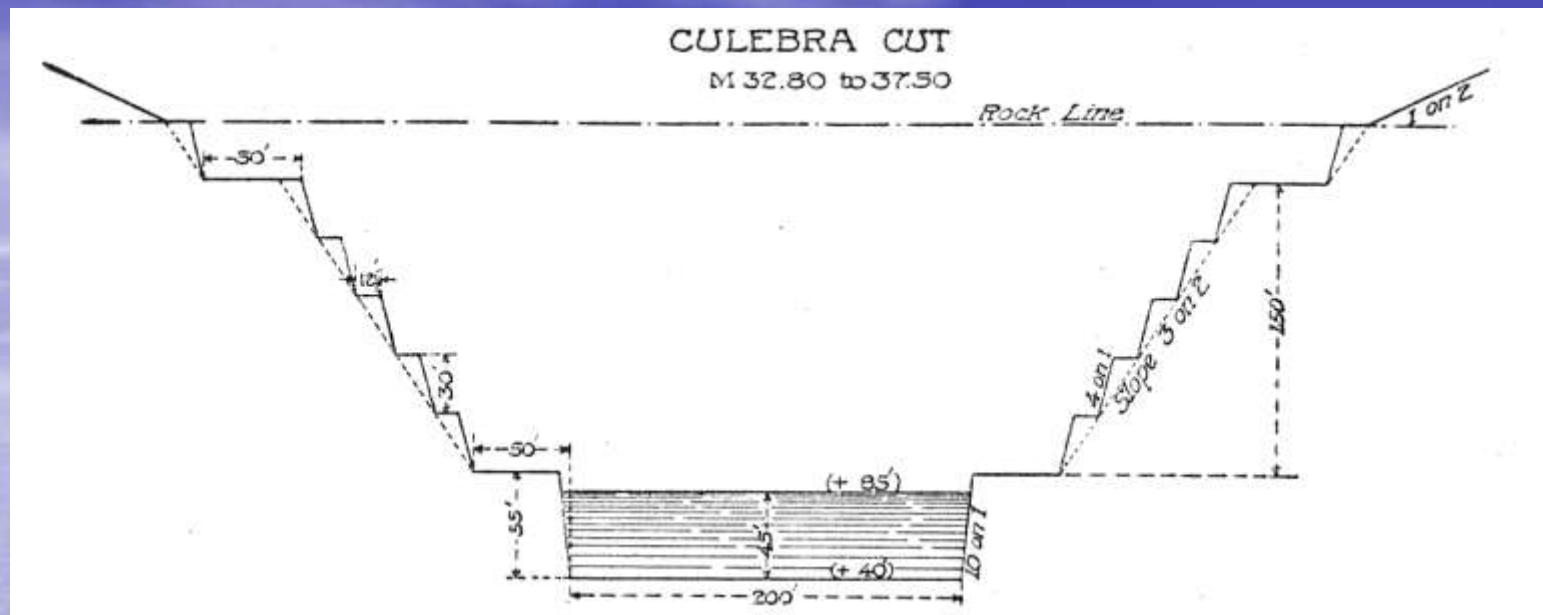
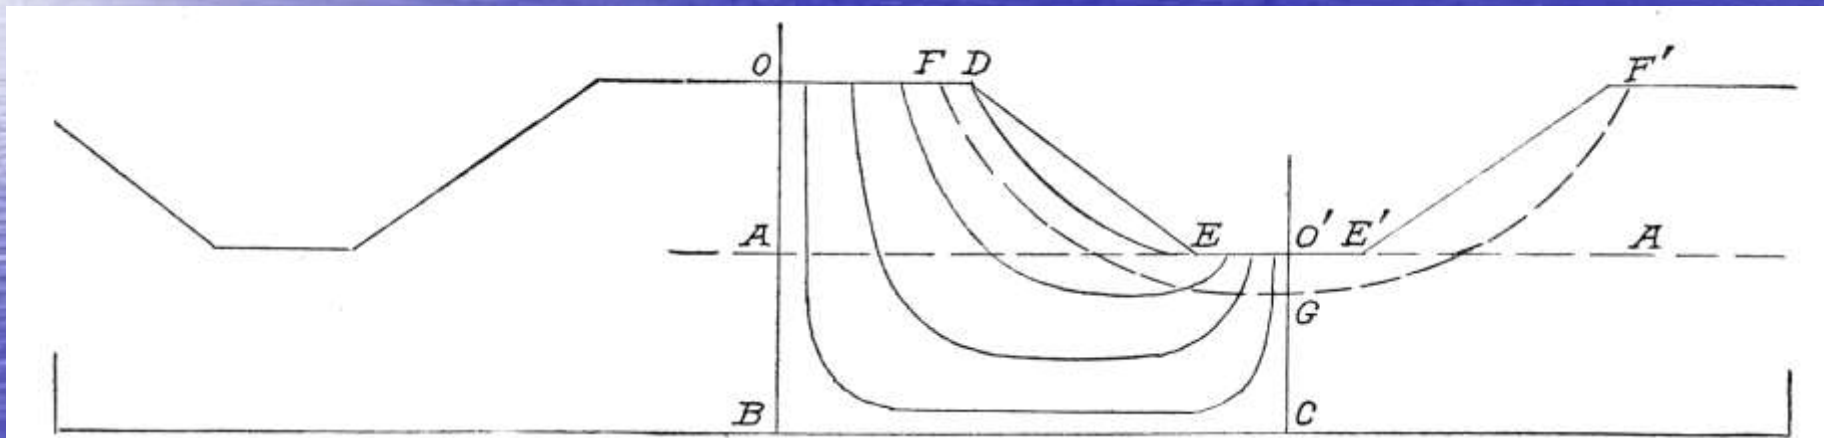
- The 1924 NAS study did a credible job of documenting the history of landslide problems along the canal excavations, but offered little in the way of meaningful analyses or solutions. Note flow net.

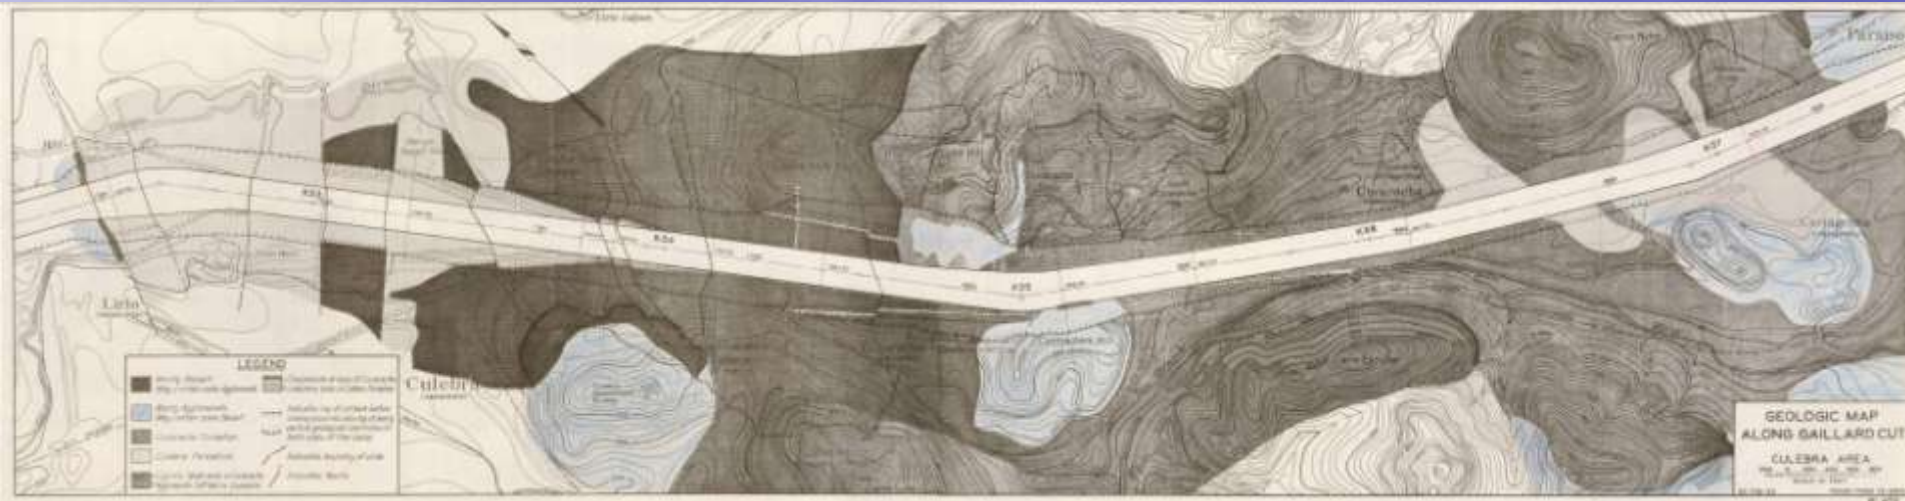
Geologic Strip Map

- The Panama Canal Commission brought Donald F. MacDonald back to work on the Third Locks Project in 1940. He supervised the compilation of a new geologic map, shown here.

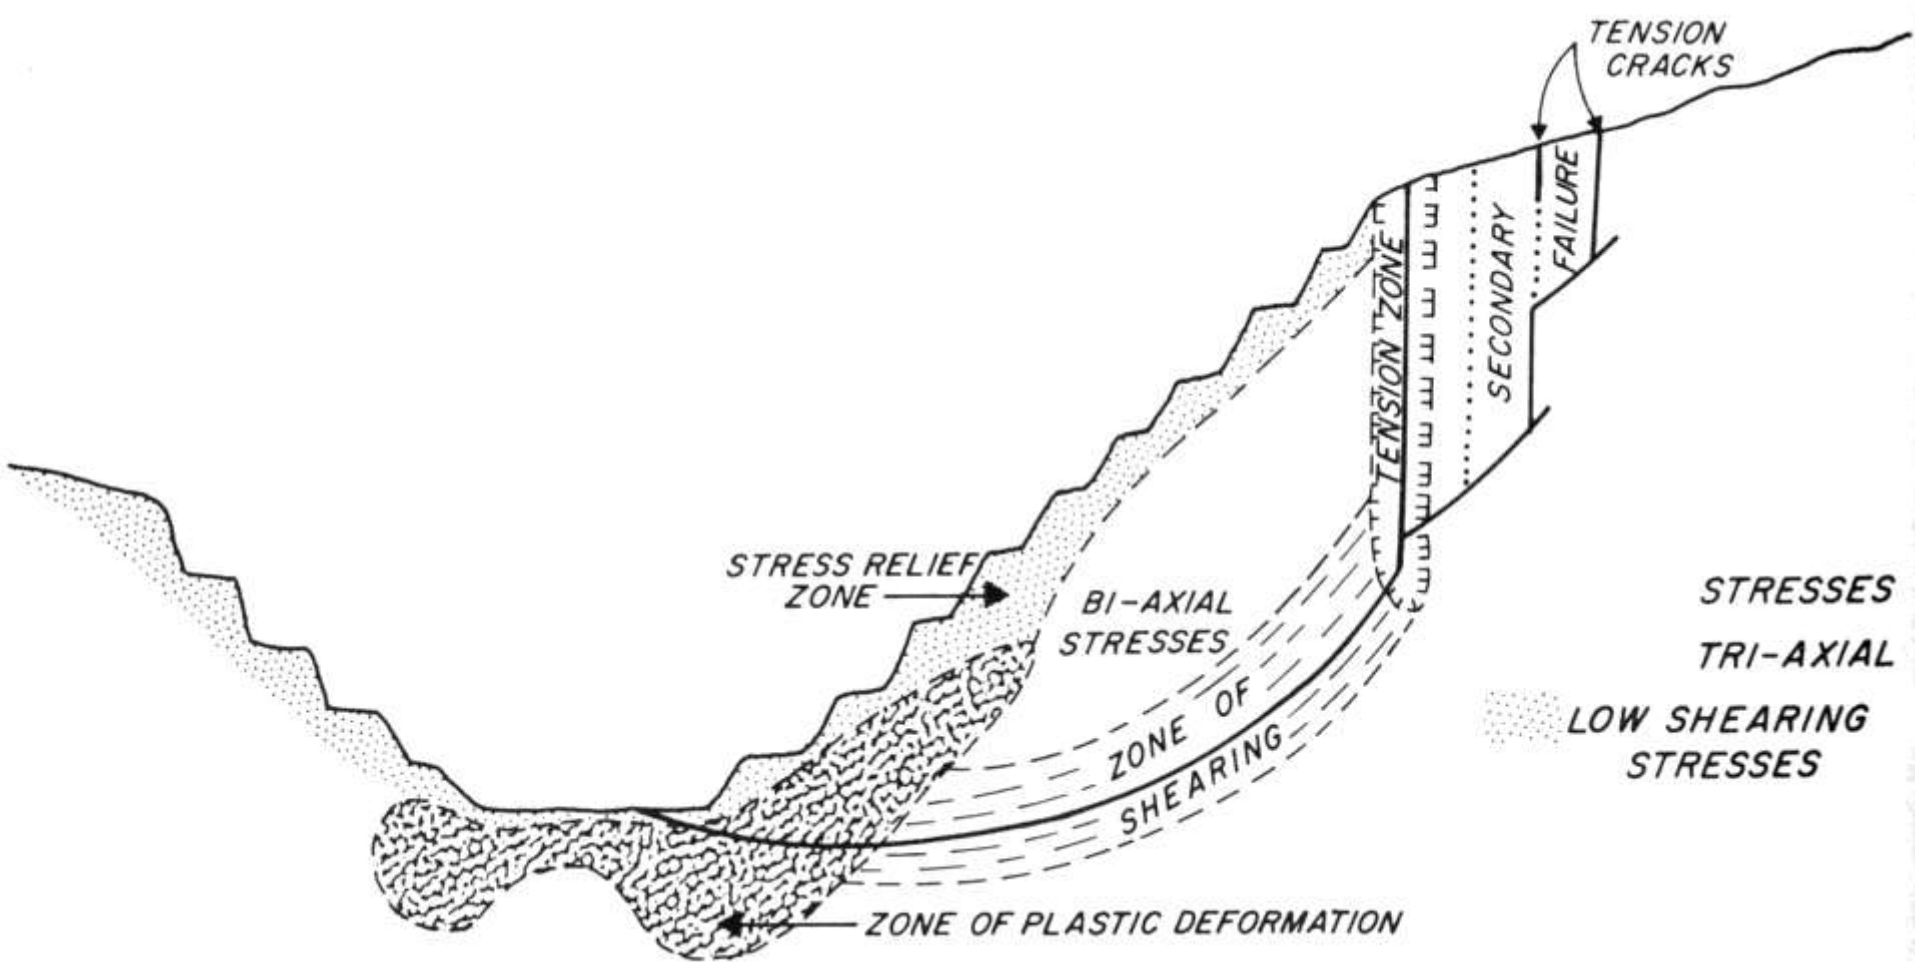
- By the mid 1940s Corps of Engineers researchers were beginning to appreciate the significance of stress regimes and strain on soil strength parameters, as sketched here.

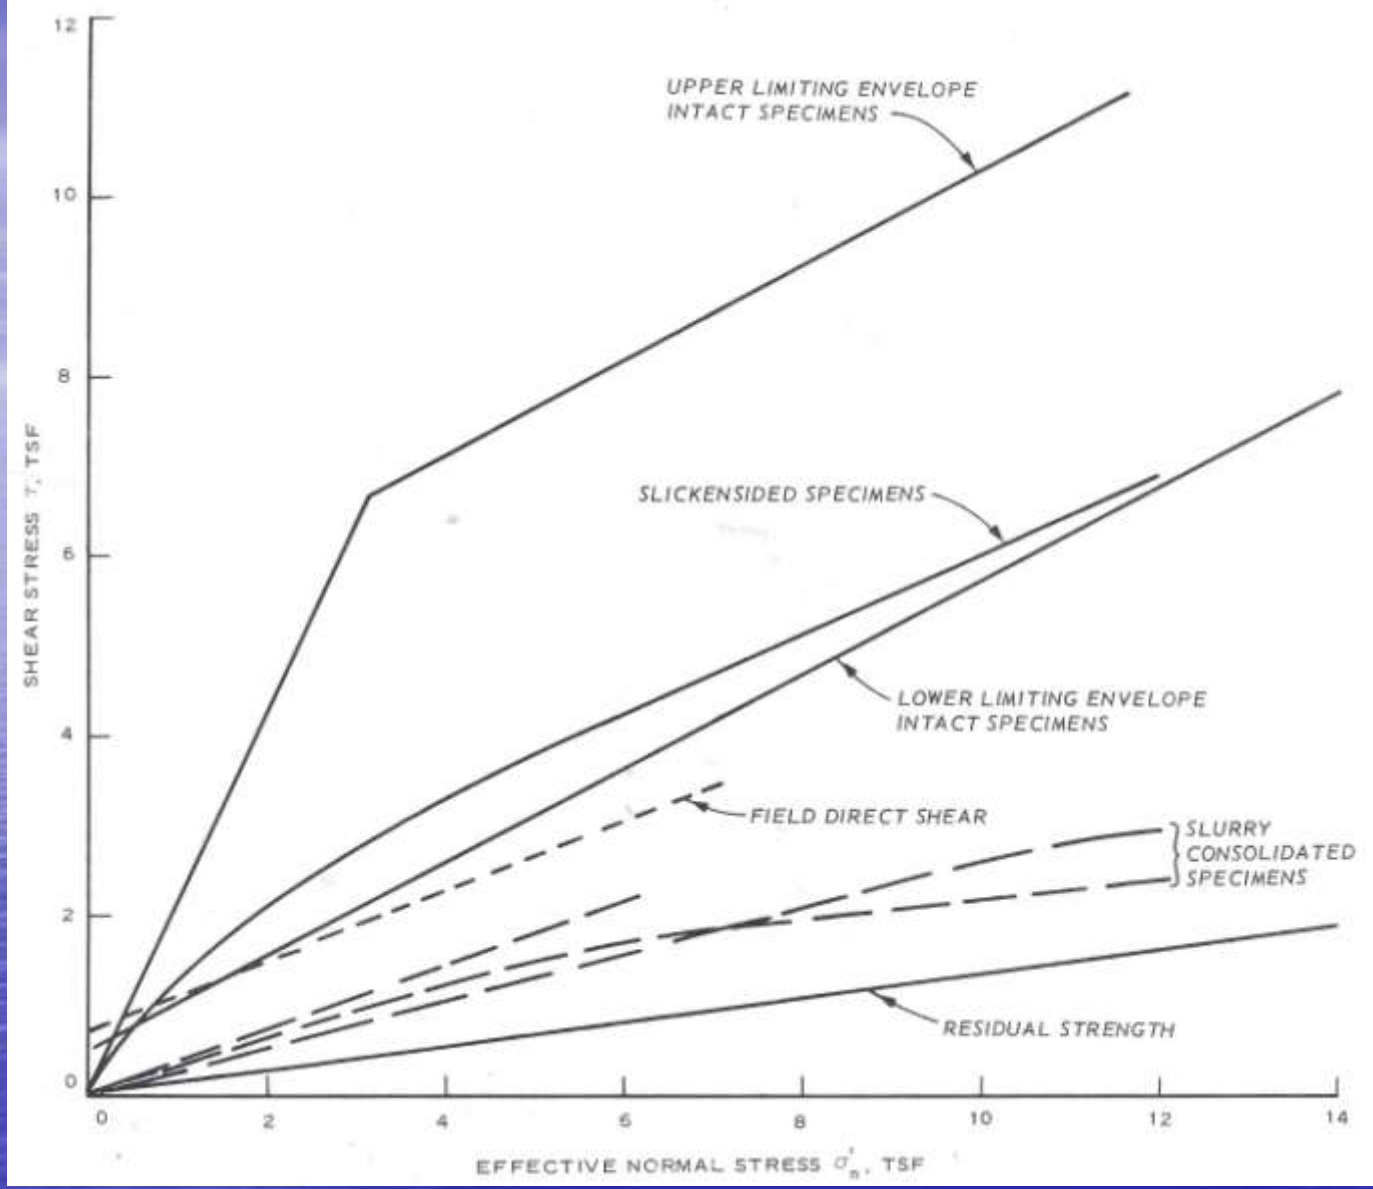
- Shear vs effective normal stress plots. Note impact of disturbance, or plastic strain, on mobilized shear strength.

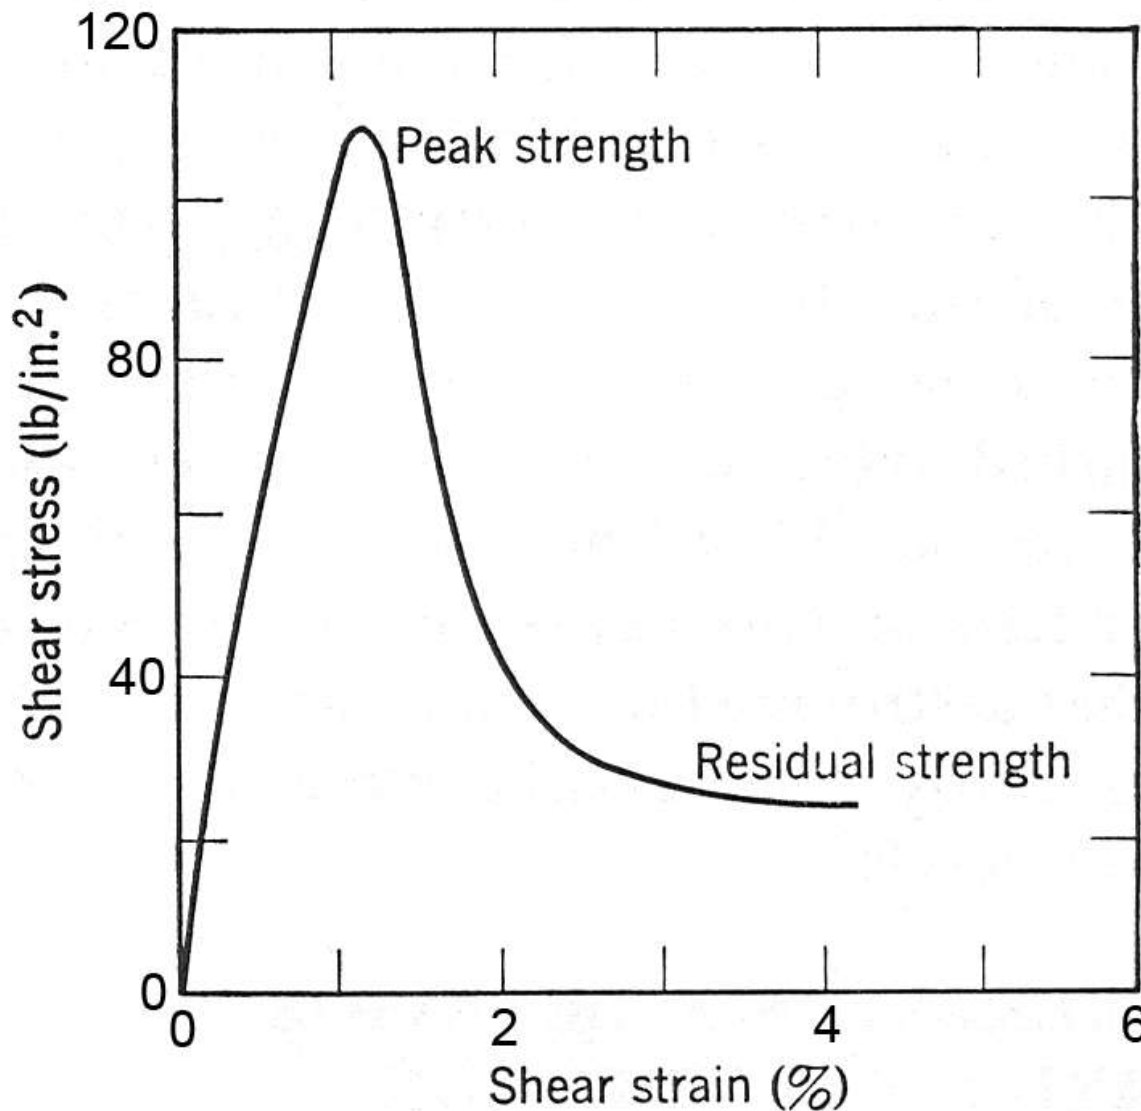
- The concept of residual strength came out of tests on the Cucaracha Shale in the late 1940s for the Corps of Engineers, shown here.

Overconsolidated shales tend to exhibit strain softening behavior

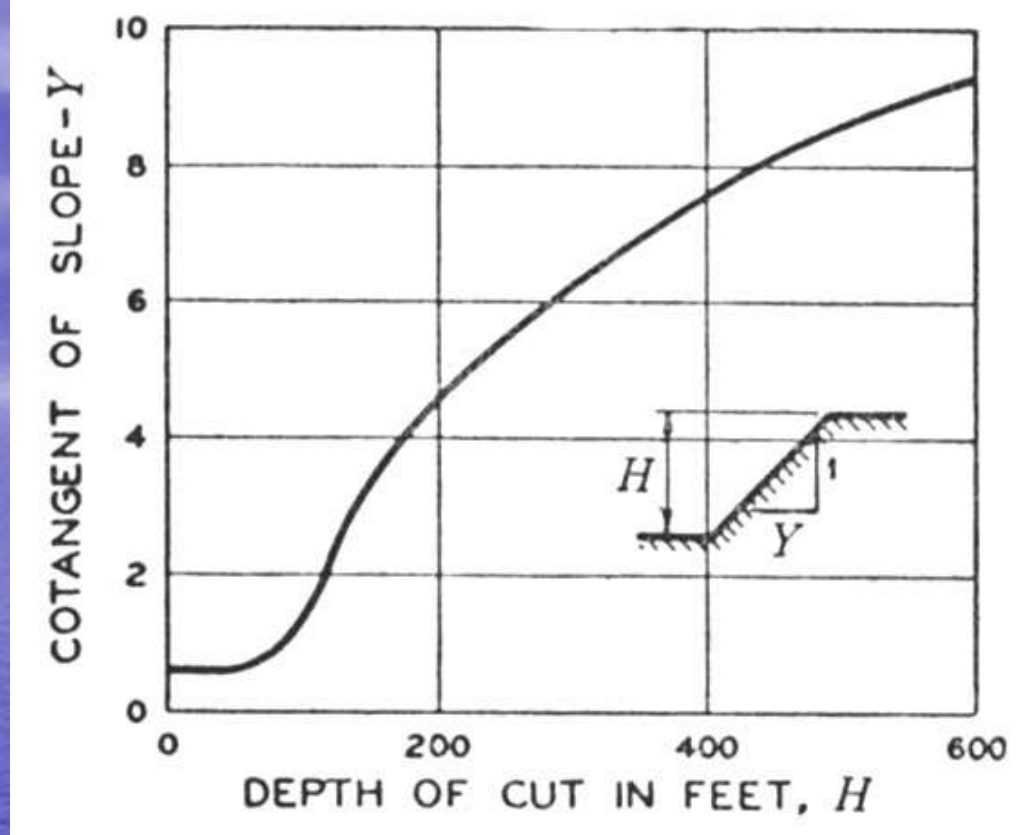
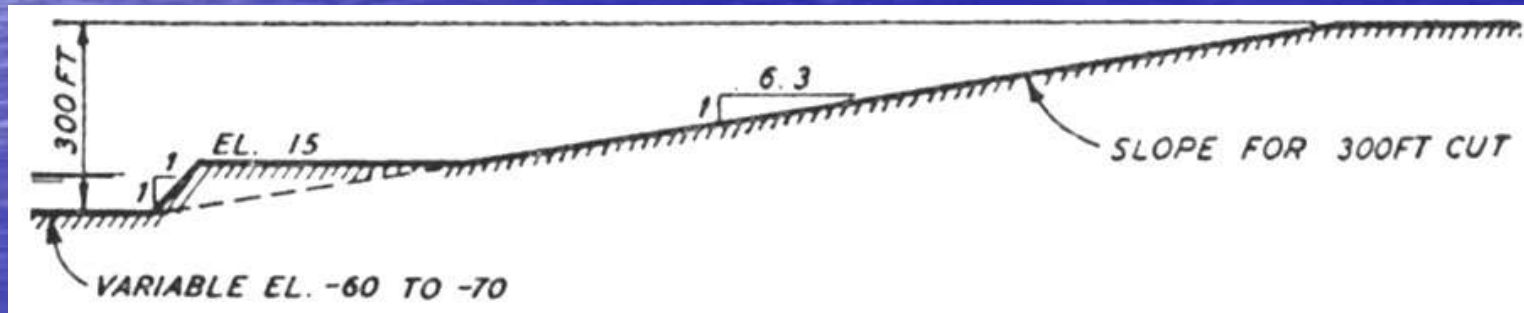
- In 1947 the Corps evolved the first design charts for the most problematic units along the canal; these are for the Cucaracha Shale
