LANDSLIDES of the PANAMA CANAL

J. David Rogers, Ph.D., P.E., P.G.

2011 Pacific Section Meeting

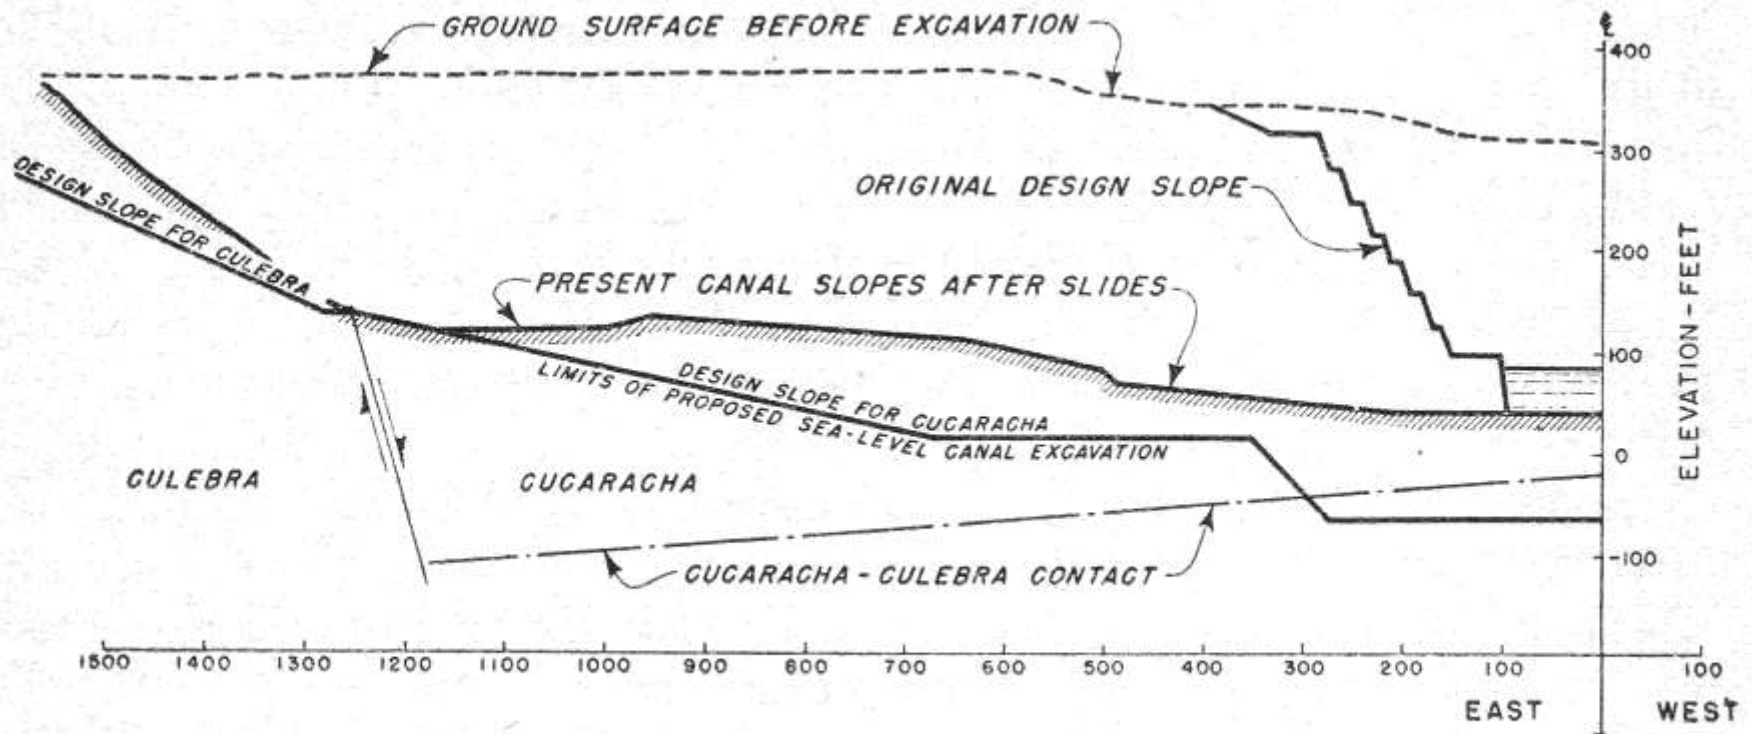
FIG. 10.—ORIGINAL AND PRESENT SLOPE DESIGN CRITERION (OLD CANAL STATION 1785+00)

- Slope design criteria at the Cucaracha Slide adopted for the sea level canal option in 1948

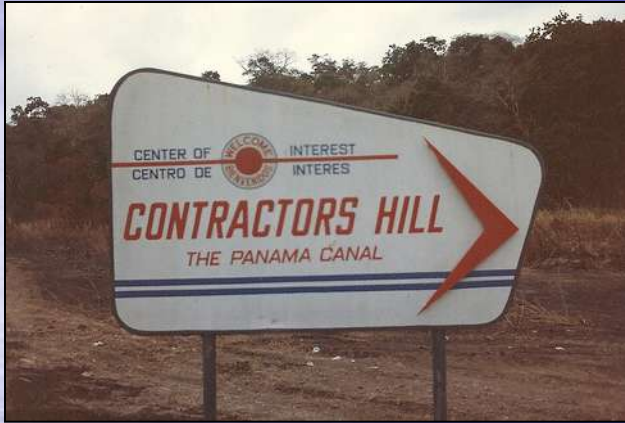
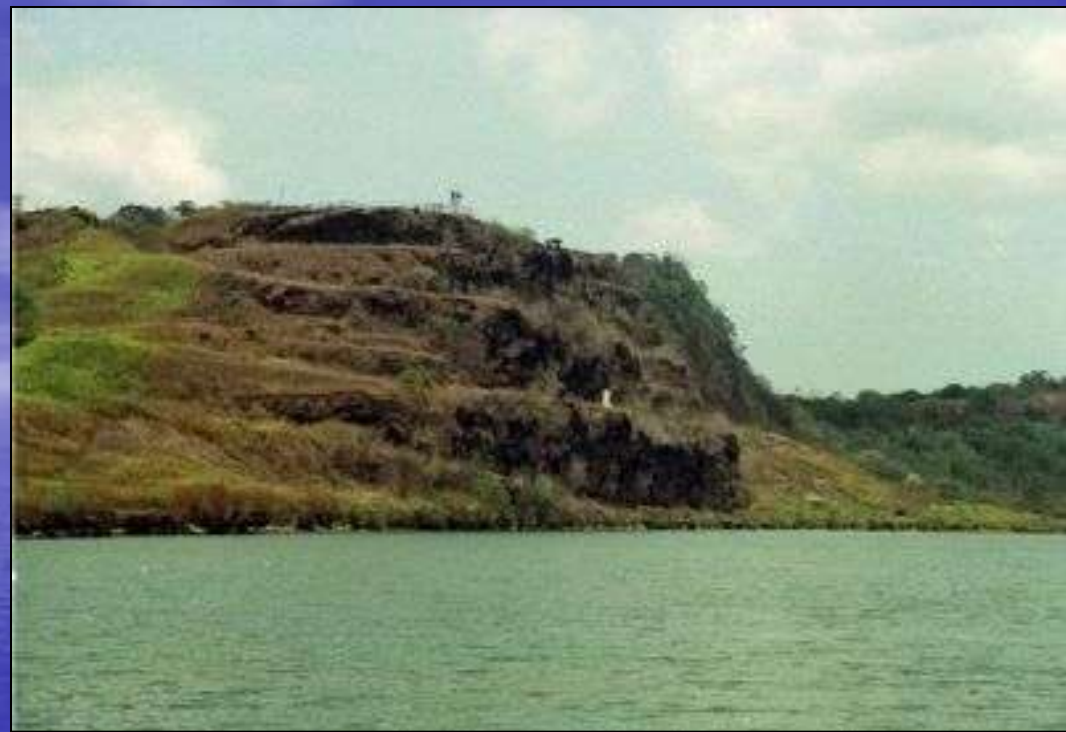
Contractor's Hill

- In 1954 much concern was aroused when a series of tension cracks developed behind Contractor's hill, along the southwestern side of the Gaillard Cut, which rises 330 ft above the canal.
- Careful monitoring by the Corps of Engineers revealed that a block consisting of more than one million yds³ of material was slowly moving towards the canal, each time the groundwater levels exceed a certain threshold level.
- The recommendation was made to cut the face back in a series of massive steps (shown above) to an average inclination of 45 degrees

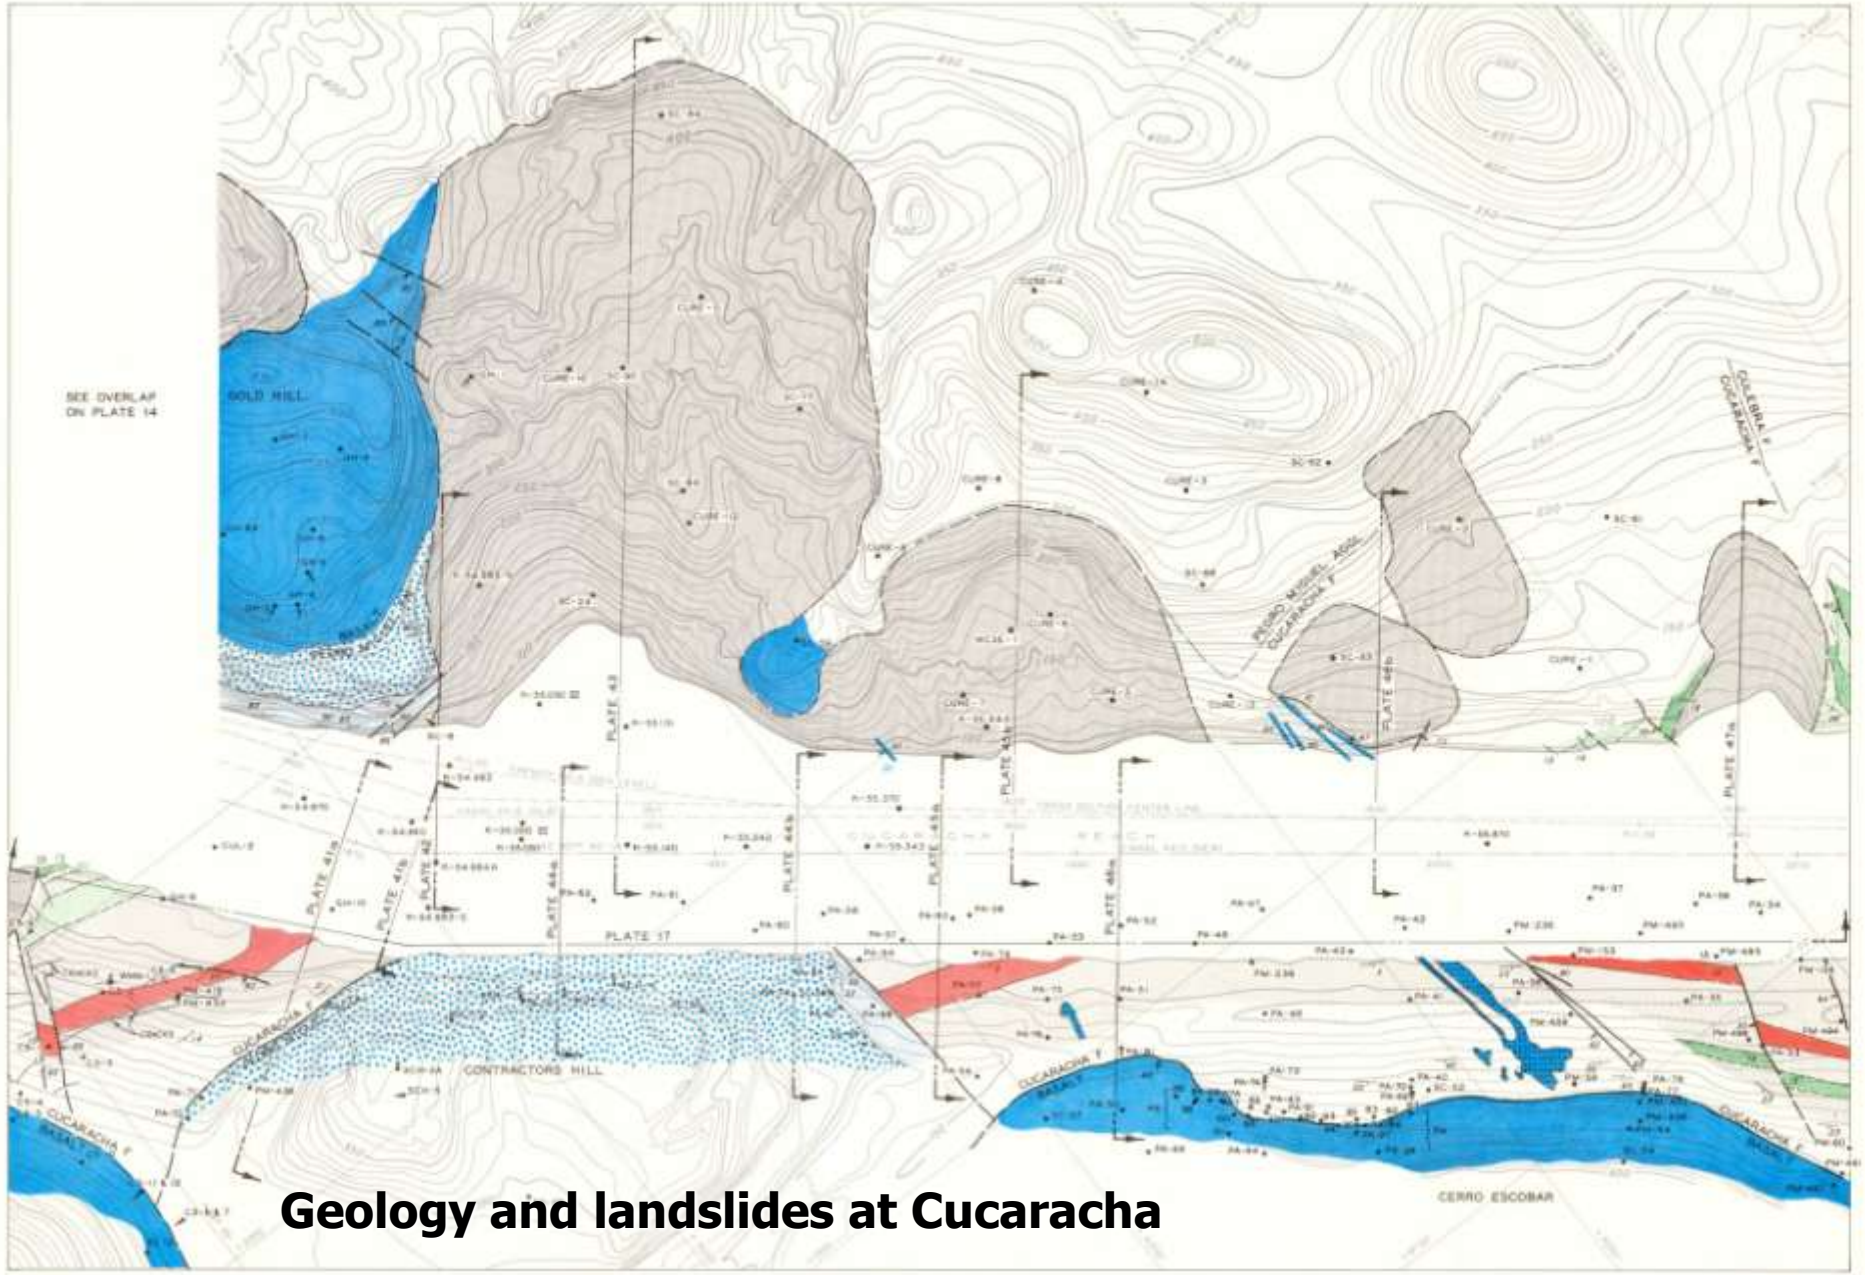
GEOLOGY OF CUCARACHA REACH, NORTH END

Geology and landslides at Cucaracha

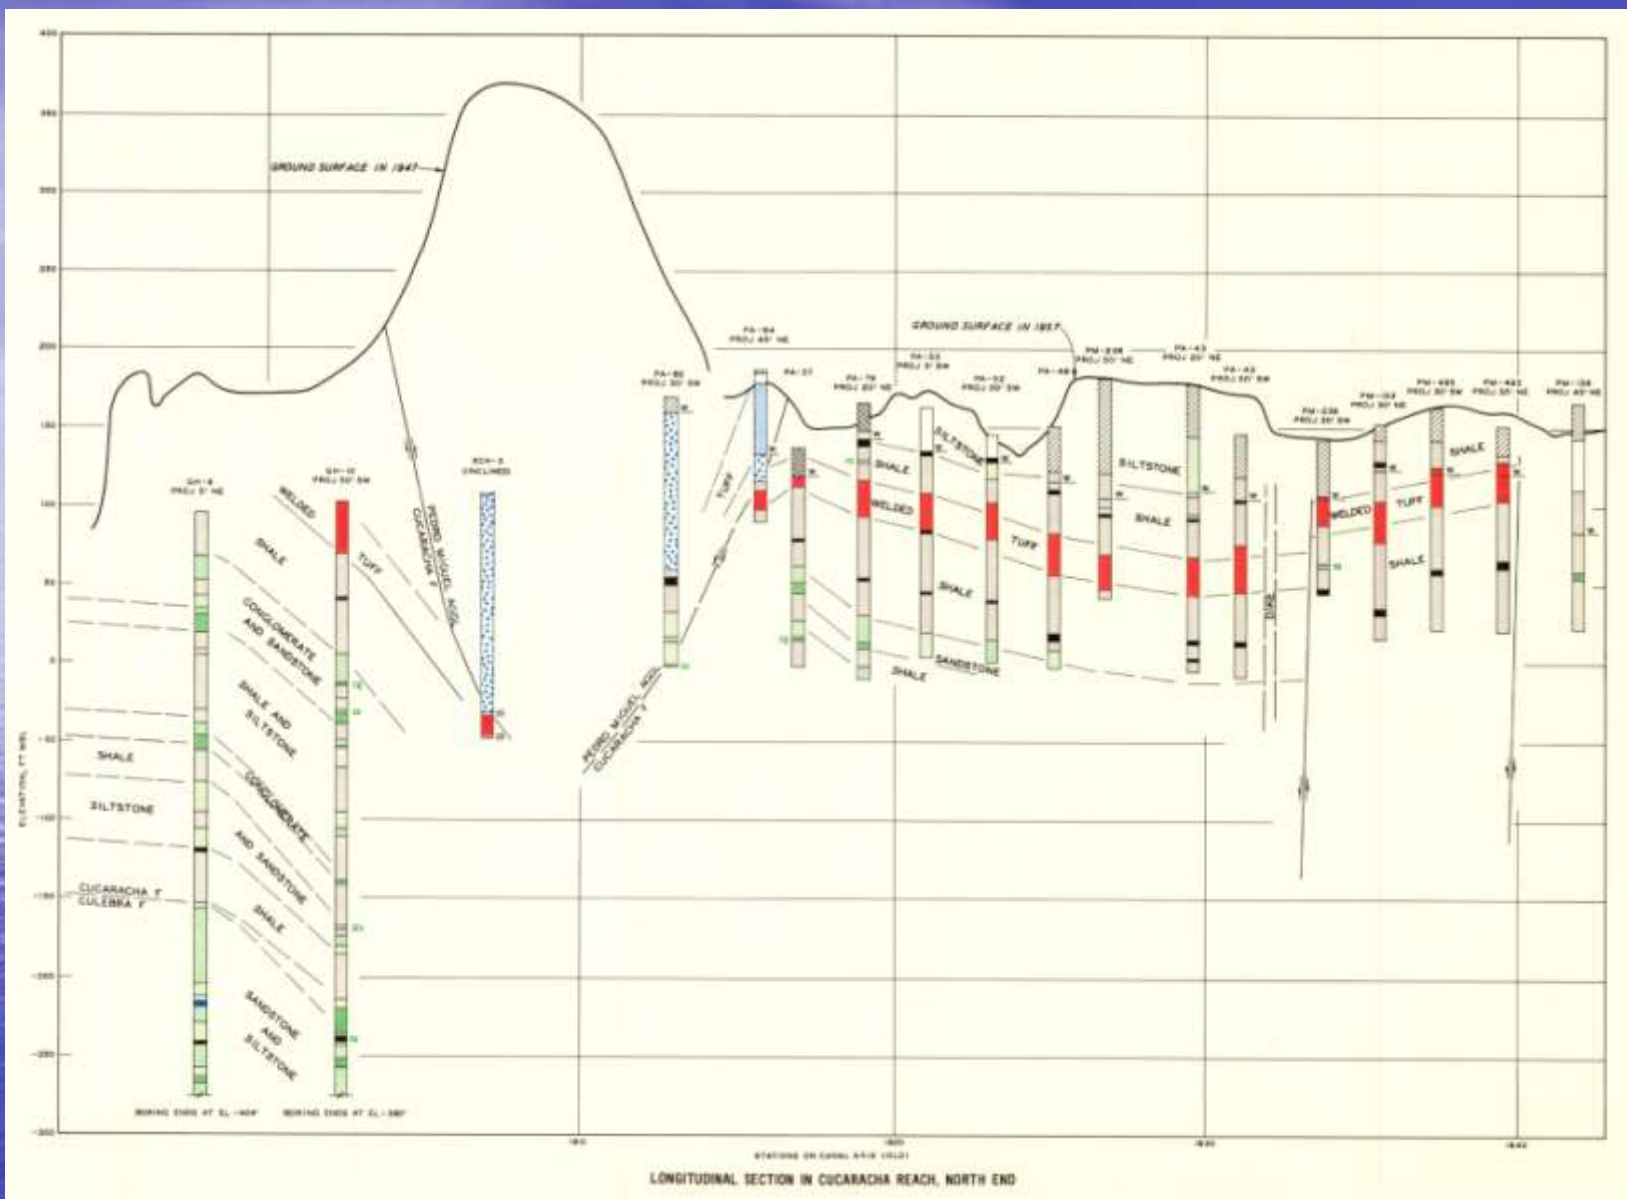
- Longitudinal section through Cucaracha, showing floating nature of Gold Hill.

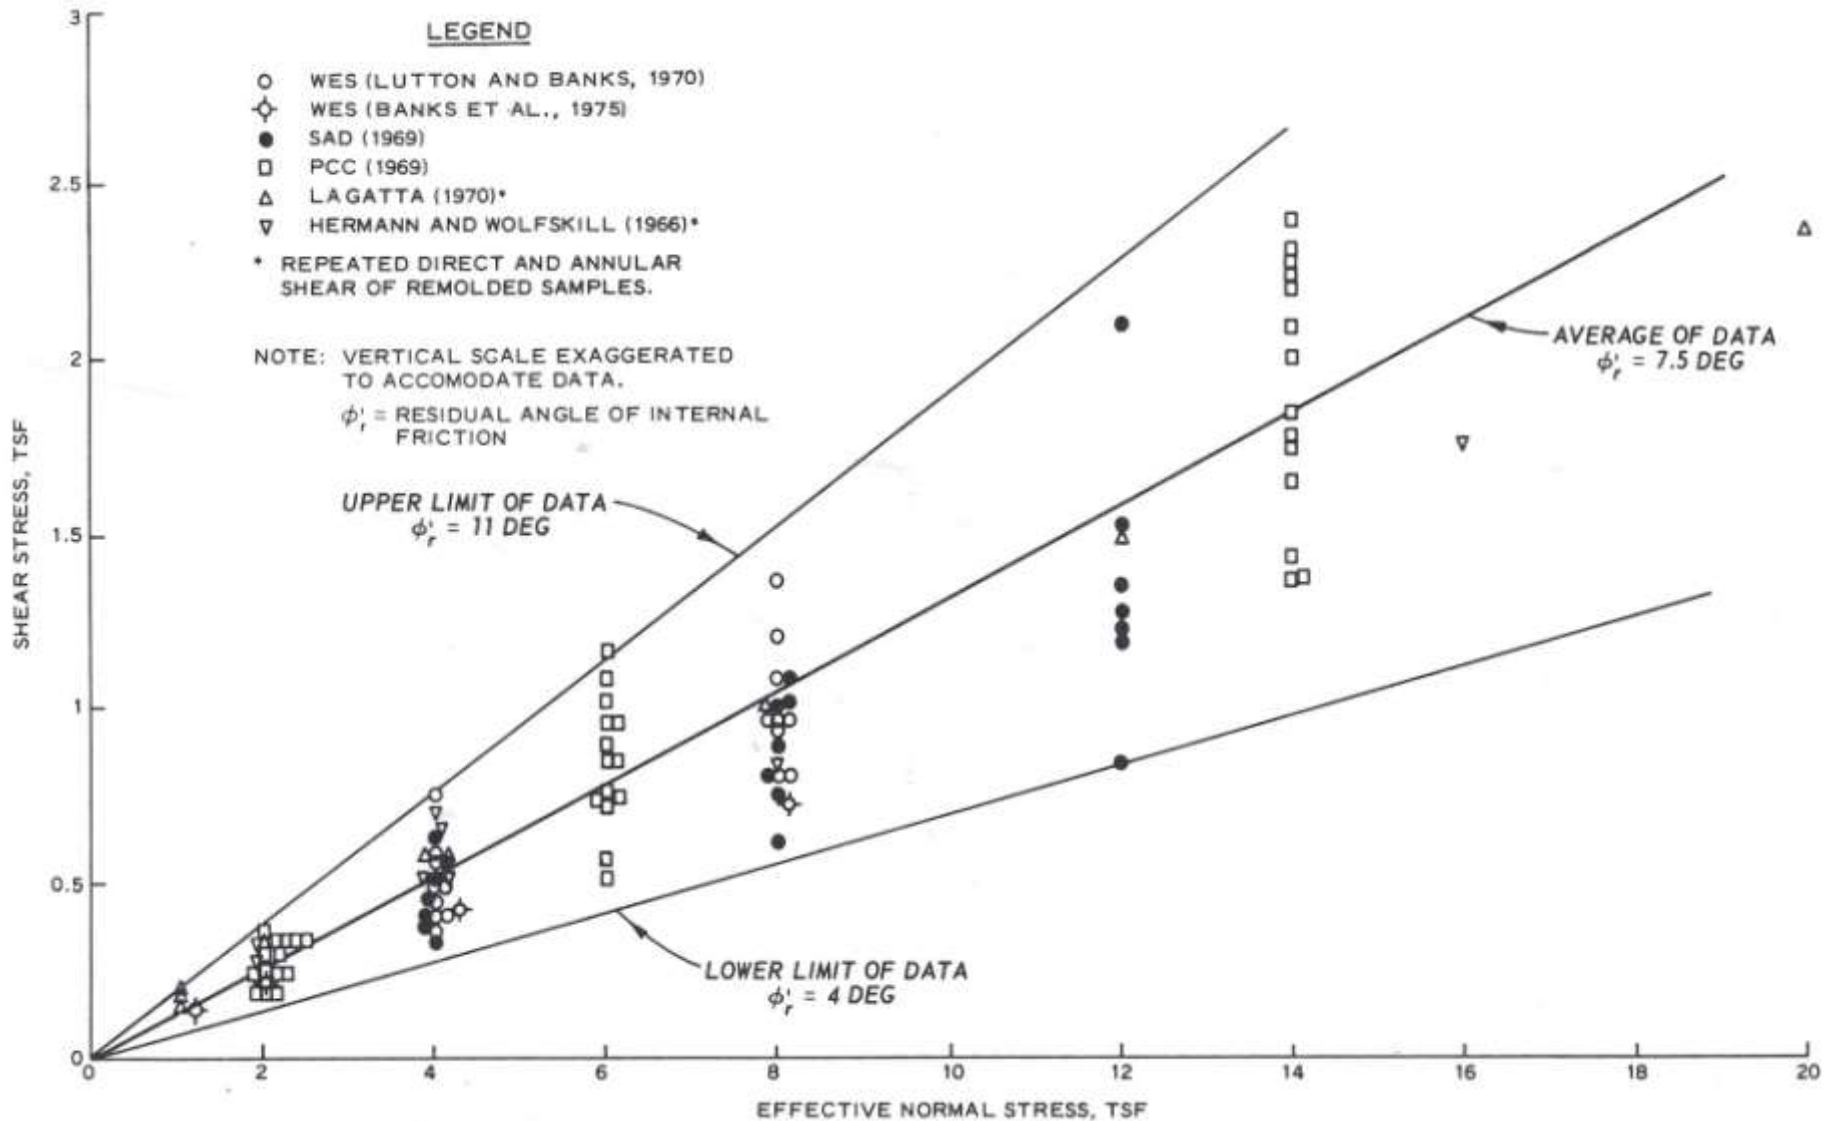
- By 1974, the Corps of Engineers decided that the best graphical method to describe strain-softened materials was to use a fan plot, showing the upper and lower limits of mobilized shear strength.

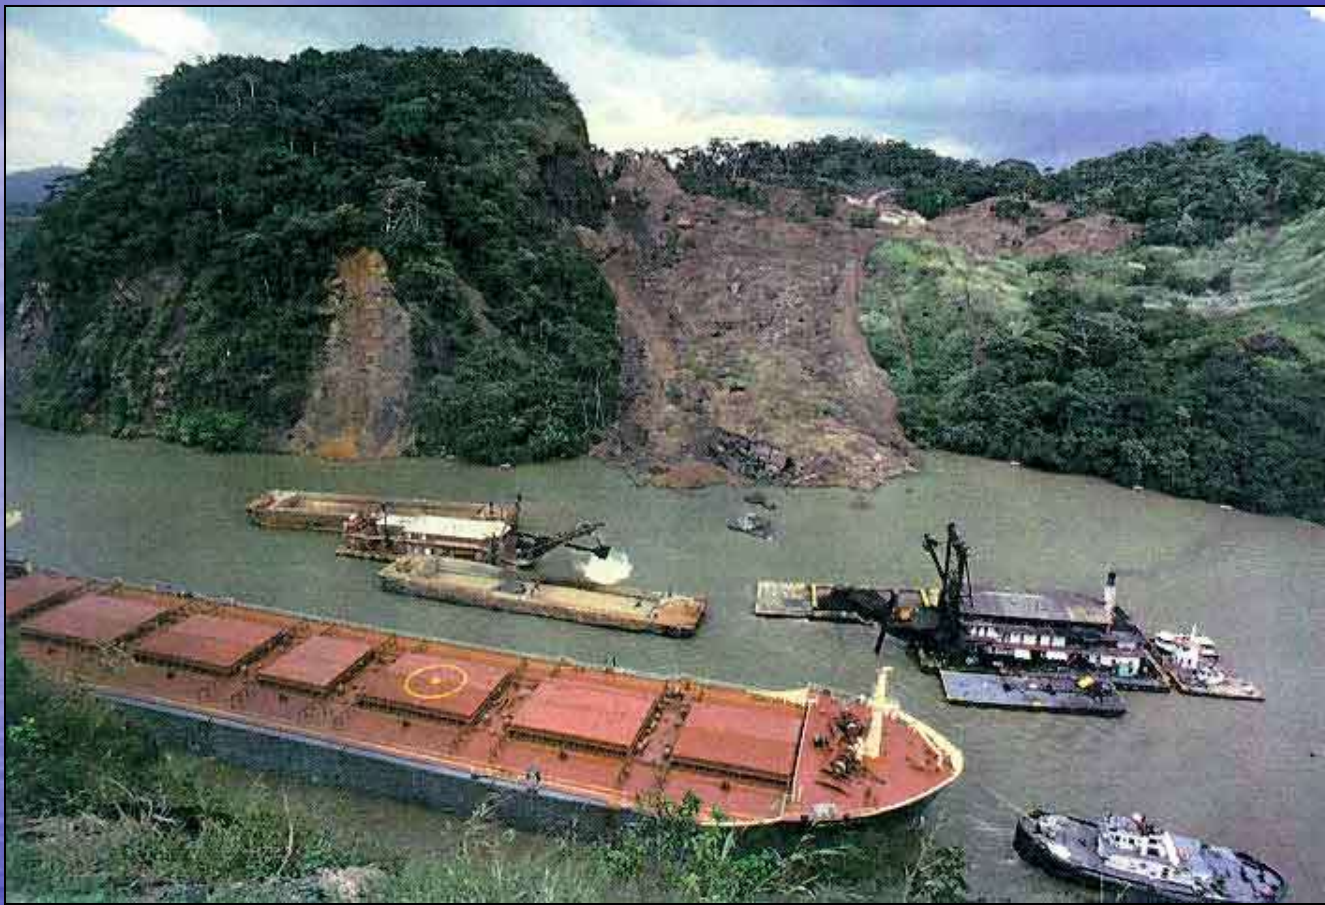
- On **October 13, 1986** the eastern side of the **Cucaracha Slide** reactivated, spilling 526,000 yds³ of debris into the canal, narrowing the opening to just 115 ft! The slope had crept 13 ft towards the canal during the previous 4 years before rupturing.
- The Canal's experienced pilots were able to keep ships moving at a reduced speed and the debris was removed using dredges.

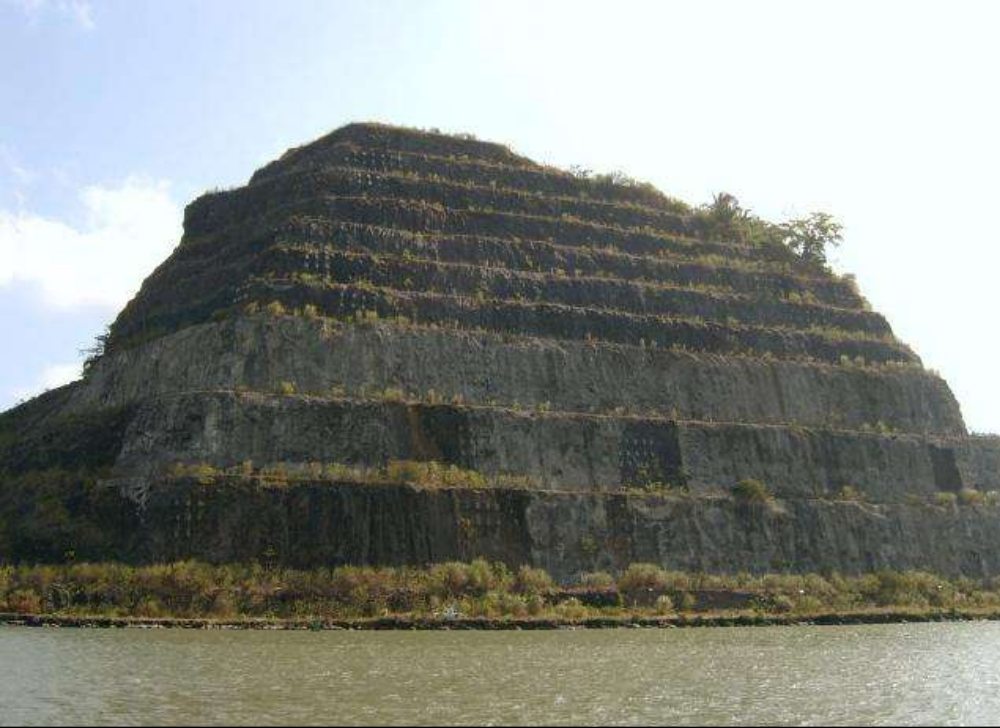
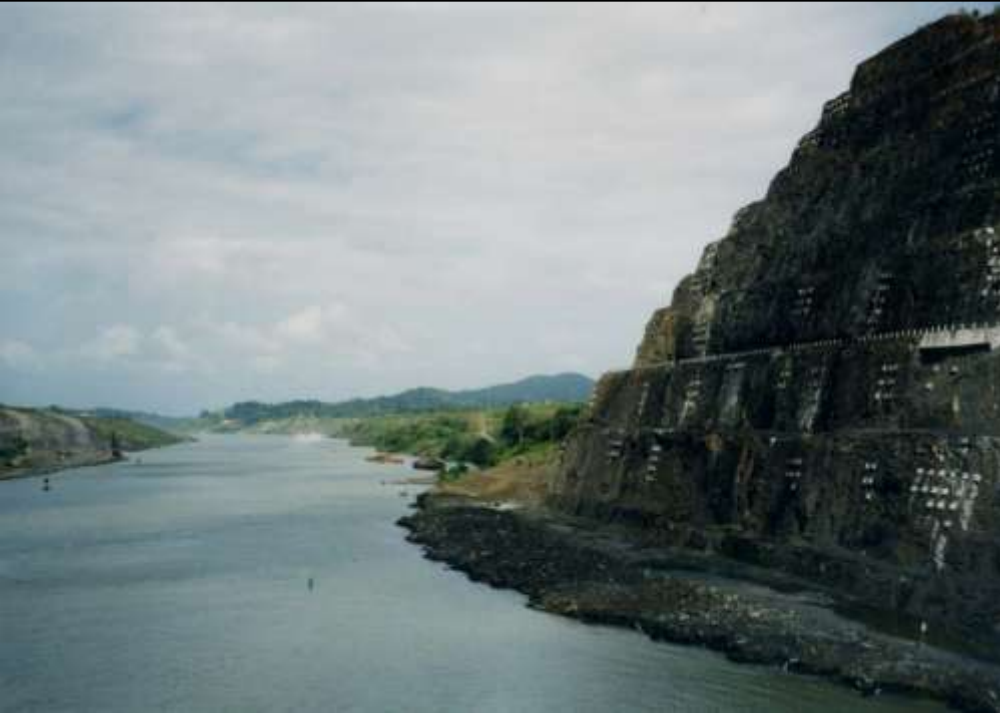
Saving Gold Hill and Contractor's Hill

- For years Gold Hill and Contractor's hill were slowly slipping into the canal along the faults bordering their margins
- It was retrofitted with a series of drilled postensioned rock anchor tendons during the late 1990s to tie it together and retard its creep towards the canal.

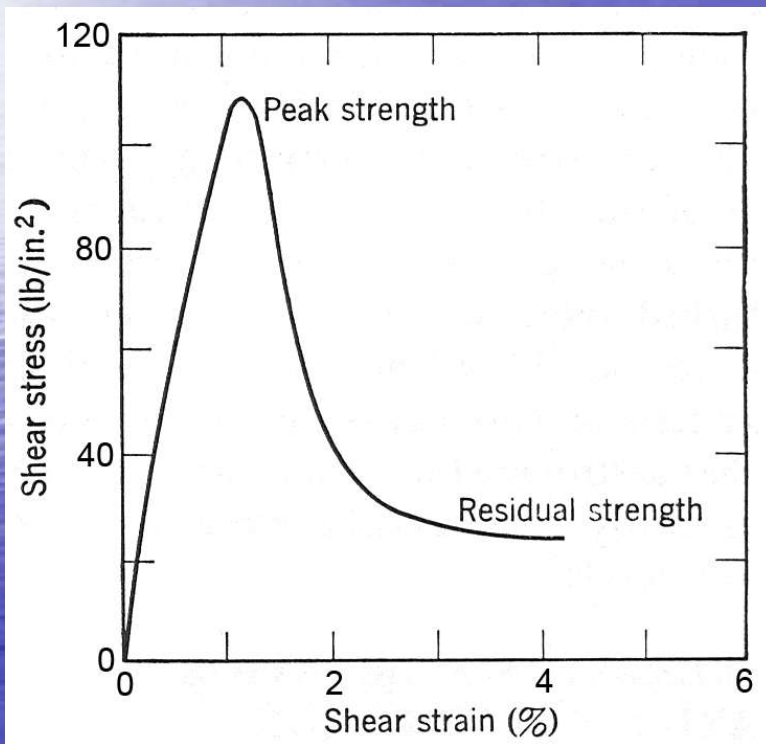
Strain Softening

- For initial unloading/relaxation of cut slopes, the effective strength parameters are close to peak shear strength.
- For reactivated slides, the effective strength parameters degrade to residual values, about 75% less than peak strength.

This led to an increased understanding of the role of strain softening in the degradation of slope stability with time.

- Degradation of safety factor with decreasing slope when the cut slope is floored in *overconsolidated shales* that exhibit *strain-softening*.
