LESSONS ON SITE CHARACTERIZATION GLEANED FROM FORENSIC STUDIES

J. David Rogers

Department of Geological Sciences &
Engineering

University of Missouri-Rolla

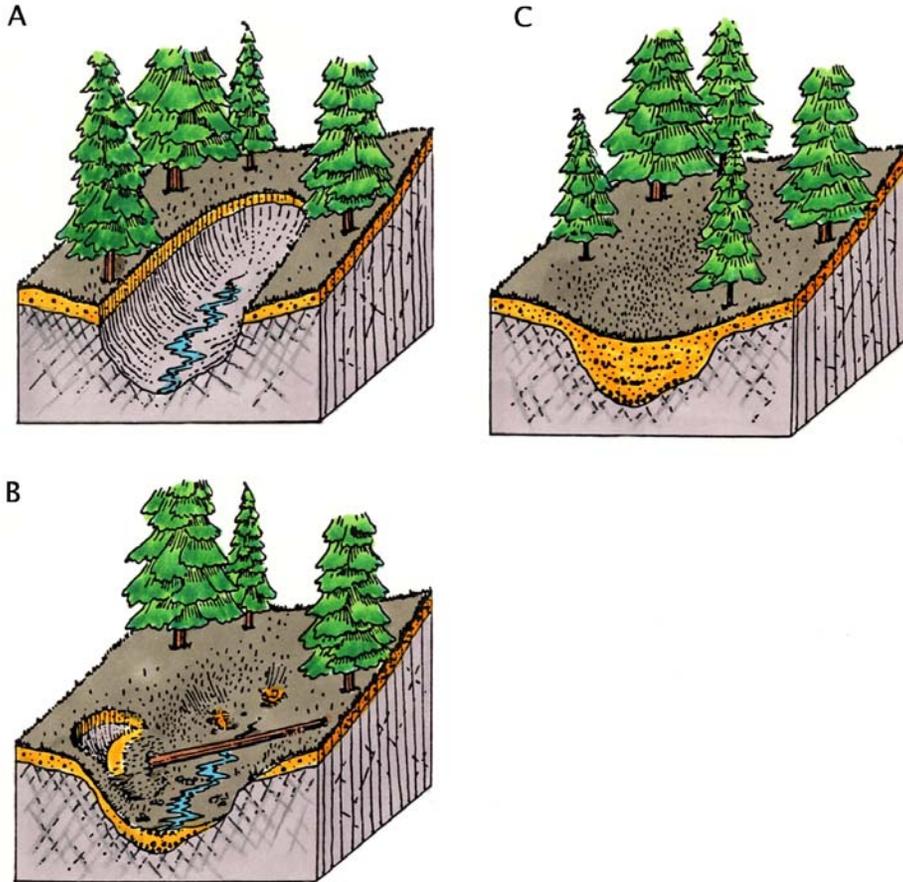
THE COLLUVIUM CATCH ALL

- Colluvium is loose, heterogeneous, and incoherent mass of soil material and/or rock fragments deposited by rainwash, sheet wash, or downslope creep

- Block diagrams showing cycle of colluvial deposition and erosion

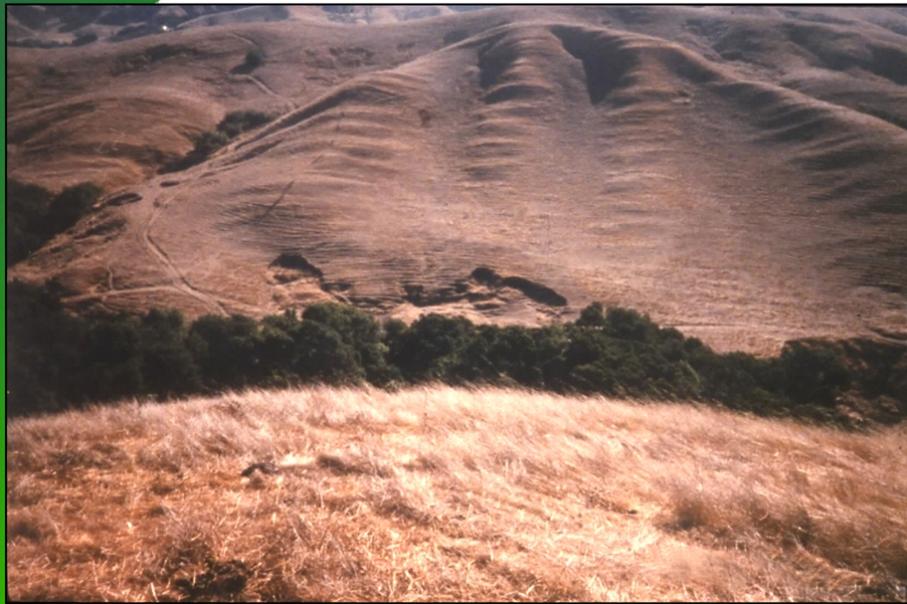
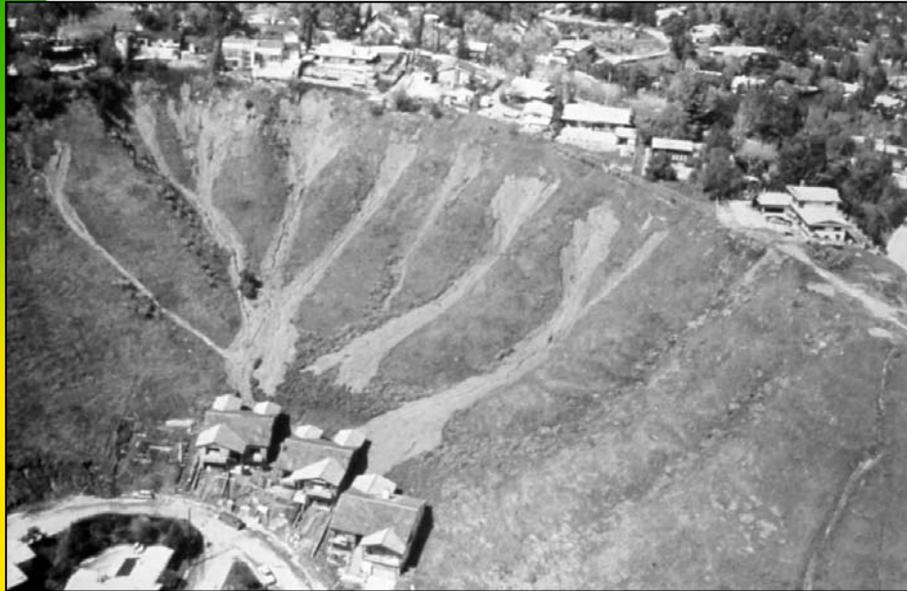
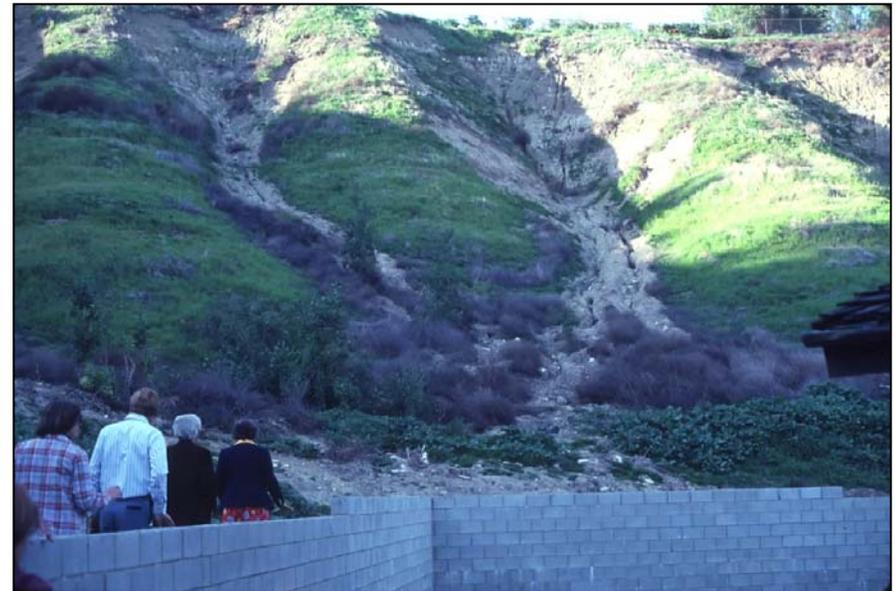
- Slide debris is often mistaken for colluvium because the geologist doesn't see a slip surface

- Loose soil debris on a grassy slope will be deposited without a shear surface

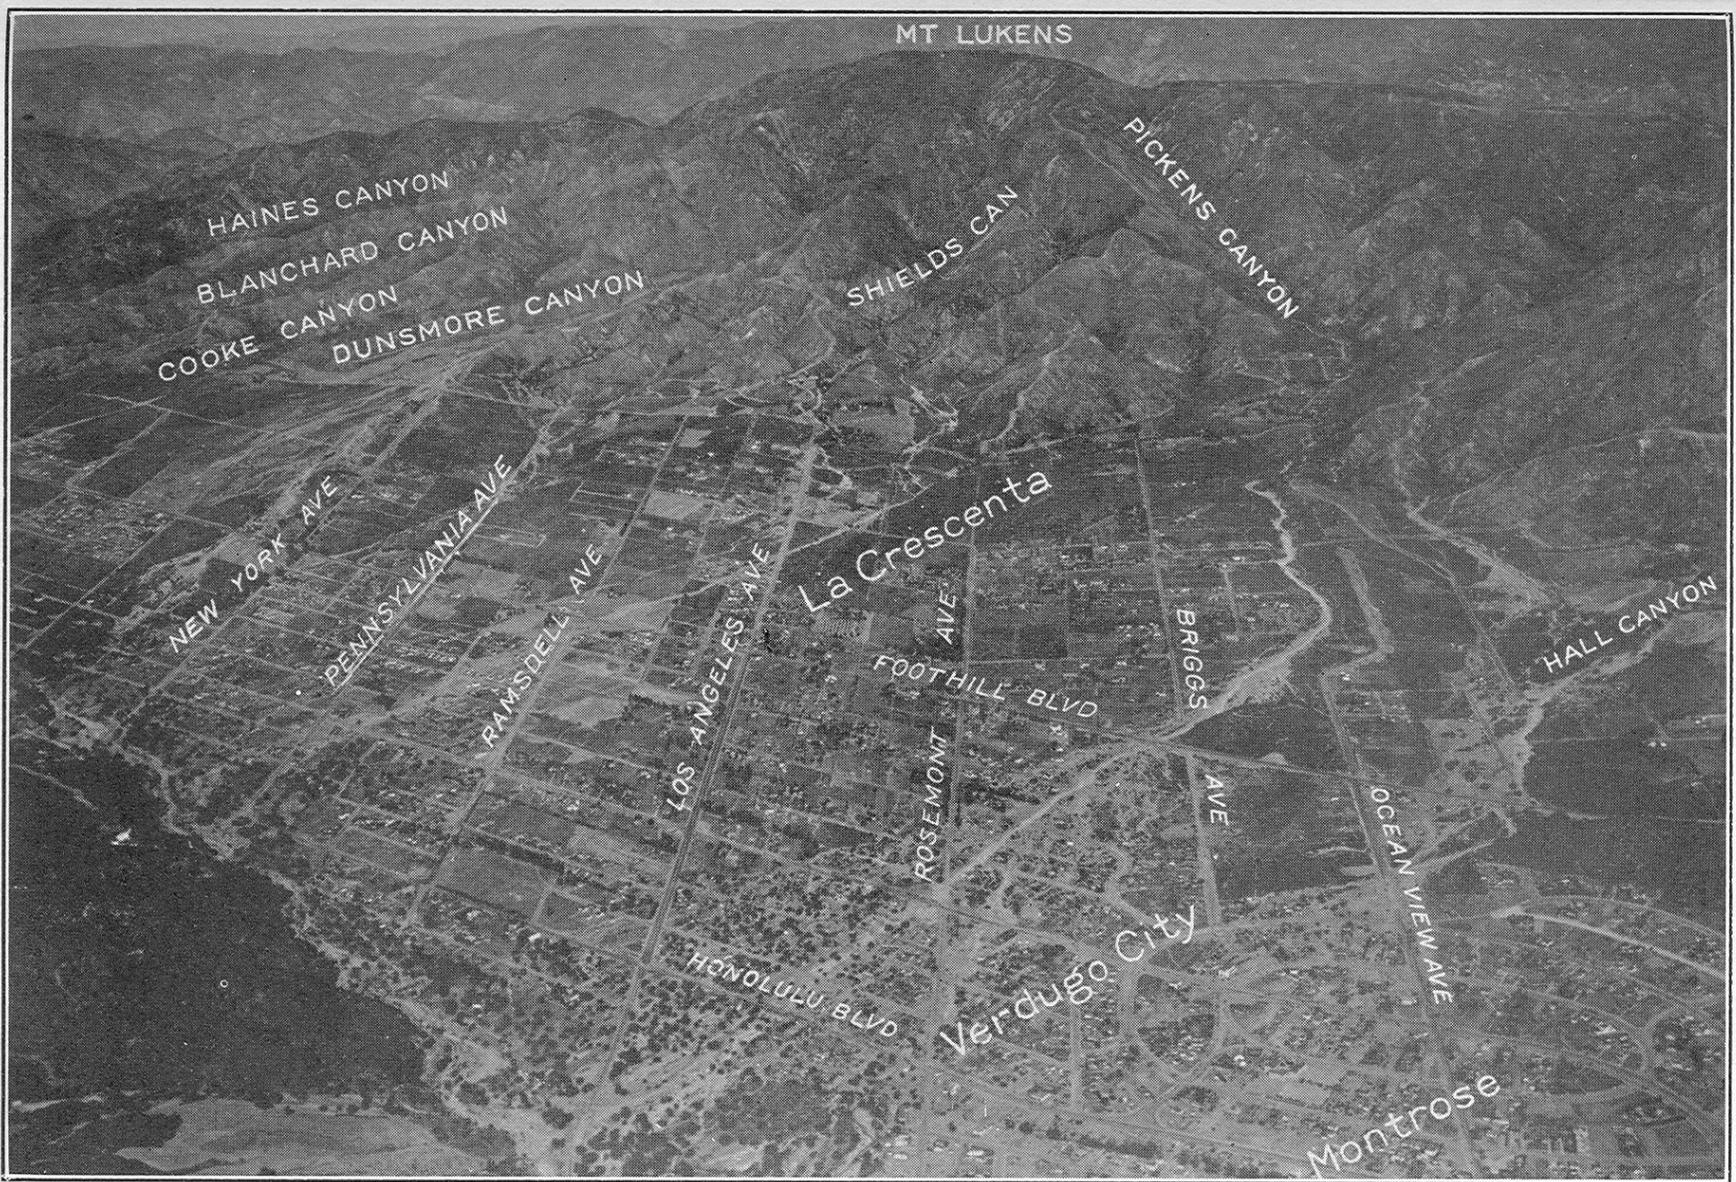
- The Dec 31, 1933-Jan 1, 1934 Montrose-LaCrescenta debris flows damaged or destroyed 600 homes and killed 44. 600,000 cubic yards of material was deposited on the fan in one evening.

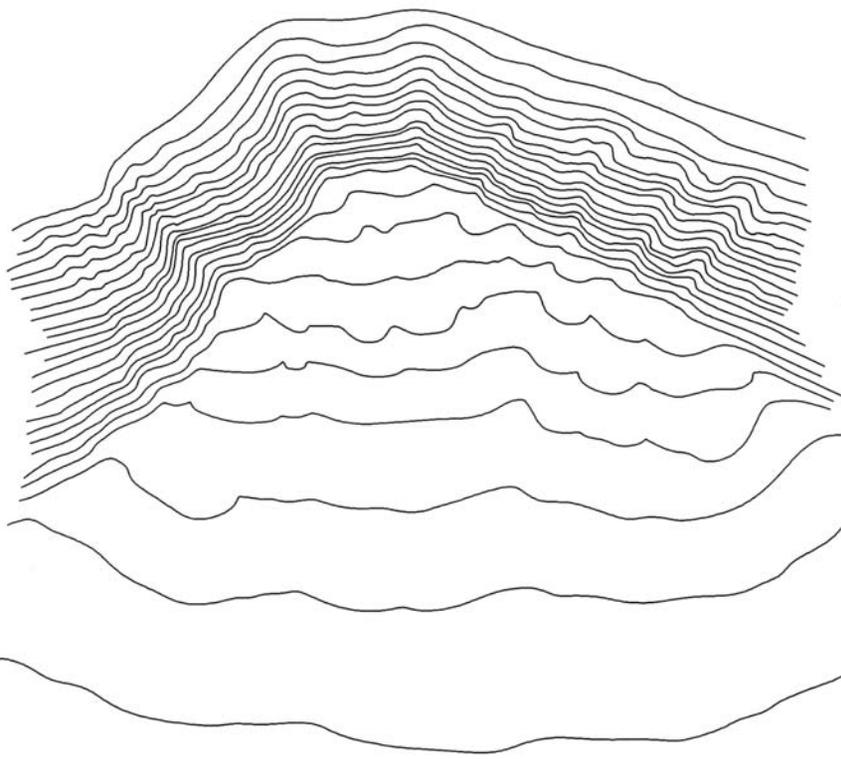
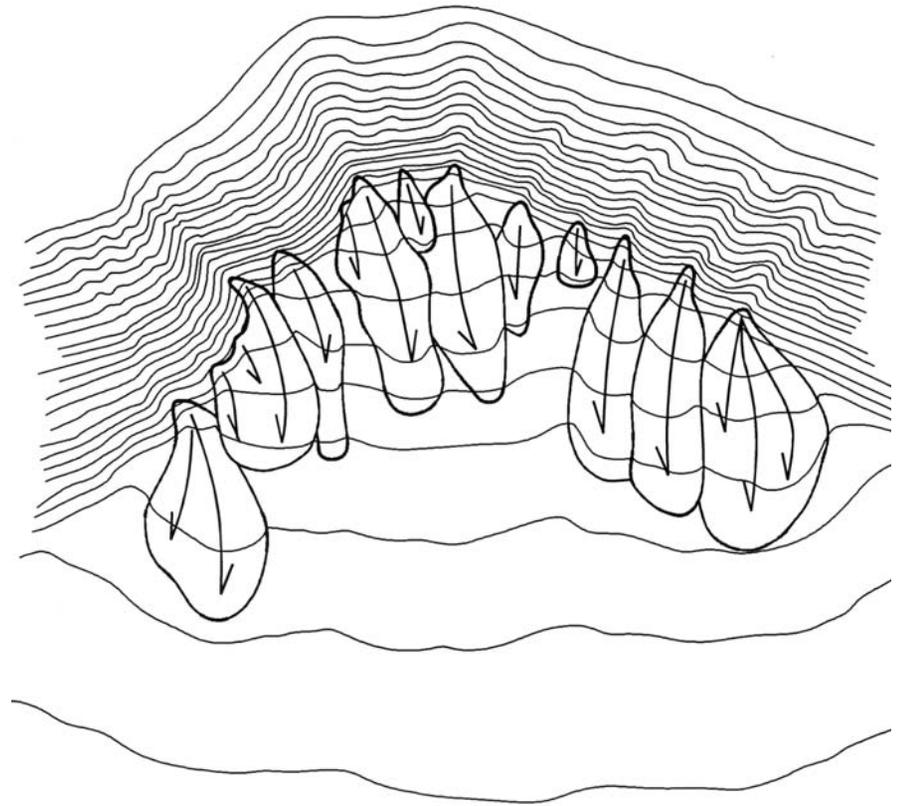
- **Many mapped alluvial fans (Qal) are actually debris fans, constructed by countless series of coalescing debris flows. One trench can expose the character and genesis of underlying material. If it is matrix-supported, it was likely deposited in a debris flow.**

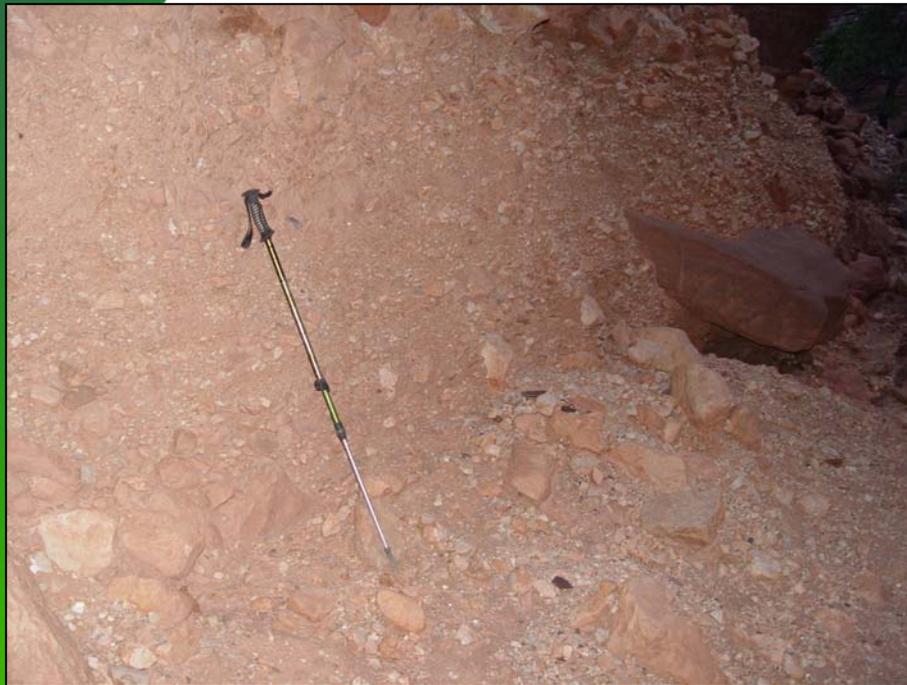
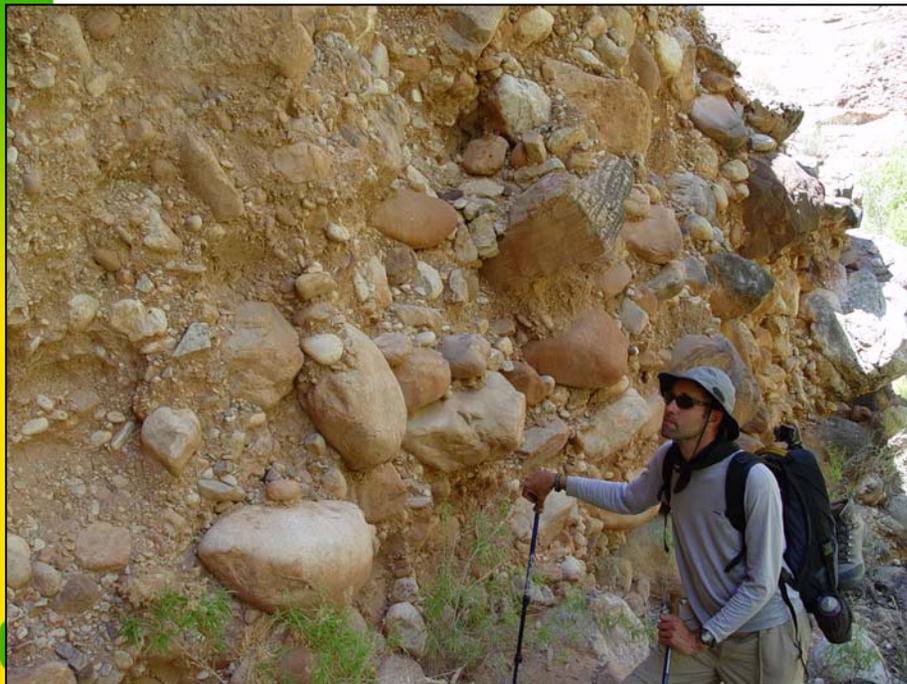
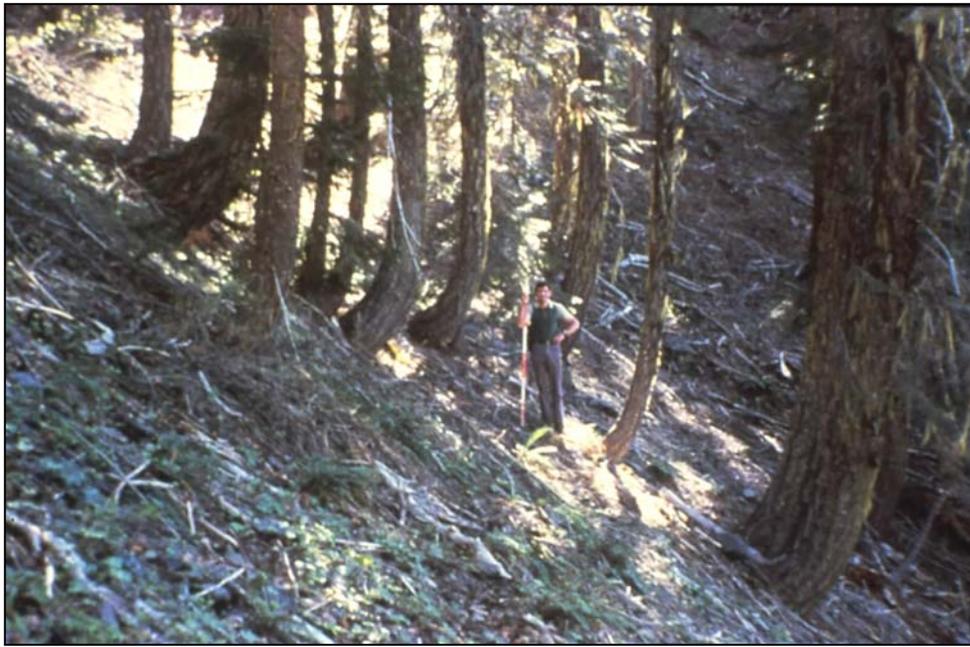
MATRIX SUPPORTED MATERIALS

- Debris flow deposits are typically deposited on channel slopes around 10%
- They are characterized by fine grained matrix between clasts, large variation in clast and particle sizes, and often, by inverse sorting

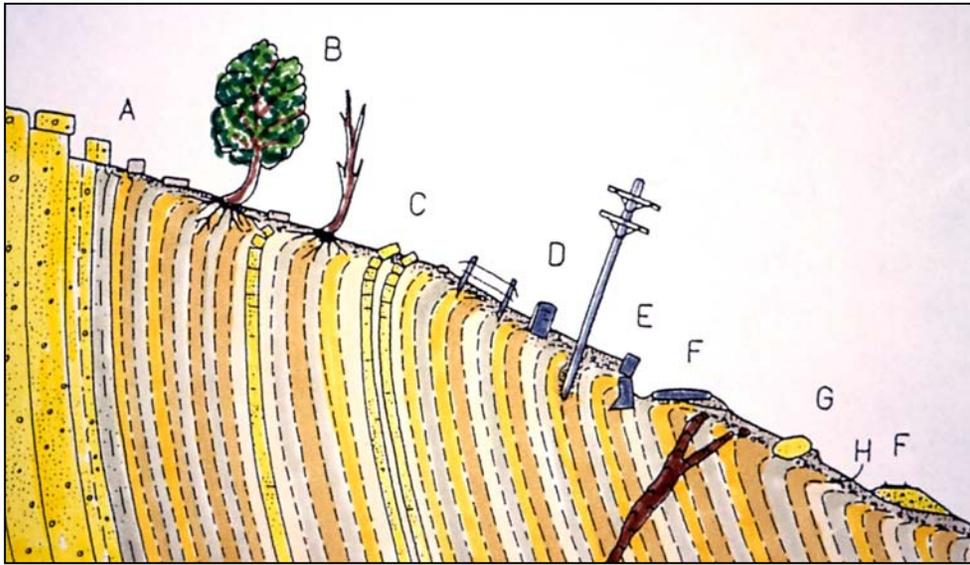
SLOPE CREEP

- Geologists are often asked to estimate depth and magnitude of slope creep
- Creep is a function of soil plasticity, slope inclination, seasonal moisture variation and height of slope

Slope creep can exert passive soil pressures against embedded foundations

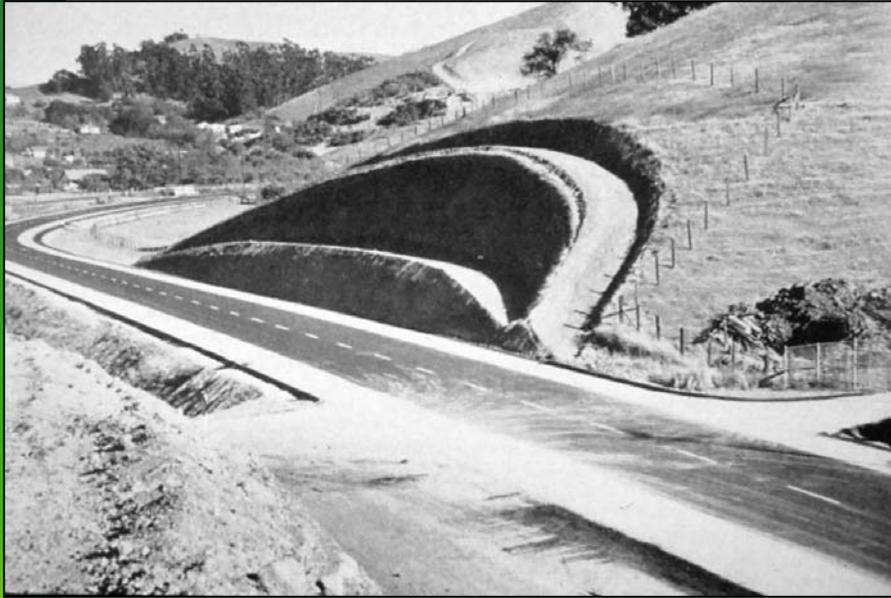
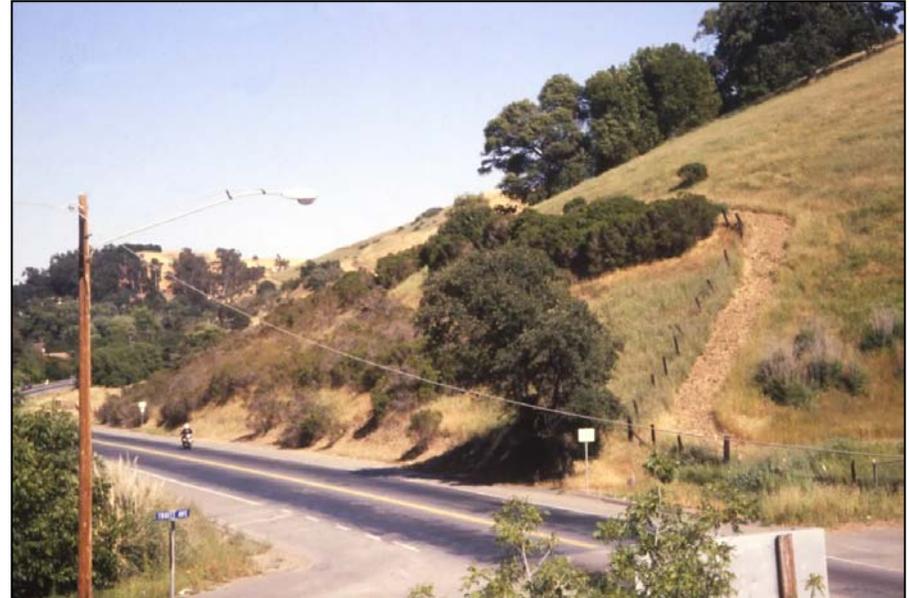
AGING FACTORS

- **Clayey soils and argillaceous materials are susceptible to slope creep. Be careful to advise clients of likely movements and need for ongoing maintenance**
- **These comparative views of the same highway cut were taken in 1954 and 1986, 32 years apart. The benches were gone.**

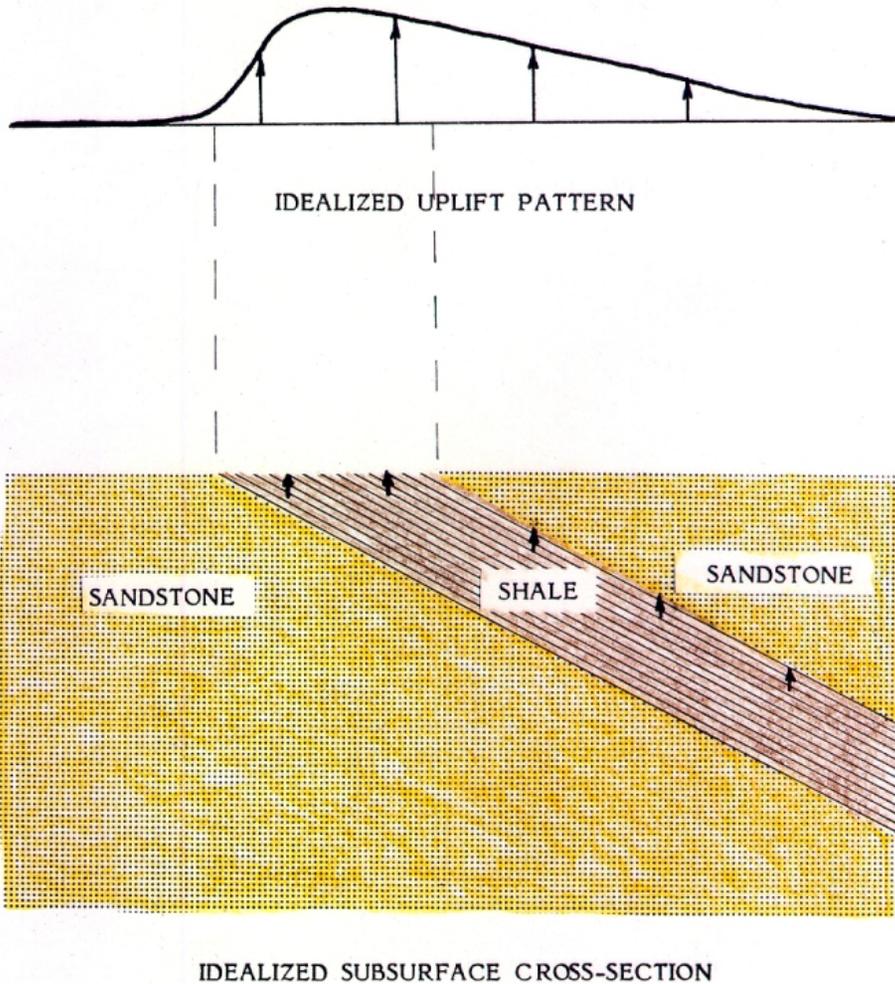
DIFFERENTIAL HEAVE

- Differential heave is a recurring problem whenever expansive clay shales are sandwiched between non-expansive beds, as sketched at left
- Expansive soils are the #2 cause of property loss in the United States, second only to dry rot

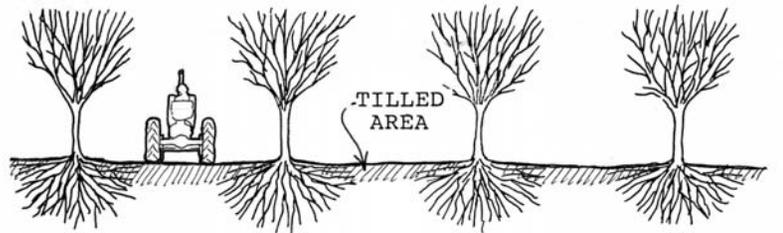
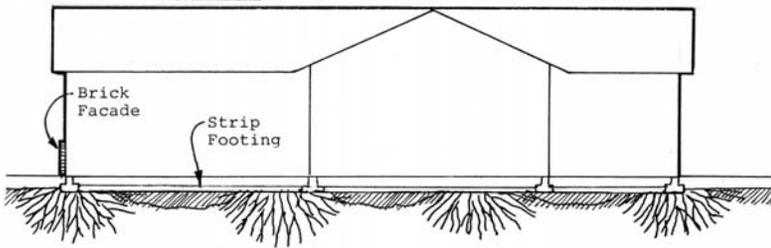
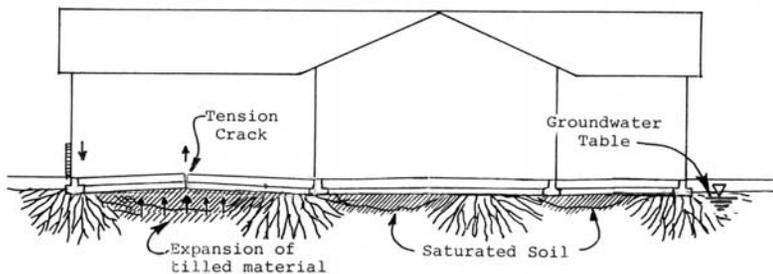
PAST LAND USEAGE

GRADING - 1956

Trees have been removed, yet there root systems still exist

CONSTRUCTION - 1957

RAIN AND SATURATION - 1982

- A preliminary check of aerial photos is essential to understand what a site was used for prior to anticipated construction
- This shows the case of a subdivision in San Jose, CA which was built over an old orchard

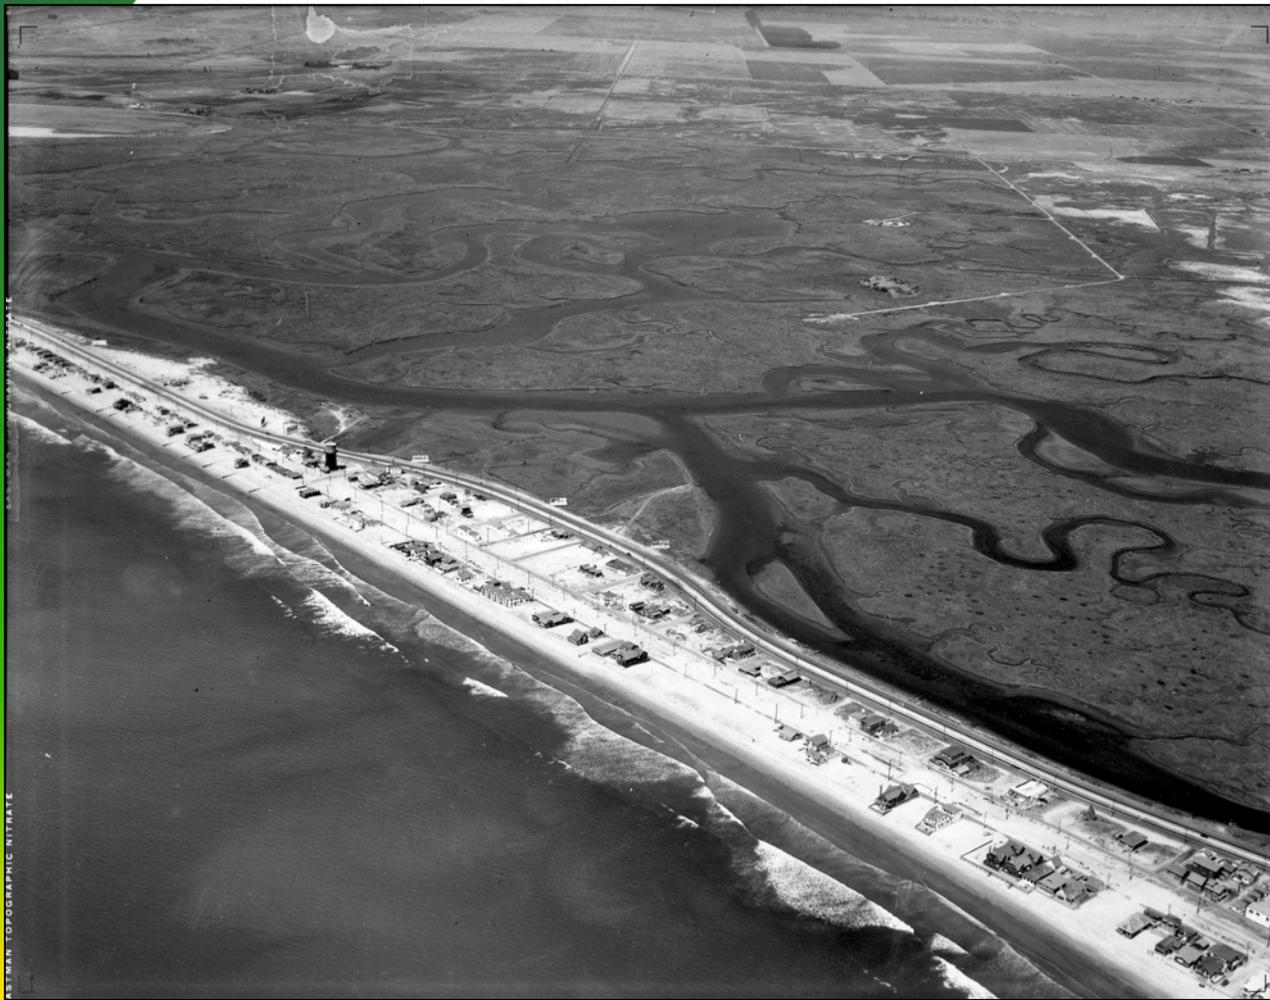
FILLS AND OLD CHANNELS

- Check old maps and air photos to see where channels and sloughs were located prior to infilling, draining or re-direction. This is a common problem in urban areas

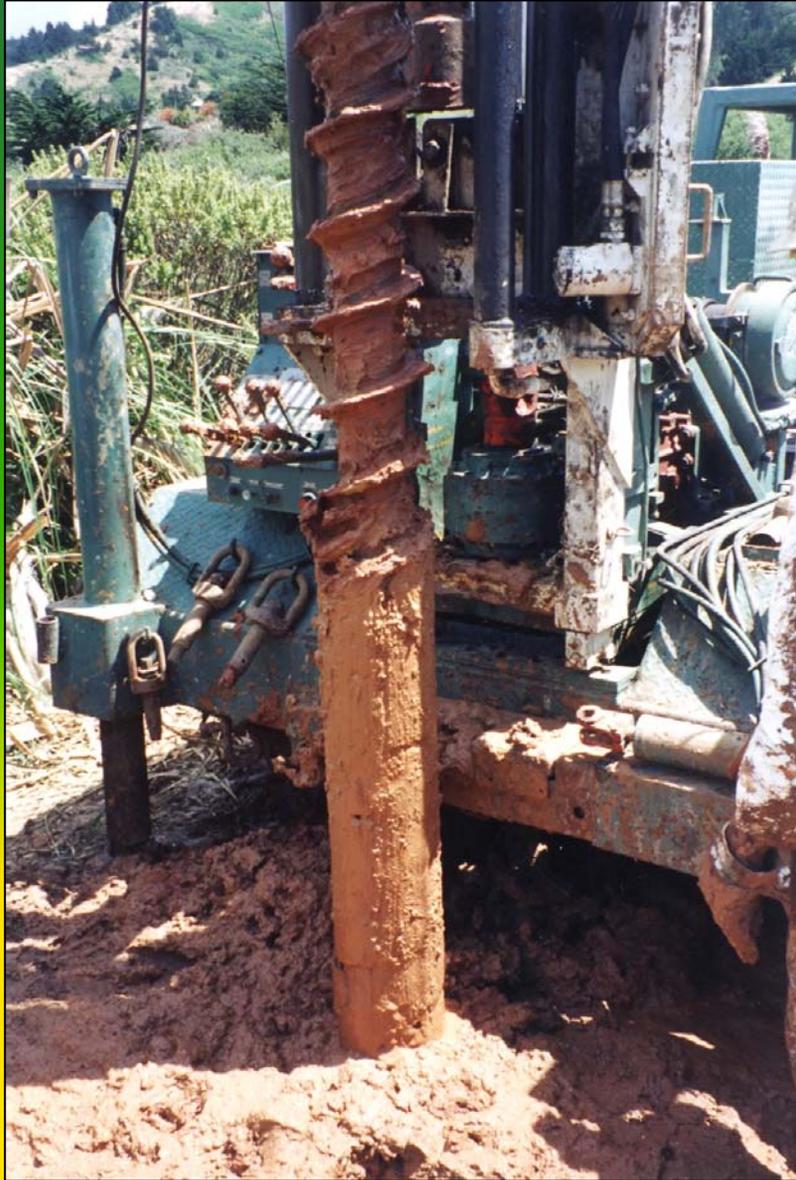
INTERPRETING SUBSURFACE DATA

- Soils engineers tend to focus on providing foundation recommendations, not on detecting geologic contacts
- Proper interpretation of subsurface information requires experience on part of the drillers and the logging geologist
- Circulation problems can negate accurate assessments of cuttings depth and weak seams of horizons are easily missed

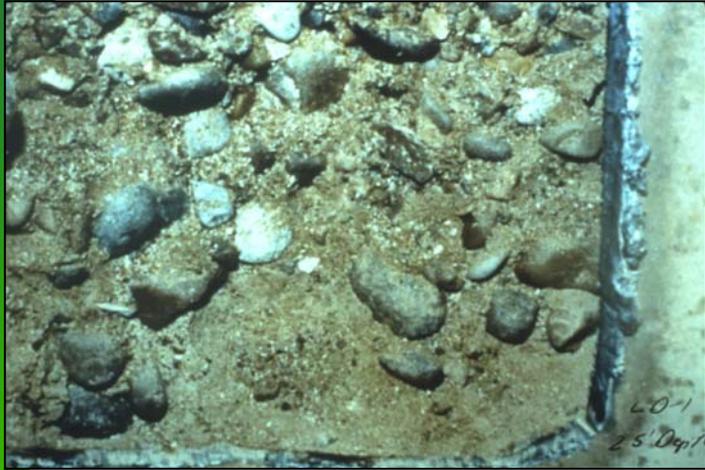
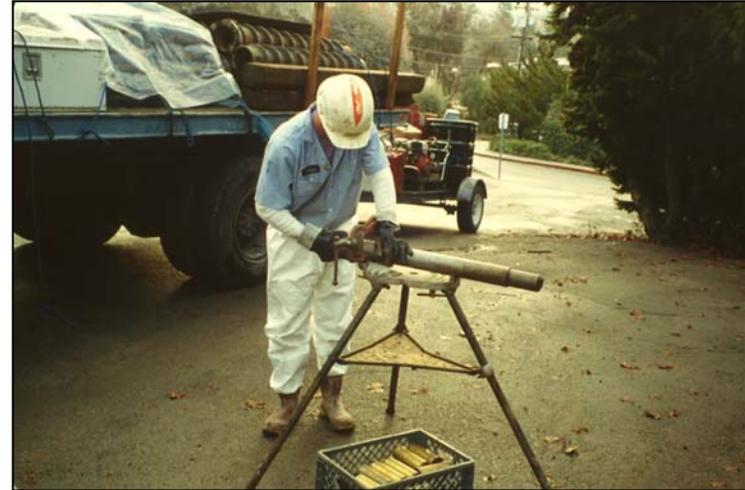
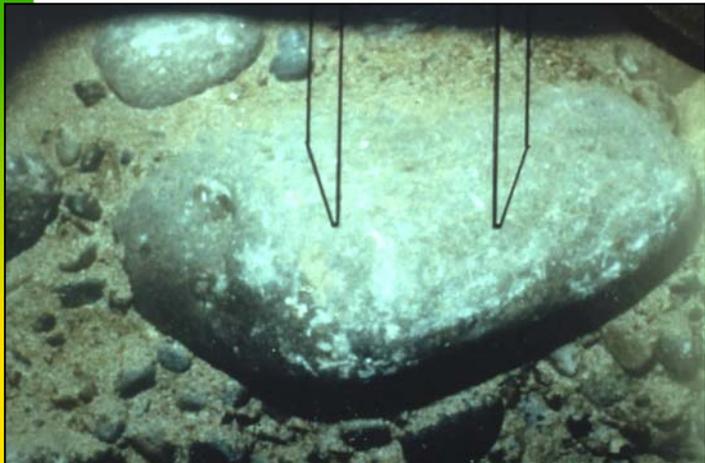
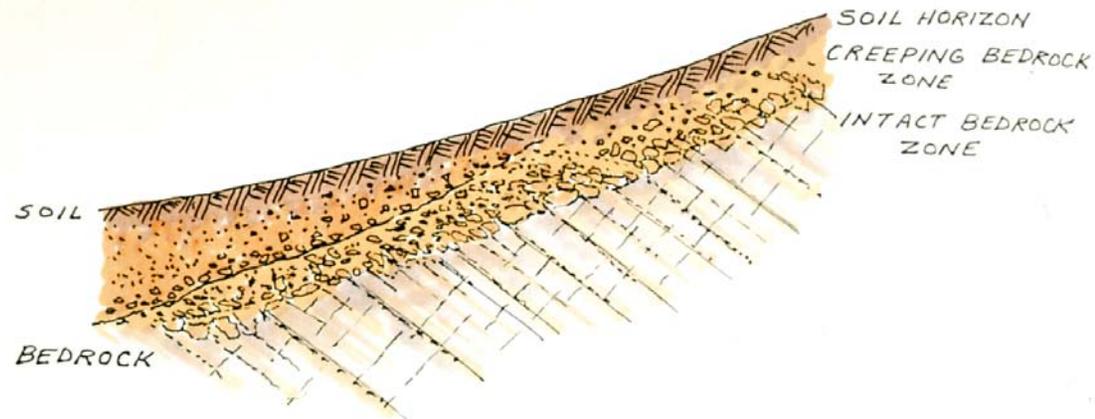
CLASTS LARGER THAN SAMPLER SHOE

- Bedrock contacts are commonly misidentified when the sampler shoe encounters a floater of greater diameter, as sketched at lower left

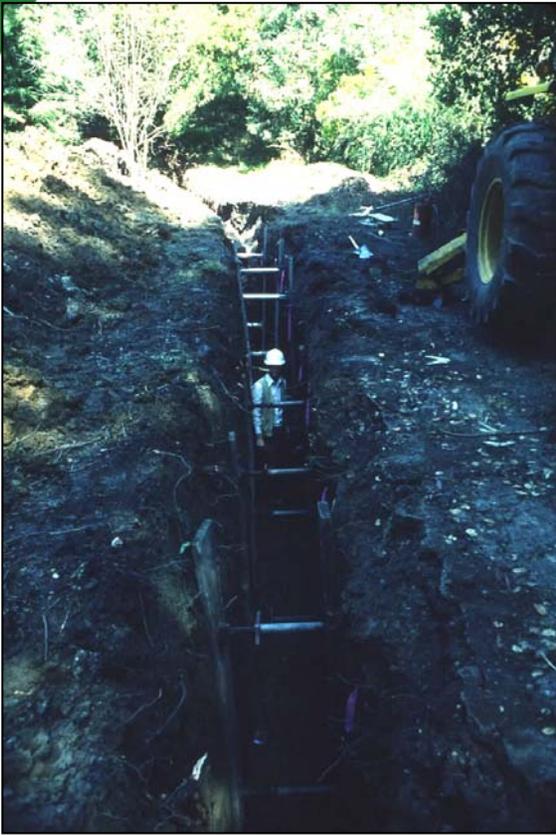
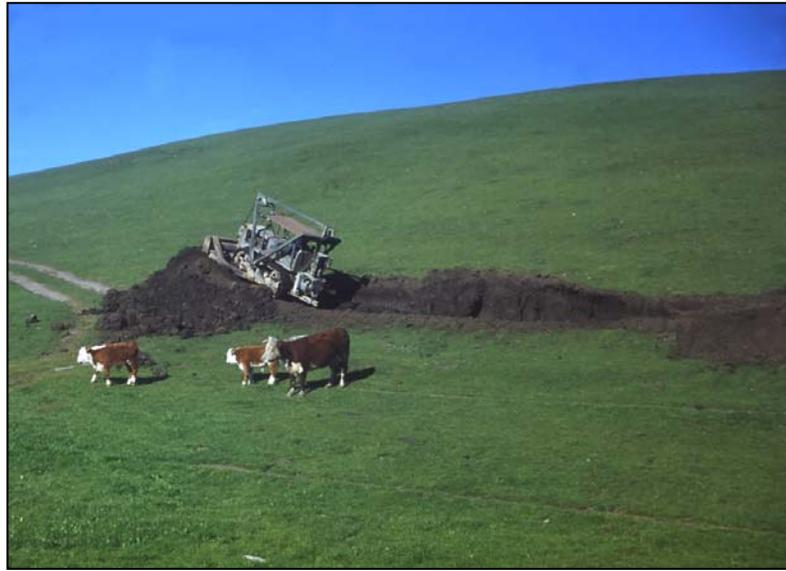
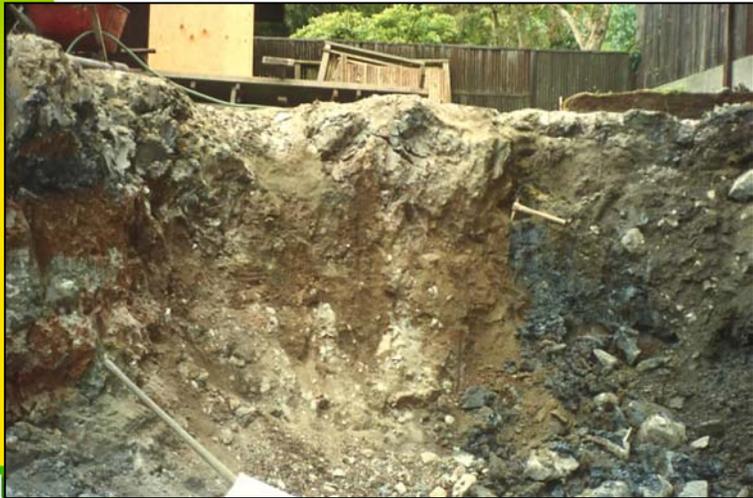
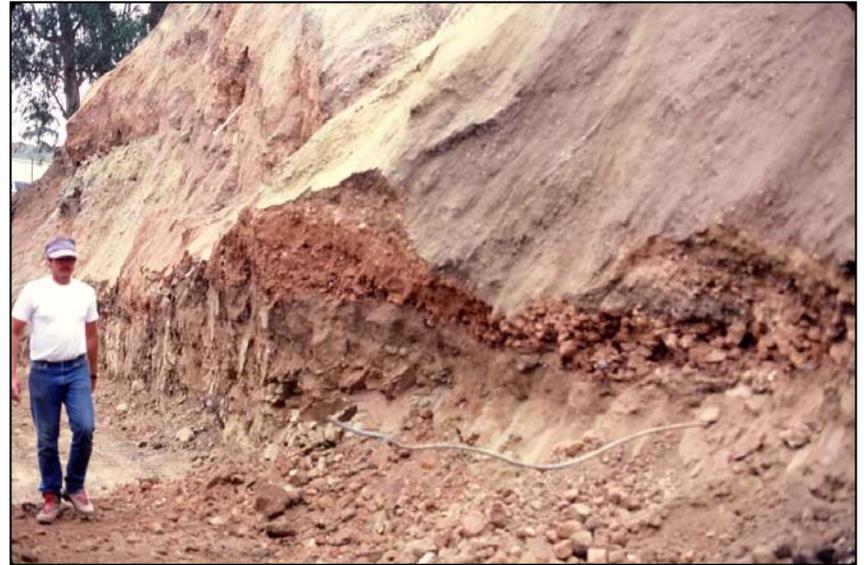
Exploratory trenches can effectively expose geologic structures and the nature or genesis of key contacts

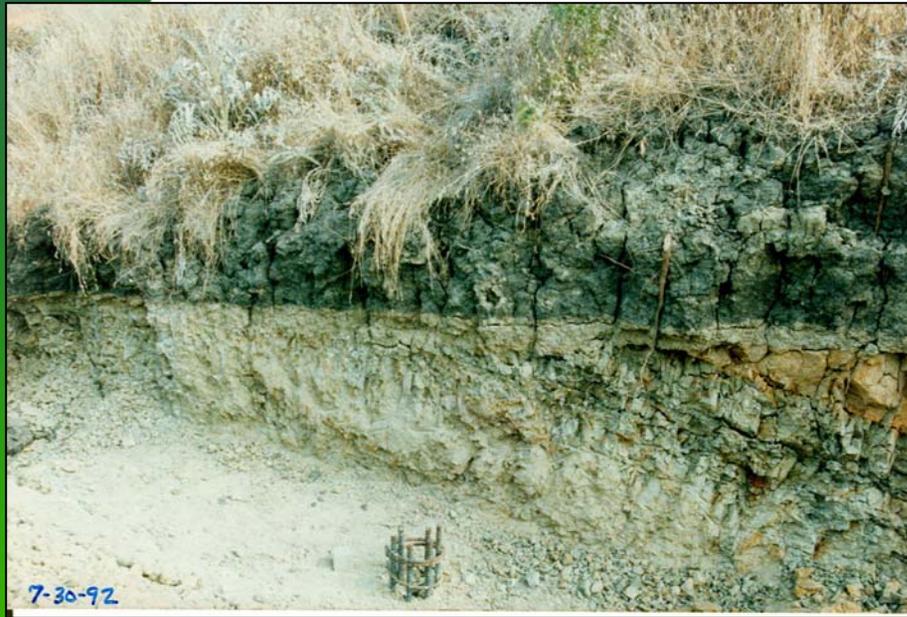
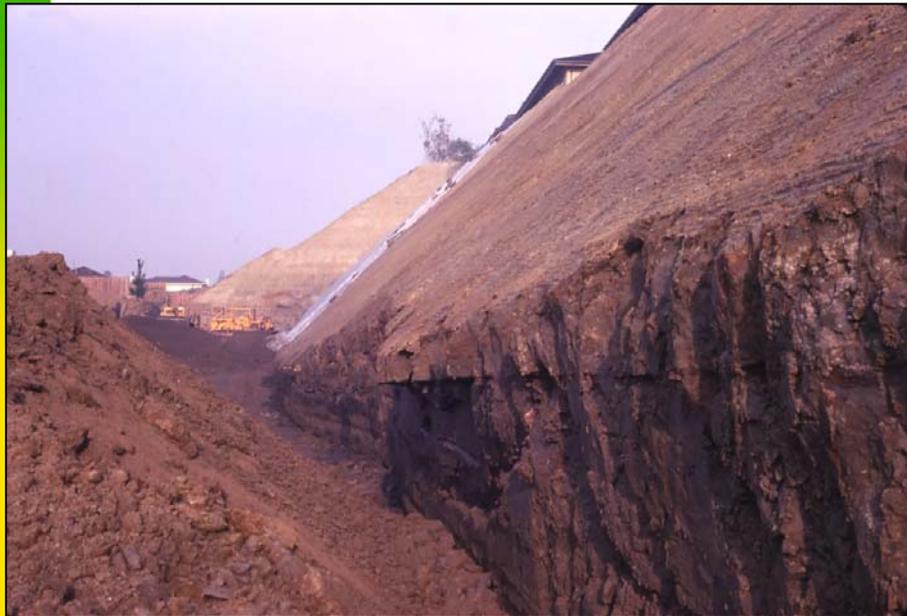
RECOGNIZING OLD LANDSLIDES

- Old landslide features can be difficult to discern, even for experienced engineering geologists
- One needs to be “looking” for such features in order to recognize them
- Case at lower left was old slide reactivated on slip plane inclined just 3 degrees, without any visible moisture

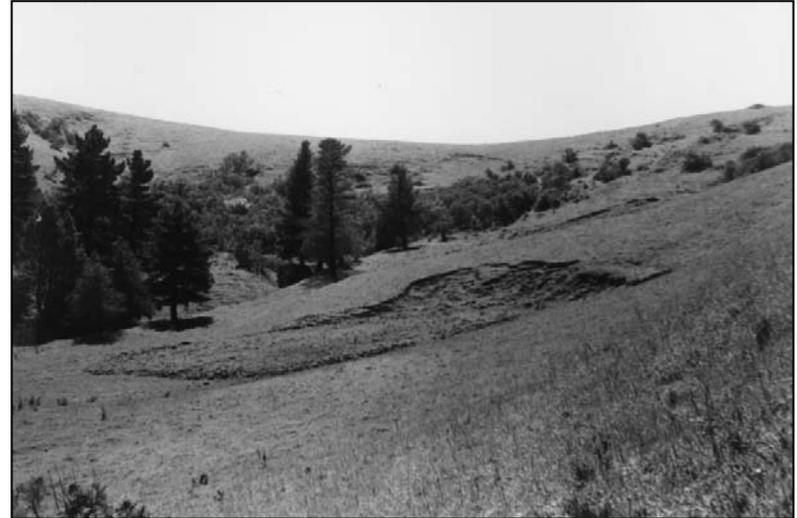
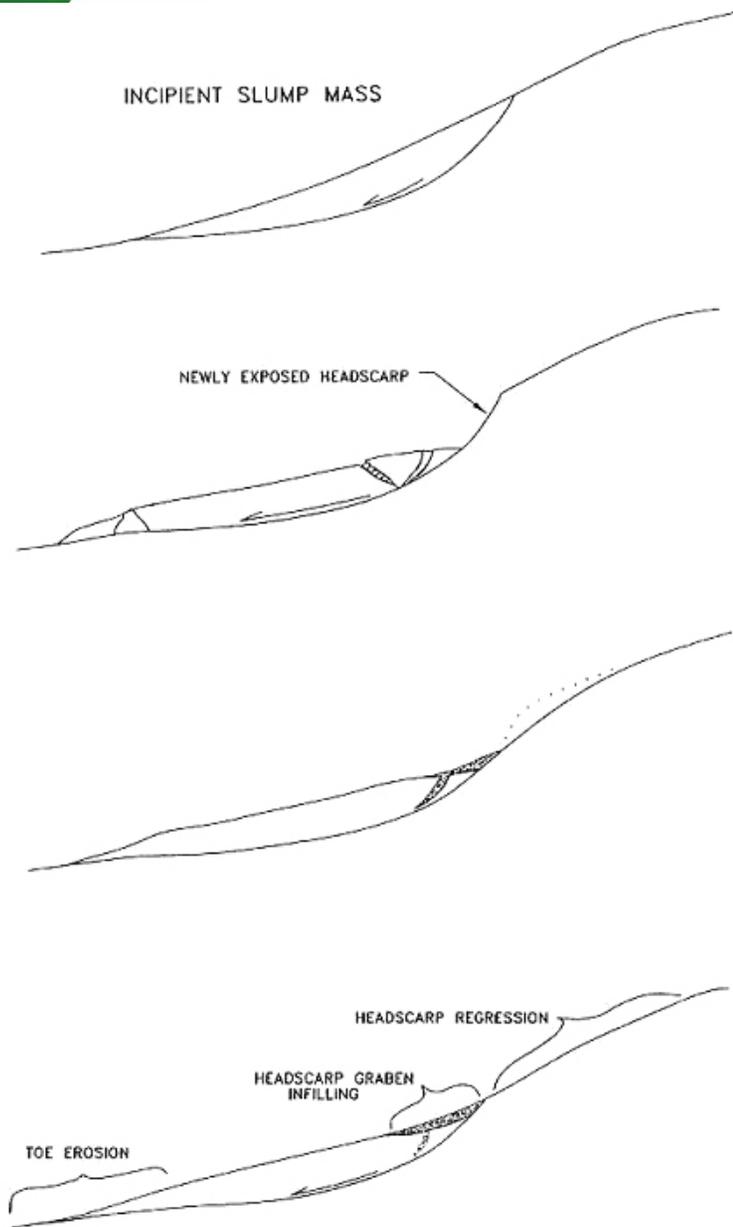
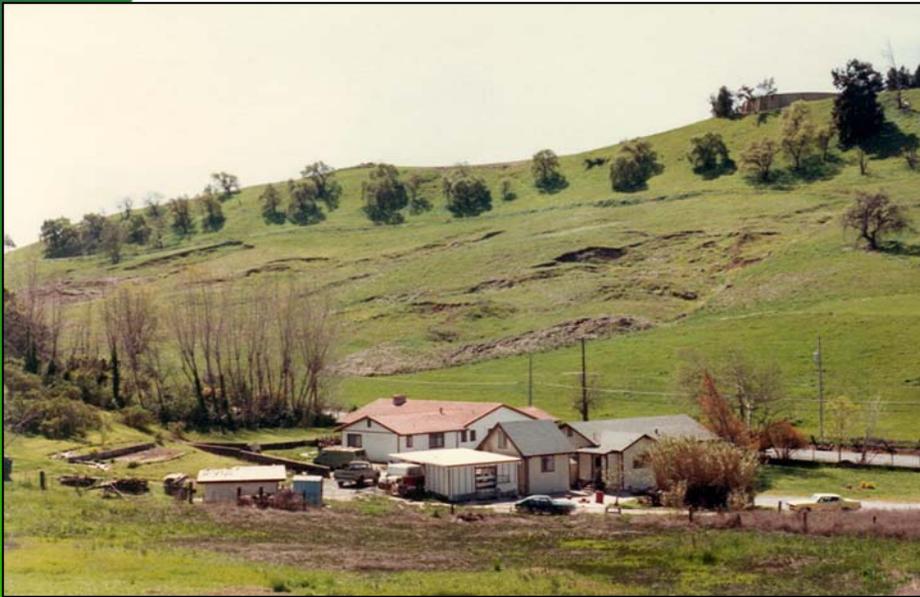
TOPOGRAPHIC EXPRESSION

- A key indicator of past landslippage is anomalous topographic expression, which becomes increasingly mollified with age, as shown in profiles at left

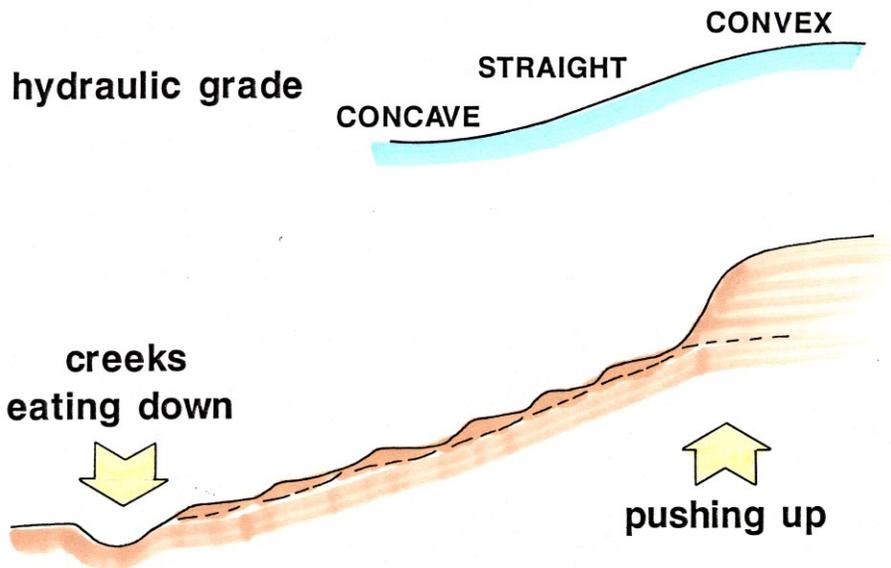
TOPOGRAPHIC EXPRESSION OF LANDSLIDES

- Landslides tend to form coalescing complexes, with hummocky topography and deranged drainage patterns. Toe undercutting or tectonic uplift are common triggers

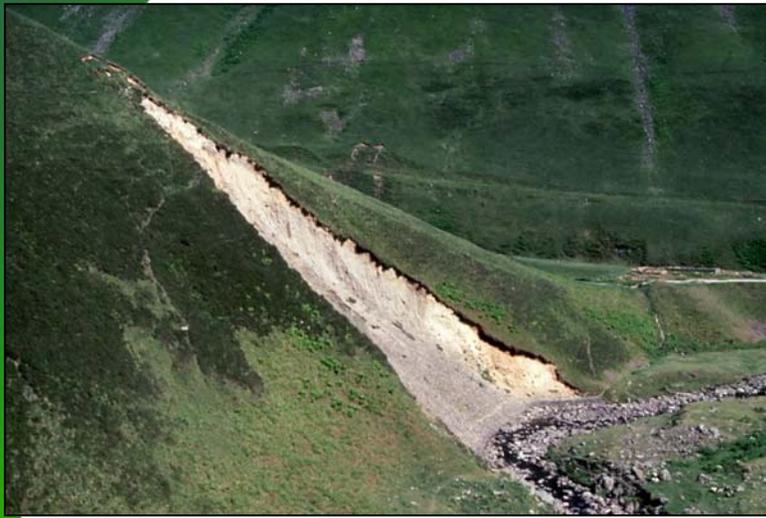
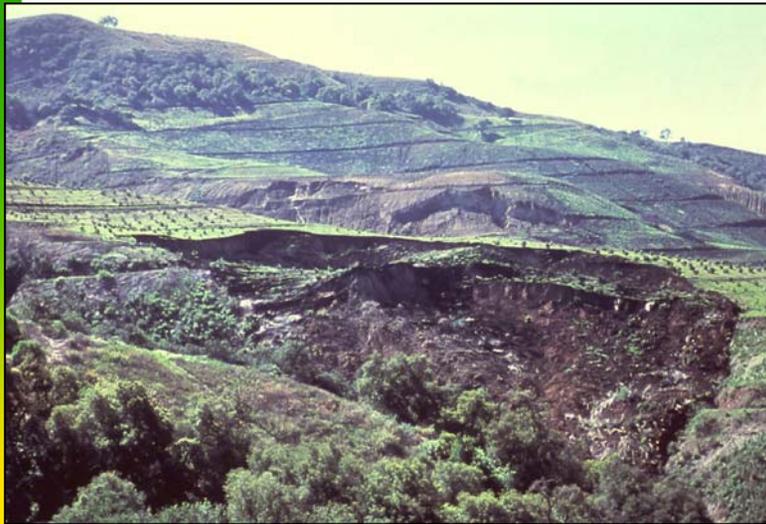
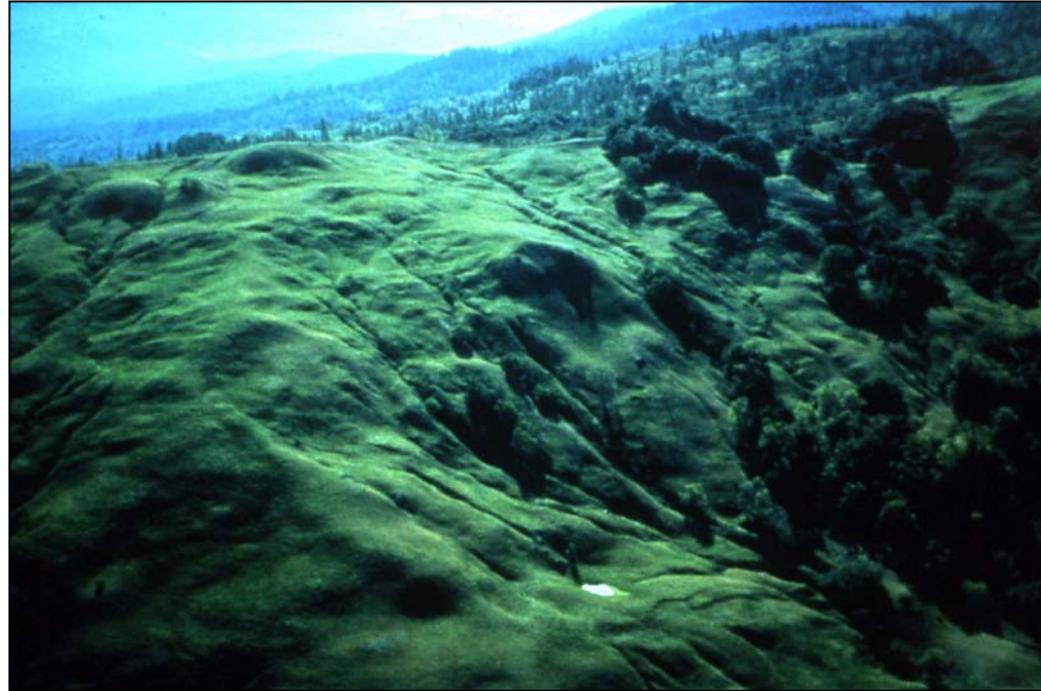
RECOGNIZING OLD LANDSLIDES

Recent landslides like those at left are easily noticed, but older complexes can be difficult to discern, especially under thick tree cover. The hummocky topography in the right image is typical of landslide-prone terrain.
