LESSONS ON SITE CHARACTERIZATION GLEANED FROM FORENSIC STUDIES

J. David Rogers

Department of Geological Sciences &
Engineering

University of Missouri-Rolla

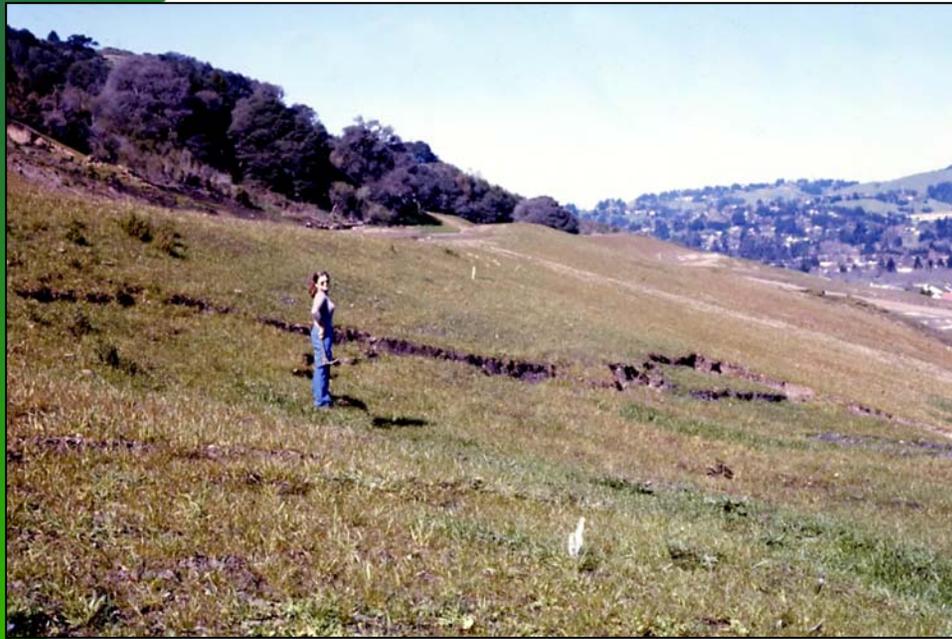
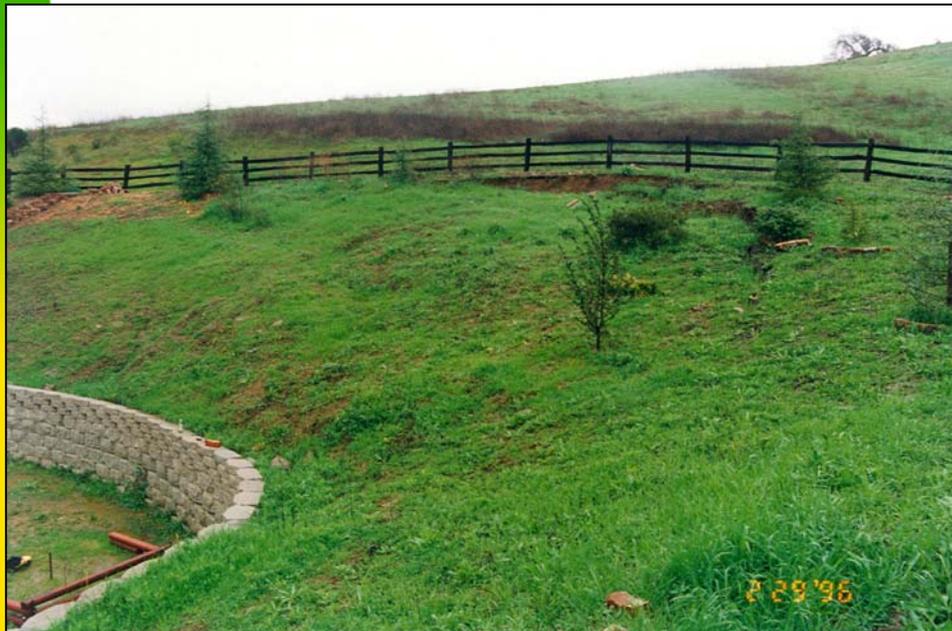
INCIPIENT LANDSLIPPAGE

- Incipient landslides are those that are beginning to fail, but have not fully ruptured
- They are easily identified by their arcuate tensile scarps crossing otherwise intact slopes

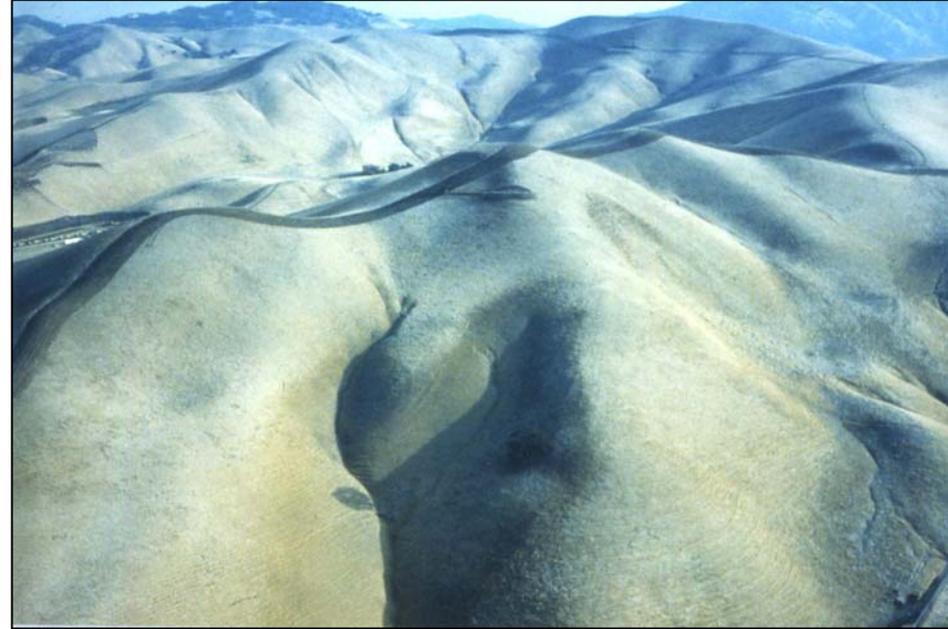
OLD BEDROCK LANDSLIDES

Old bedrock landslides can be very difficult to identify. Key indicators are anomalous isolated benches and converging parallel drainages

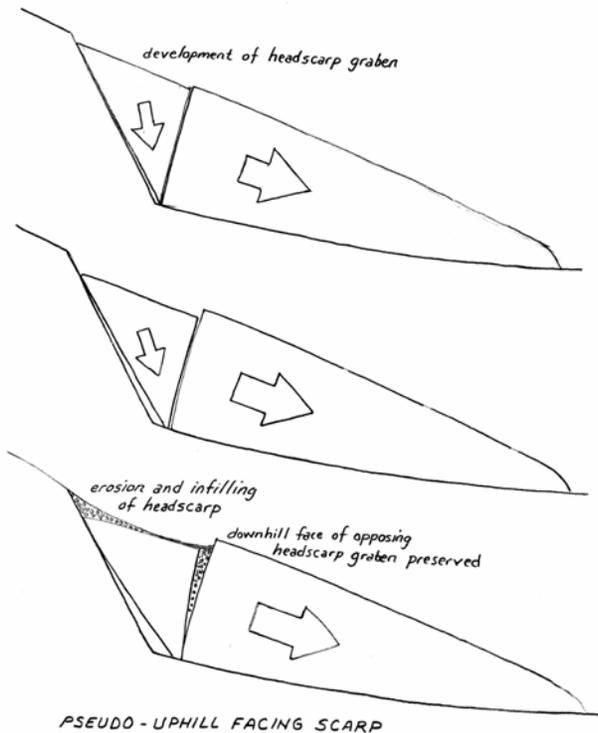
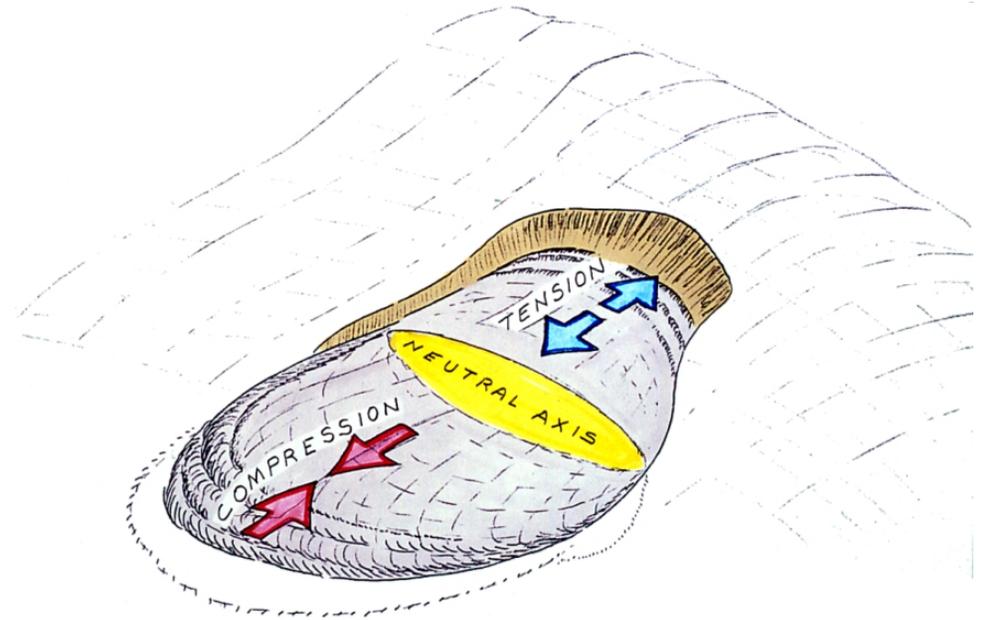
SIMPLE
TRANSLATIONAL BLOCK GLIDE LANDSLIDE

The arcuate nature of a landslide headscarp is due to tensile pull-apart as the slide mass translates downslope. It is easy to estimate the depth of sliding from the opposing scarps

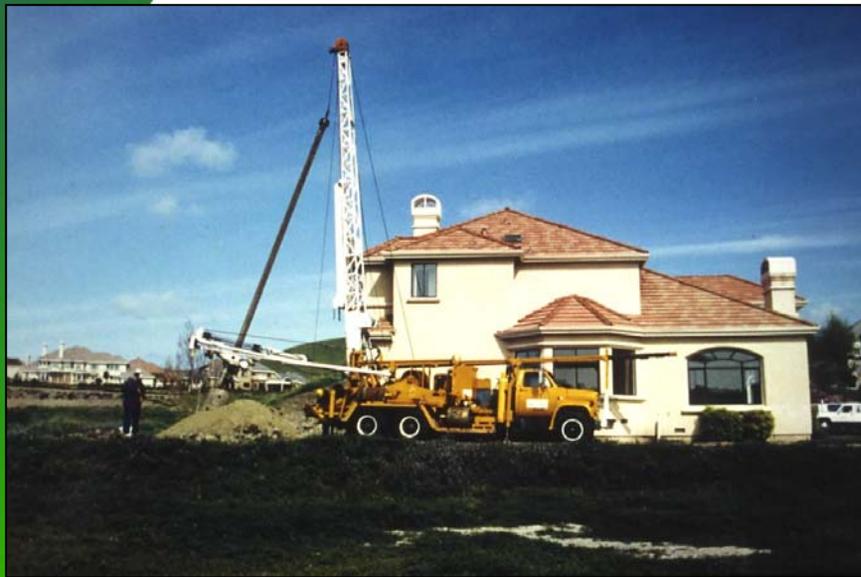
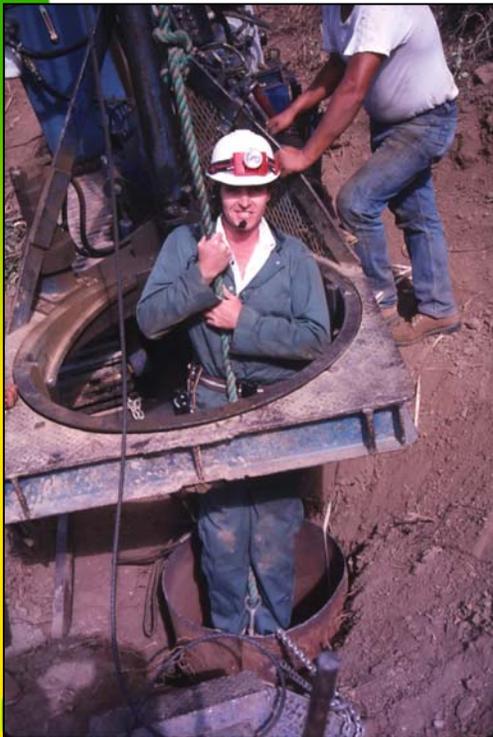
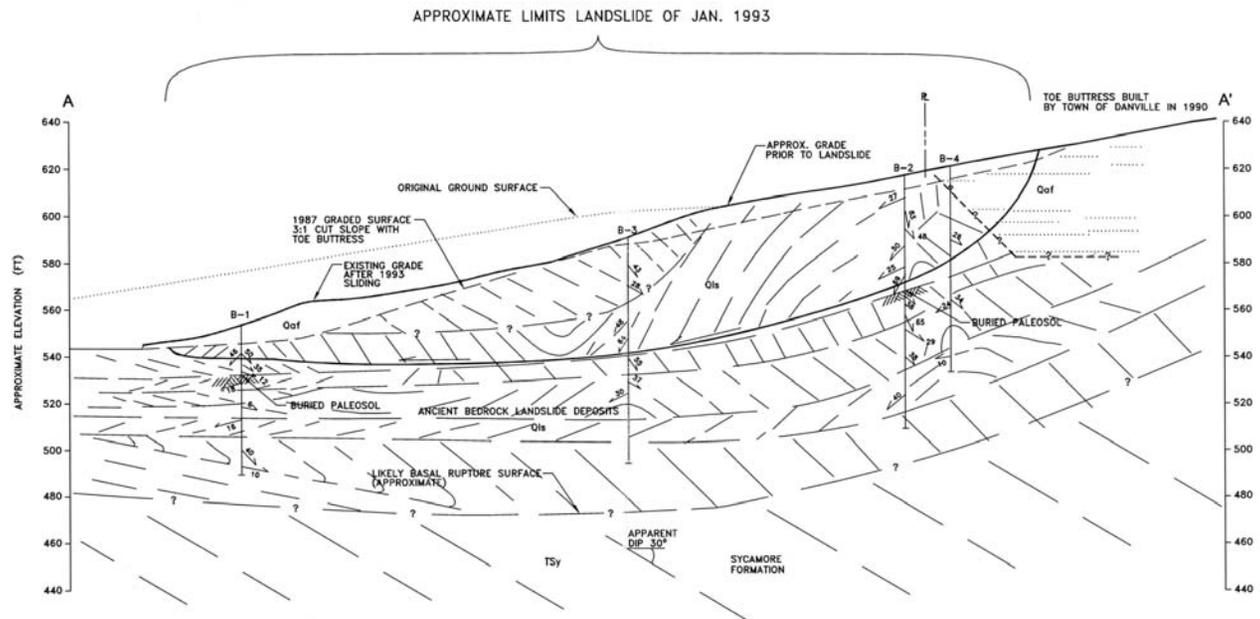
BUCKET AUGERS

Bedrock landslides are best explored using large diameter bucket auger borings, which can be downhole logged

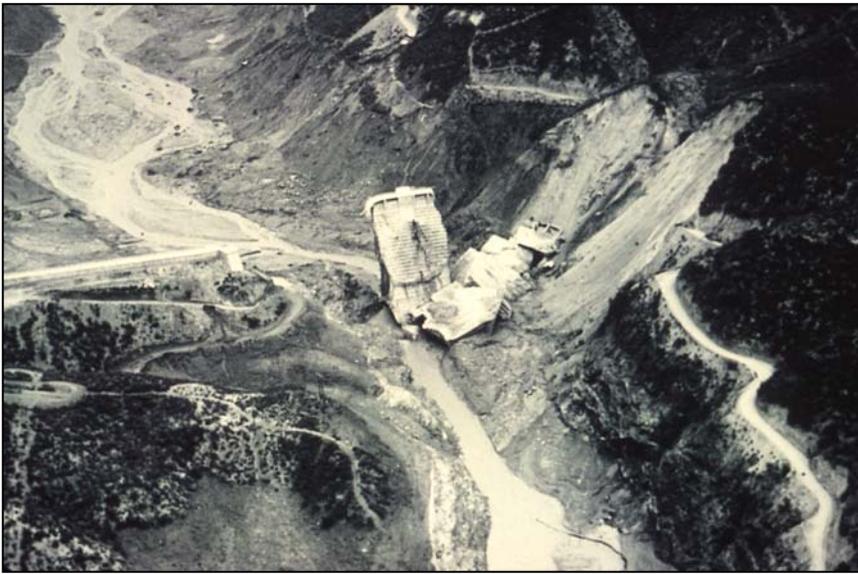
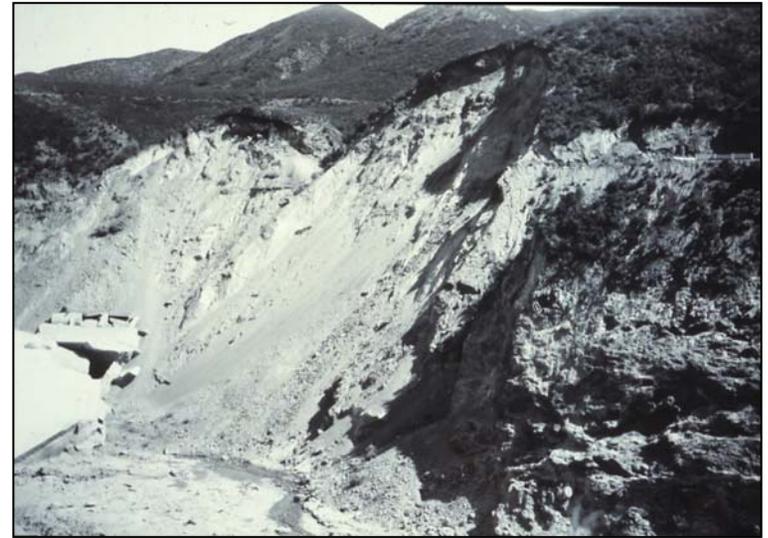
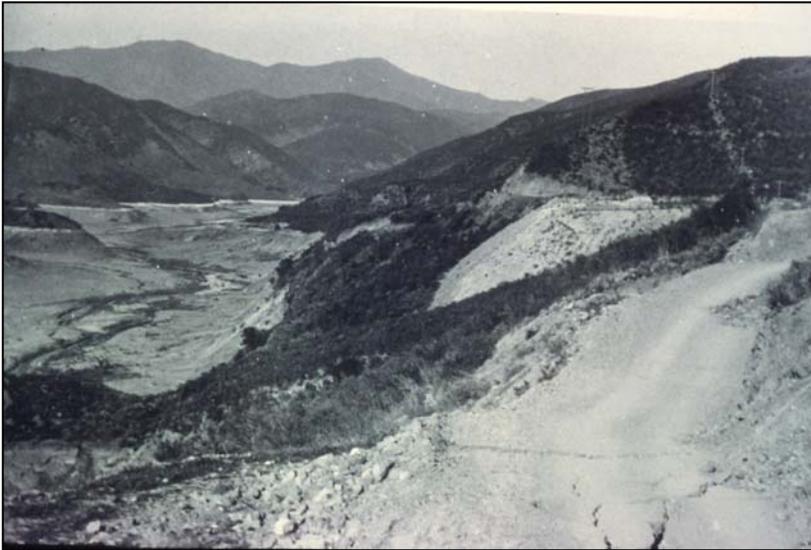
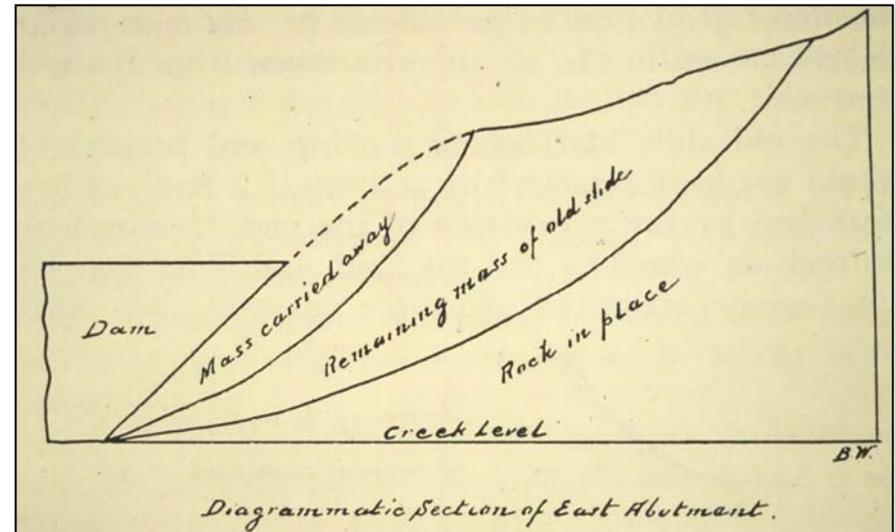
- **St. Francis Dam was unknowingly constructed against a paleo-landslide developed in pre-Cambrian age Pelona Schist in 1924-26.**

535 million m³ of schist in the dam's left abutment detached and slid downslope, destroying the dam. Relaxation movements of up to 3 m were noted at elevations more than 60 m above the left abutment

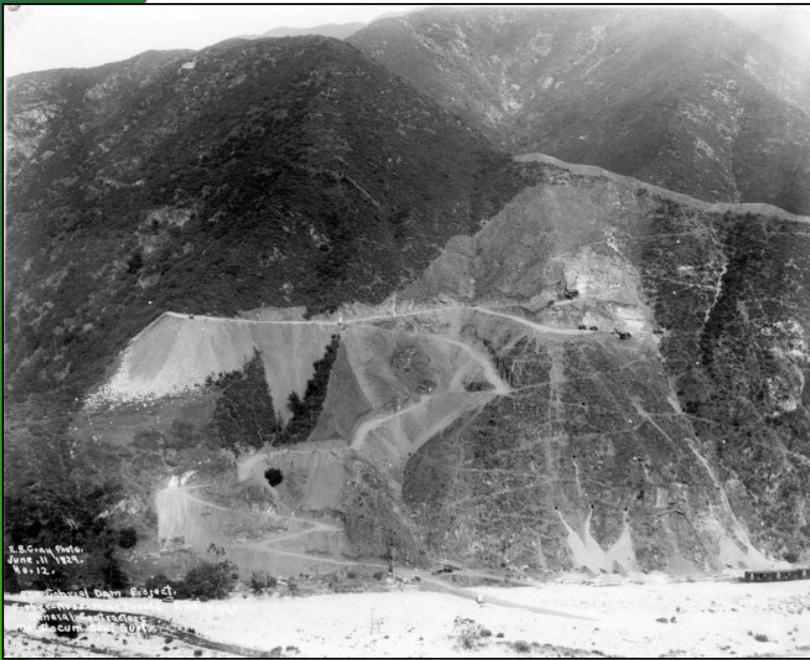
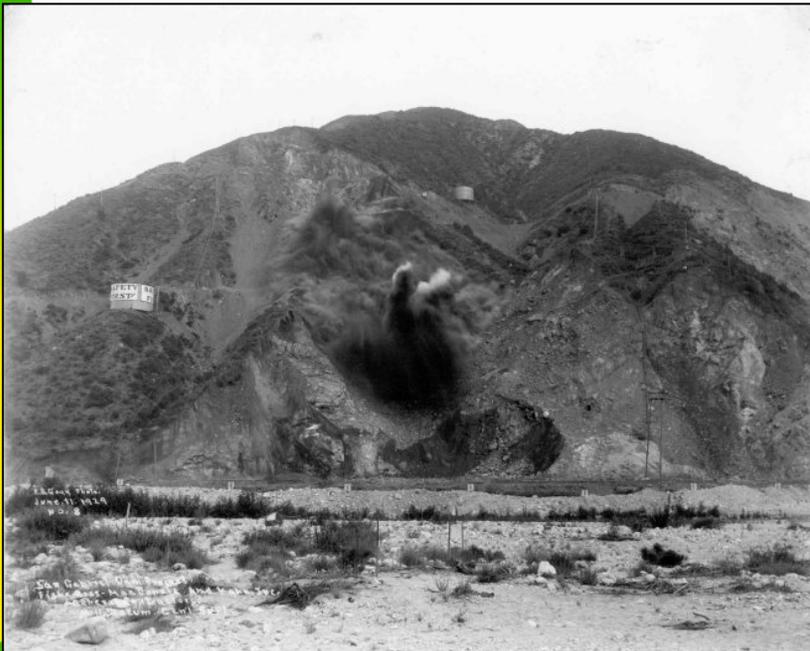
SAN GABRIEL DAM

- The San Gabriel Dam at the Forks Site would have been the largest dam in the world when construction began in September 1928
- These views show right abutment excavations at the Forks site in June 1929
- Plans called for 200,000 yds³ excavation on each abutment

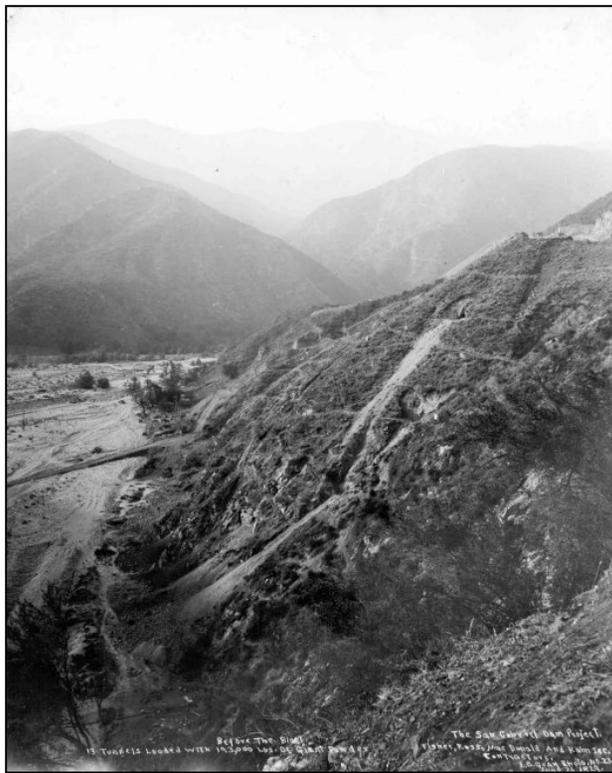
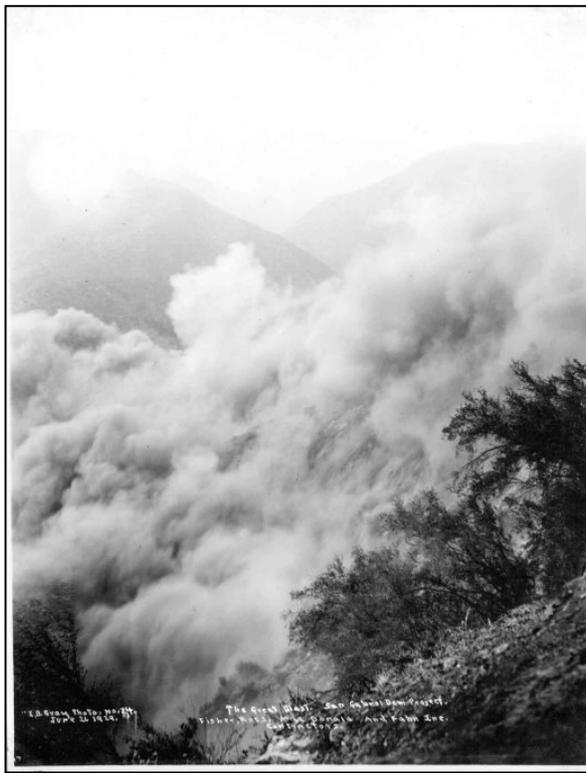
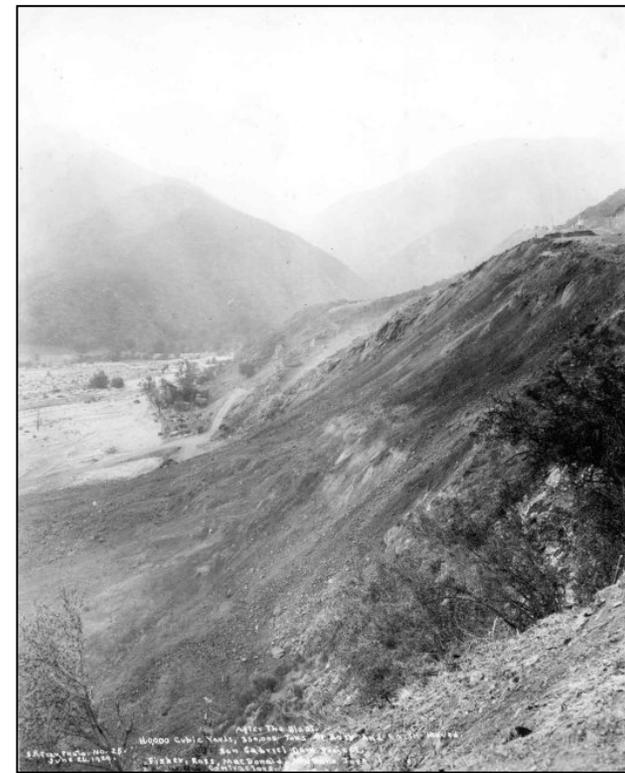
Three views showing before (left) and during (middle) and after (right) the massive detonation of the dam's right abutment. The contractor detonated 87,430 kg of dynamite. On September 16, 1929 a massive slide of the right abutment occurred, bringing down 153,000 m of additional rock. This led to an investigation and eventual cancellation of the project by the State of California.

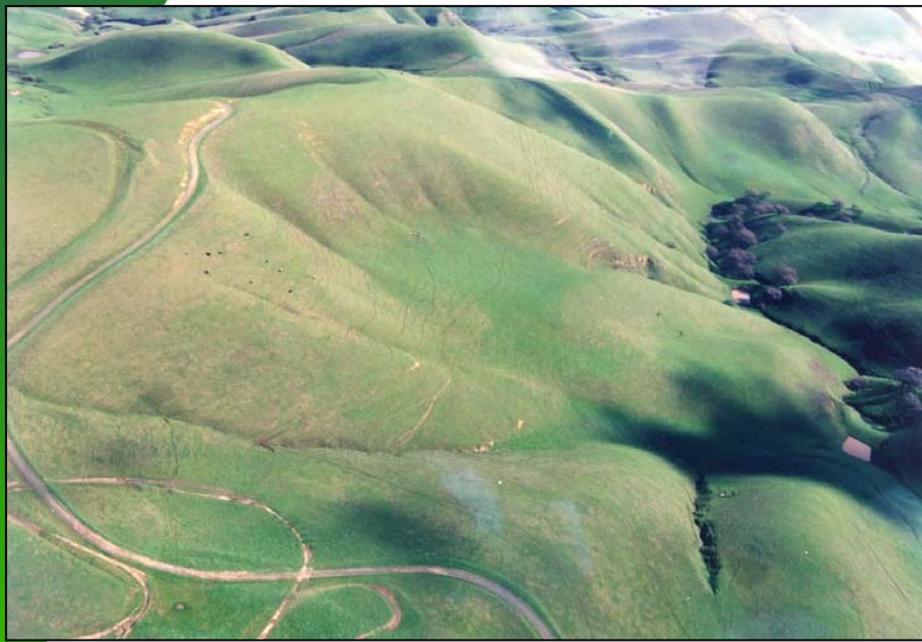
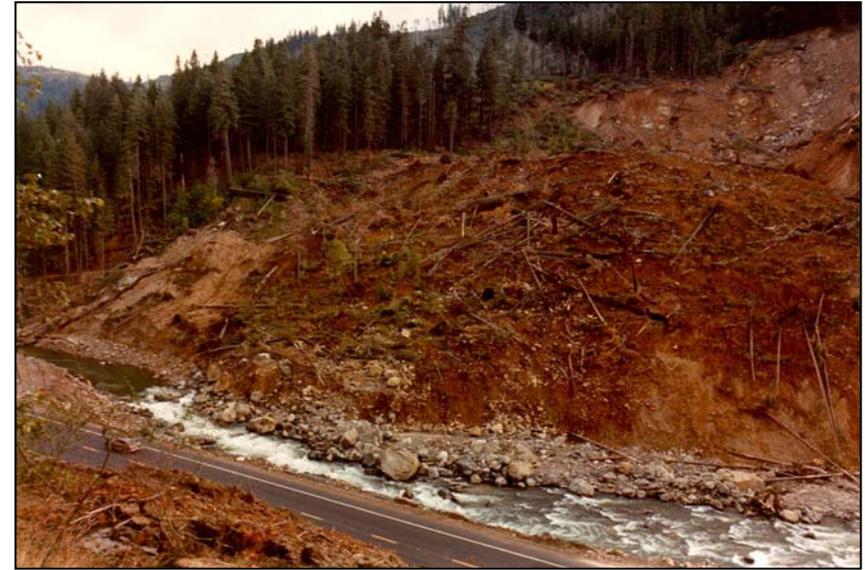
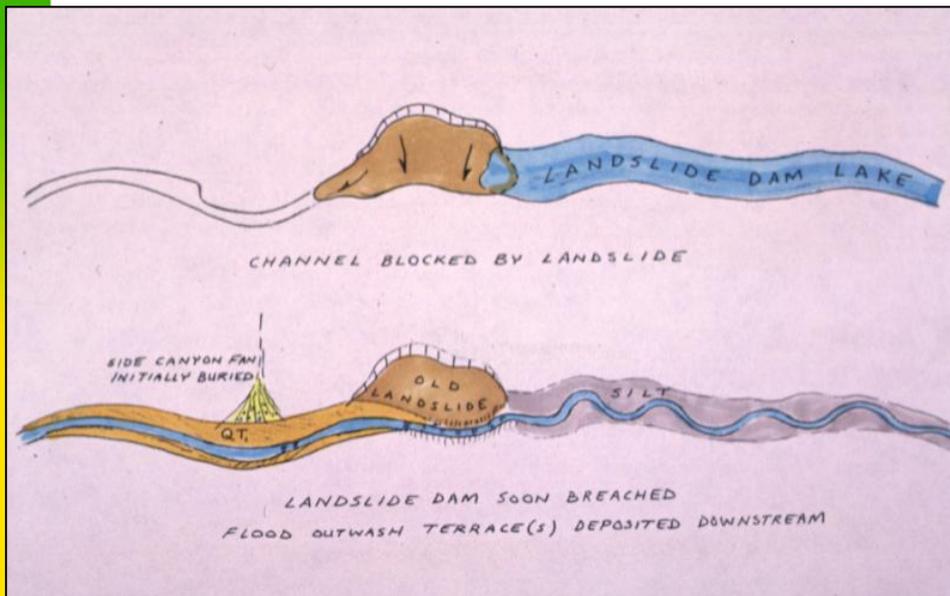
LANDSLIDE DAMS

Landslide dams perturb channel profiles. Lessened gradient upstream of blockage and increased gradients through the obstruction, as shown above. Channels often swing around the obstructions in a convex outward pattern.

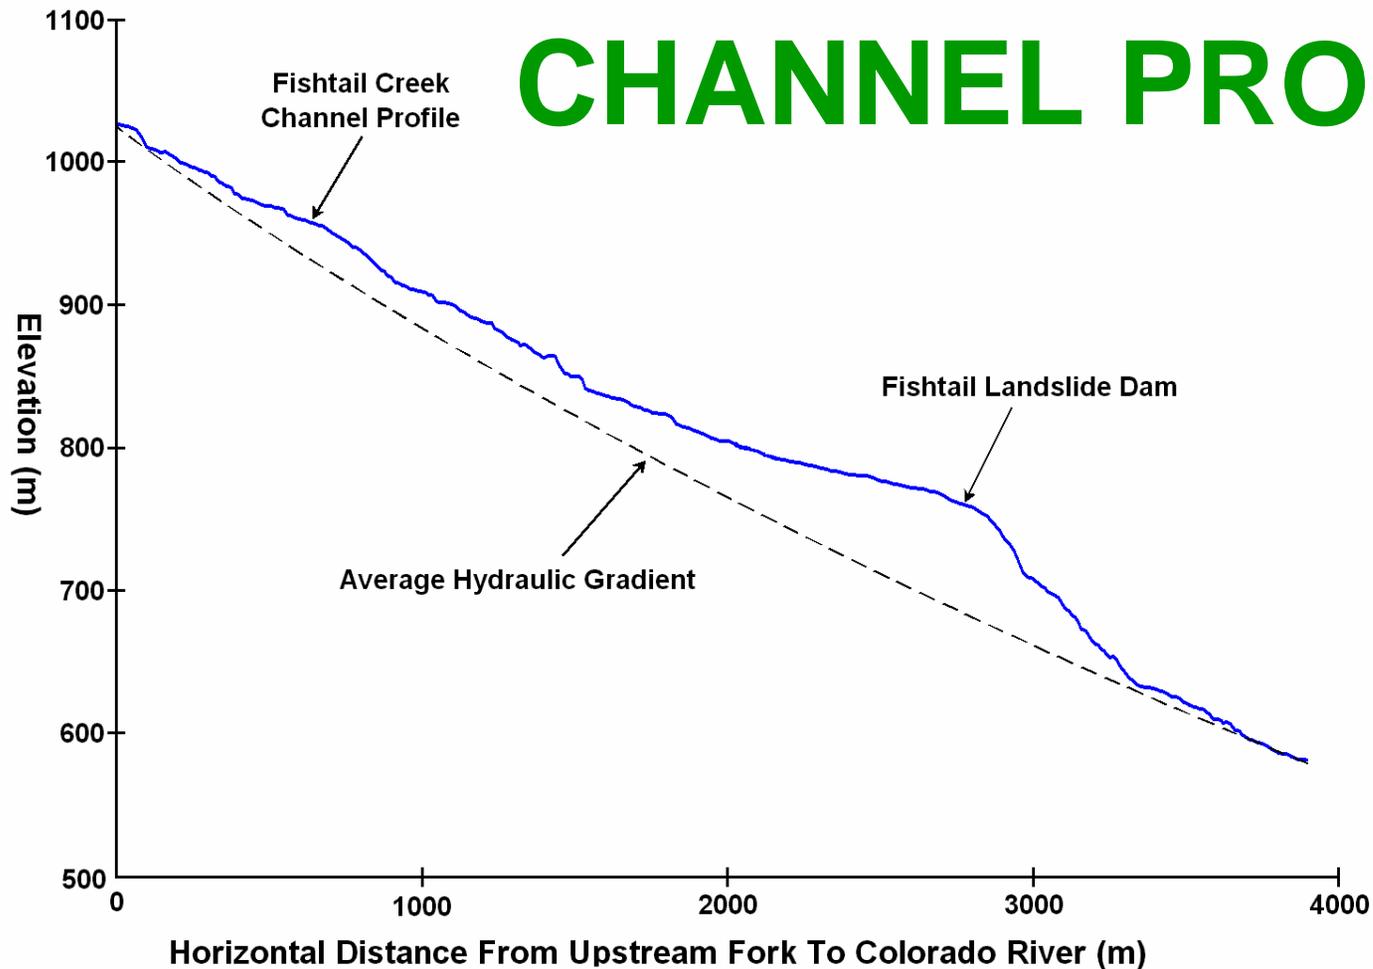
CHANNEL PROFILE

- Example of a channel profile perturbed by landslide damming in Fishtail Creek, Grand Canyon. Note lower gradient upstream of obstruction and increased gradient on downstream side.

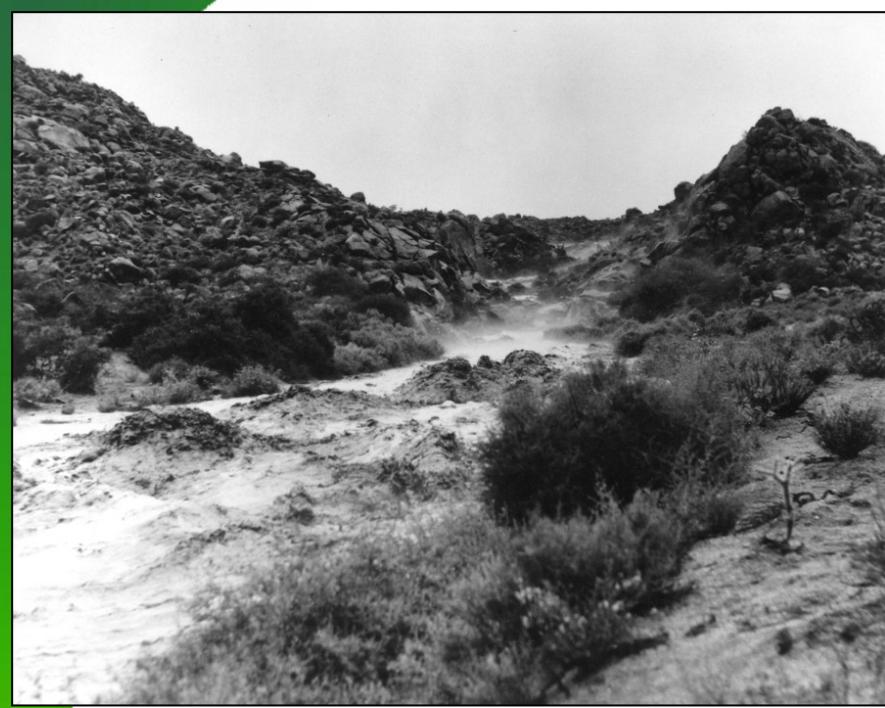
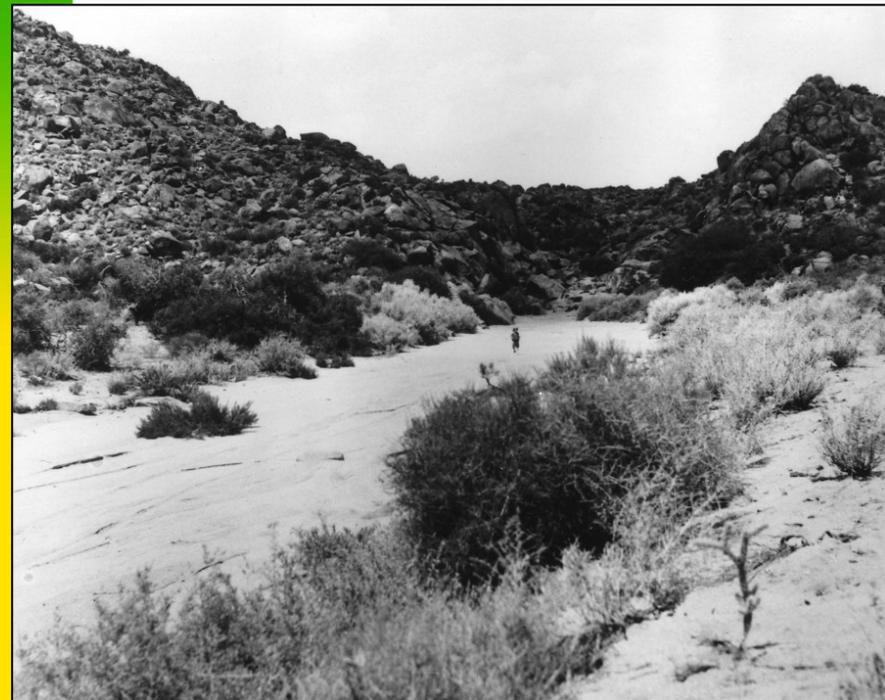
CHANNEL SCOUR

- Engineering geologists are often asked to estimate depth of channel scour, especially for bridges
- These are during and after views of a desert flash flood in June 1969 which developed 8 feet high standing waves. Note children for scale in lower image, taken a few weeks later.

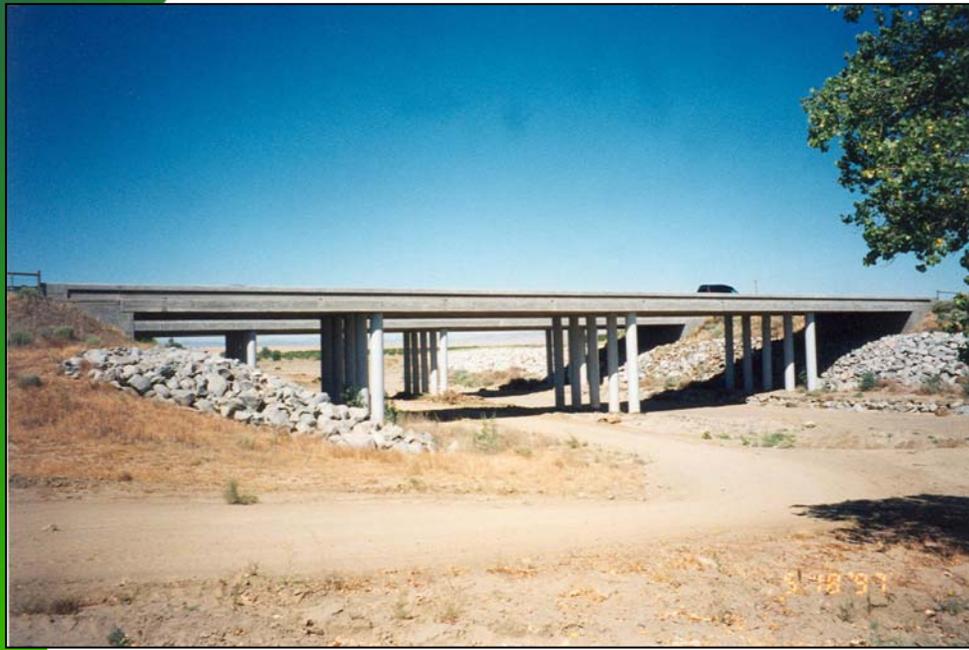
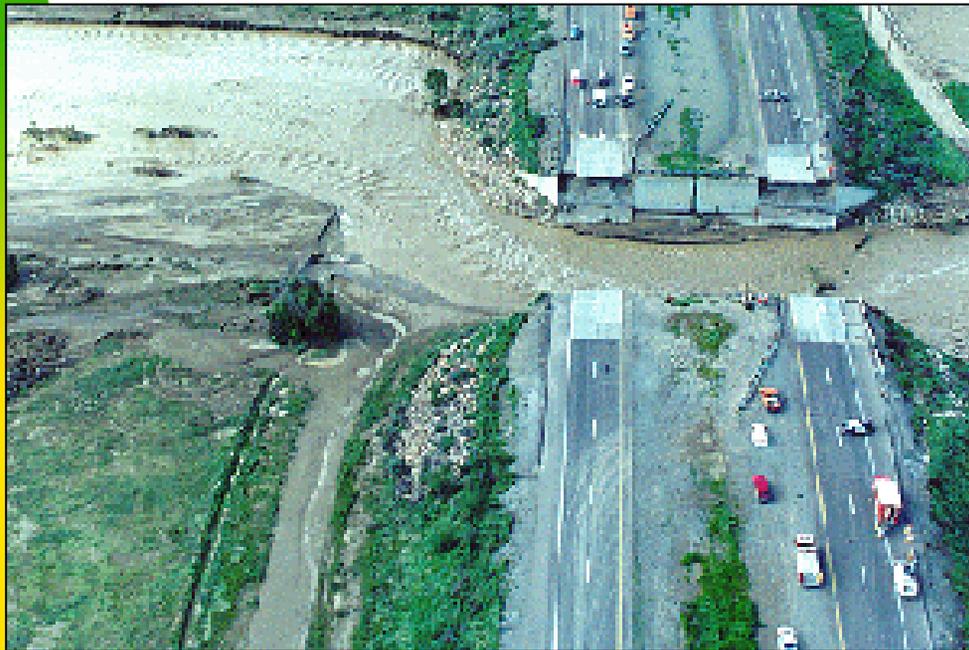
Arroyo Pasajero Wash Out

- A flash flood on March 10, 1995 brought a peak flow of 33,000 cfs through a constricted overcrossing for Interstate 5 near Coalinga, CA. The channel was downcut by almost 30 feet, undermining the bridge caissons and dropping the twin spans. 7 people were killed.

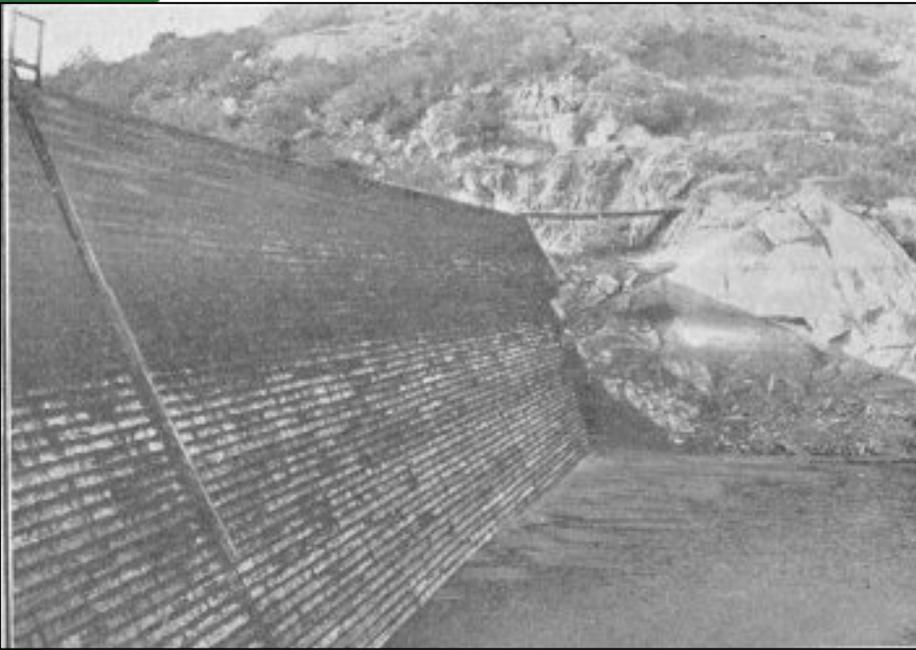
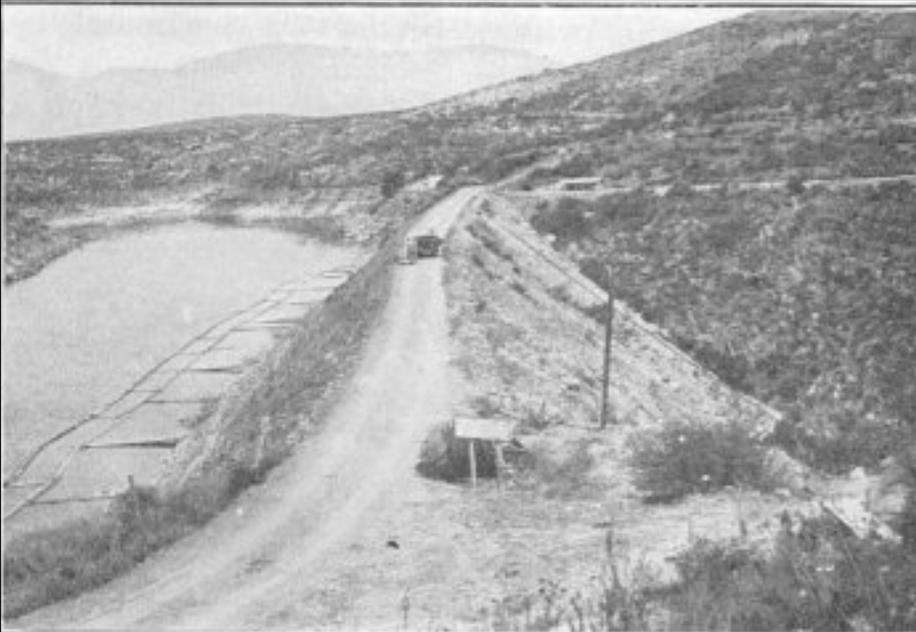
DAMS THAT WOULD NOT HOLD WATER

Escondido (upper) and Morena (lower) Dams were both constructed around 1900 in southern California. They lost large volumes of water through alluvial gravels beneath the embankments.

Escondido Dam never filled beyond 2/3 capacity, losing 100,000 gpd. Morena lost between 33,500 to 58,000 gpd, depending on head.

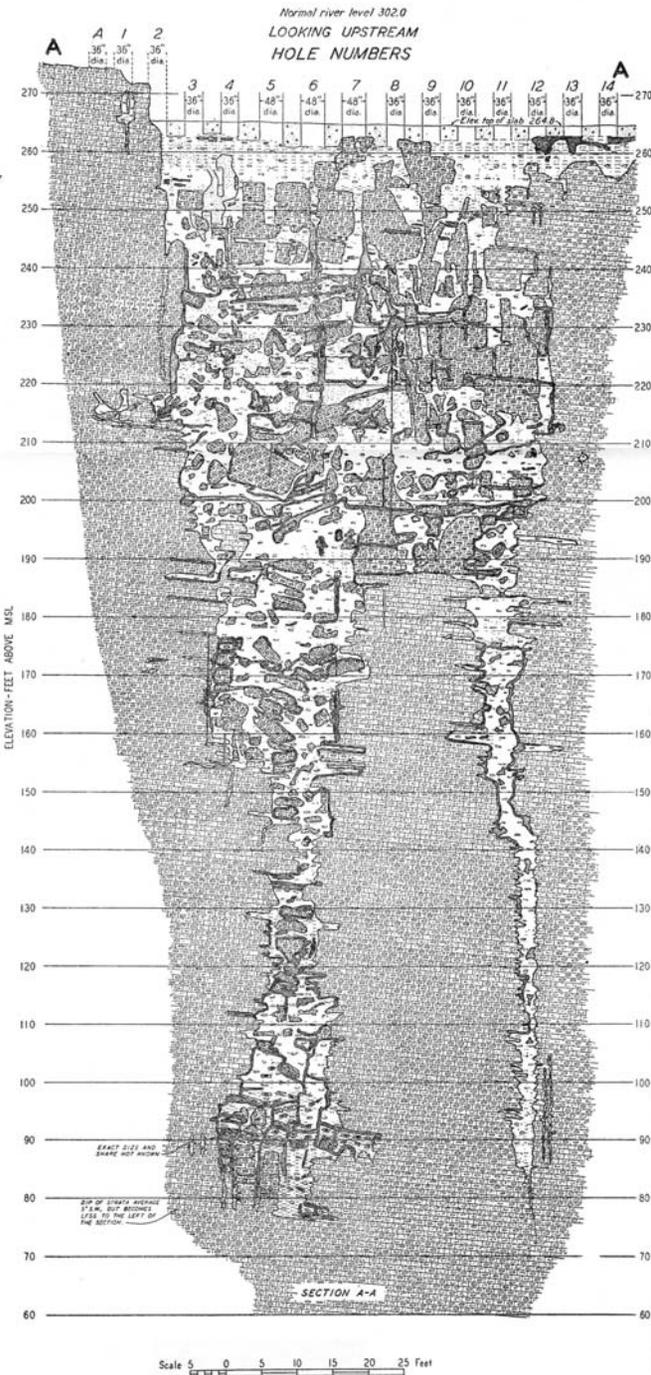
KARST FOUNDATIONS

- Cross section through the foundation for Kentucky Dam on the Tennessee River (TVA, 1949).
- The Pleistocene Valley floor was about 70 feet lower than at present, with deep solution cavities extending 200 feet beneath the channel
- 734,000 sacks of cement were pumped into the foundation during construction (20,000 m³)

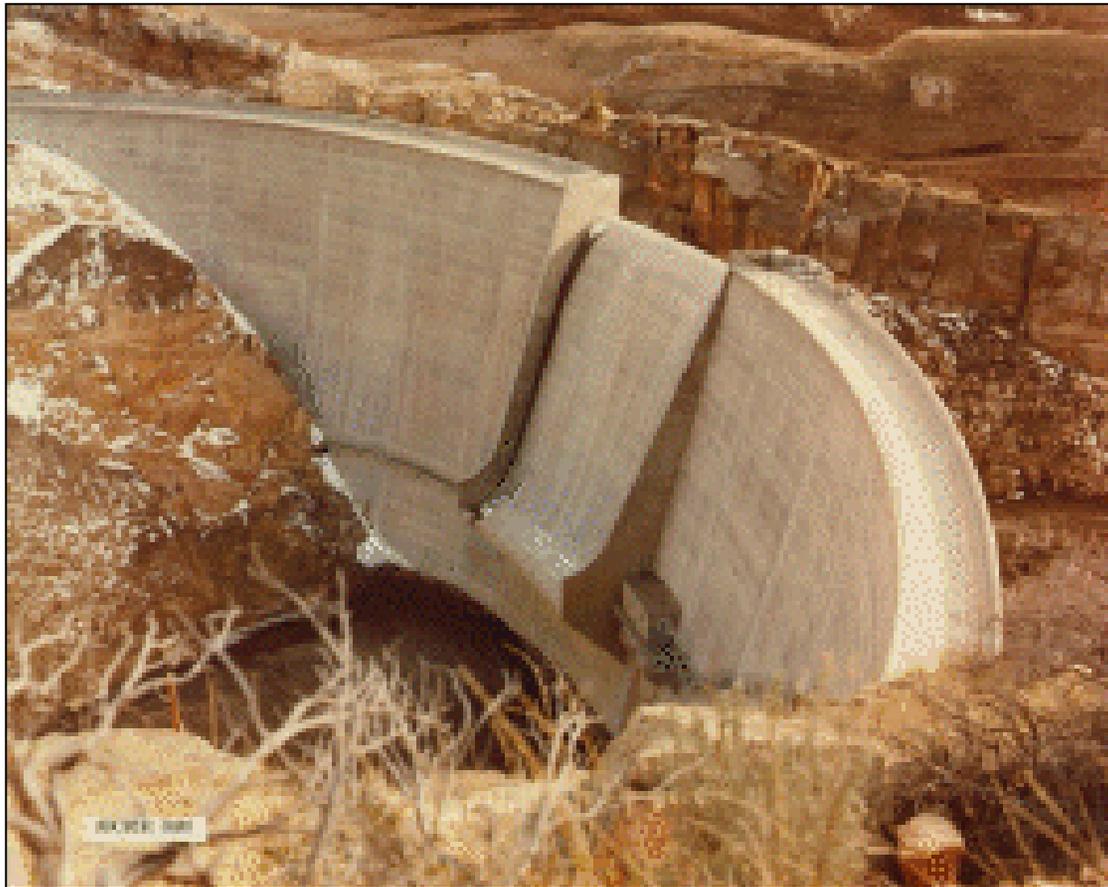
- **Anchor Dam was built by the U.S. Bureau of Reclamation 56 km west of Thermopolis, WY in 1957-60. Reservoir water seeps downward into karstified redbeds of the Permian age Goose Egg and Triassic age Chugwater formations. The dam has never retained any significant volume of water.**

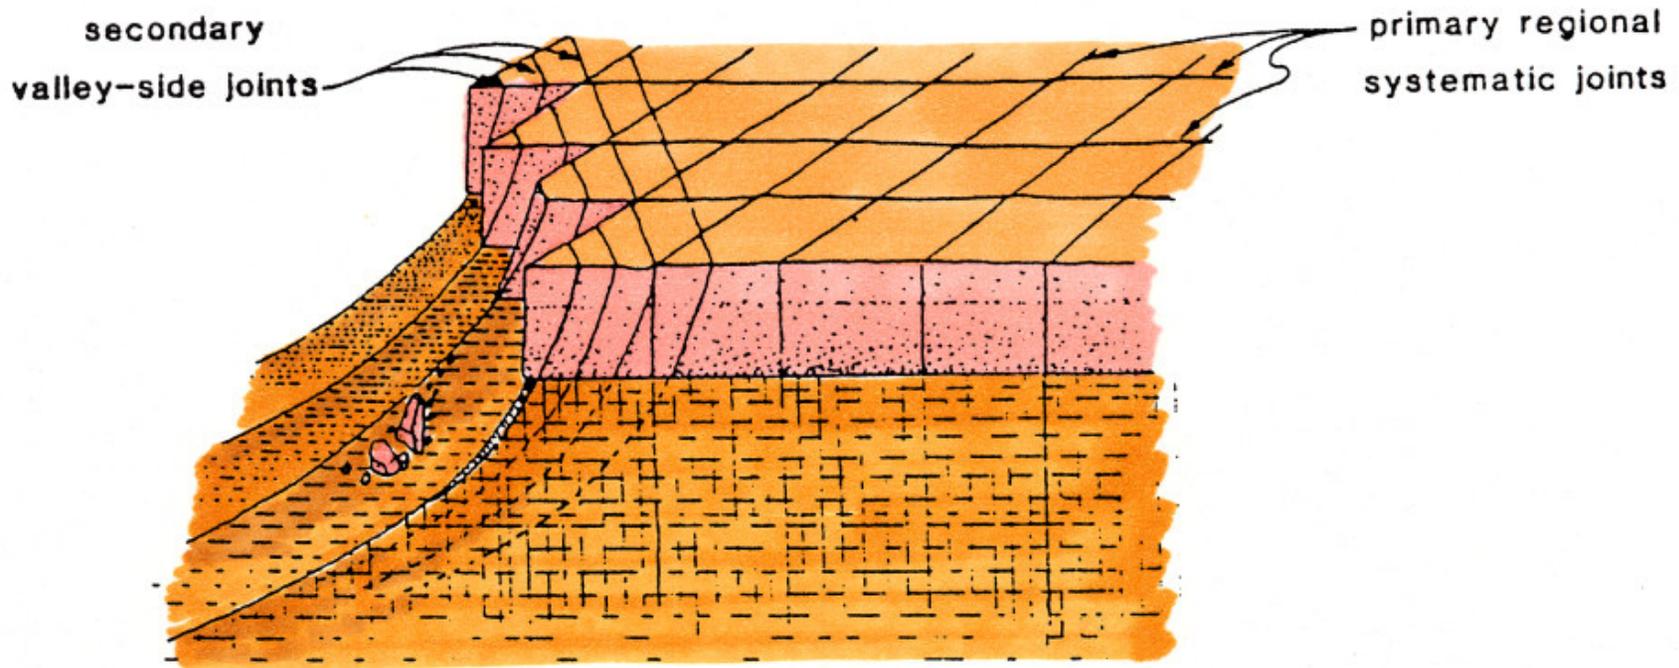
OUT-OF-PLANE DISCONTINUITIES

- **Valley-side stress relief joints tend to form parallel to free cliff faces, in response to stress changes engendered by excavation of the valleys, slope creep and thermally-induced stresses. They are dangerous because they cannot be seen in casual mapping.**

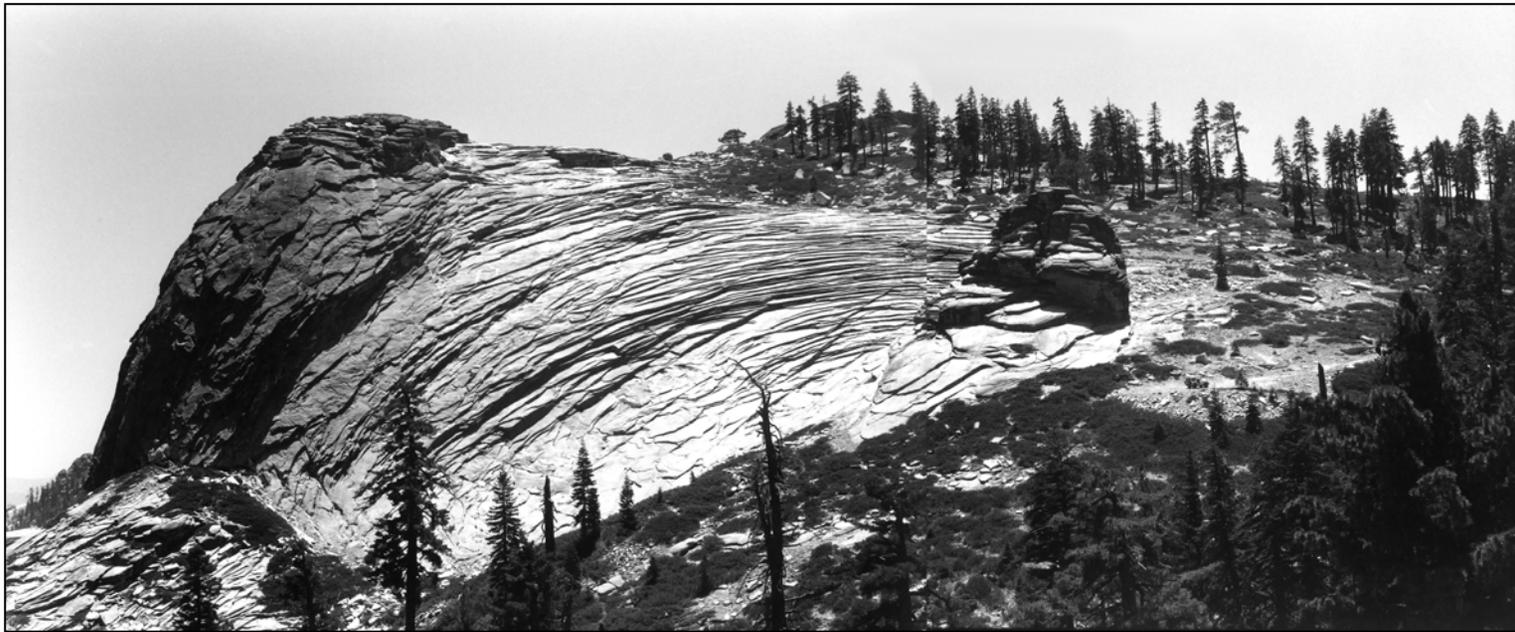
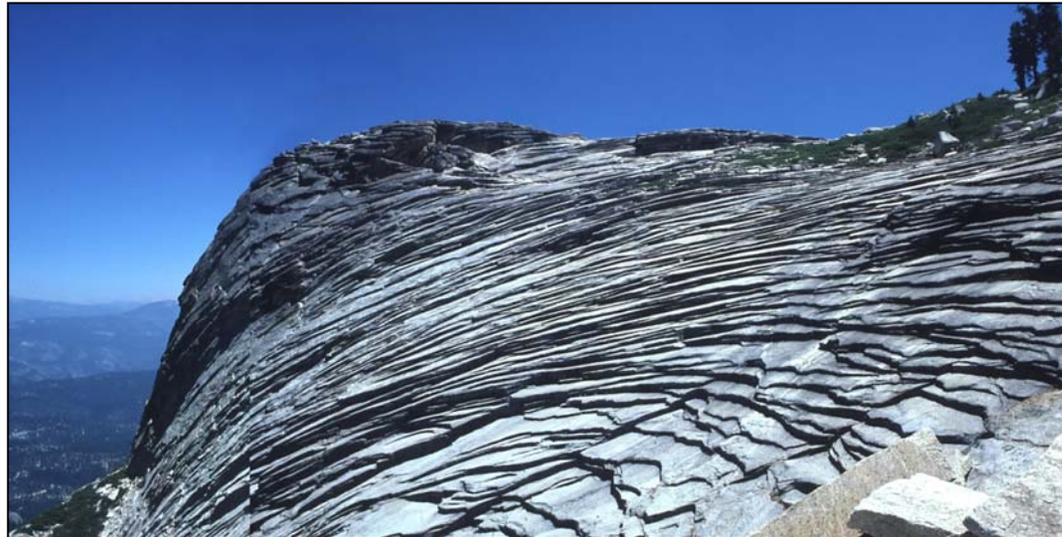
- Exfoliation joints exposed in glacial cirque of Little Shuteye Pass, in California's Sierra Nevada Mountains, in the Mt. Givens granodiorite

- Sheet joints, valley side joints or exfoliation joints all describe the same features
- When the valley side is excavated new joints form beneath the unloading
- This caused problems at Mammoth Pool dam site in California, shown here
- Terzaghi recommended placing fill for dam and grouting the joints as construction progressed

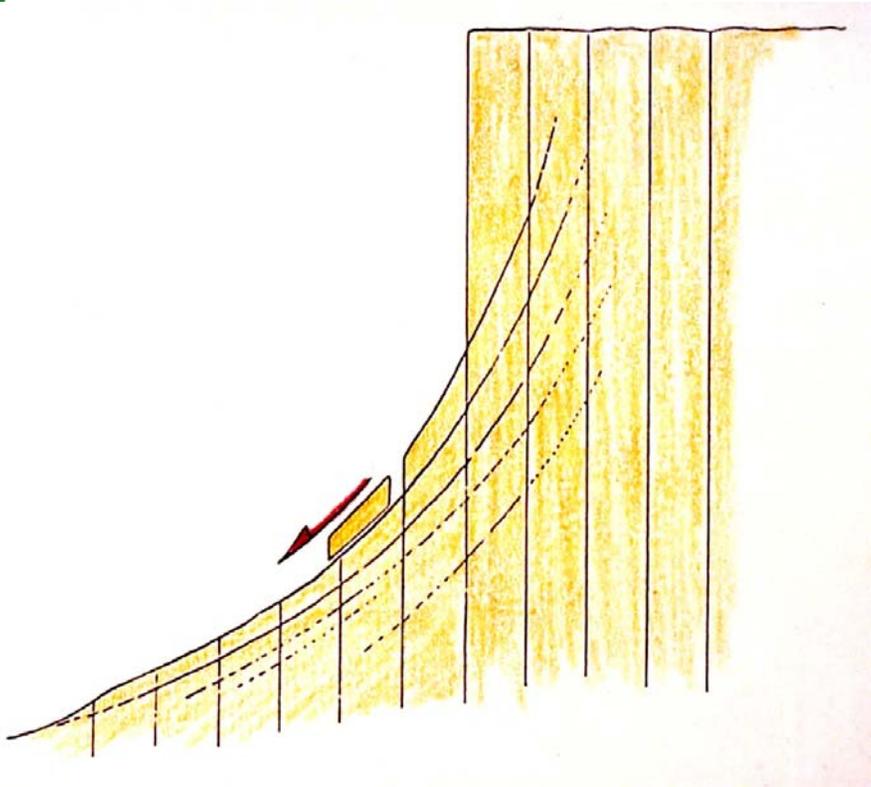
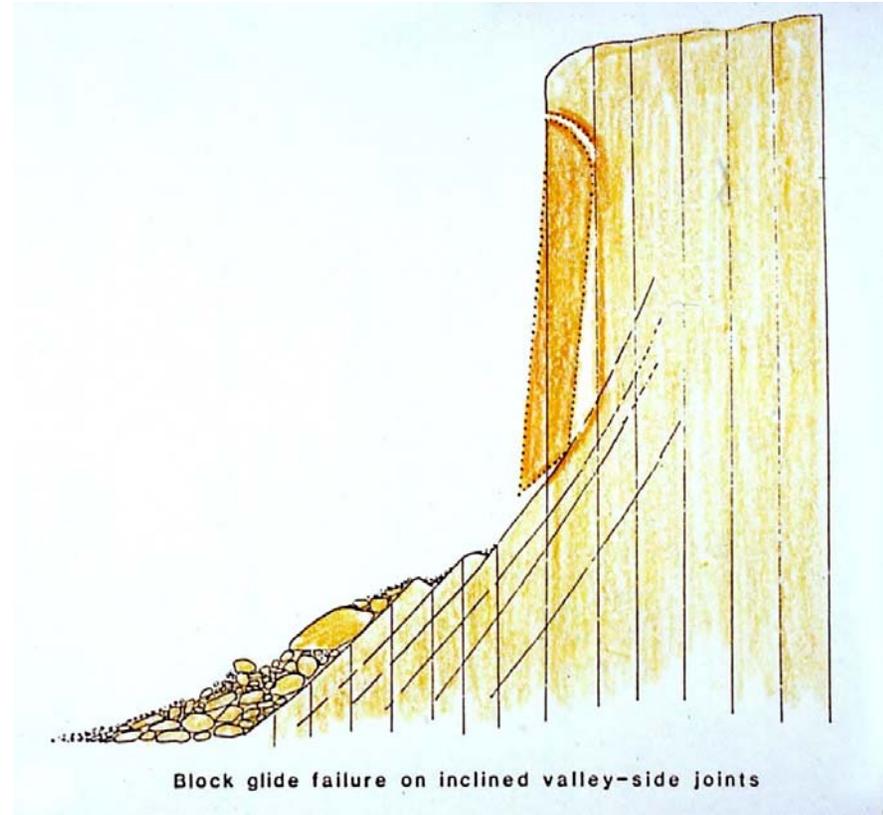
VALLEY-SIDE JOINT FAILURE MODES

- Valley-side joints are particularly treacherous because they are usually inclined at close to $45-\phi/2$ degrees from vertical (around 60 degrees), which offers the least shear resistance to slippage.
