LESSONS ON SITE CHARACTERIZATION GLEANED FROM FORENSIC STUDIES

J. David Rogers

Department of Geological Sciences &
Engineering

University of Missouri-Rolla

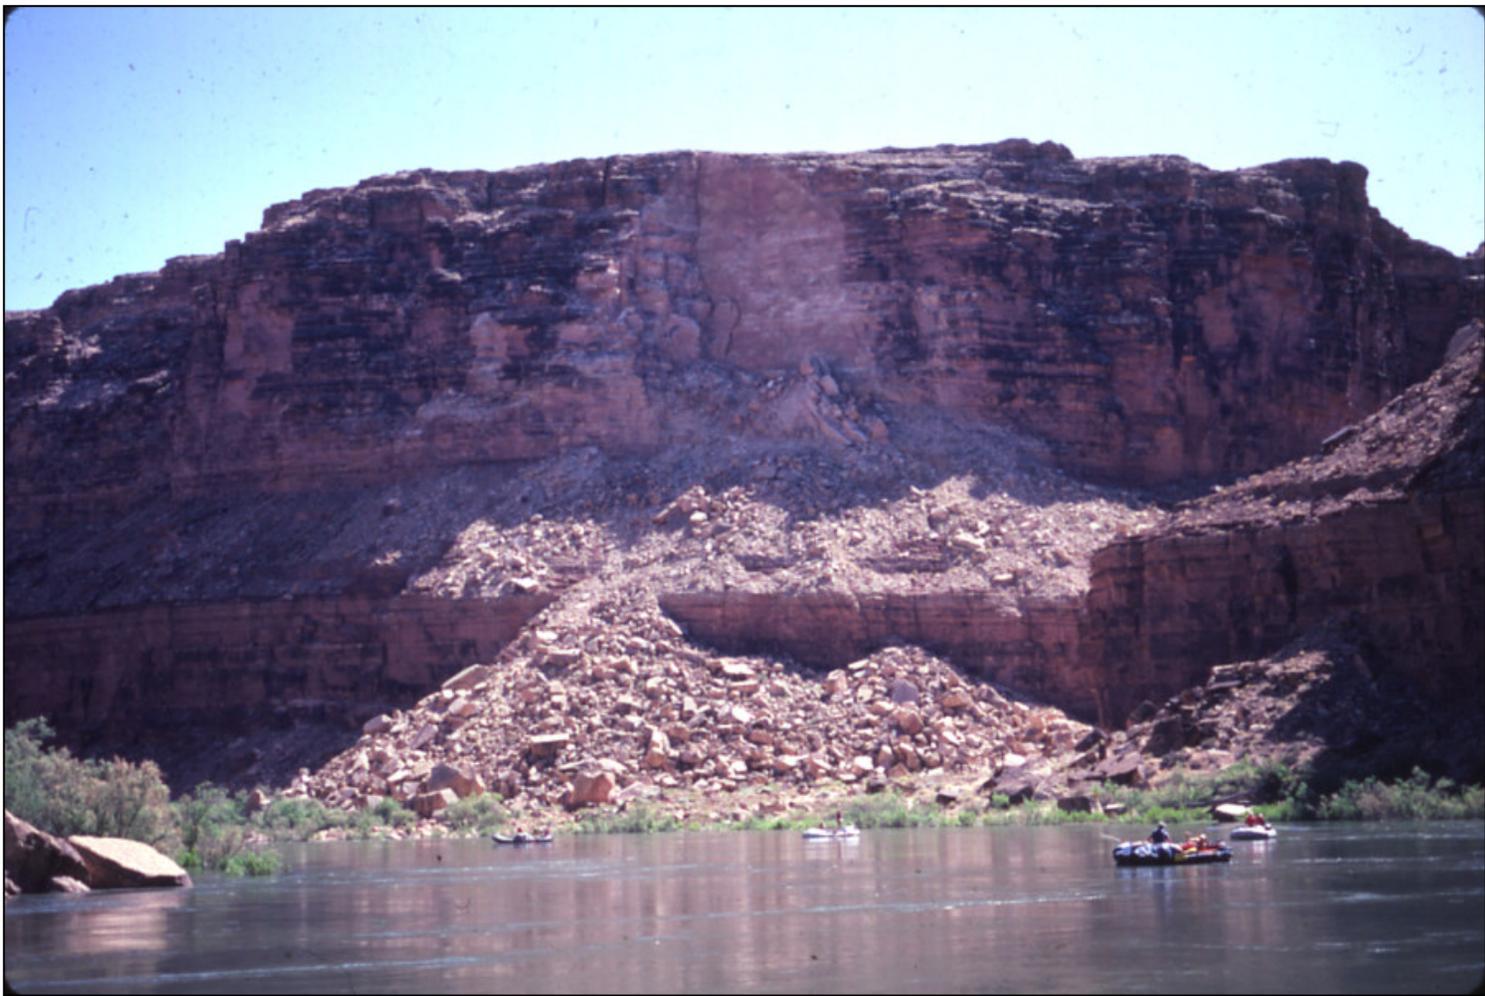
- **Catastrophic rockfall typical of steeply inclined bluffs with out-of-plane discontinuities. This example is from 6 Mile Wash in Marble Canyon, Arizona**

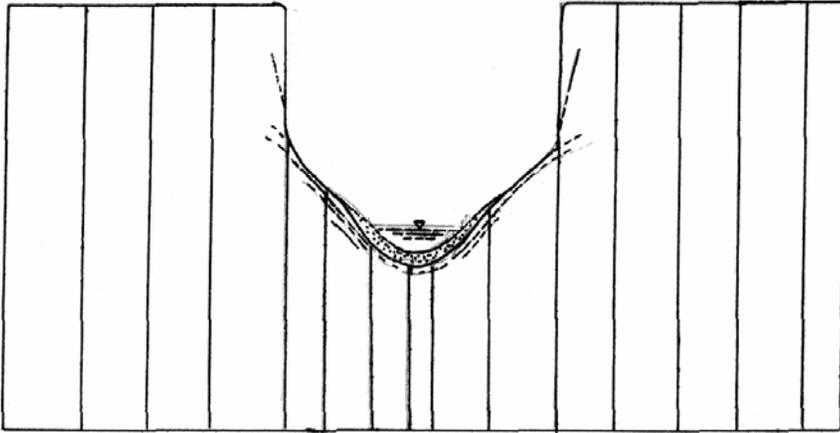
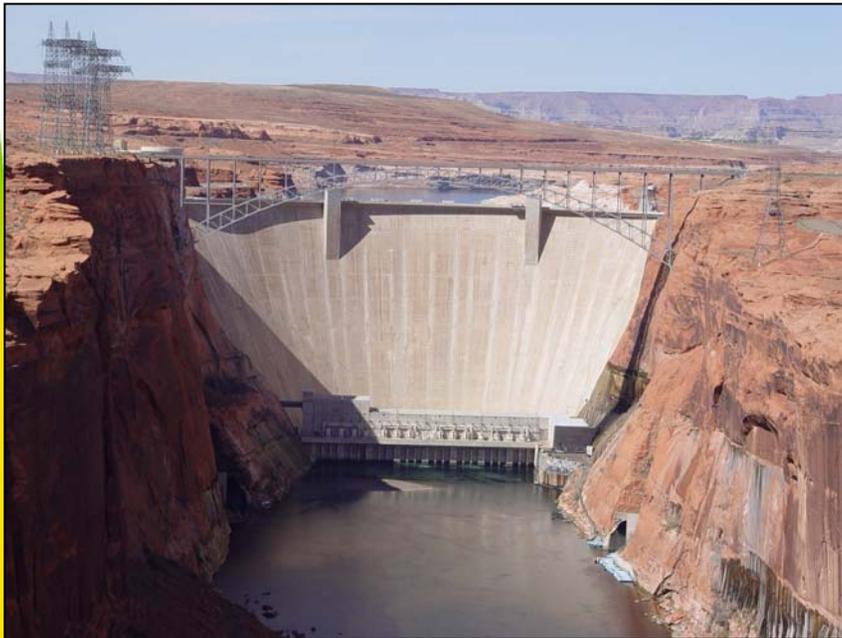
HAUNCHES OF GLEN CANYON DAM

- **Glen Canyon damsite has prominent haunches formed by curvilinear valley side joints. The upper vertical walls are controlled by regional systematic joints.**

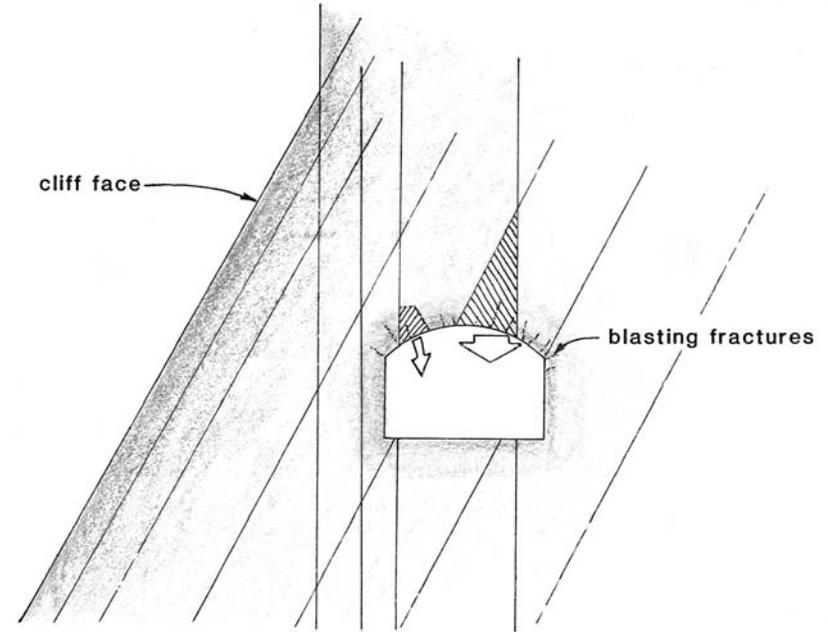
GLEN CANYON TUNNEL FAILURE

Roof cave-ins in the Glen Canyon Powerplant Service Tunnel during construction in 1958.

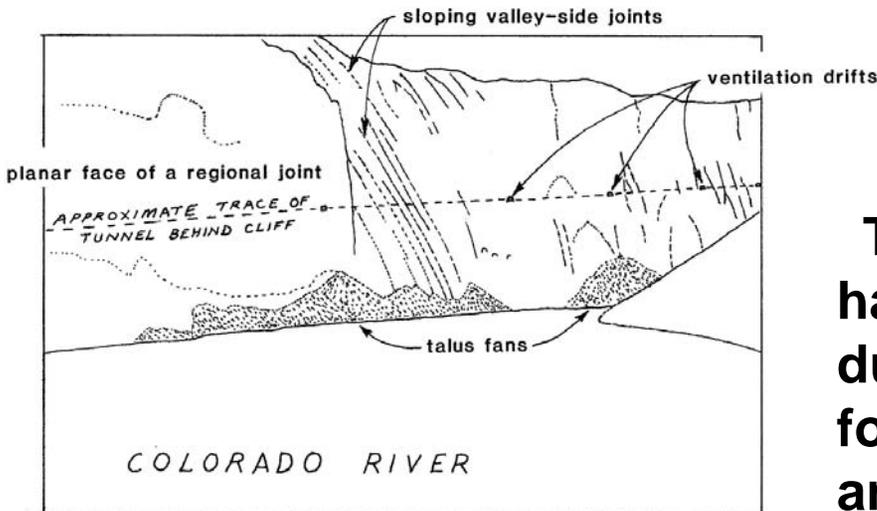
The Glen Canyon Powerplant Tunnel had a series of deadly block failures during excavation because of wedges formed between inclined valley side and systematic joints, sketched above

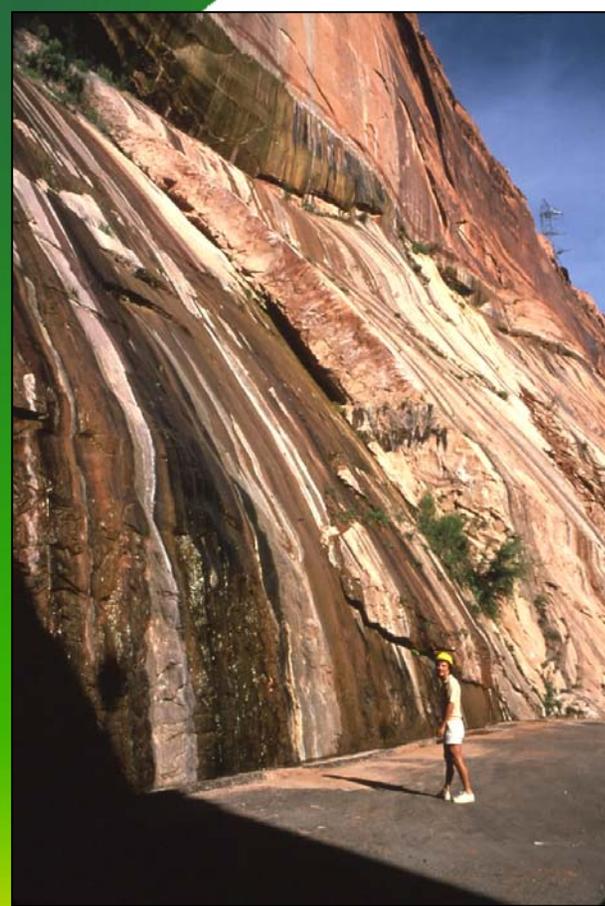
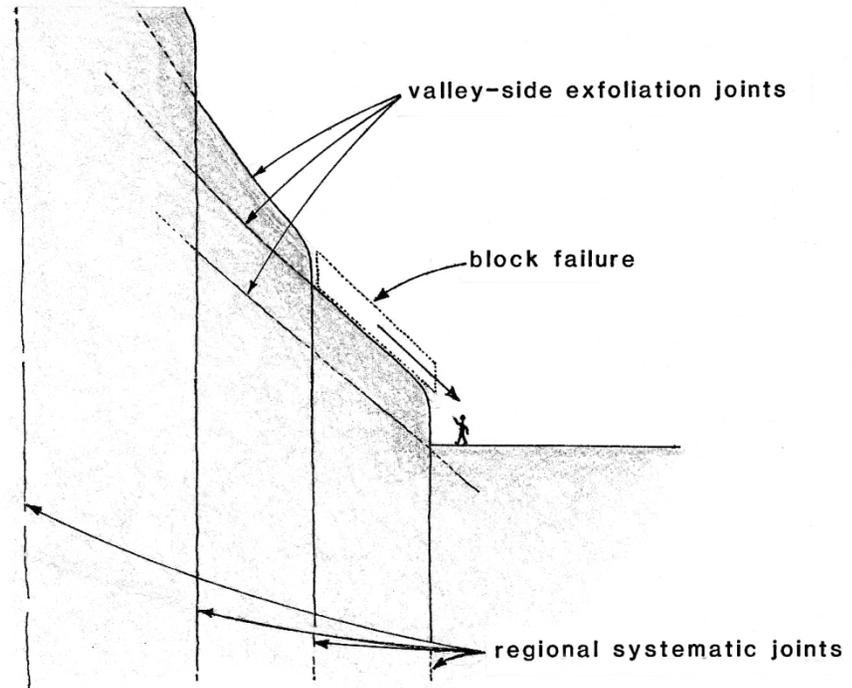
BLOCK FAILURES

Valley side joints are inclined. Where these intercept near vertical systematic joints, massive blocks are formed on steep inclines. When these are undercut the blocks slide off. A little bit of water hastens the process by decreasing the friction markedly.

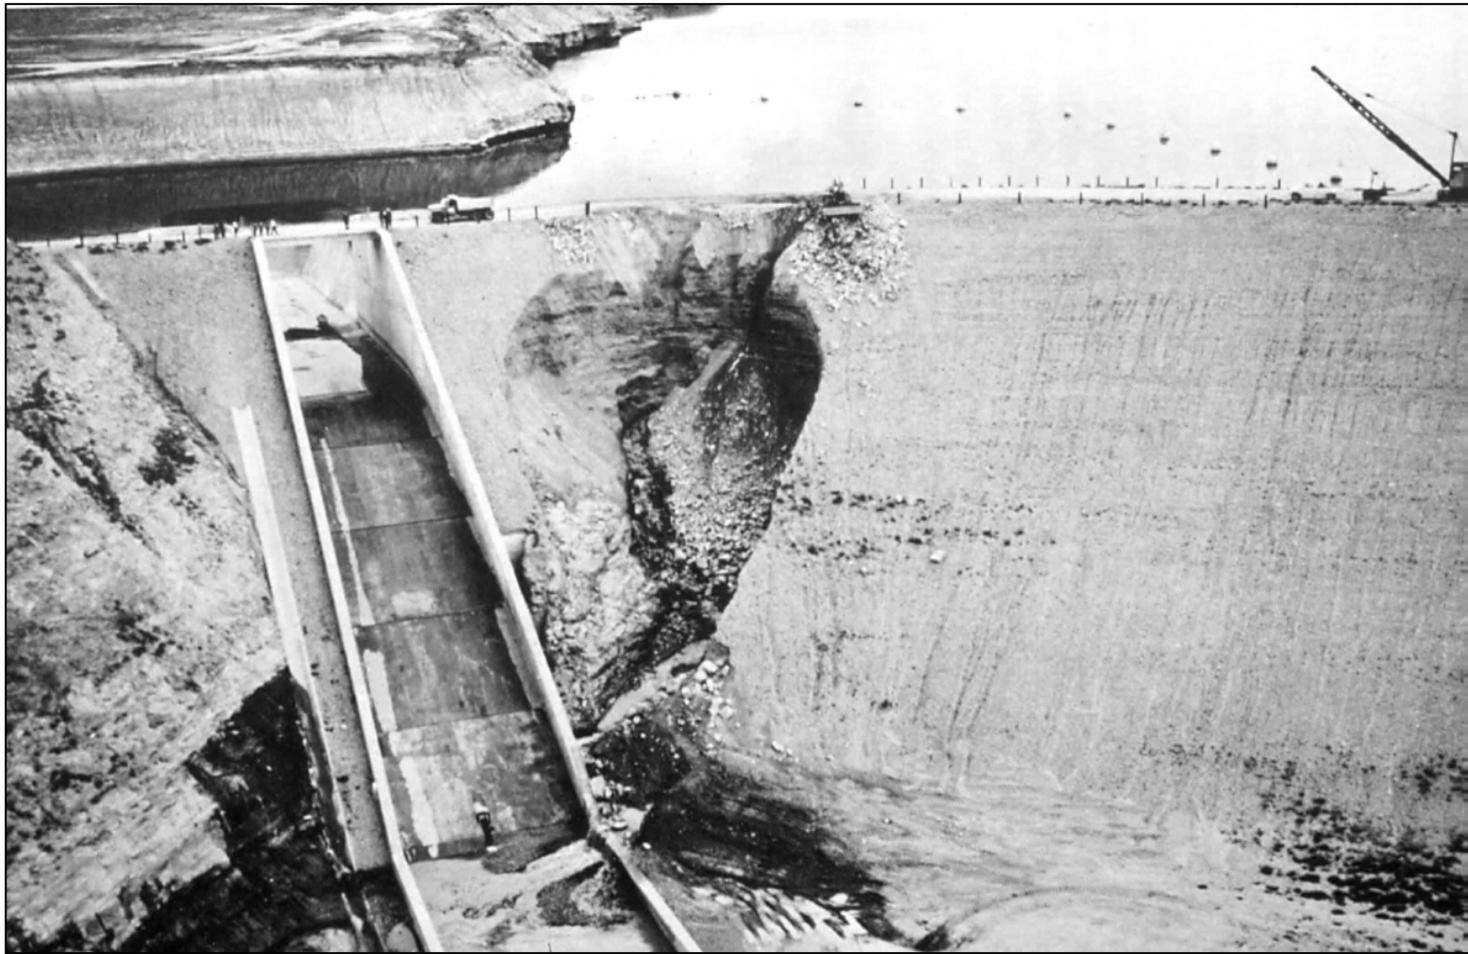
- **Fontenelle Dam** came perilously close to failing catastrophically in Sept 1965 during its initial filling. Seepage emanated from the right abutment. The same failure mode befell Teton Dam 11 years later.

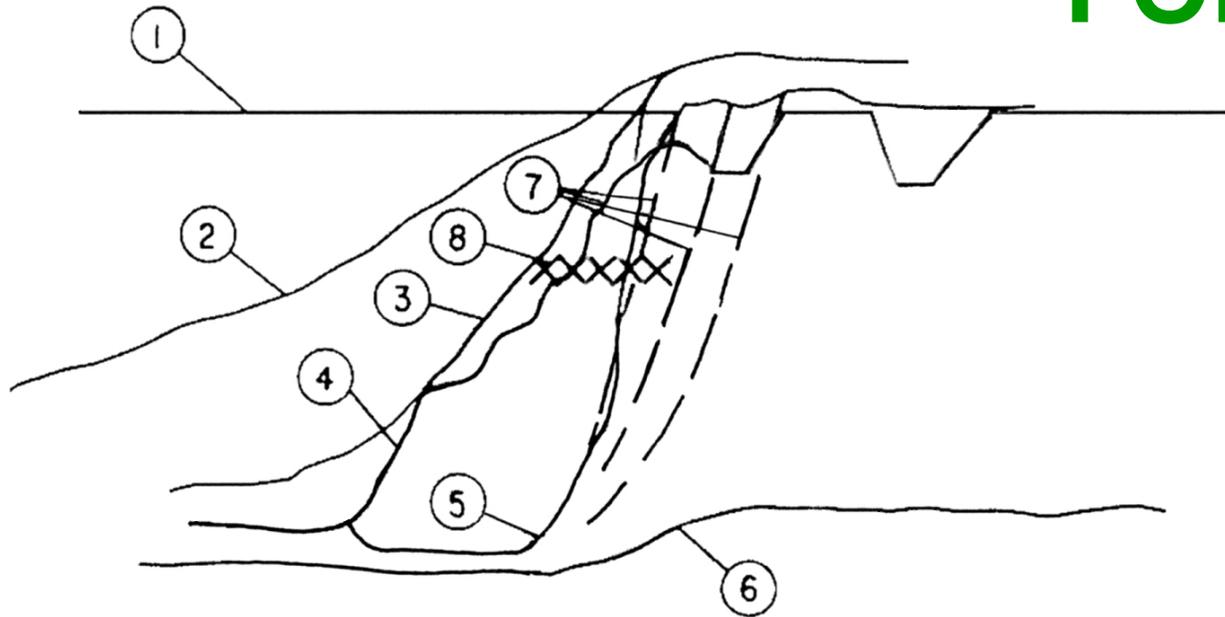
Right Abutment Detail.

Plan :

- (A) Embankment.
- (B) Spillway.
- (C) Canal outlet.
- (D) Road.
- (E) September 3, 1965, leakage and slough.
- (F) Open cracks.

Section :

- (1) Dam crest.

- (2) Downstream abutment slope.
- (3) Abutment slope at dam centerline.
- (4) Bedrock surface at dam centerline.
- (5) Upstream abutment slope.
- (6) Lower limit of grout acceptance.
- (7) Open cracks.
- (8) Approximate location of leak.

- Seepage percolated along undiscovered valley-side joints (#7) in bedded sedimentary rocks at position #8
- 8 lines of grout holes were then drilled and filled with 203,500 sacks of cement

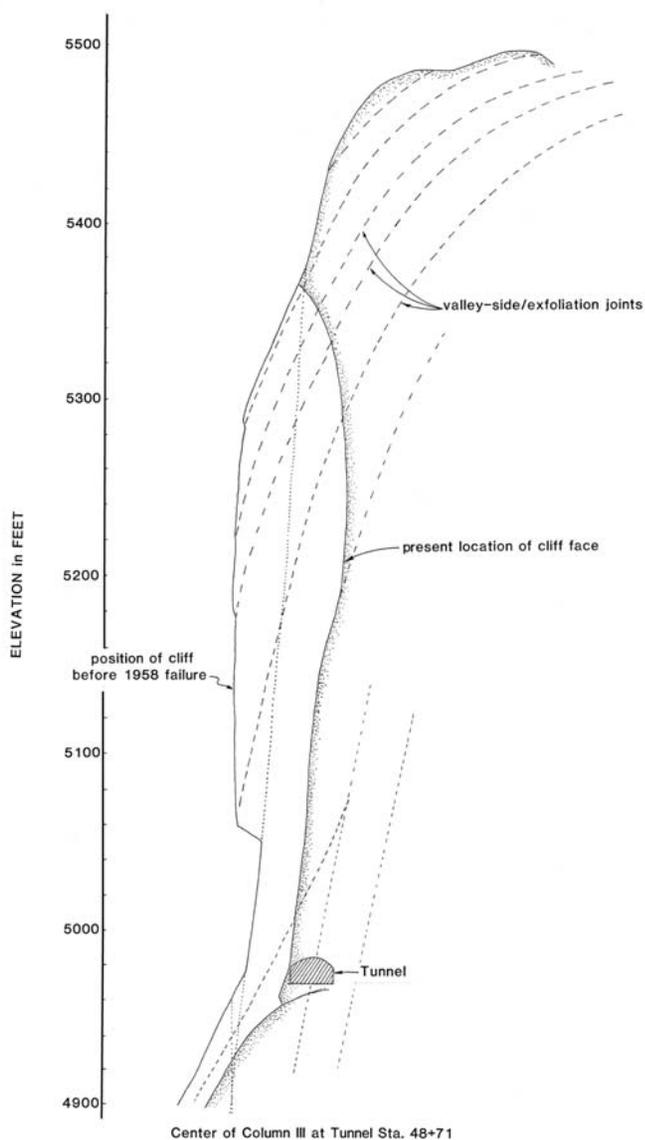
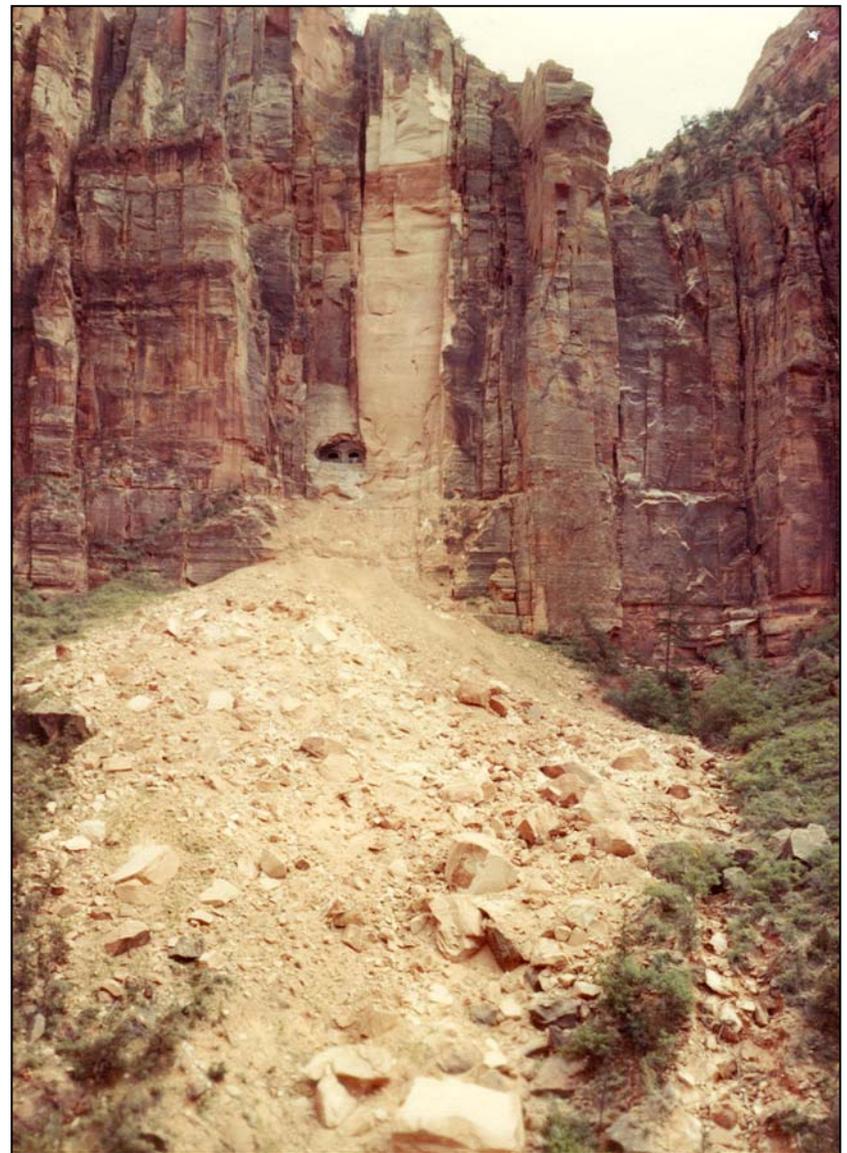
■ **The Zion-Mt Carmel Tunnel Gallery 3 failure occurred in April 18, 1958, spilling 84,000 tons of Navajo Sandstone onto the slope below and damaging the tunnel**

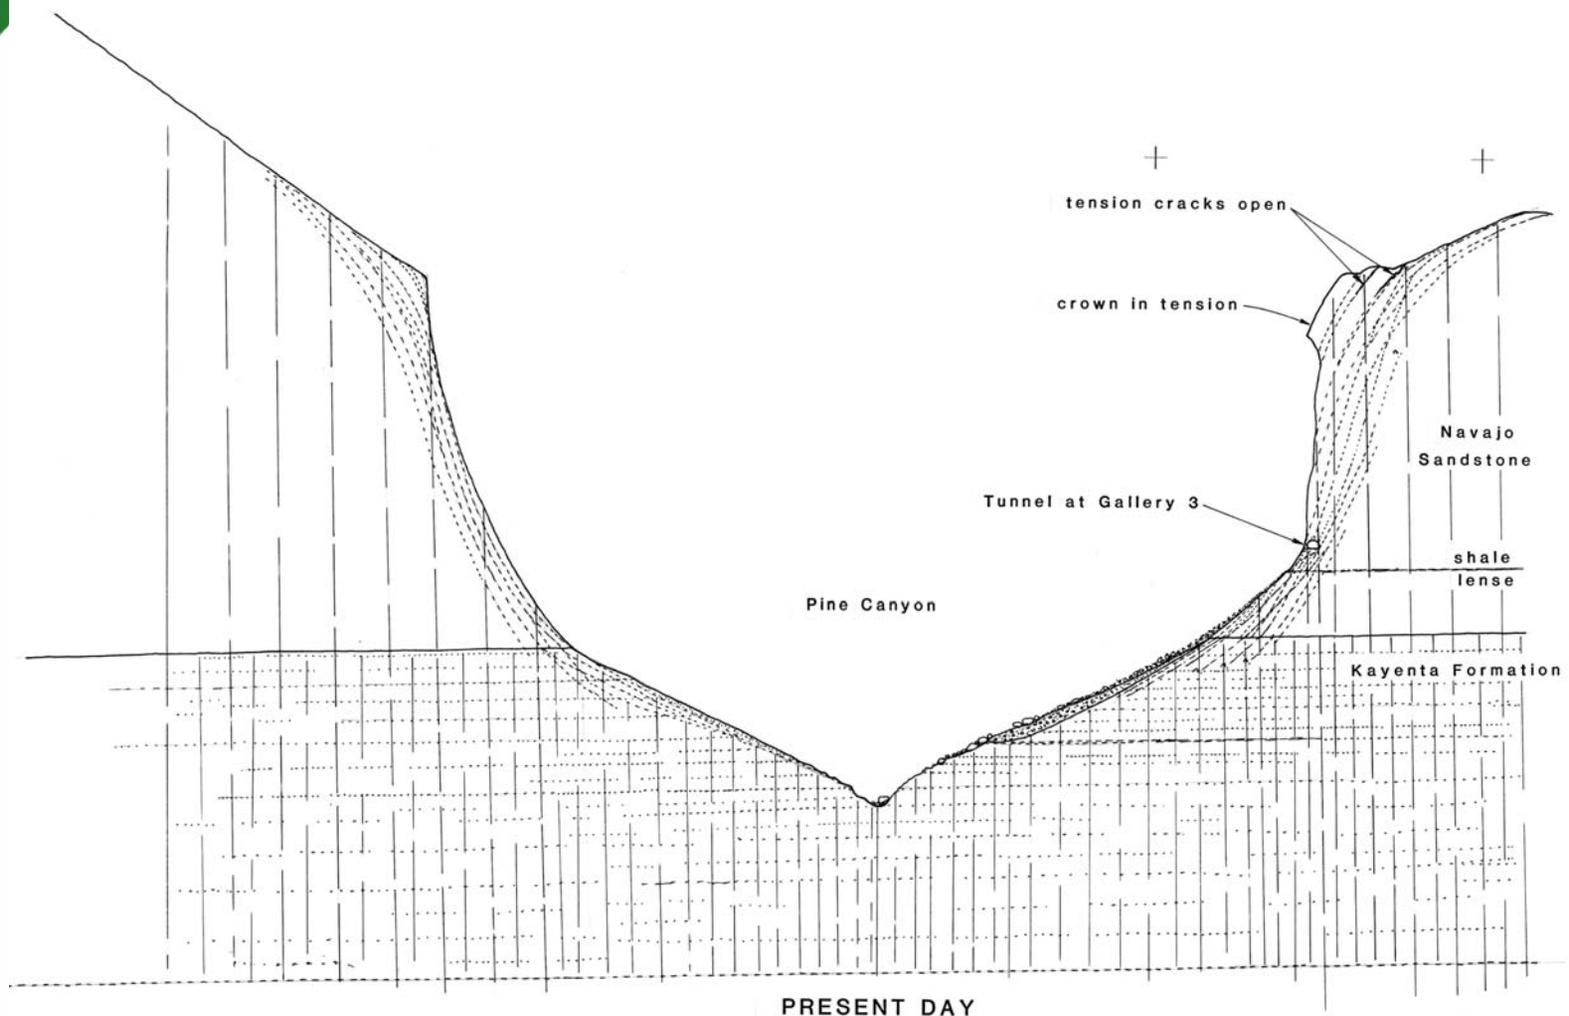
GENERALIZED CROSS SECTION
OF PINE CREEK CANYON
ZION NATIONAL PARK, UTAH

- Cross section of Pine Canyon at location of the Gallery 3 rockfall. Note valley-side joints

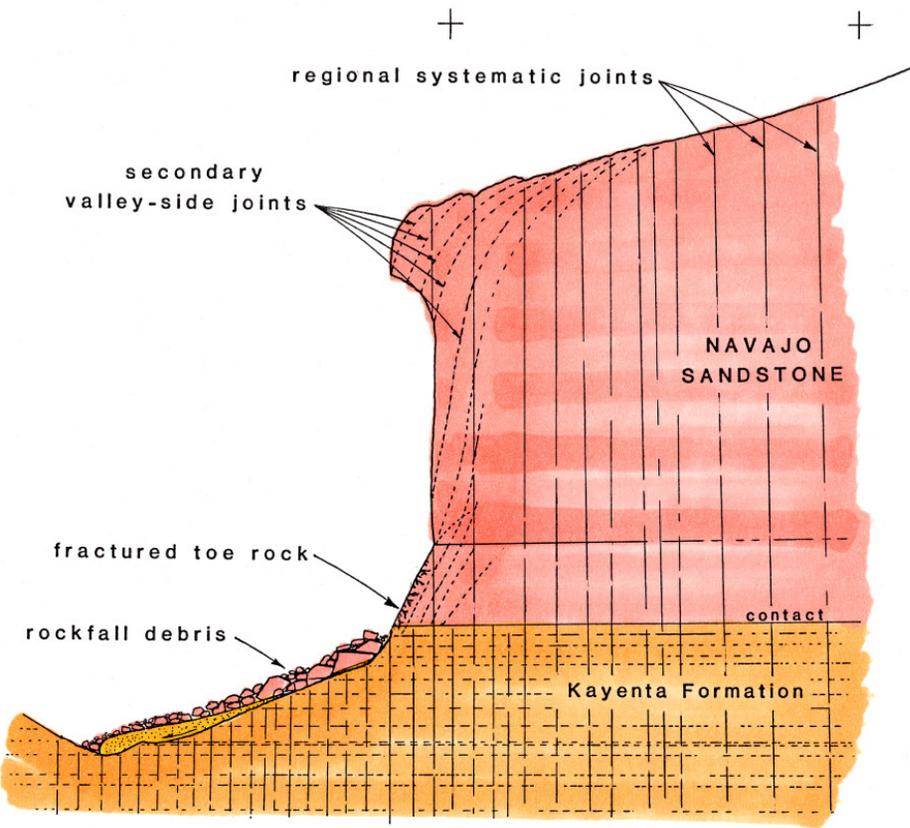
STAGE 1

as viewed at Column III

- Stage 1 is gross cliff retreat immediately following a major detachment. After the remaining overhang drops, a completely smooth face forms, arbitrarily designated here as Stage 2.

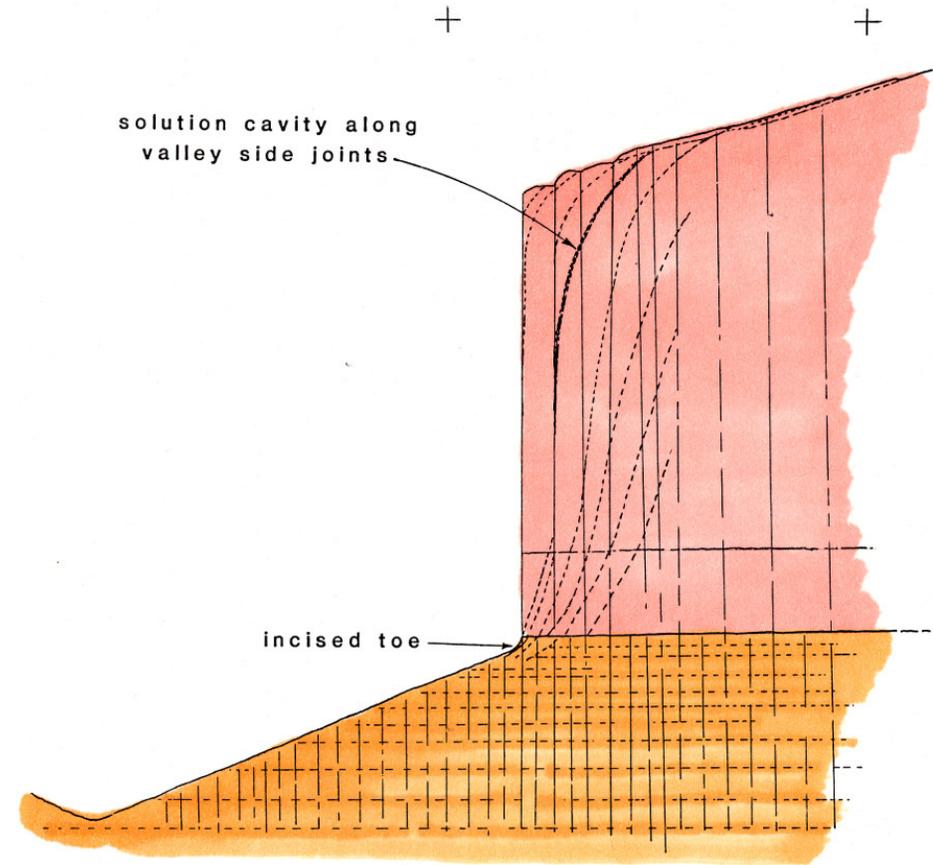
STAGE 2

as viewed at Column V

tensile separation

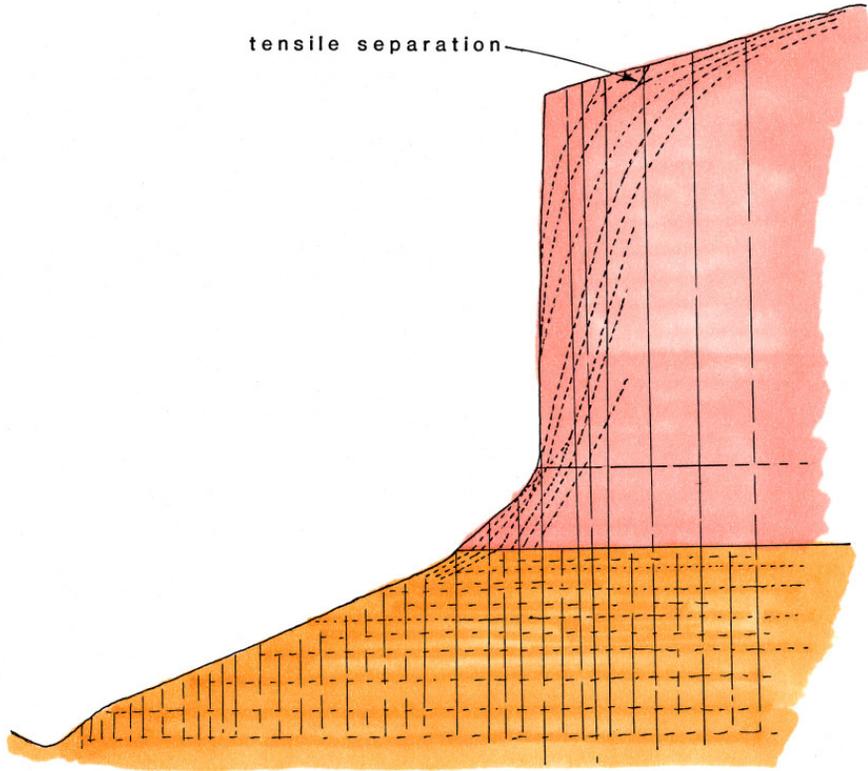
STAGE 3

as viewed at Column I

- Stage 3 a sloping cliff toe forms, controlled by valley-side joints. In Stage 4 crown blocks have detached along inclined valley-side joints

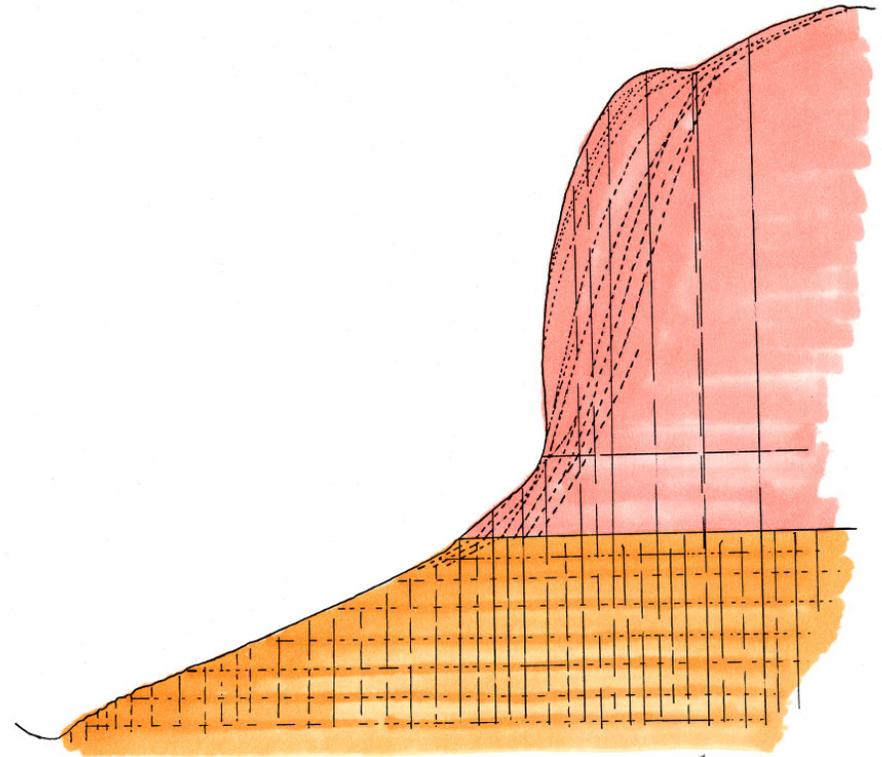
STAGE 4

as viewed at Column IV

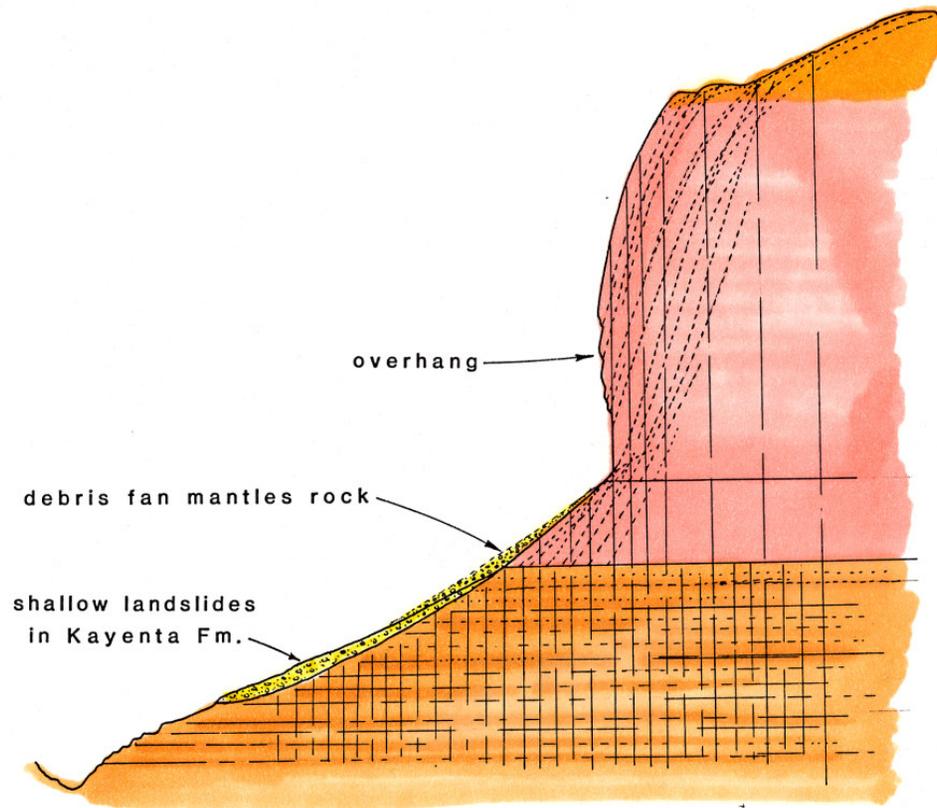
STAGE 5

as viewed at Column III before failure
