# SLOPE FACE TREATMENT

**J. David Rogers, Ph.D., P.E., P.G.**  
Karl F. Hasselmann Chair in Geological Engineering  
Missouri University of Science & Technology  
for the course

**GE 441 Geotechnical Construction Practice**

# CUT SLOPES IN ROCK

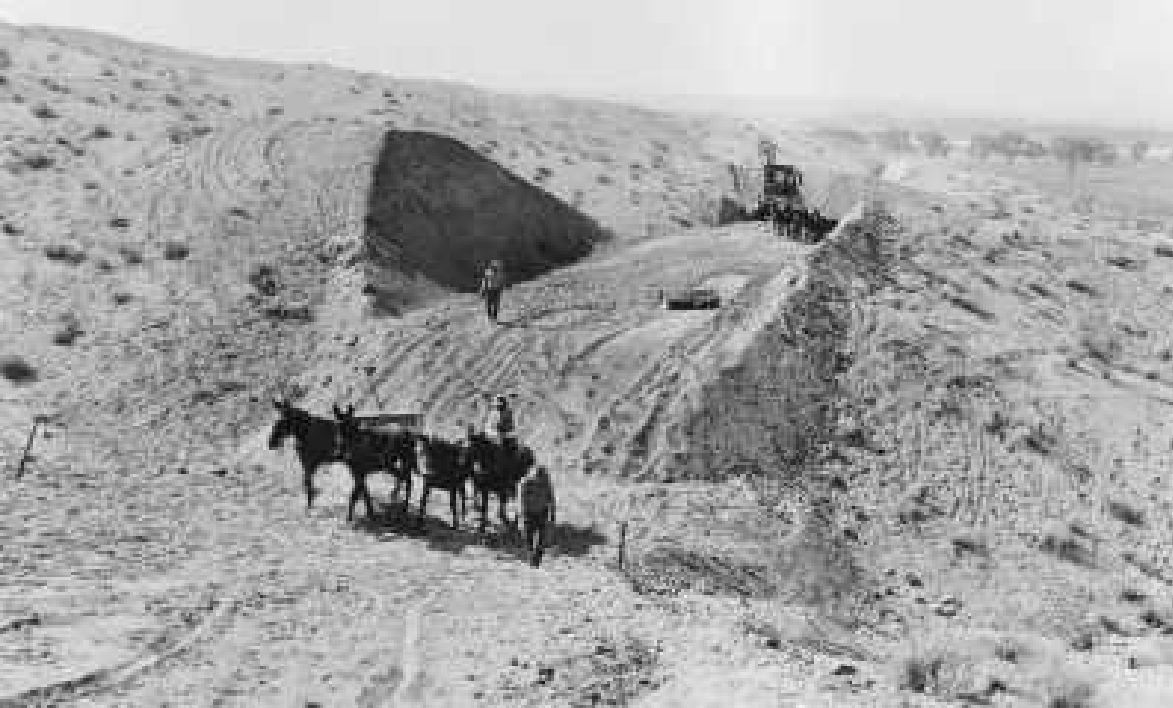
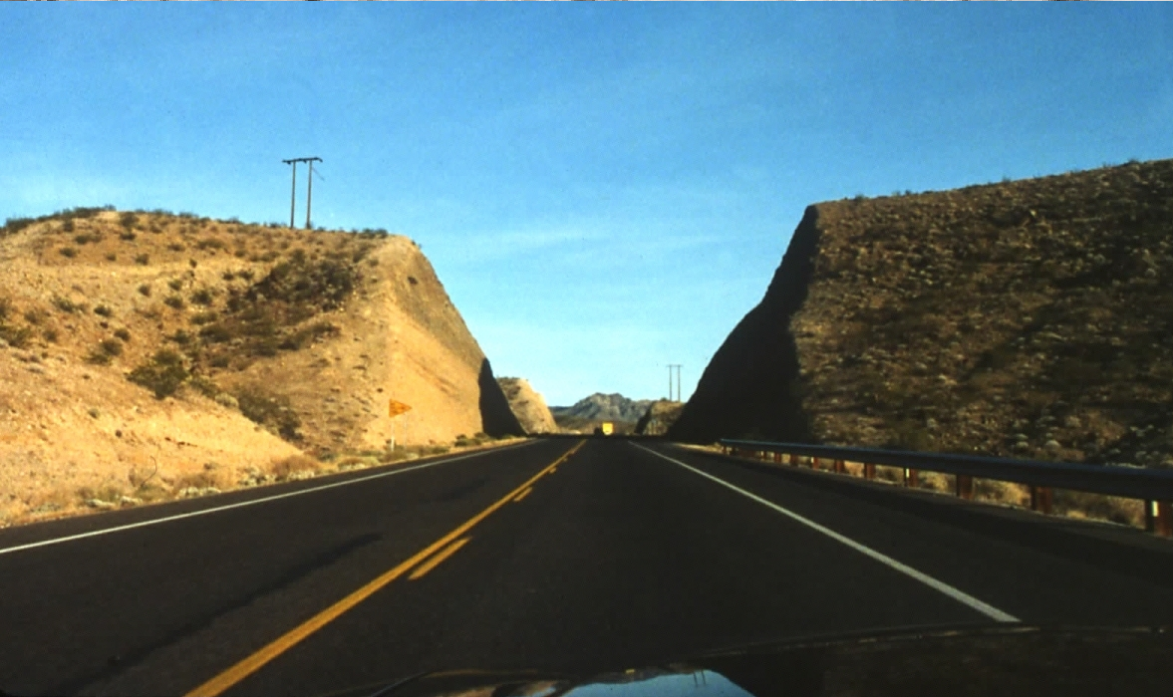
## **Cut slope erosion not a big issue in dry areas**

- **Steep cuts in competent rock may remain stable for long periods of time. Even so, a wide debris trough should be excavated at the foot of such cuts to catch falling rock and dissipate its energy. US Hwy 93 southeast of Hoover Dam.**

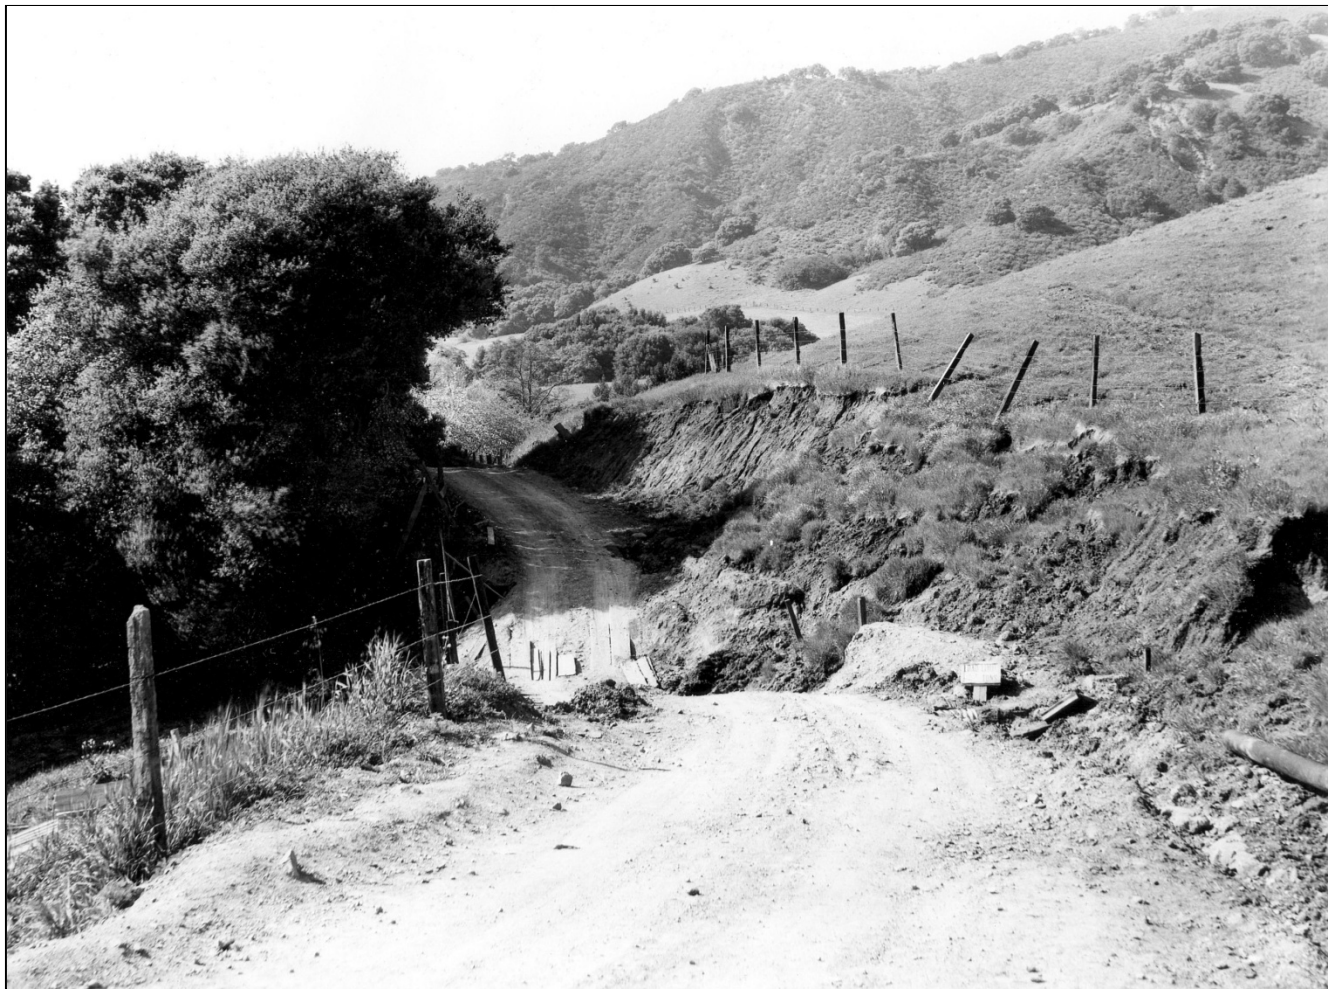
- **Steep cuts in weathered rock, shale, or soil may degrade rapidly, especially during periods of sustained precipitation and runoff, as shown here (note tilted fence posts).**

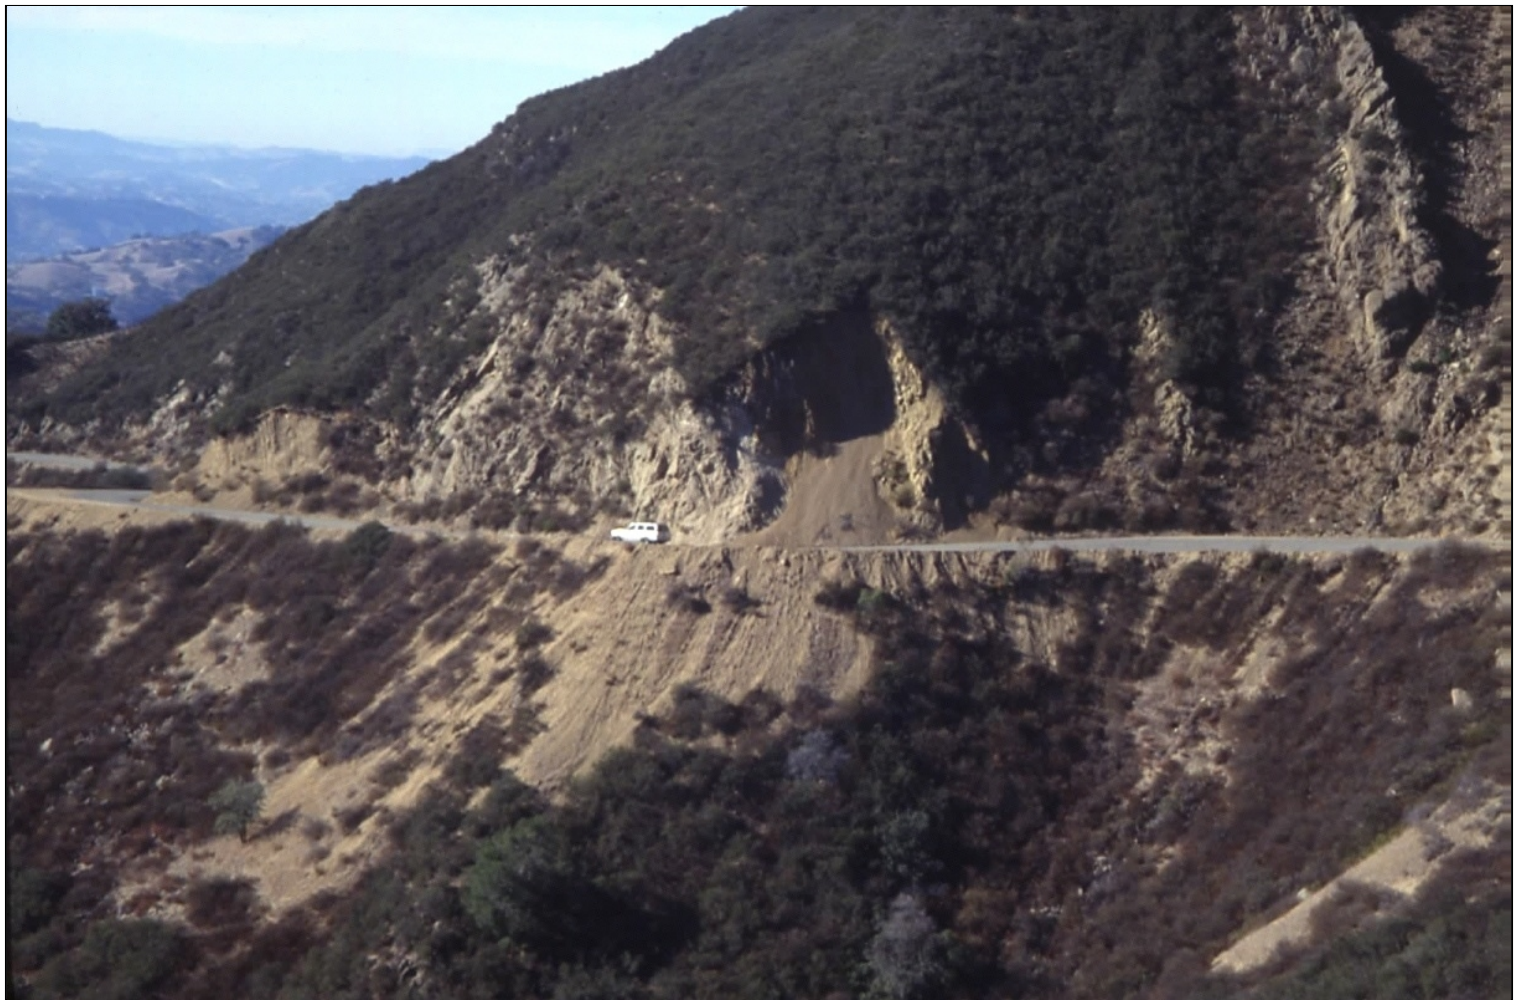
- **Selective raveling of steep cuts in competent rock are a recurring problem. Joint patterns and intensity generally control long-term behavior. Note the saw tooth shape of the raveling cut shown above, caused by the intersection of steeply-inclined bedding and one set of joints.**

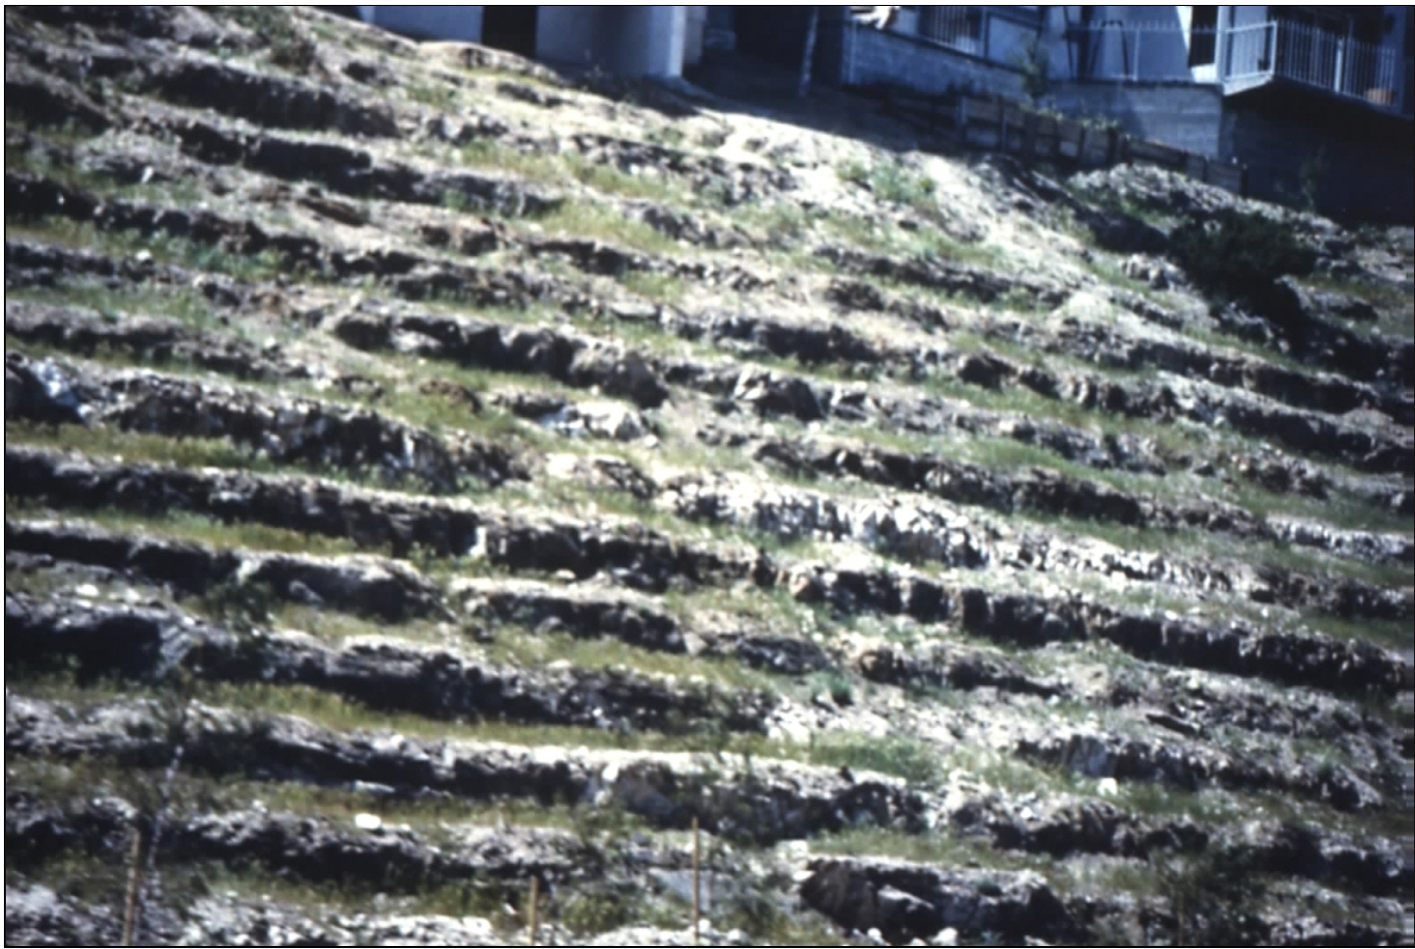
- **“Serrated cuts”, or “step cut” slopes are intended to retard rill erosion in semi-homogeneous materials. They are used chiefly in semi-arid climates.**

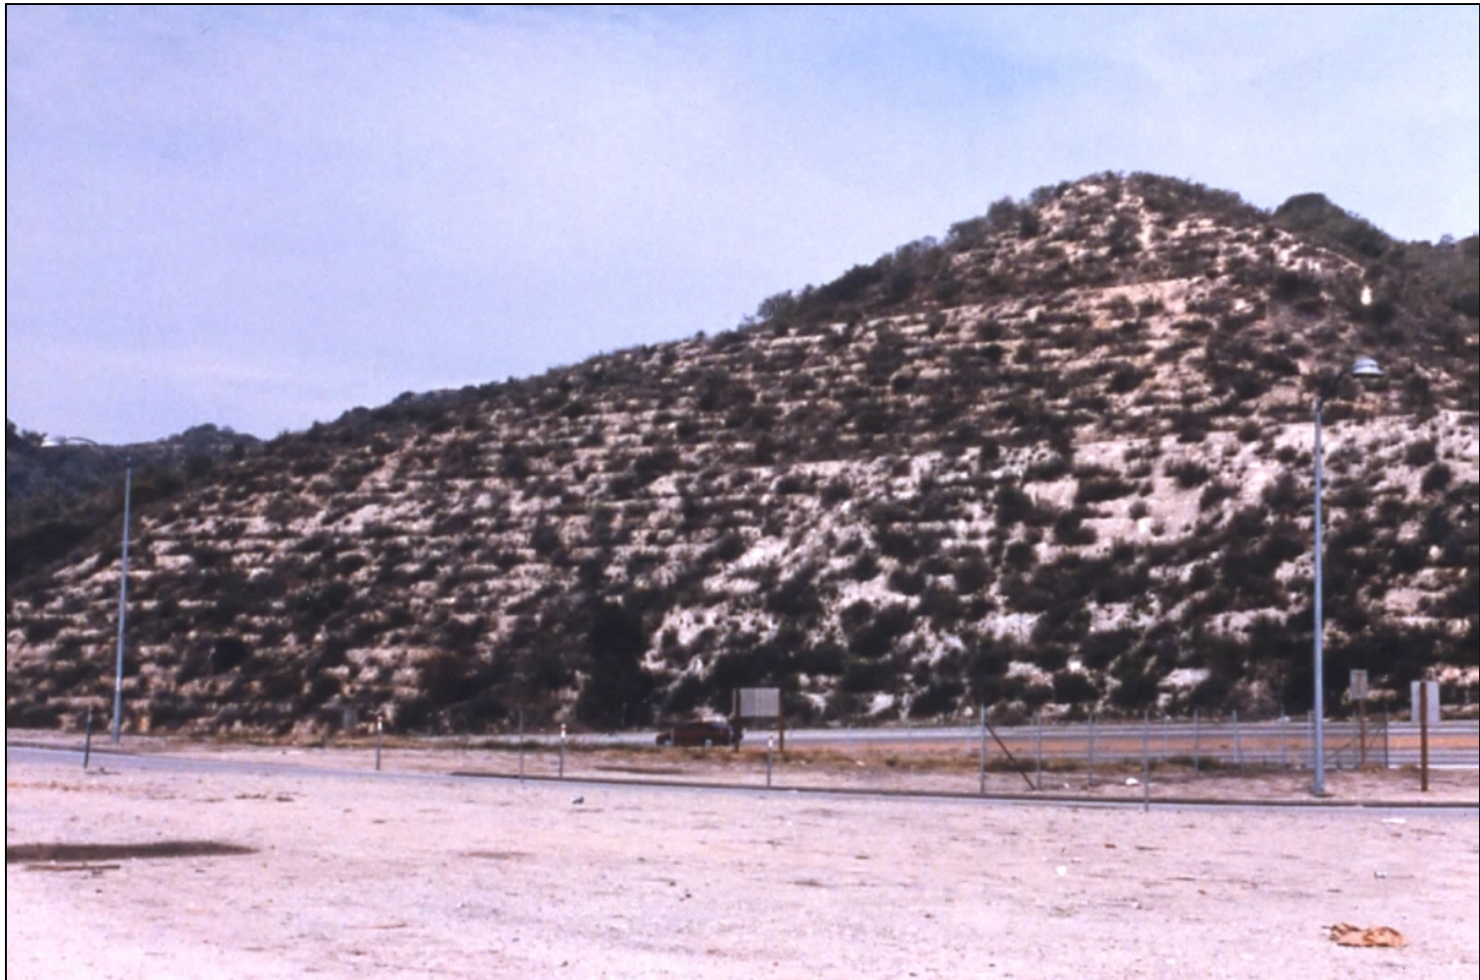
- **Stepped cut along Interstate 210 near Sunland, CA cut in Precambrian metamorphic gneiss complex in the early 1970s. This cut is just over 150 feet high**

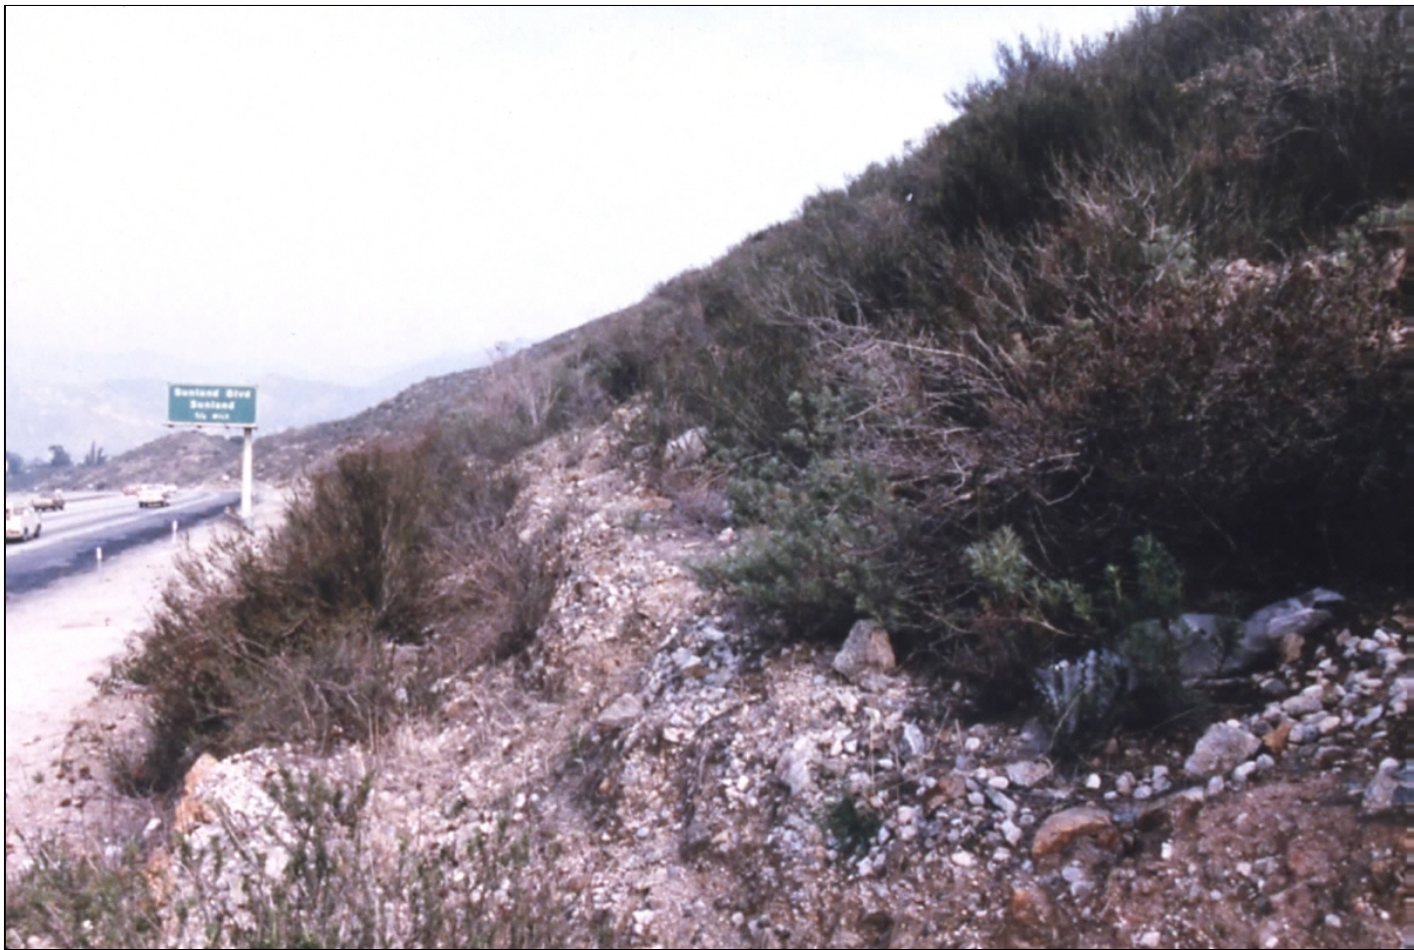
- **Detail of disintegrating steps in highly fractured metamorphic rock after 15 years (1990). The steps are 3 feet high and 4.5 feet wide. The vegetation is natural (volunteers), mostly creosote. The area receives about 20 inches of annual rainfall**

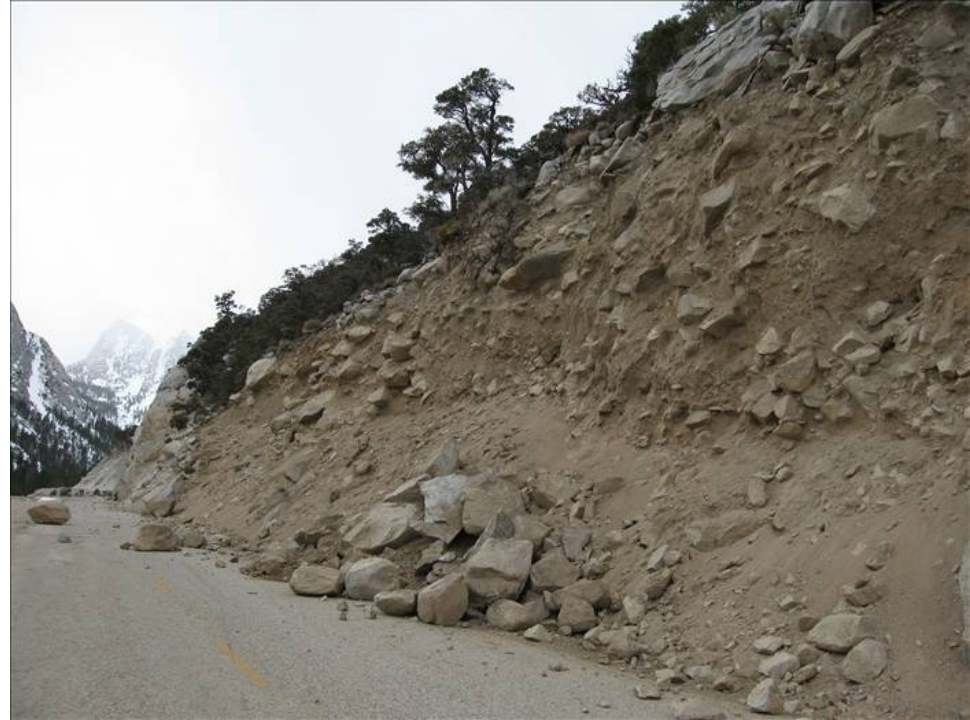
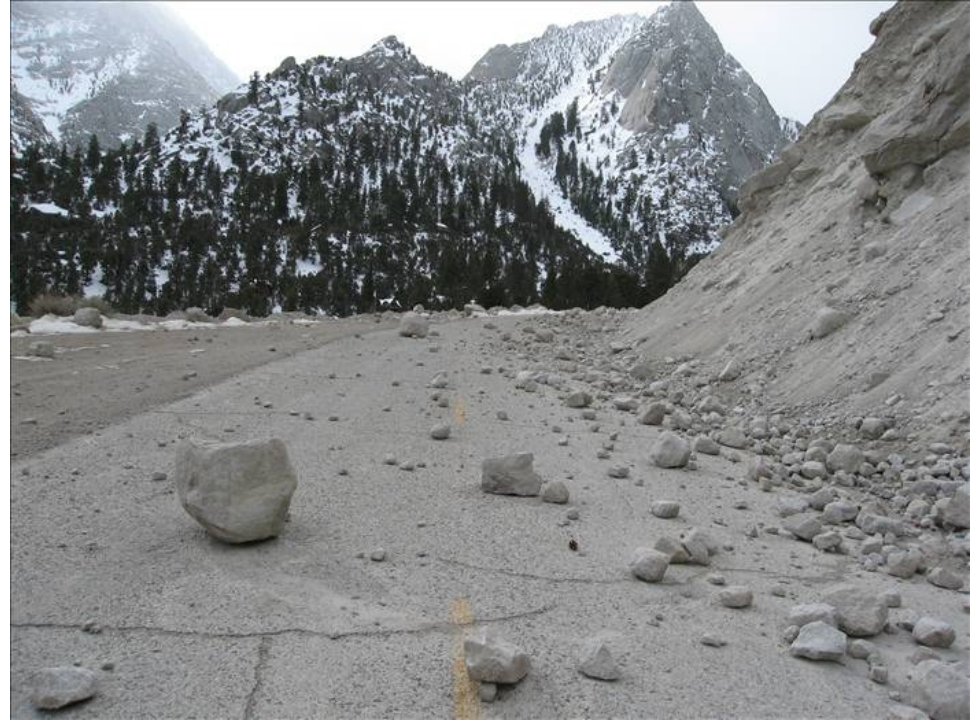
- A characteristic problem of steep roadcuts in glacial tills is their tendency to shed blocky debris during storms or rapid thaw cycles, as shown here
- Tills contain blocks of varying size, which are angular. This makes them difficult for drilling rock anchors, requiring an overburden drilling system
- This slope would need to be faced with gabion mesh attached to rockbolt anchors, with diagonal cable ties; or construct a roadside ditch with a debris fence

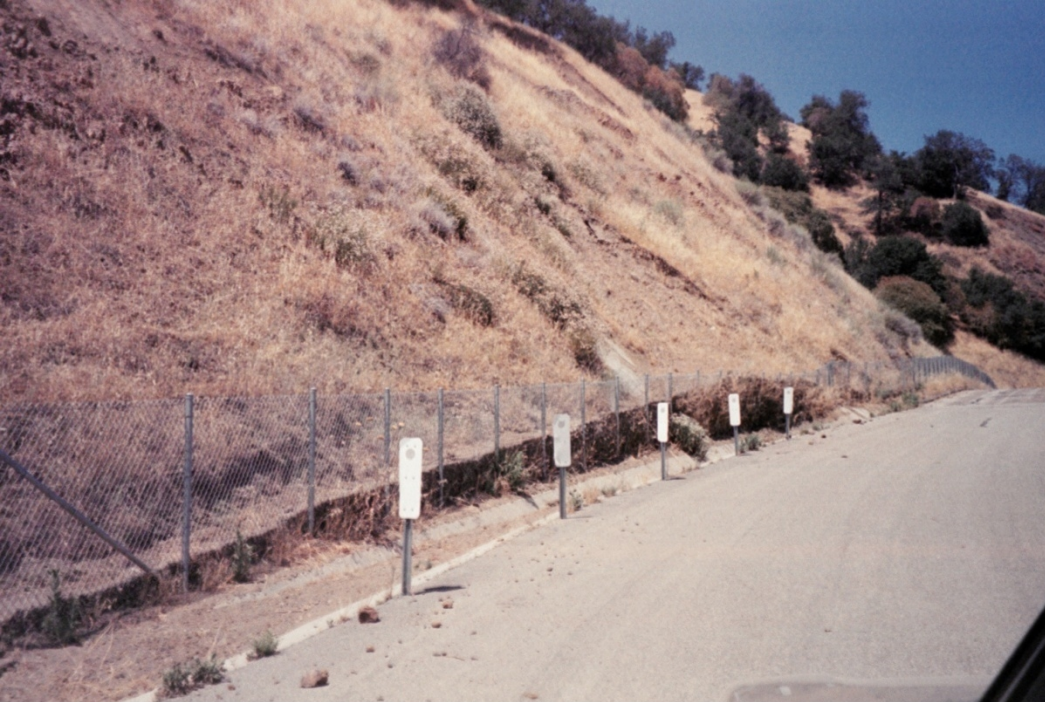
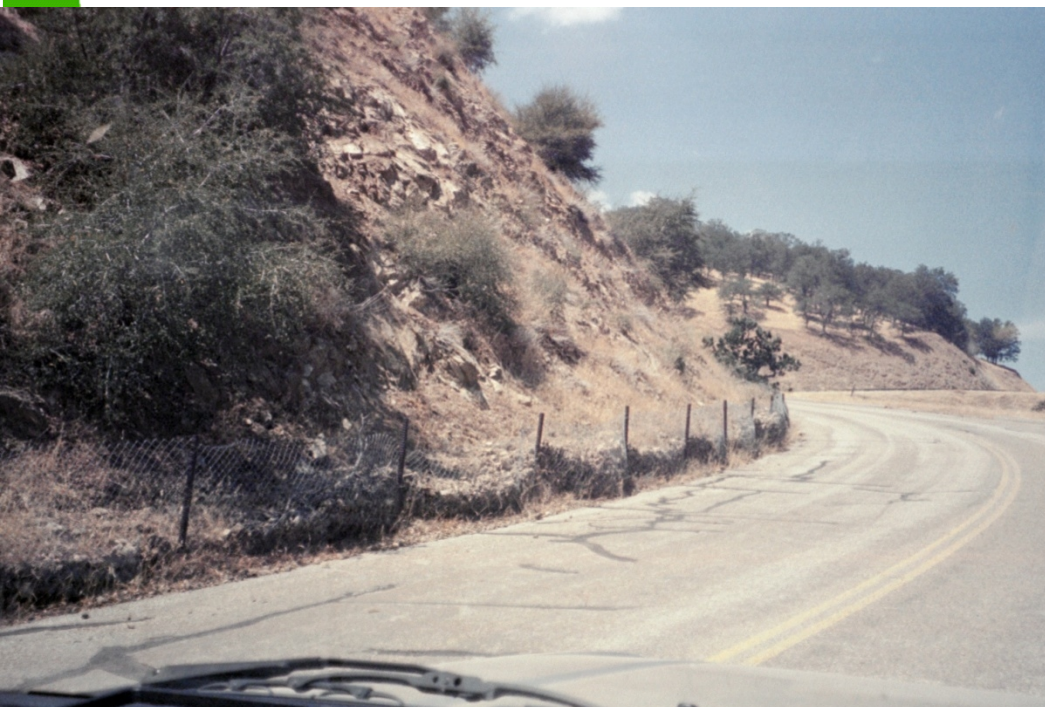
# Chain Link Debris Fences

- In the 1960s chain link fences were often placed to catch raveling rocky debris, to prevent its landing on the highway
- It was surprising how much debris could accumulate behind such lightweight fences, as seen at upper left
- In the case at lower left, larger diameter ductile iron pipes were employed, to provide increased support
- The problem with these is periodic mucking

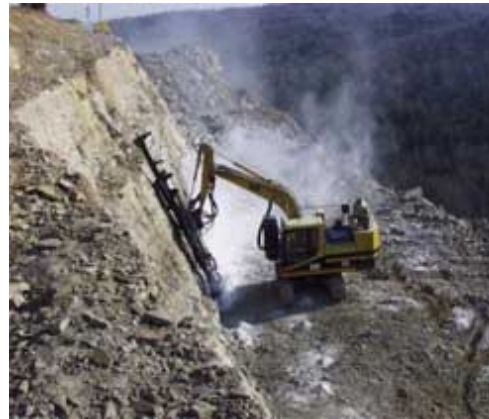
Drilling presplit holes

- Most rock cuts in competent rock are excavated using a blasting process known as **presplitting**
- A line of parallel holes are drilled on spacings between 10 and 14 times the drill hole diameter (shown above), sometimes adjacent to buffer or cushion holes set at slightly wider spacings
- Presplitting produces a continuous crack at the back of the cut before the remainder of the burden rock is detonated, lessening the blast energy against the finished cut face

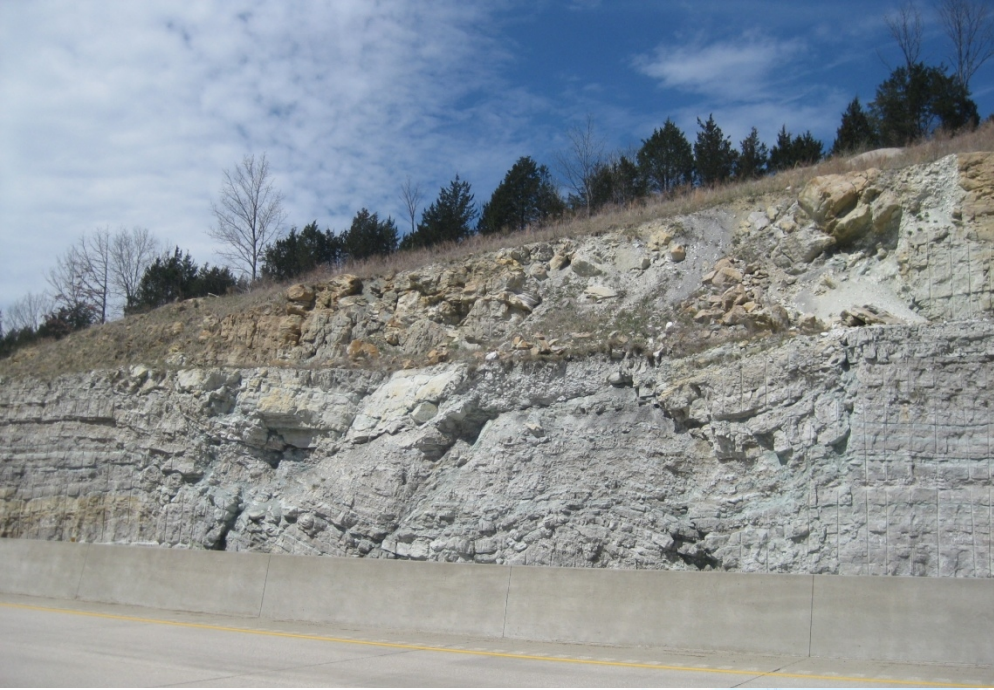
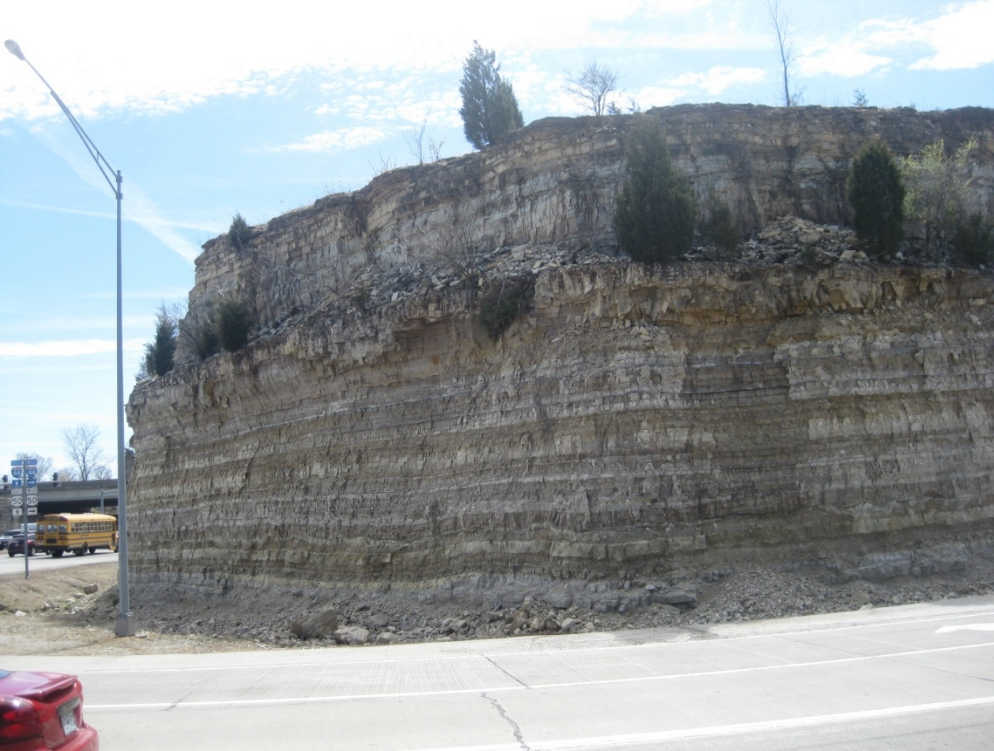
# Problems with Presplit Cuts

- Presplit cuts only work well if the underlying rock is relatively uniform and homogeneous, and bereft of differential weathering.
- Upper left shows result of presplitting across an **old filled sink**, which has a broken and chaotic structure, which has promoted raveling (Interstate 44 near Pacific, MO)
- Lower left shows a **setback bench**, intended to prevent raveling debris from free-falling to the base of the cut. The debris is piling up on the bench. A tapered cut, laying the slope back at 50 or 60 degrees, would have worked better here (5<sup>th</sup> St. and State Route 109 in Eureka, MO).

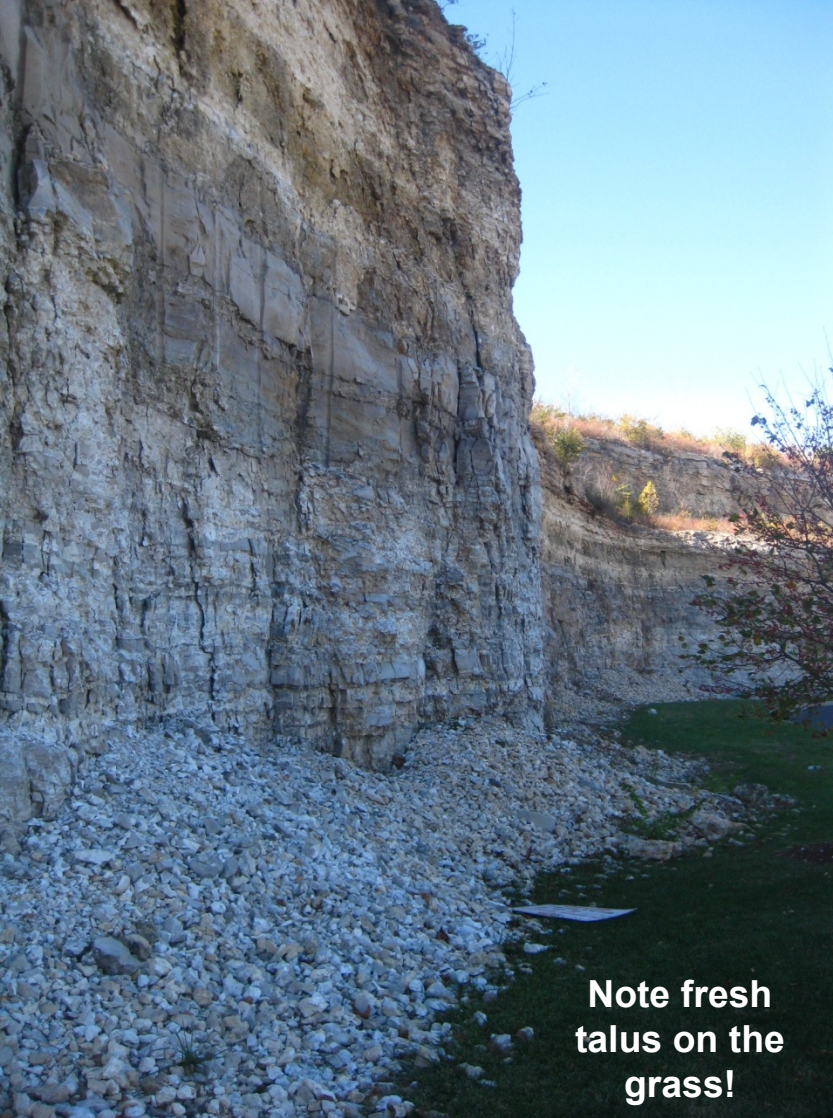
Note fresh talus on the grass!

**Above Right: Typical presplit cut slope in limestone and dolomite sequence in Fenton, MO. Note grass-covered bench between the face and the roadway.**
