Lecture 2

Levee Design Issues in Louisiana

J. David Rogers, Ph.D., P.E., R.G.

First Annual Levee School Symposium

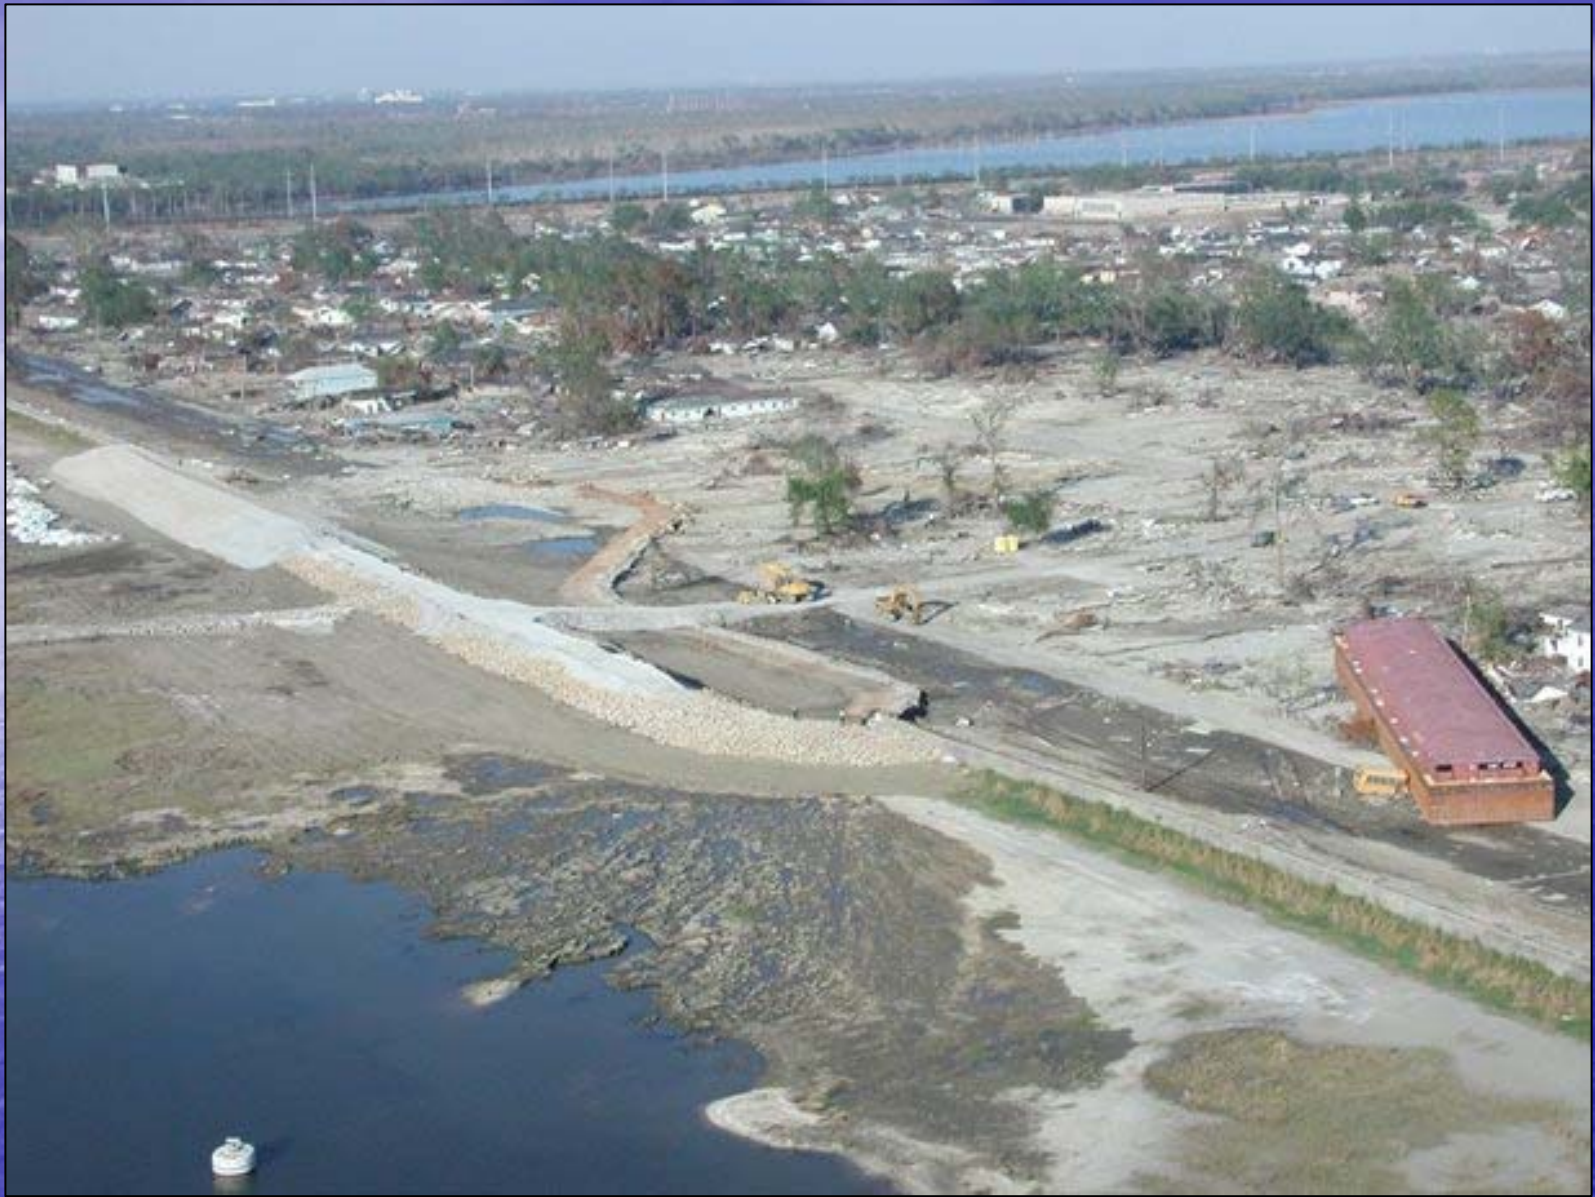
Seepage crevasse exposed at the east levee of the IHNC breach after Hurricanes Katrina and Rita

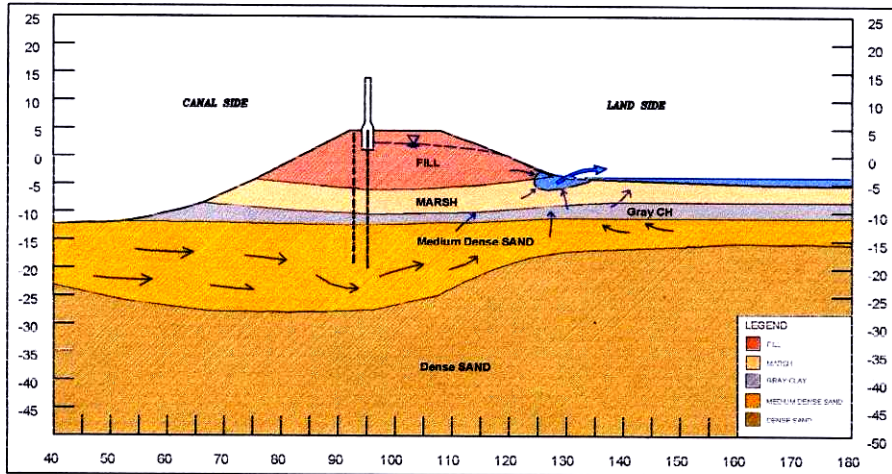
London Ave Canal South Breach precipitated by pervious sands

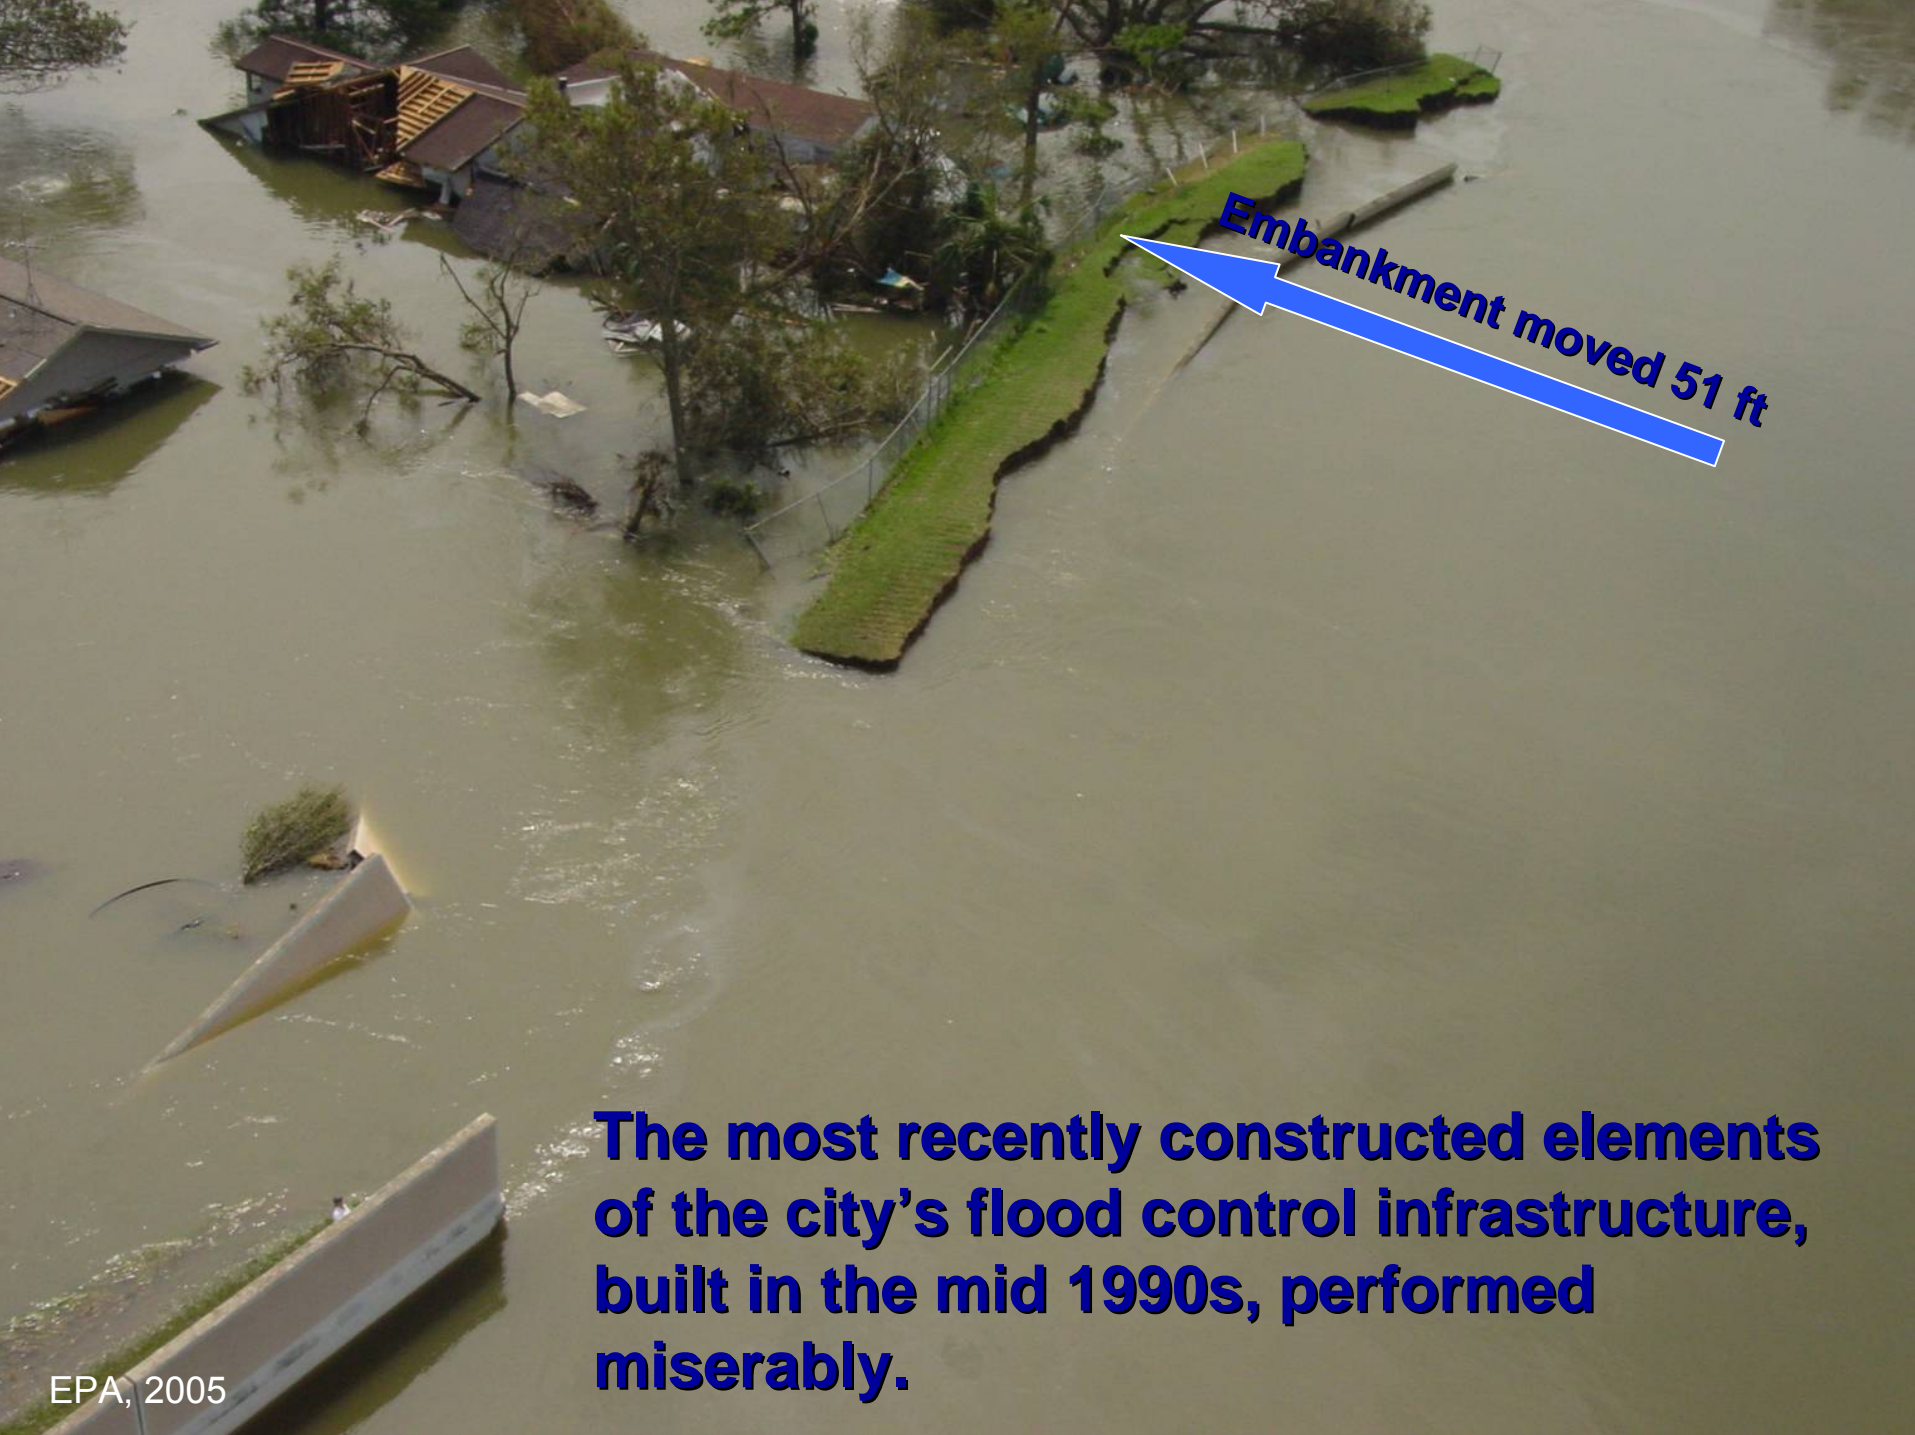
Embankment moved 51 ft

The most recently constructed elements of the city's flood control infrastructure, built in the mid 1990s, performed miserably.

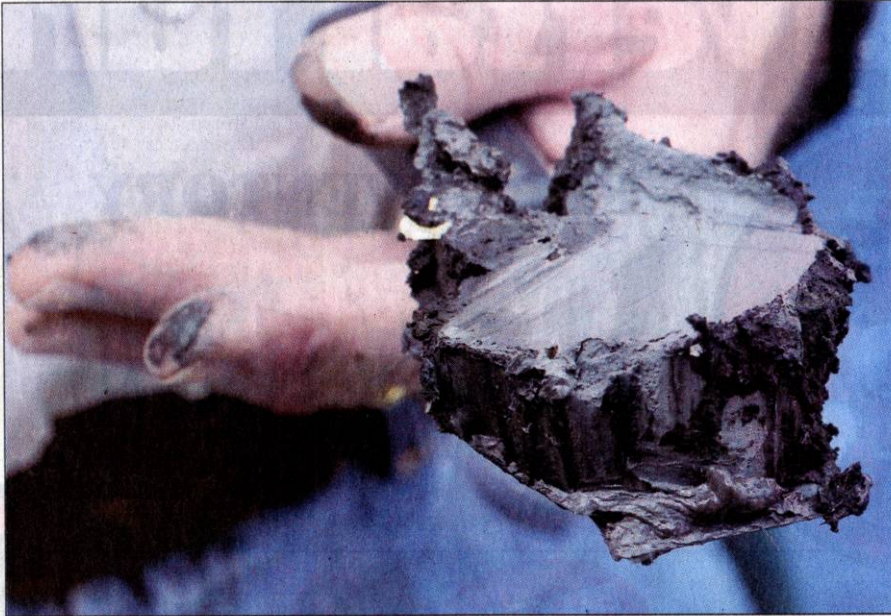
This piece of clay was just above the peat area at the site of the 17th Street Canal floodwall breach.

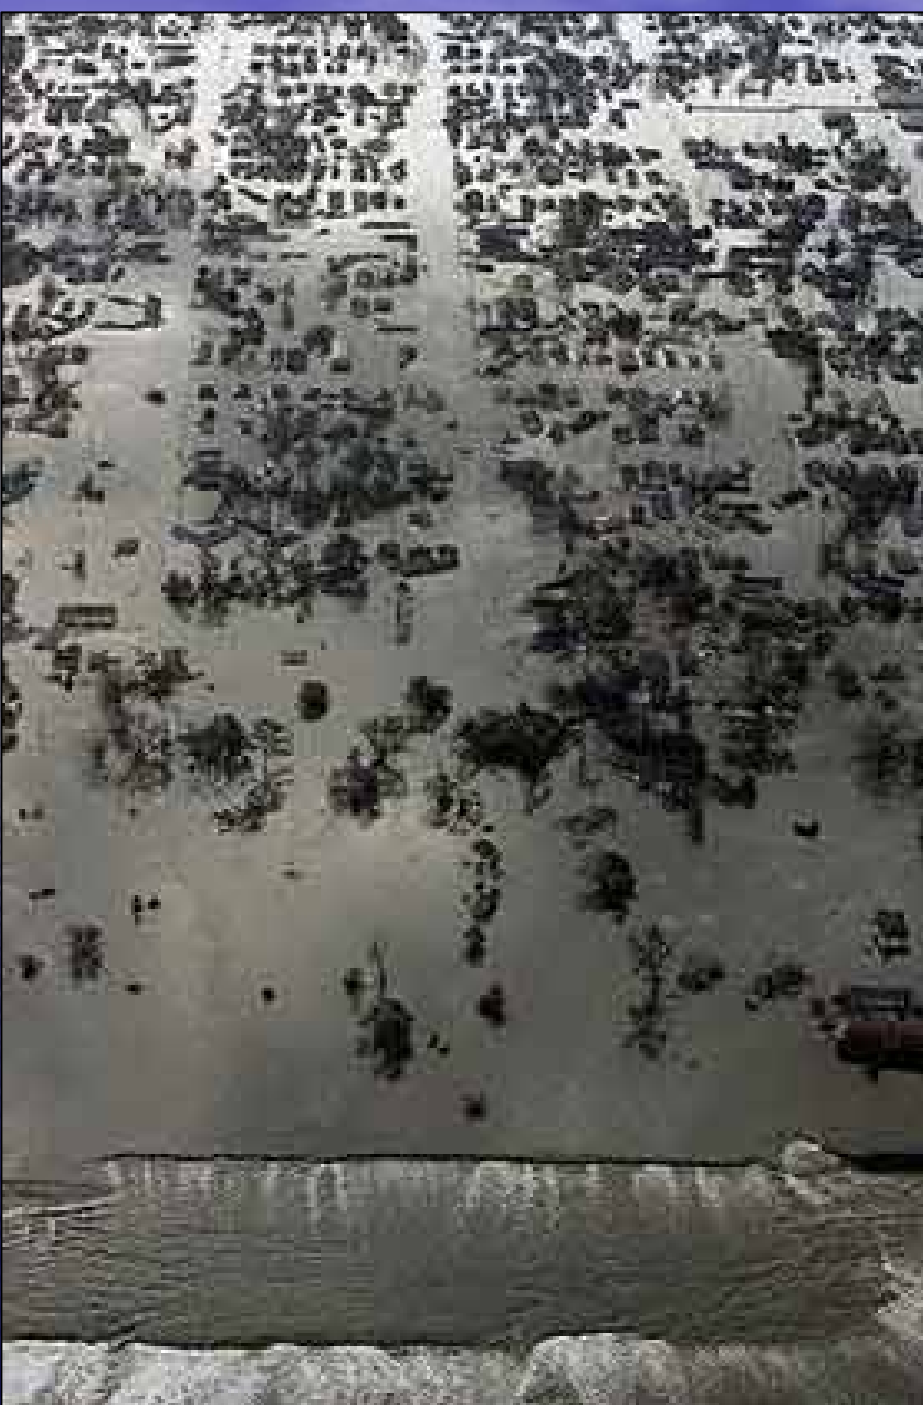
Once flood waters overtop an embankment they quickly scour the land-side toe of the embankment, and deep scour holes develop on either side of the “hydraulic jump” that forms at the point of overflowage, enlarging the breach, as shown here.

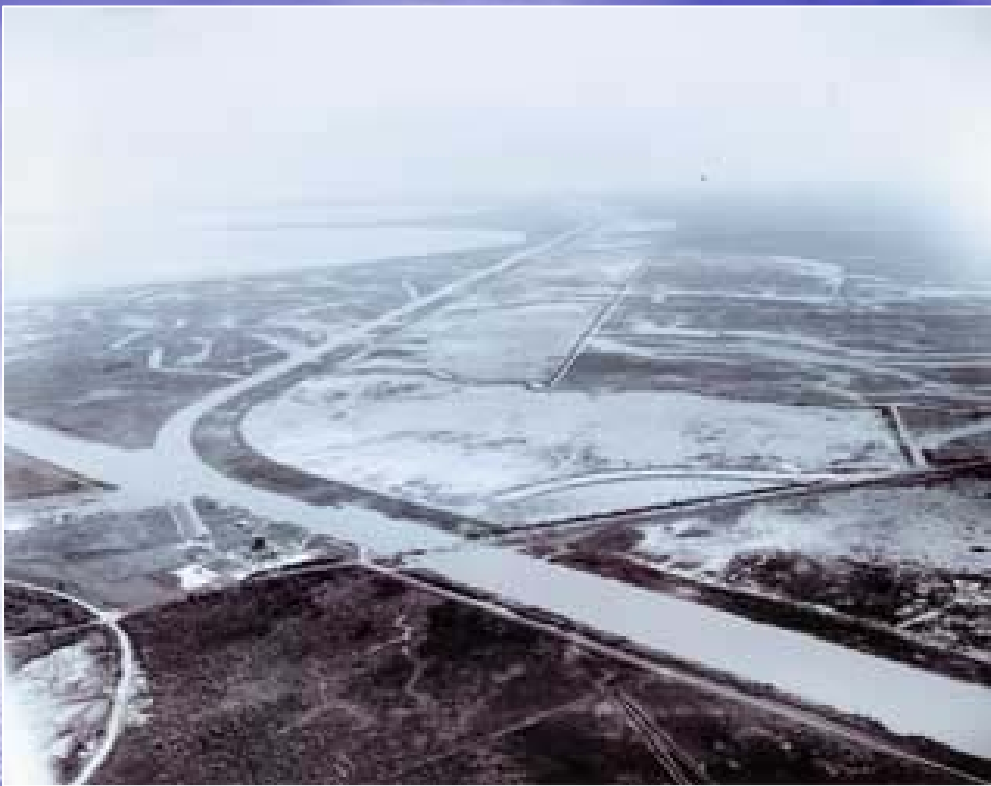
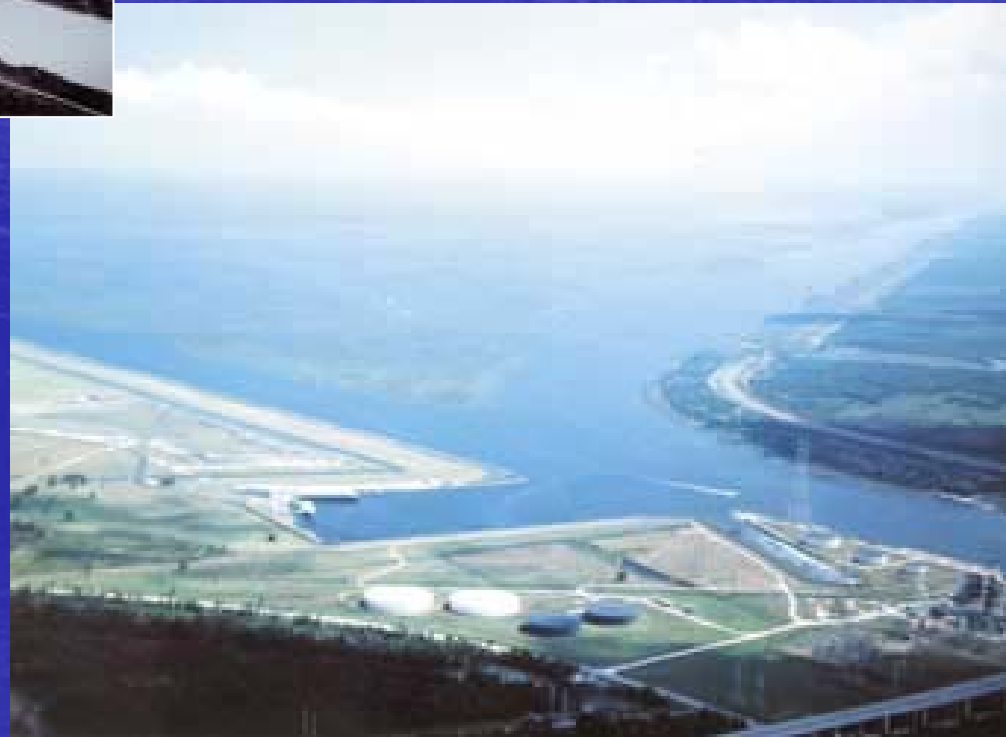
“Funnel feature” at western end of Lake Borgne created by intersection of the GIWW and the MRGO.

This gore point is 6 miles east of the Inner Harbor Navigation Channel (Industrial Canal)

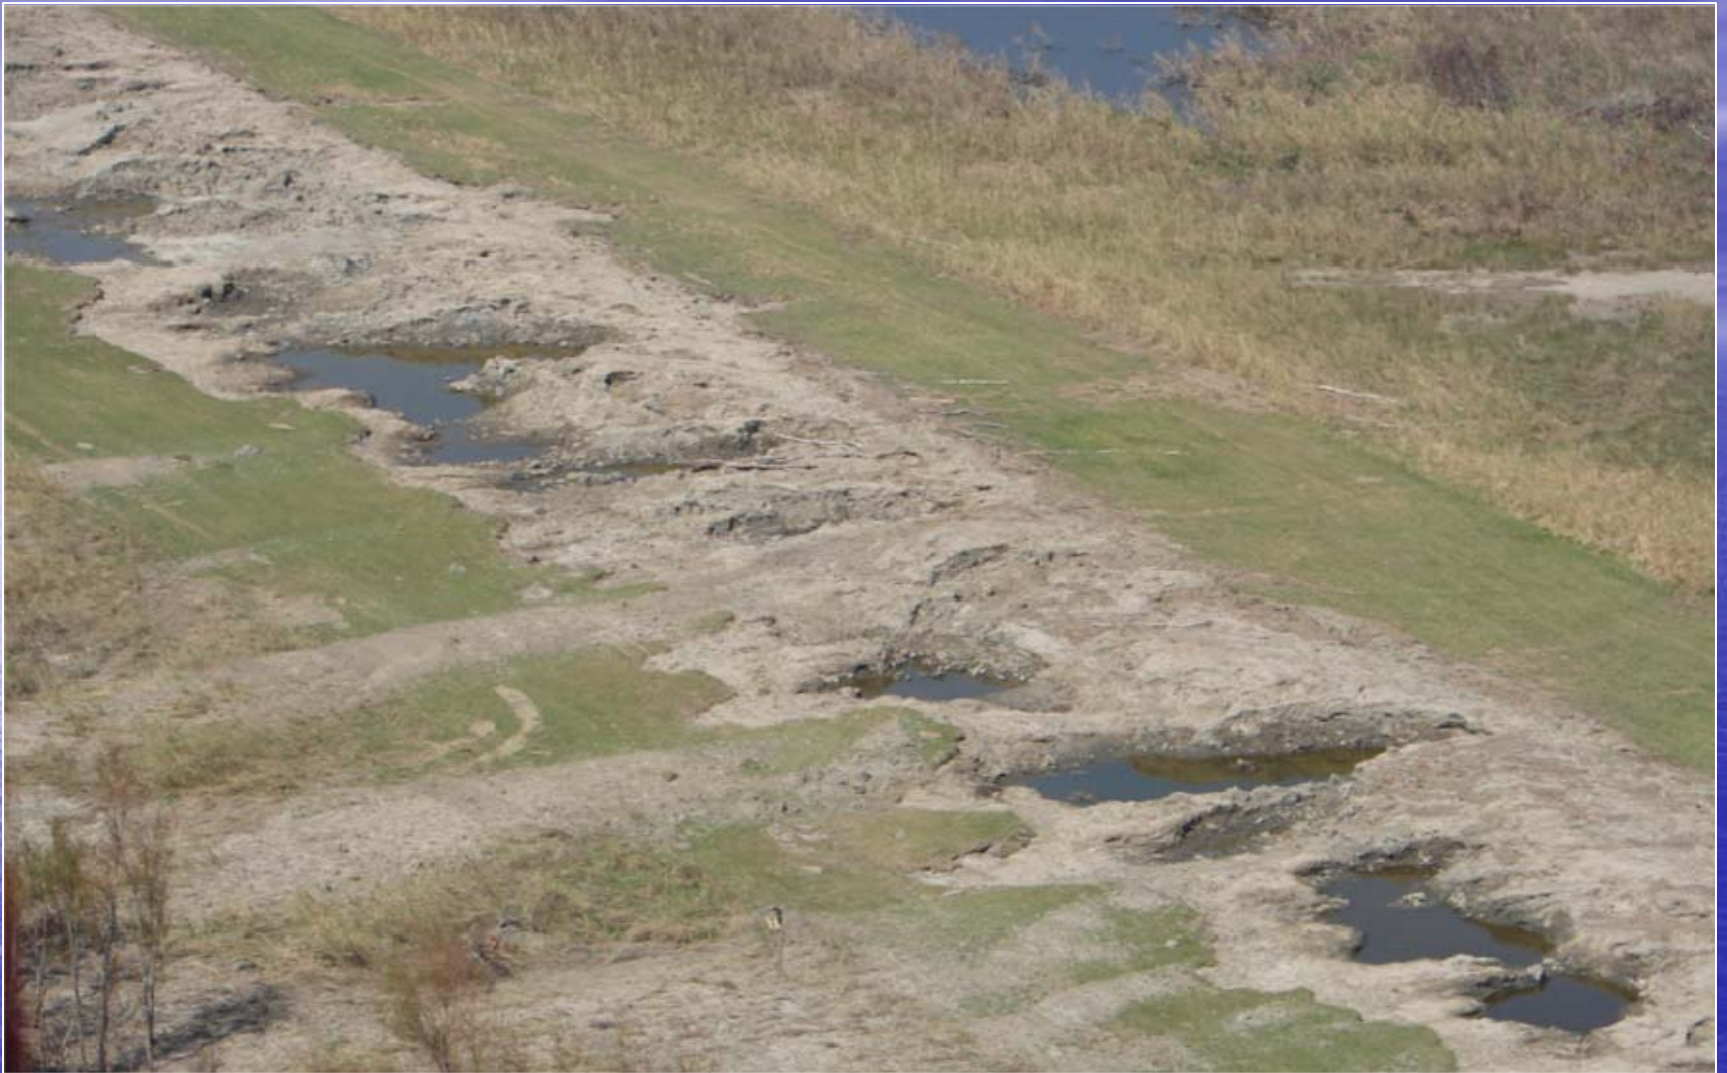
- Miles of levees just disappeared: MRGO levee completely washed away about two miles southeast of Bayou Dupree.

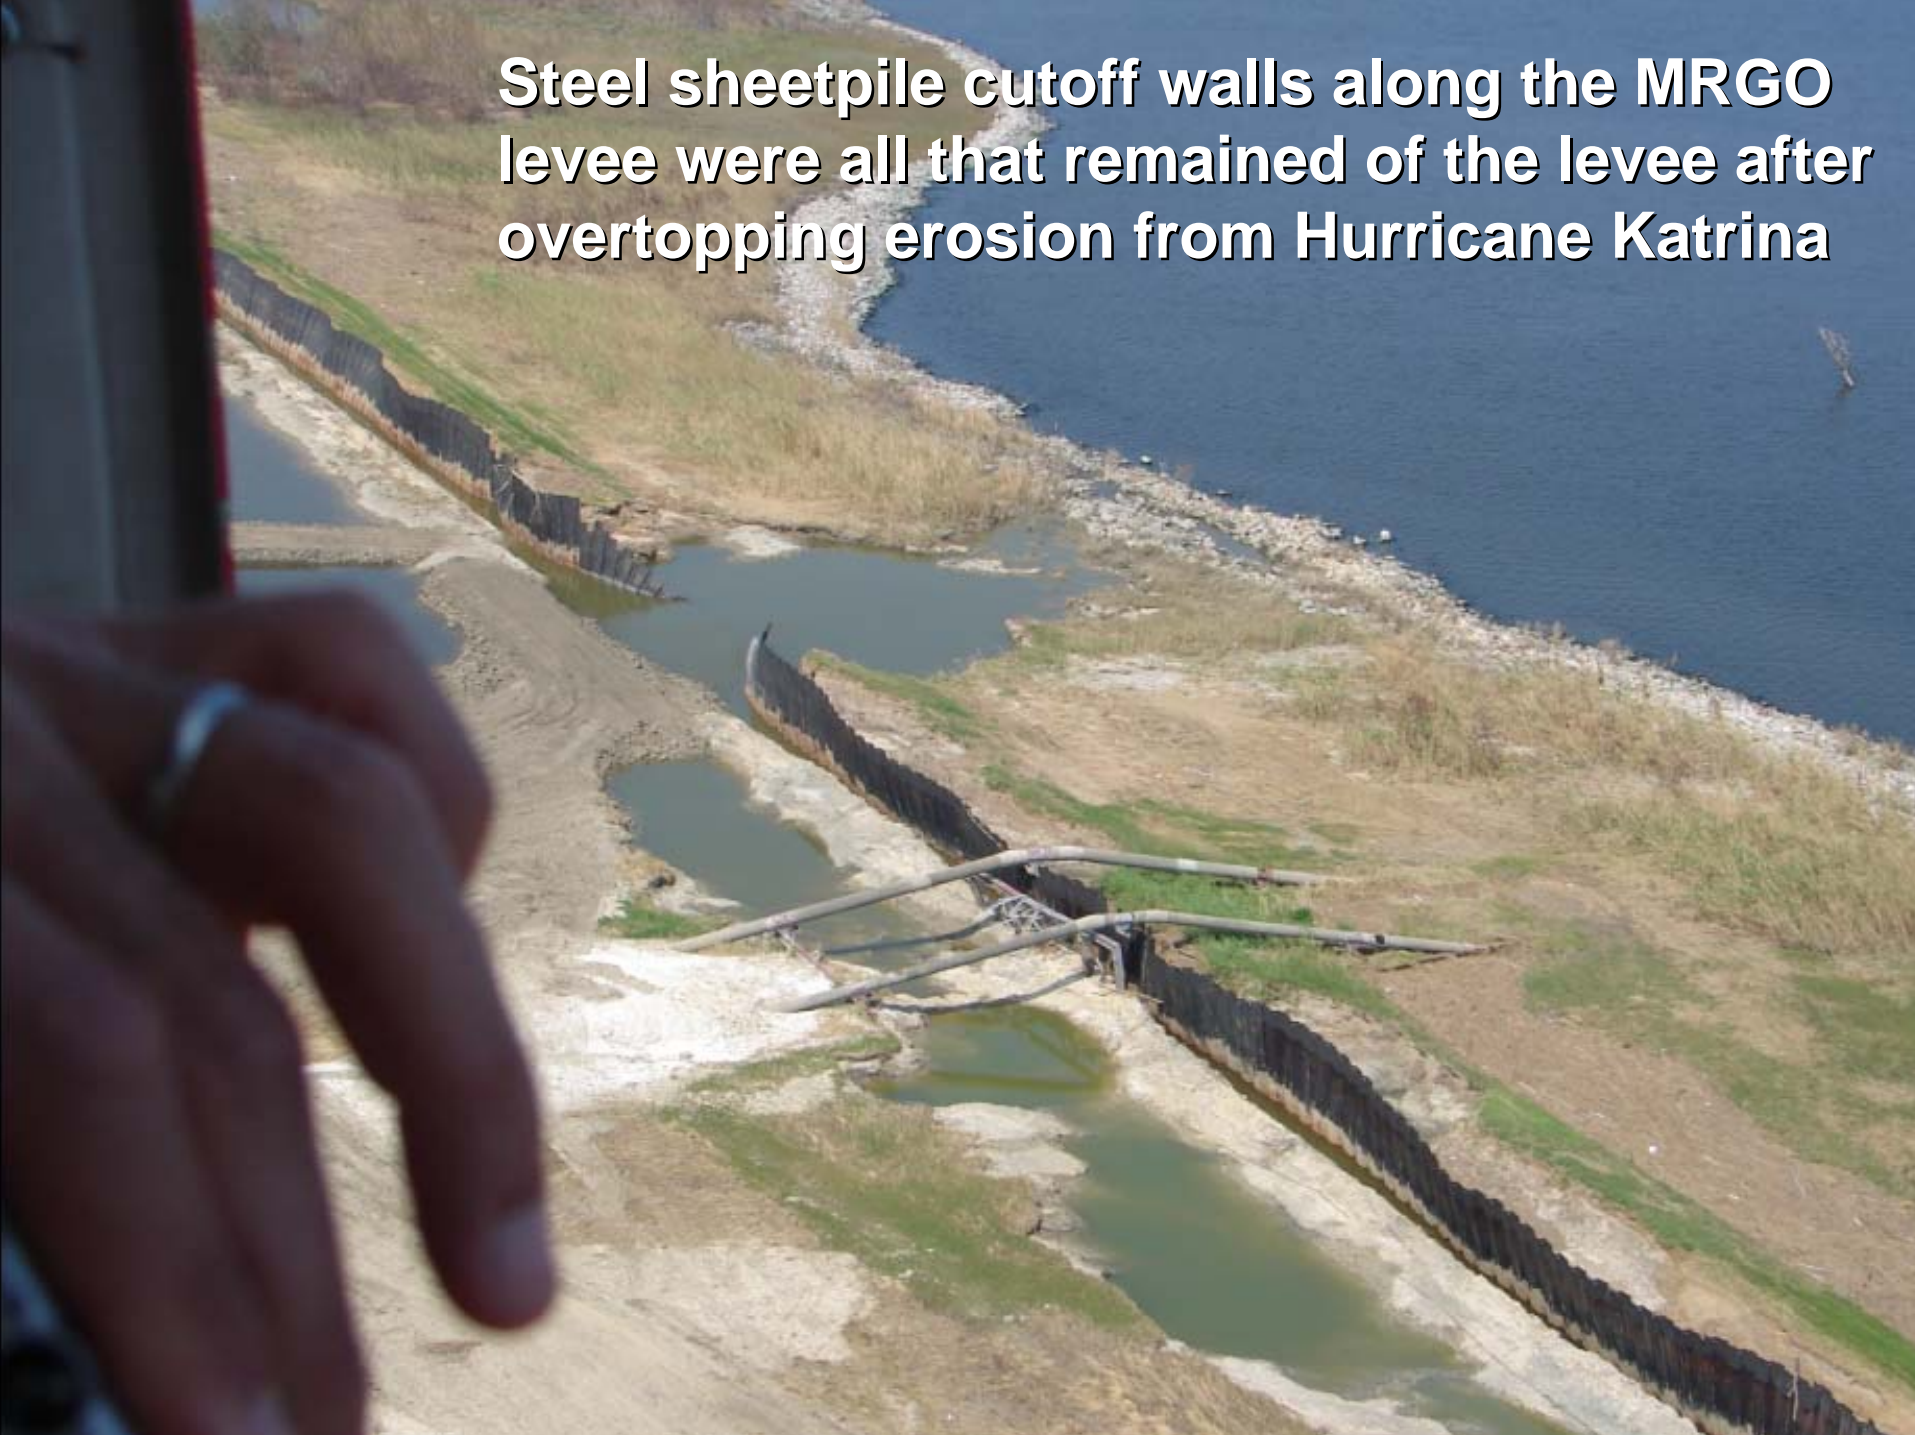
Steel sheetpile cutoff walls along the MRGO levee were all that remained of the levee after overtopping erosion from Hurricane Katrina

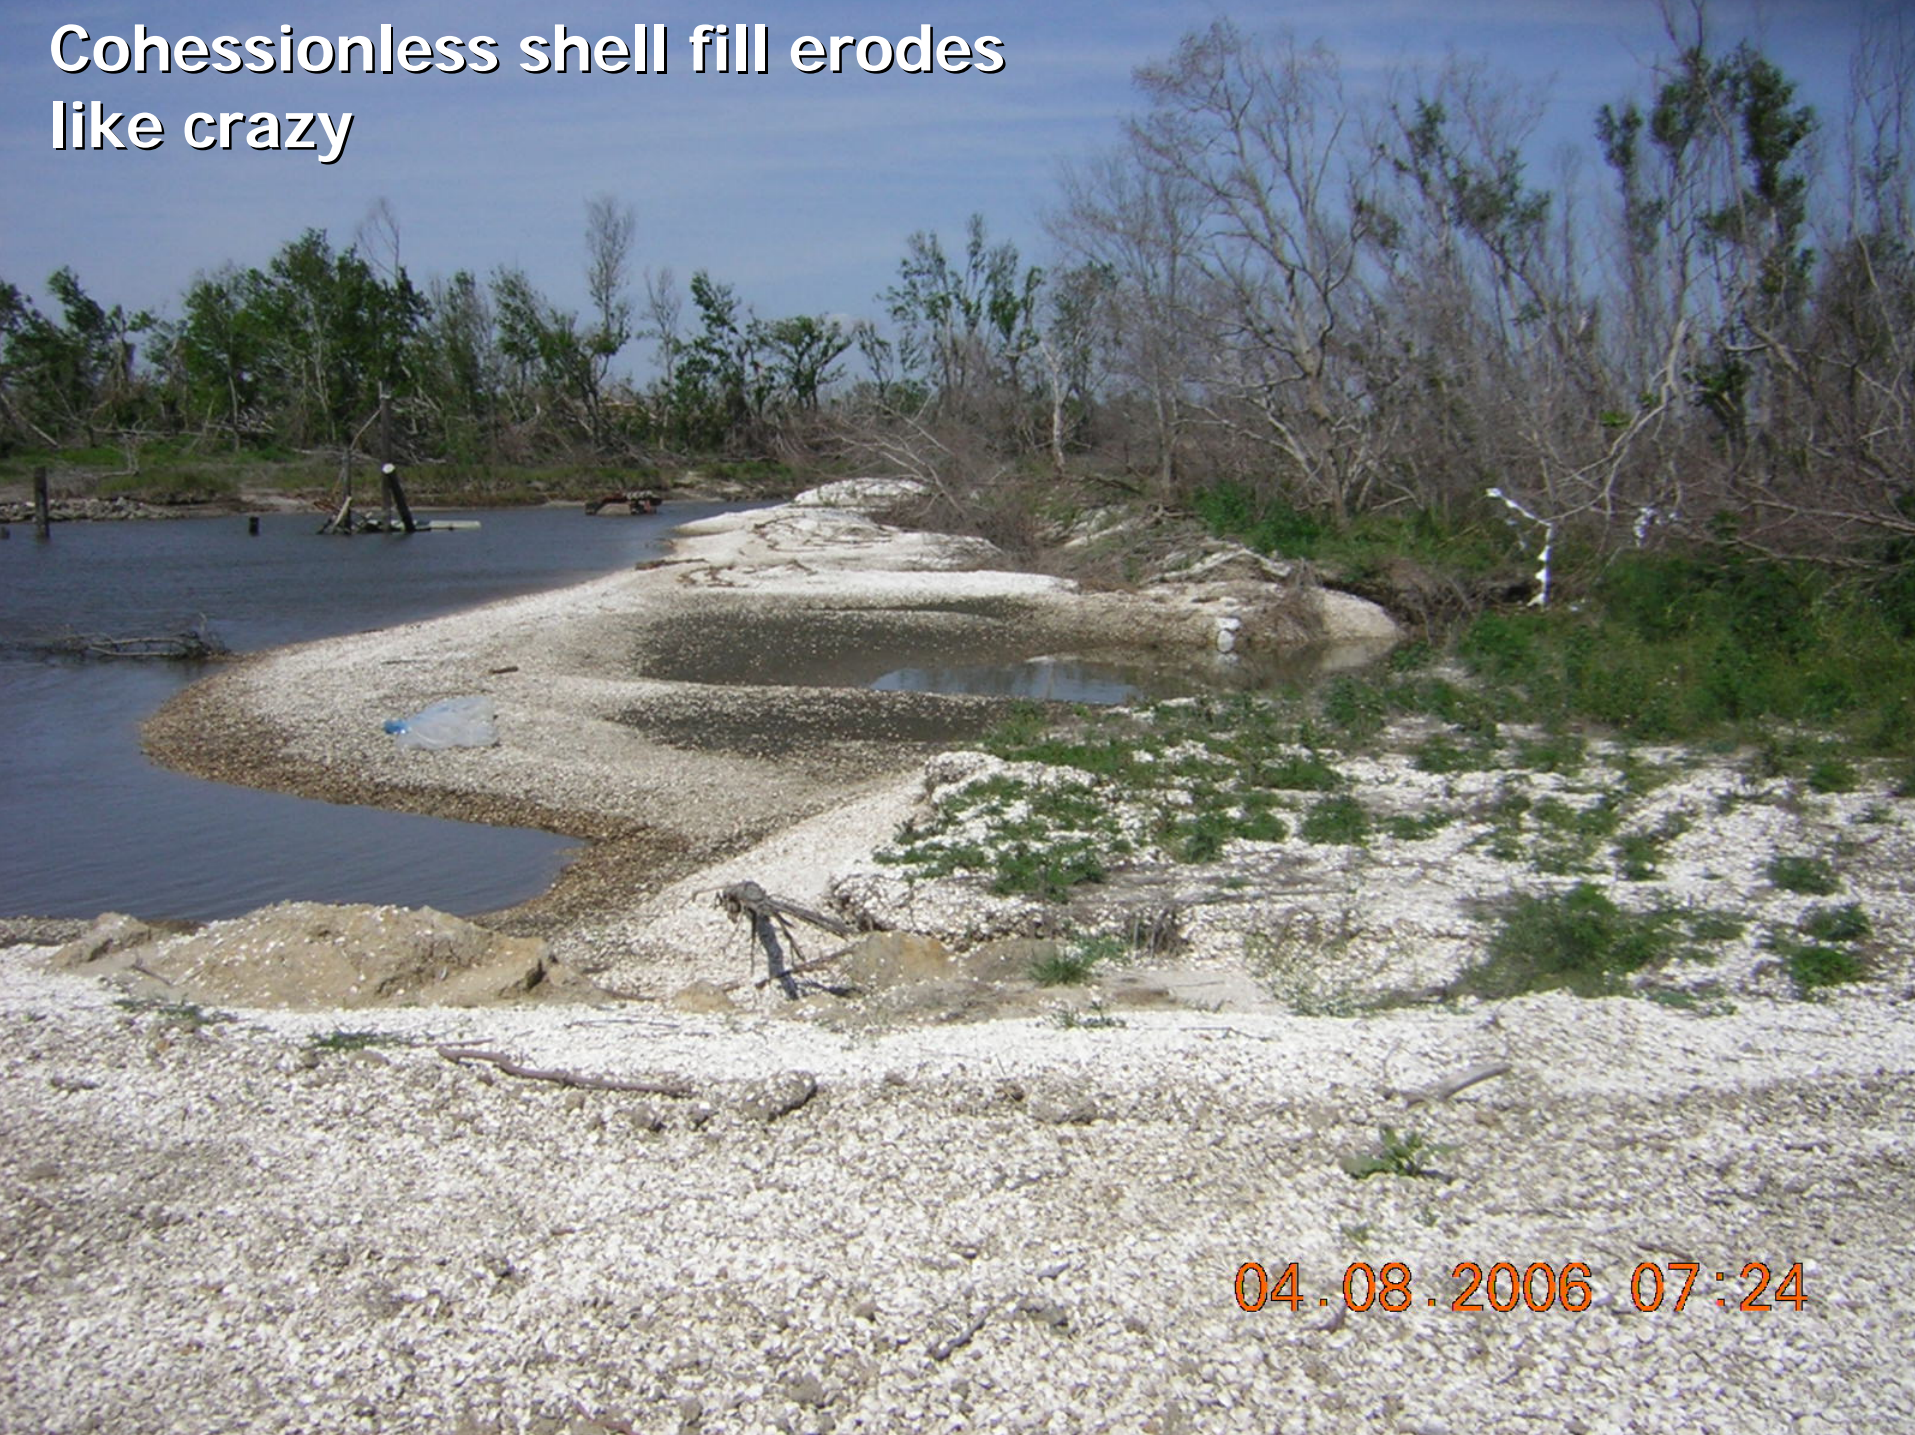
Cohesionless shell fill erodes
like crazy

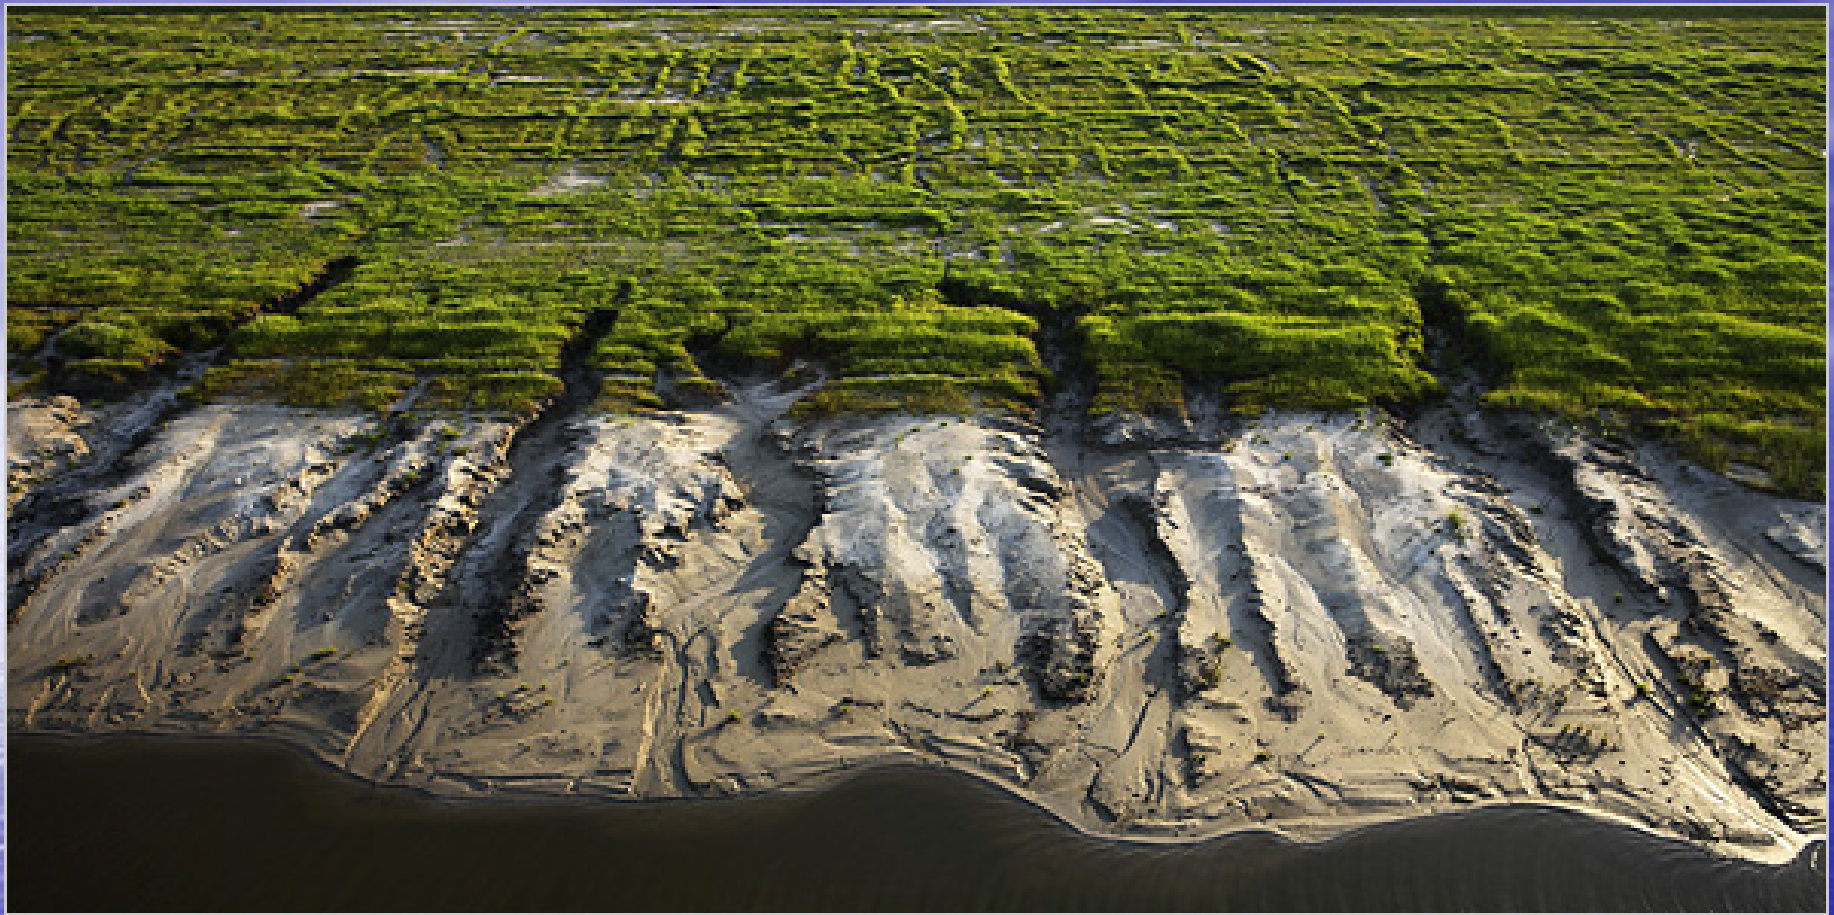
- Surficial erosion at toe of cut slope in borrow pit adjacent to the reconstructed MRGO channel, illustrating erosion of **low cohesion fill materials**.
