# **LANDSLIDES of the PANAMA CANAL**

**J. David Rogers, Ph.D., P.E., P.G.**

**2011 Pacific Section Meeting**

**American Association for the Advancement of Science  
San Diego, California  
June 13, 2011**

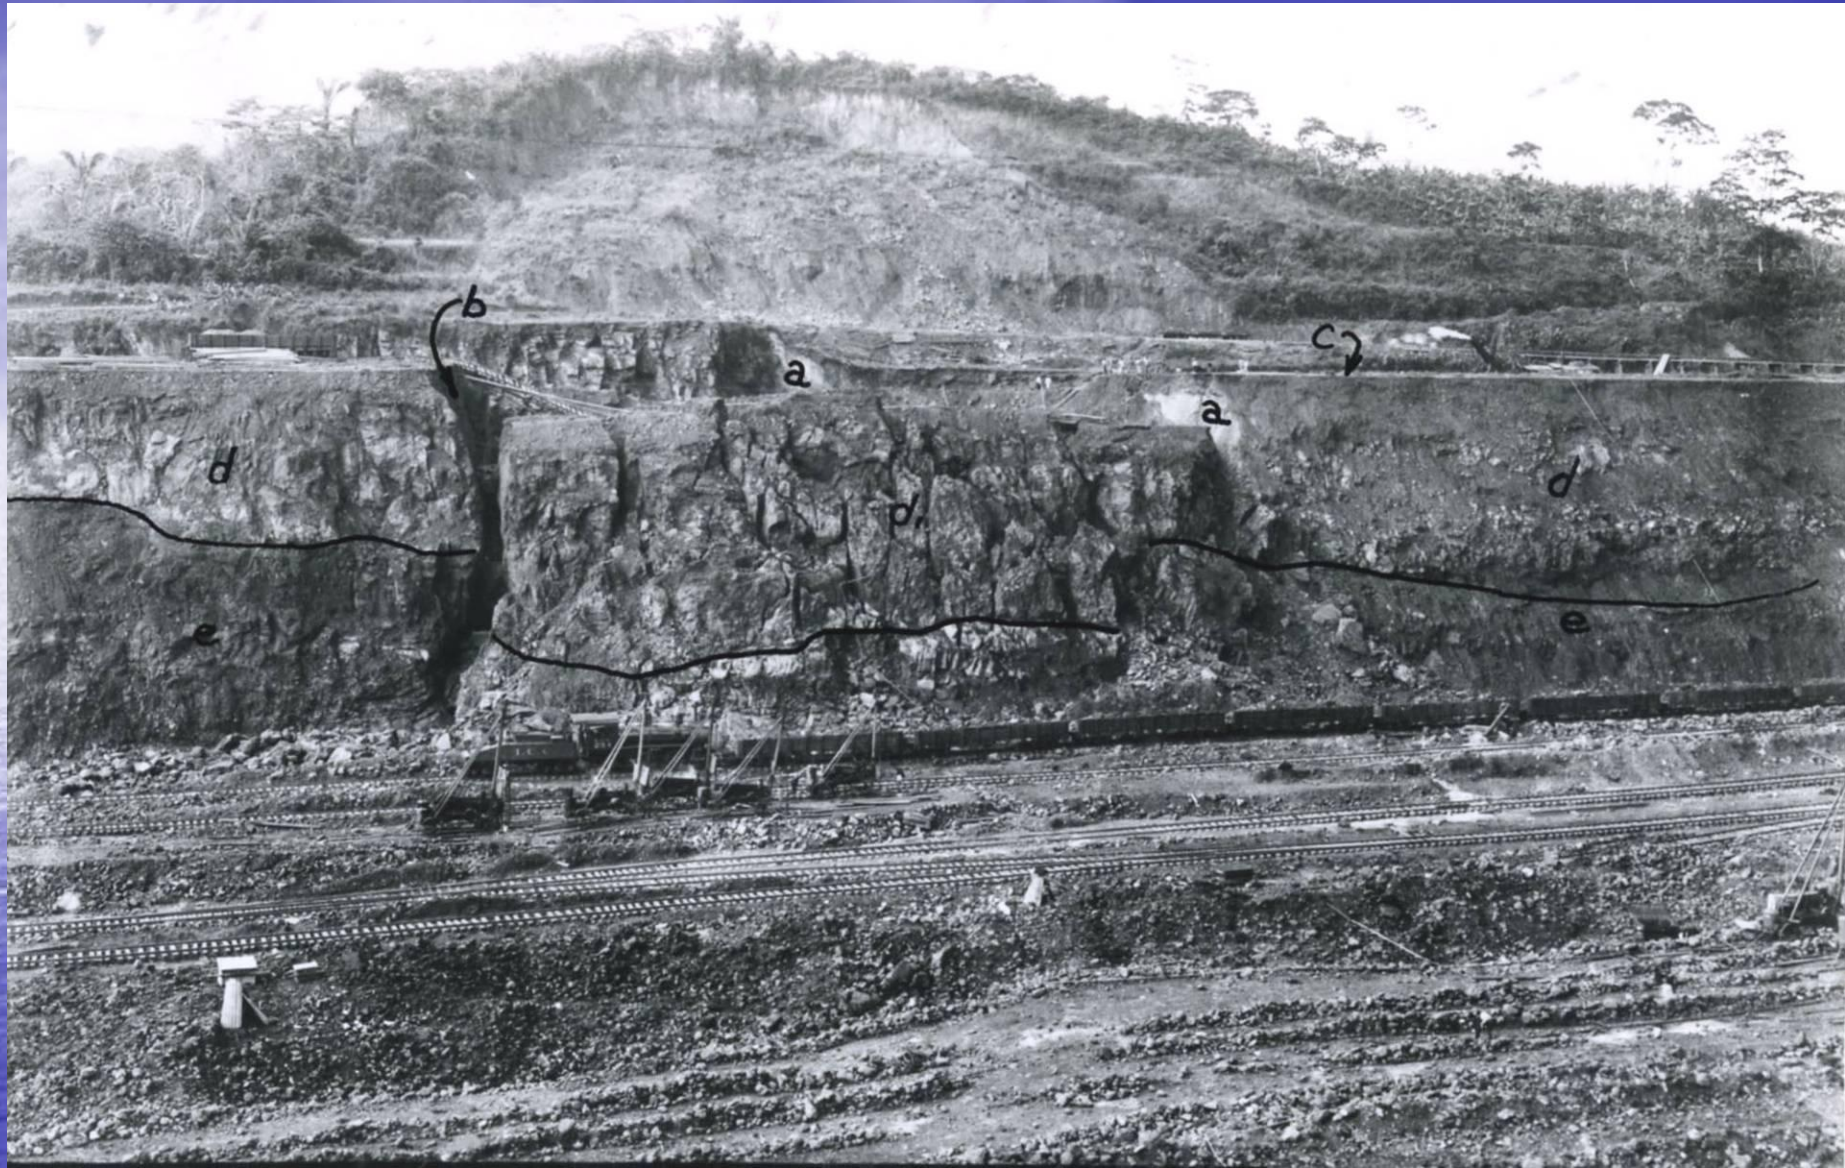
- **Block glide day-lighting into canal excavation in May 1910. This is one of the earliest slides that was scientifically evaluated by Army Engineers.**

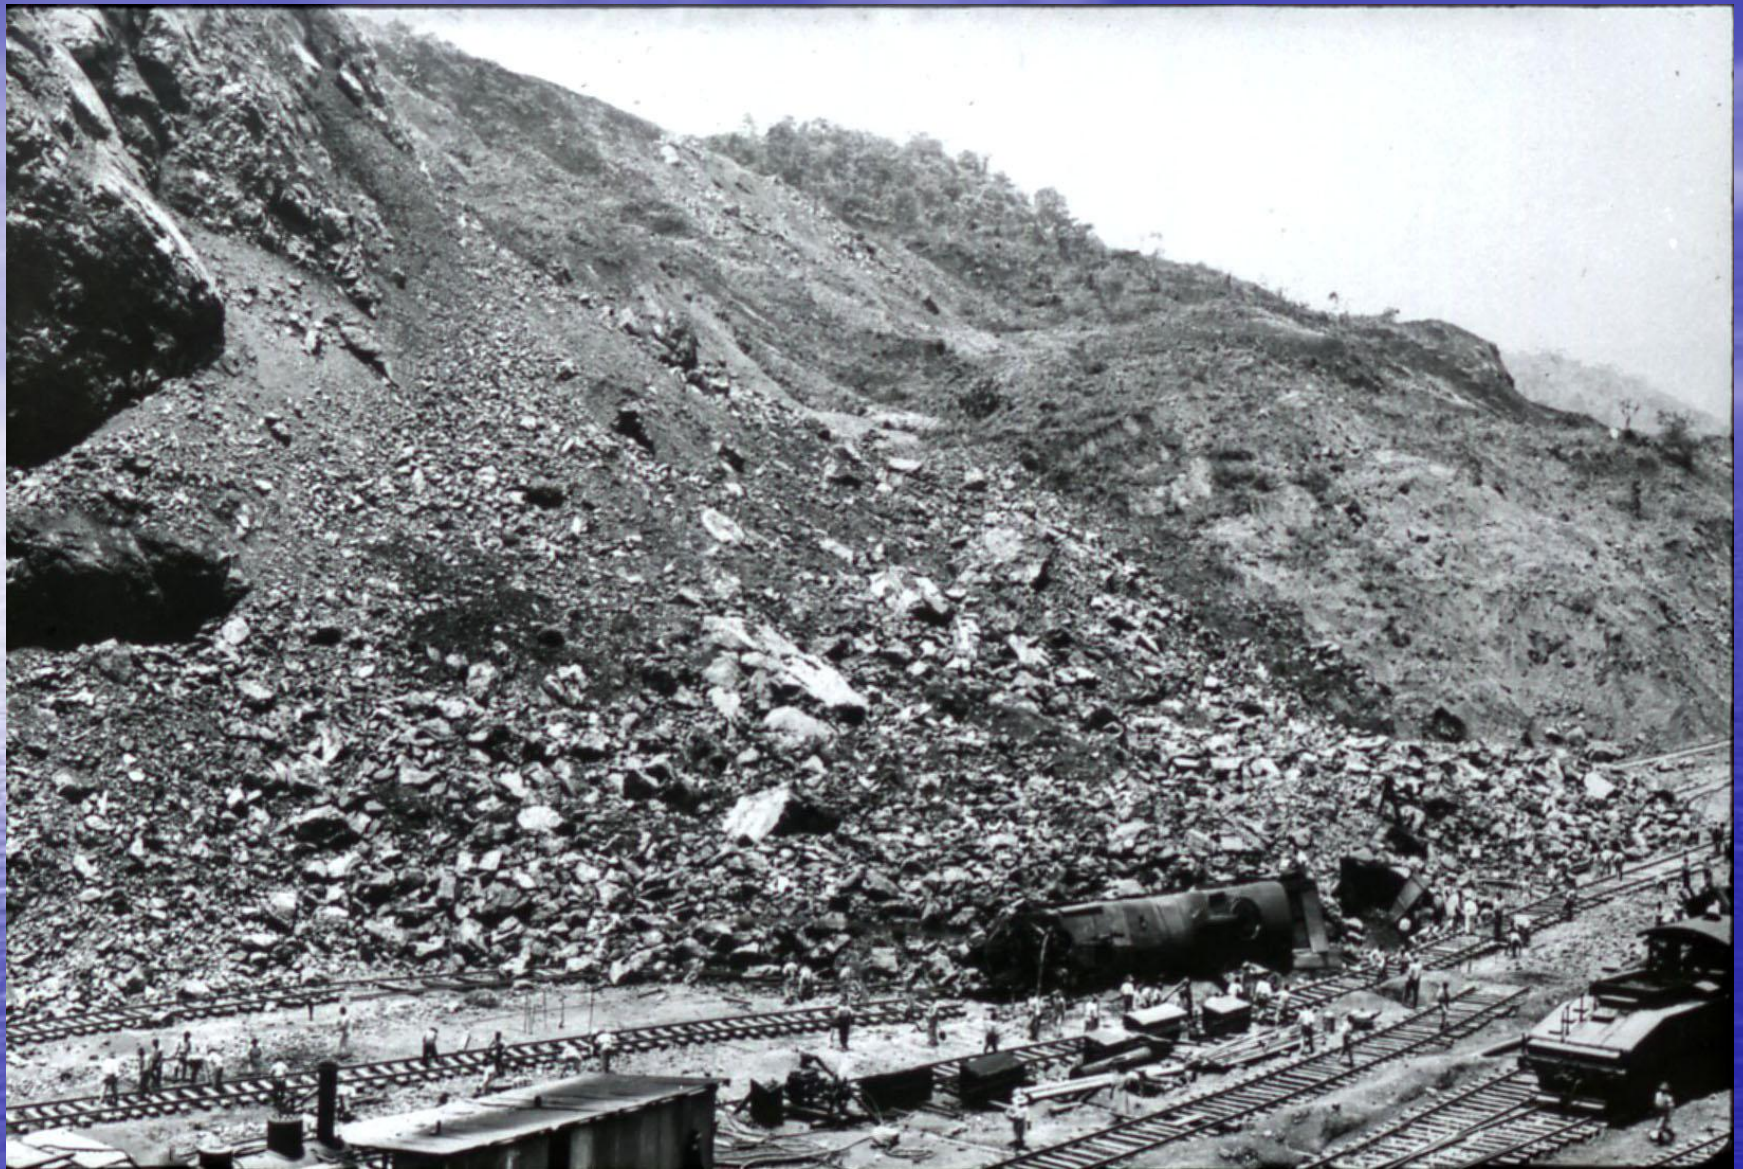
- **One of the early landslides at Cucaracha, on the south side of Gold Hill, near the Continental Divide, on July 5, 1911.**

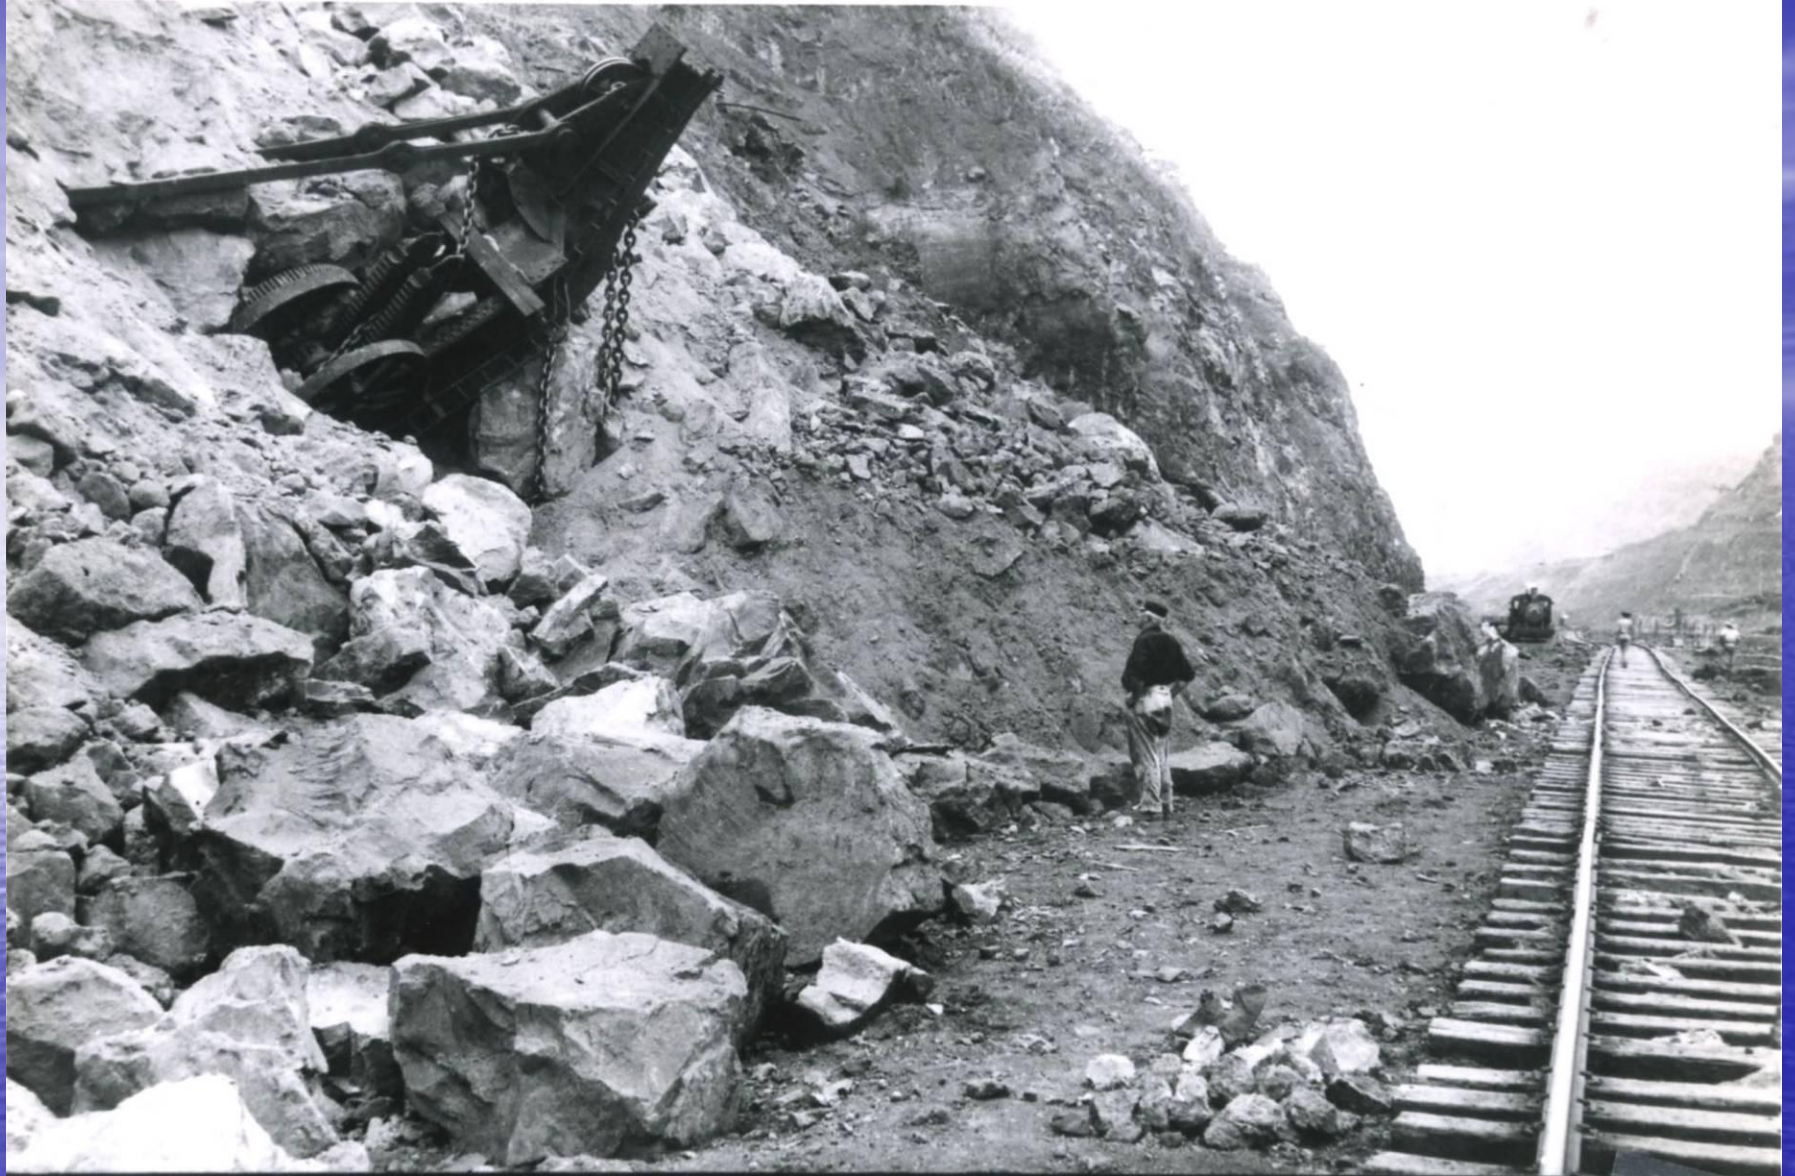
- **Ground view of the same slide of July 5, 1911 at Cucaracha, showing buried steam shovel.**

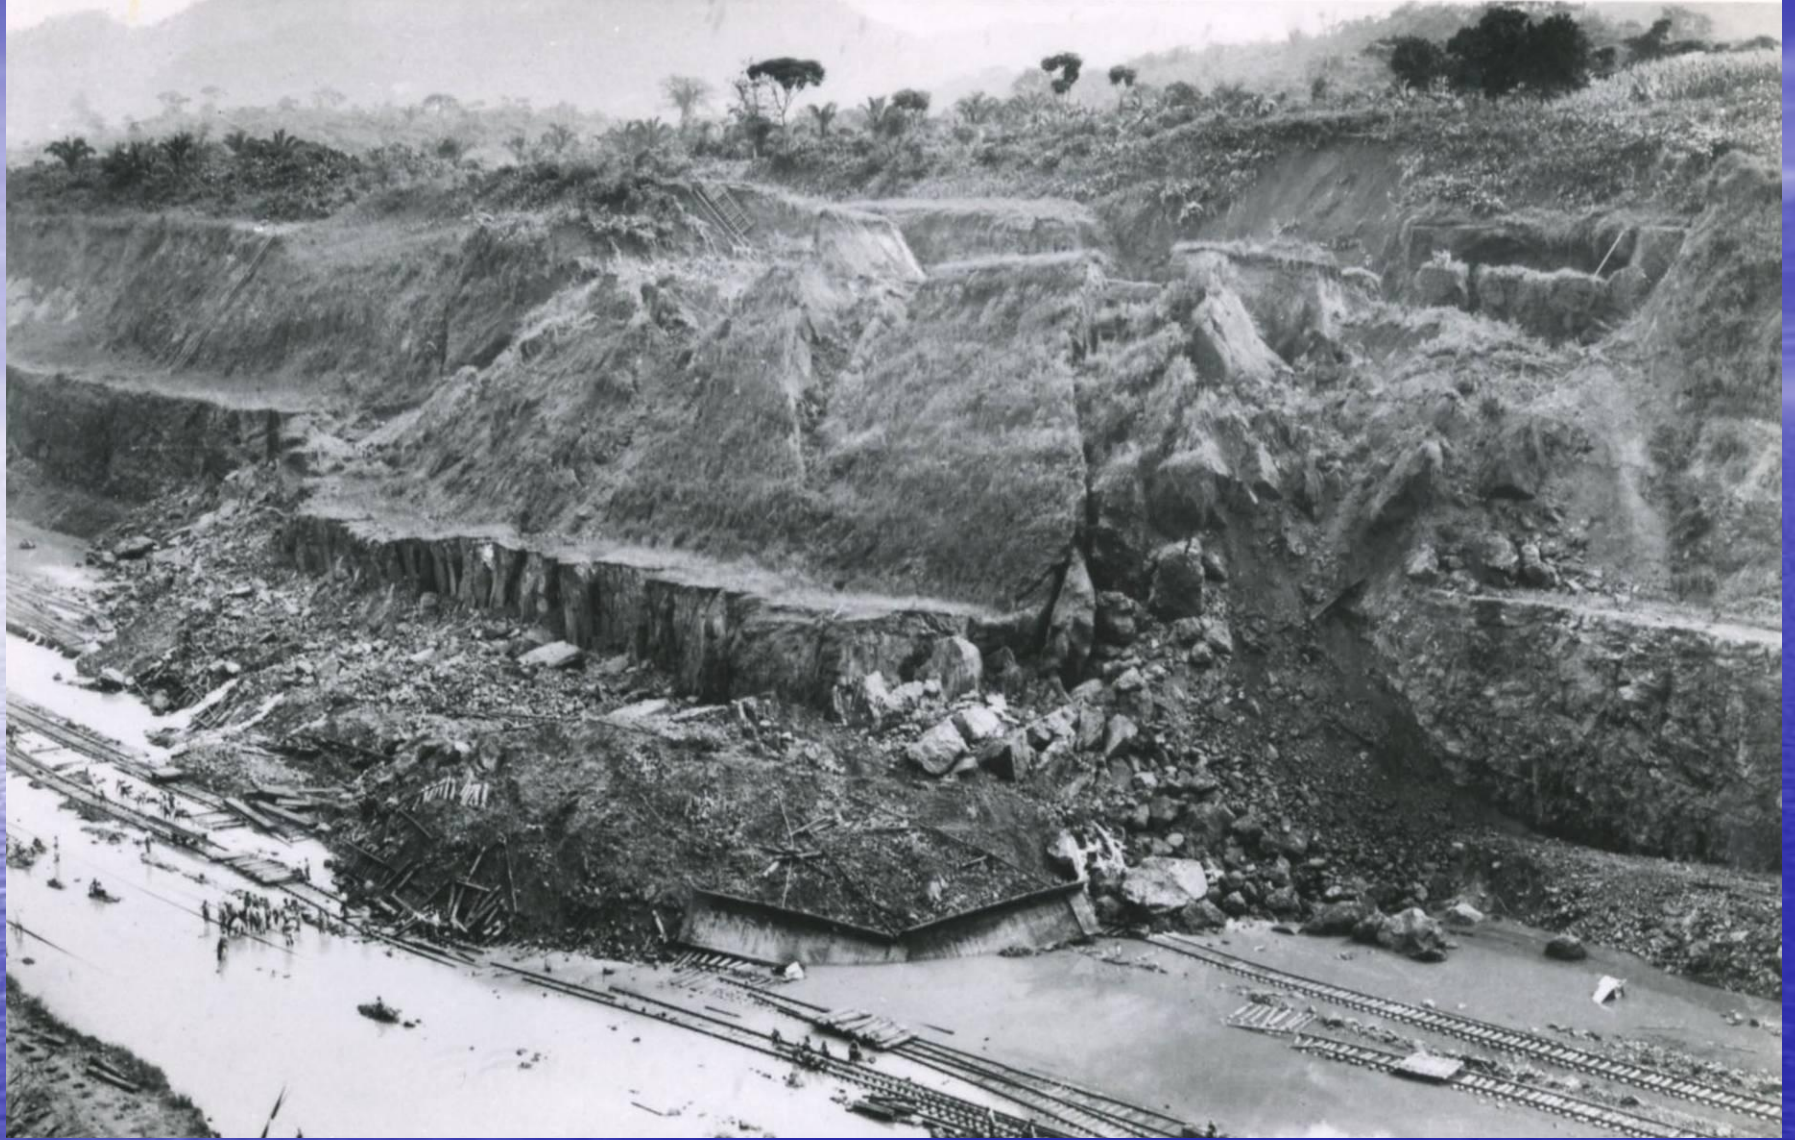
- **Cut slope failure on the Obispo Division on August 21, 1912. Note ponded water.**

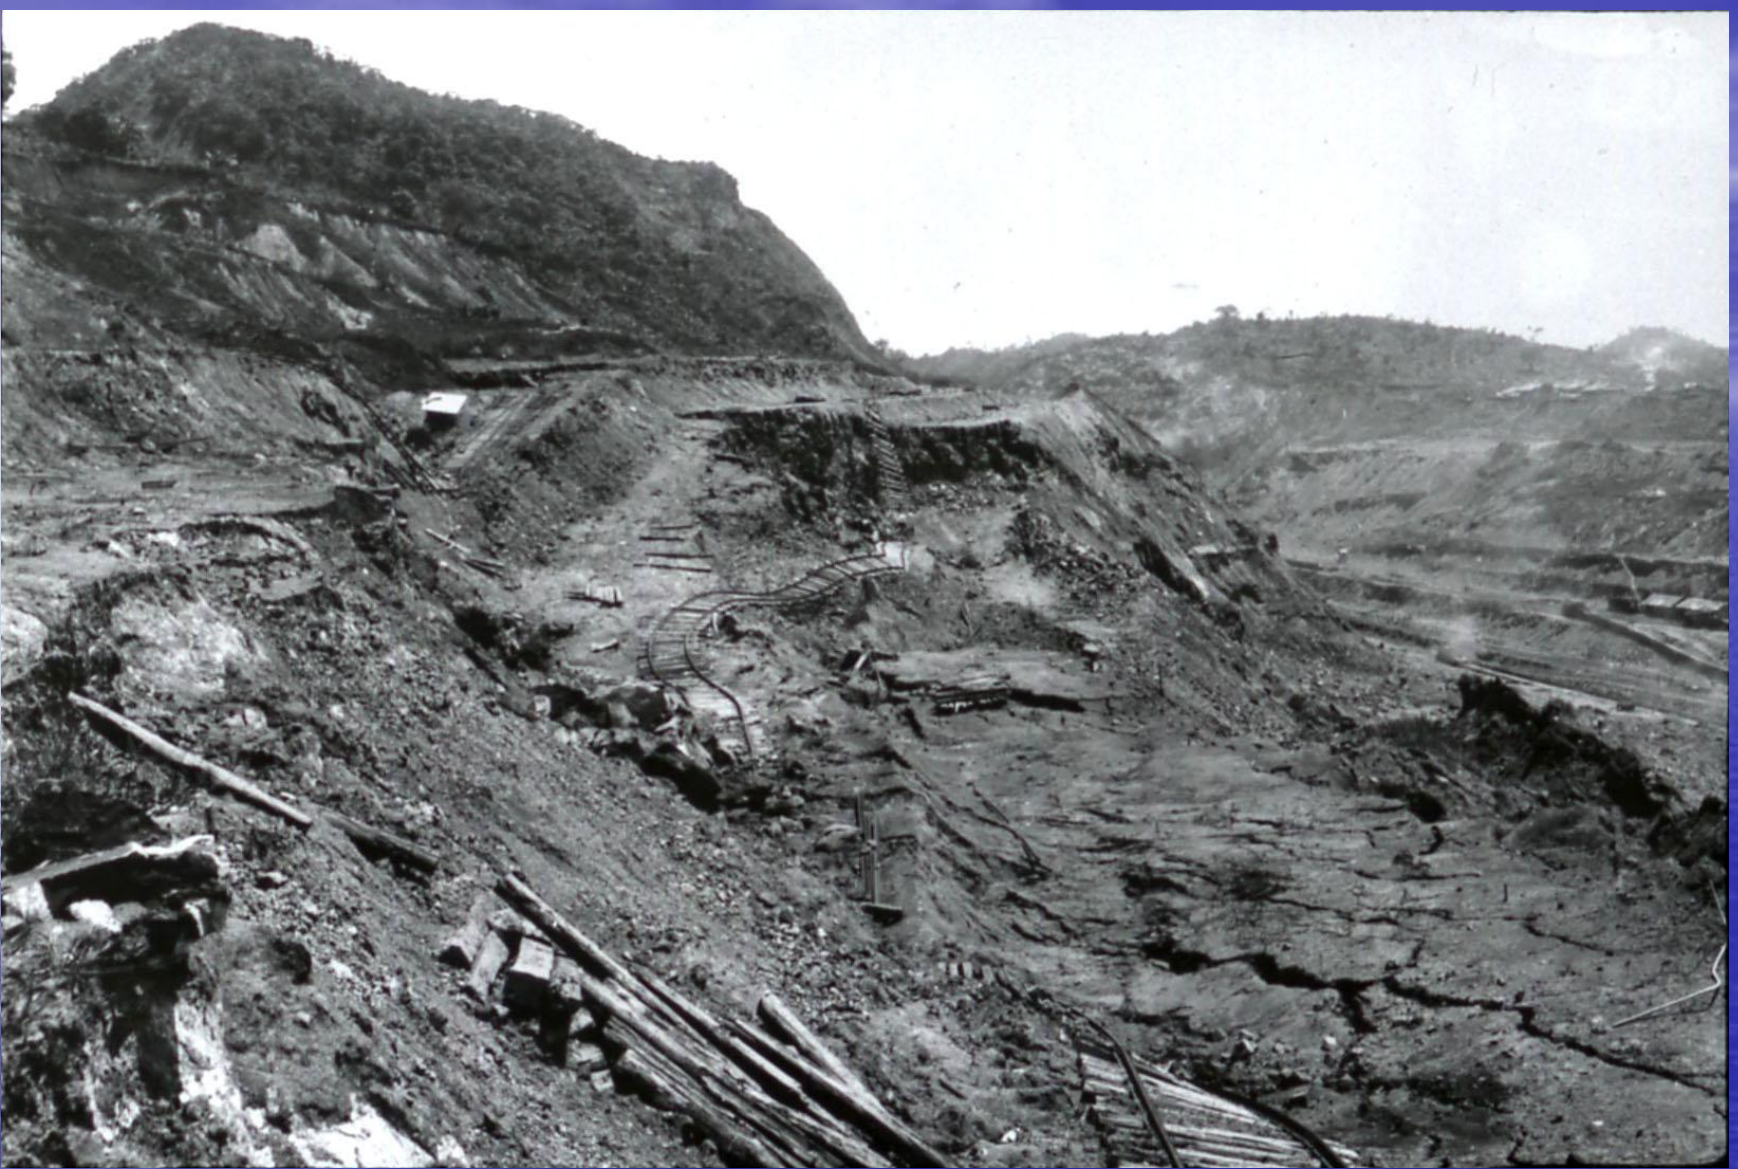
- **Crown scarp of the East Culebra Slide on September 19, 1912, looking south.**

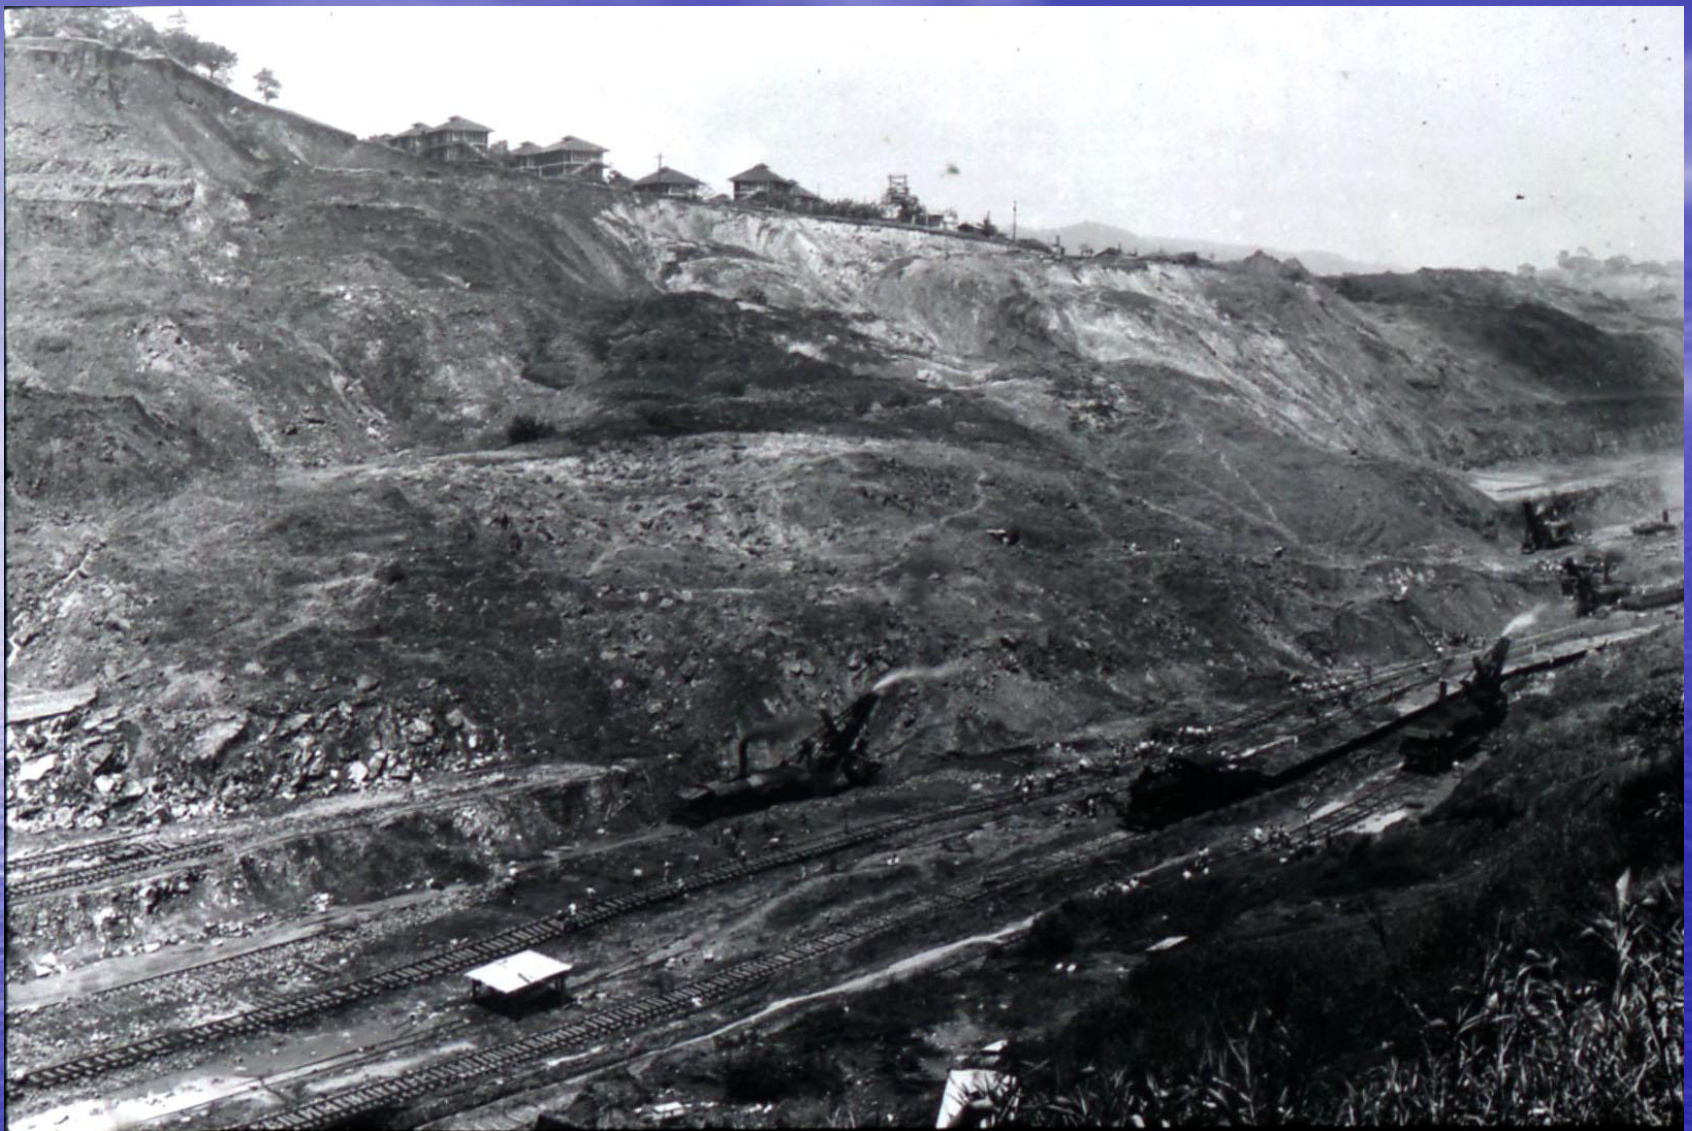
- **Excavating the toe of the West Culebra slide with steam shovels, and allowing the slide debris to disintegrate and slide into the hole.**

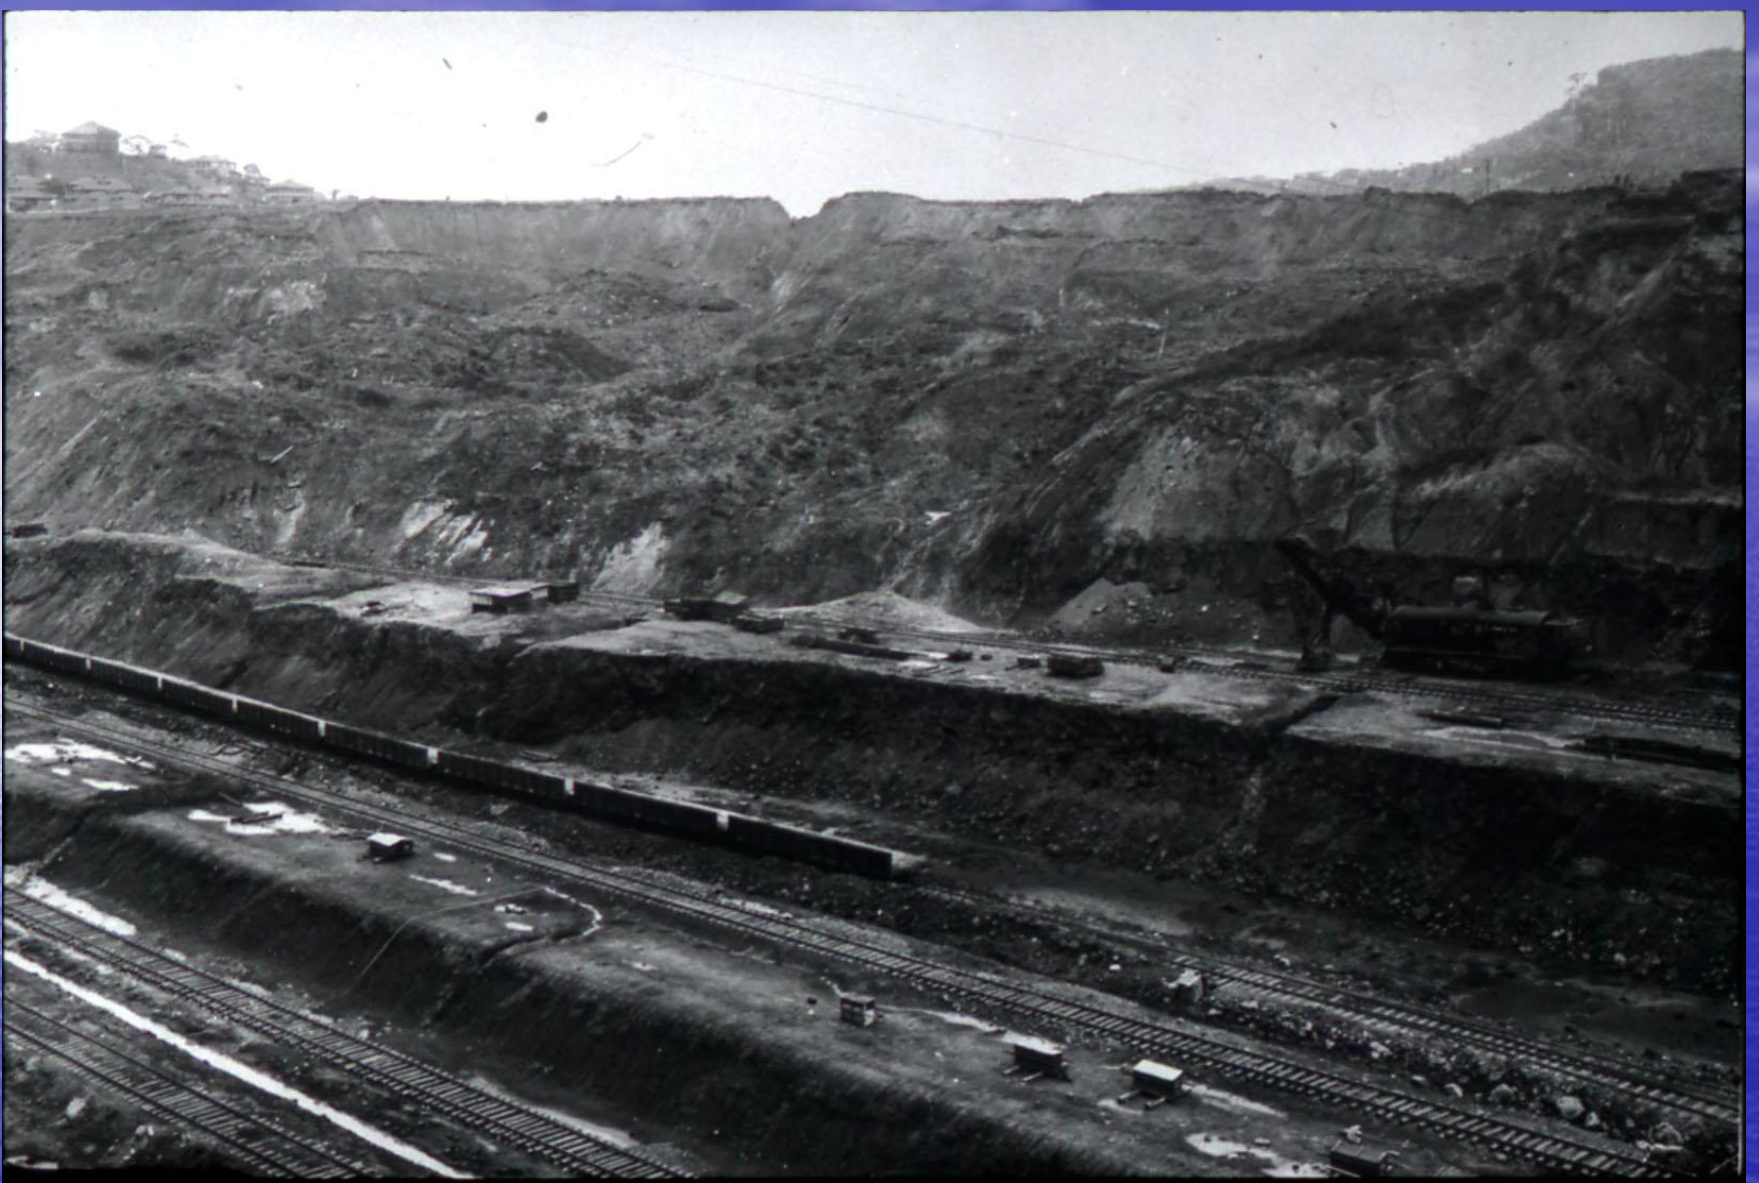
- **The shovels work desperately to fill side-dumping gondola cars and keep pace with the onslaught of earthen debris.**

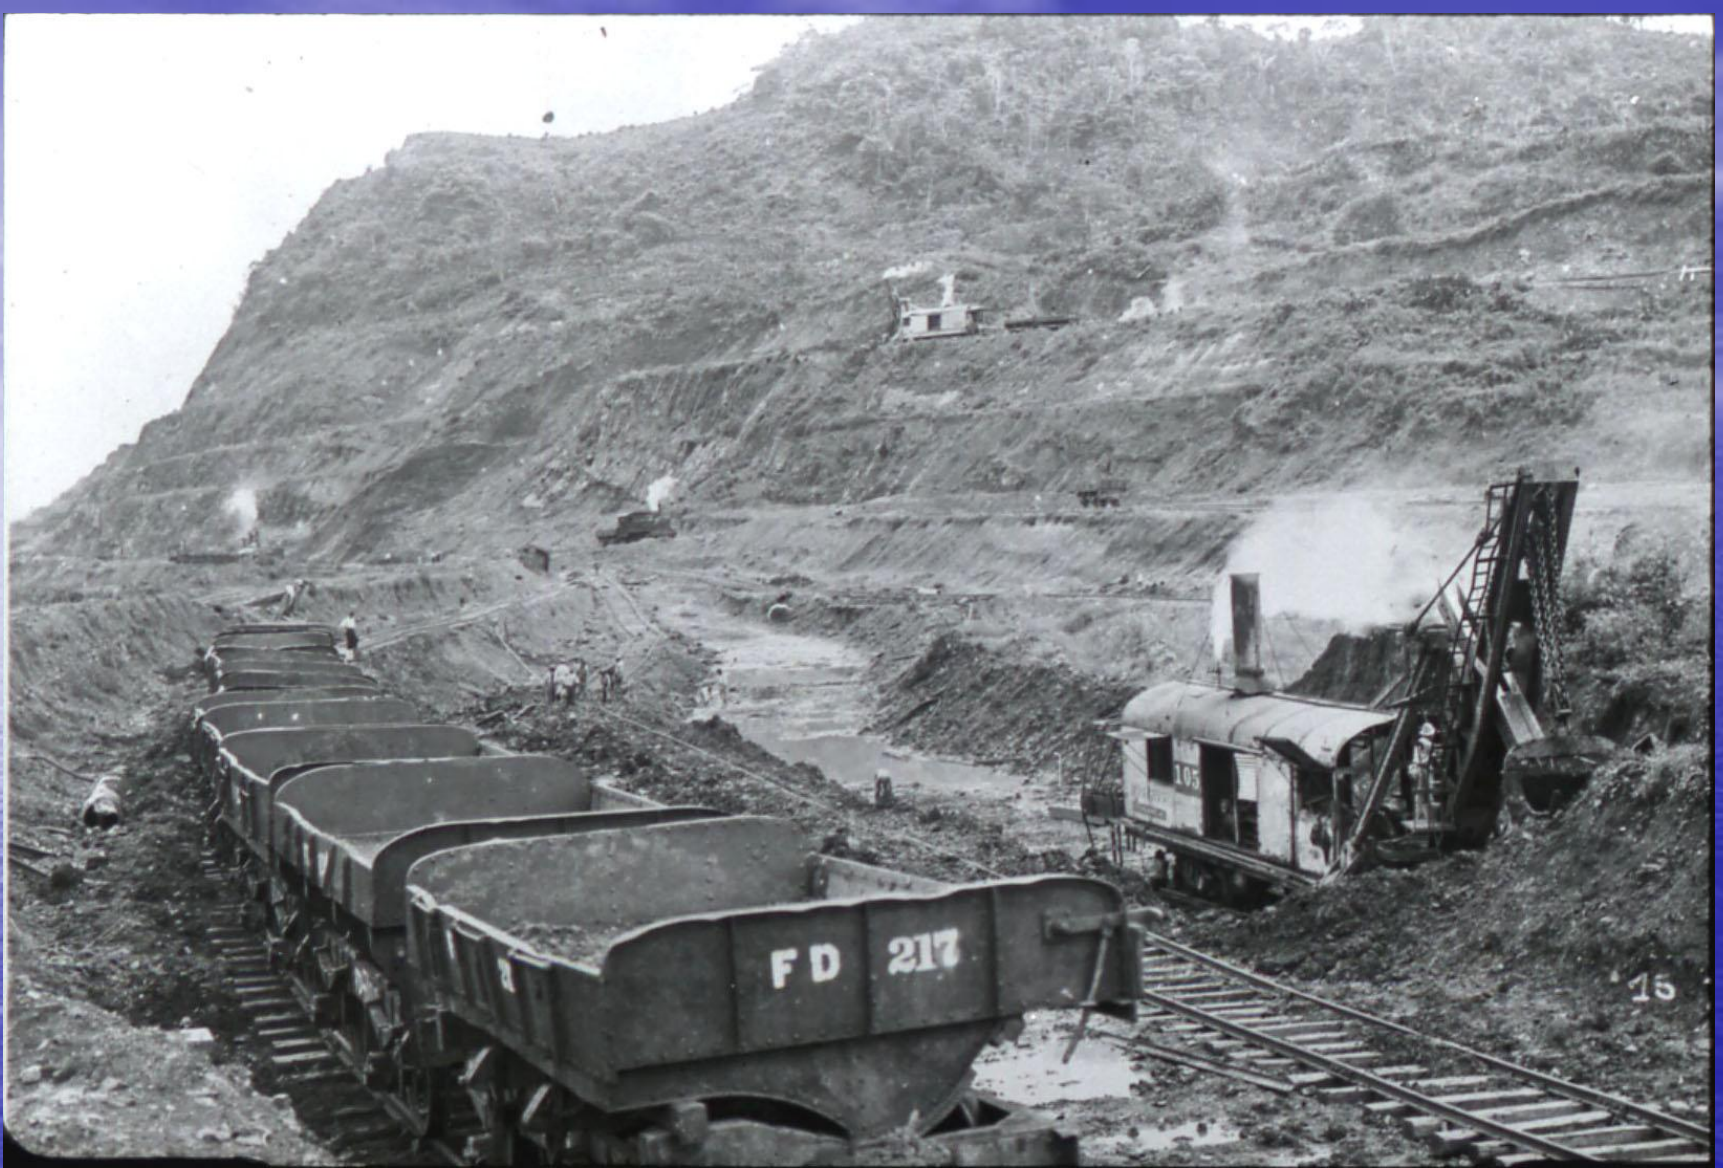
- **Close-up view of the rail-mounted shovels excavating slide debris at Culebra. Side-dumping gondola cars in foreground.**

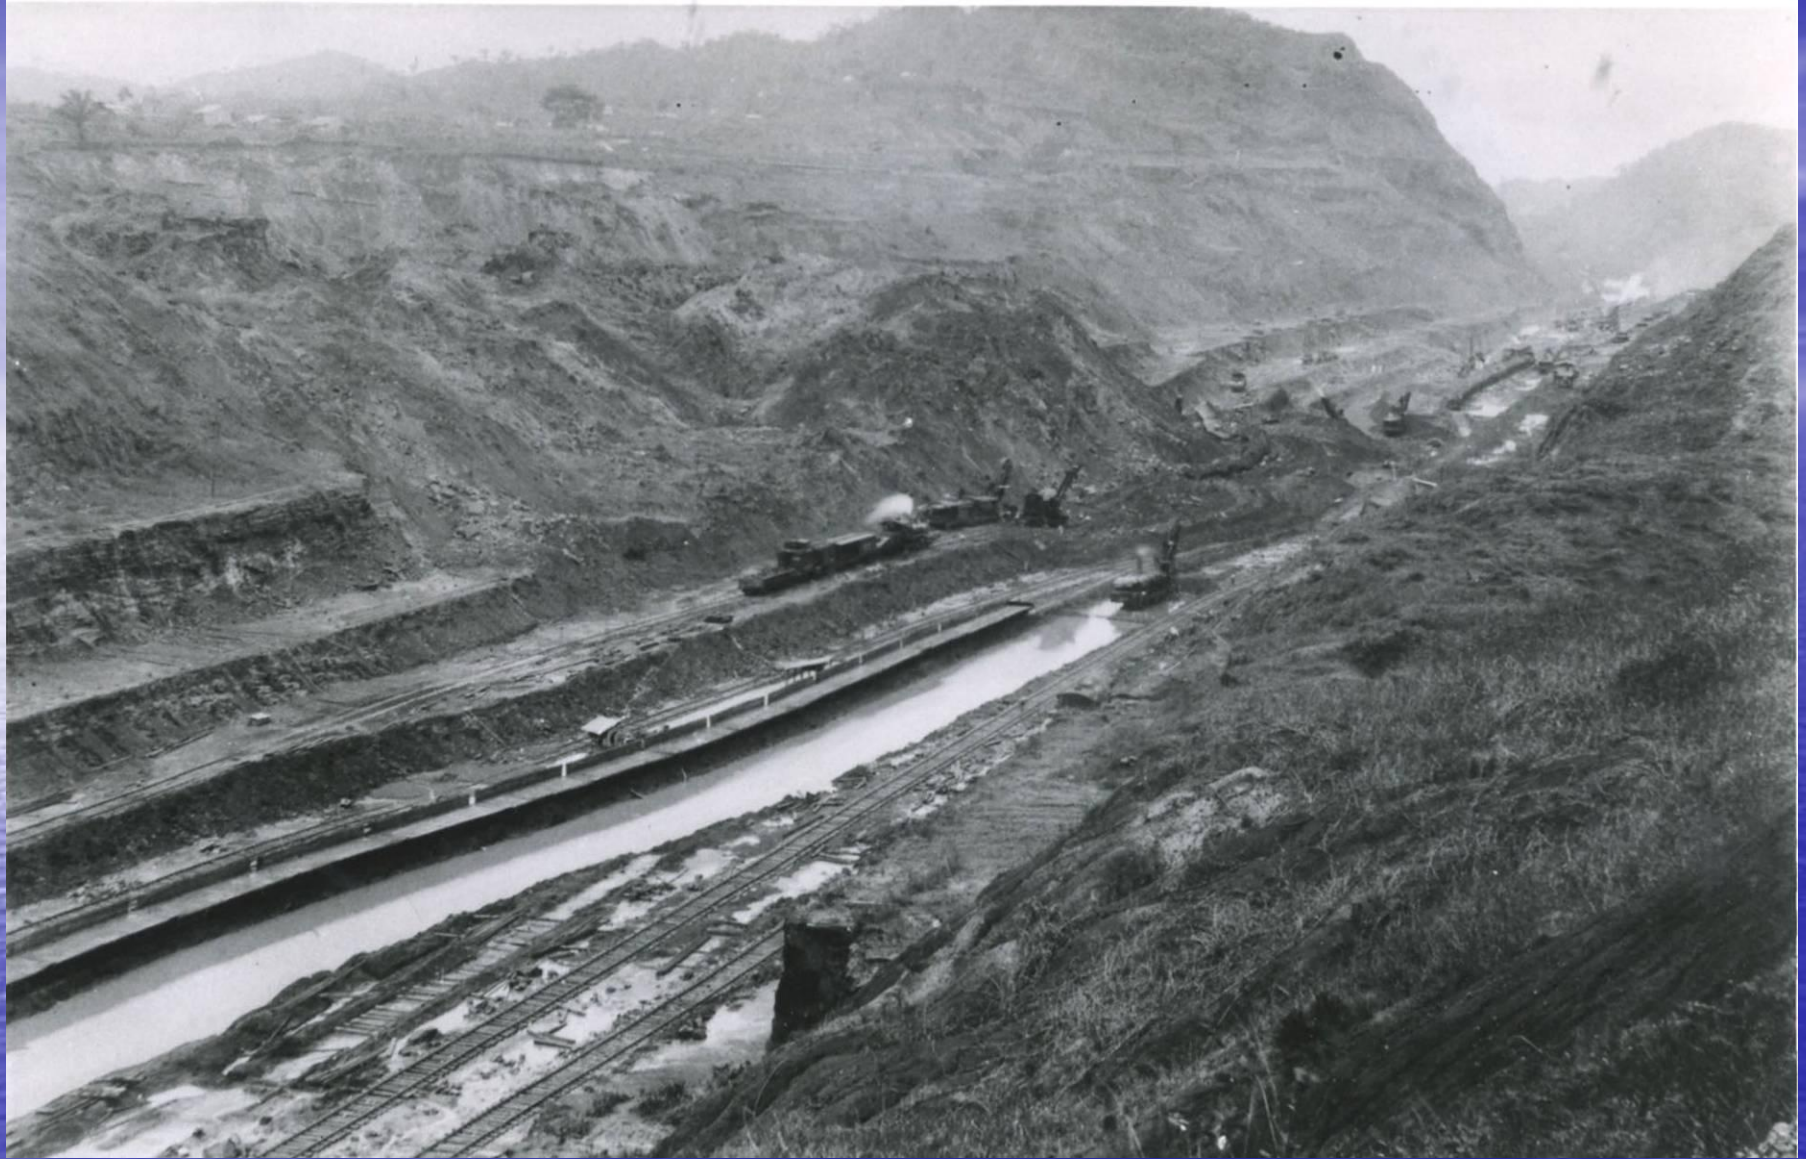
- **Large deep-seated slump on the East Culebra Slide blocks the canal excavation, May 27, 1913.**

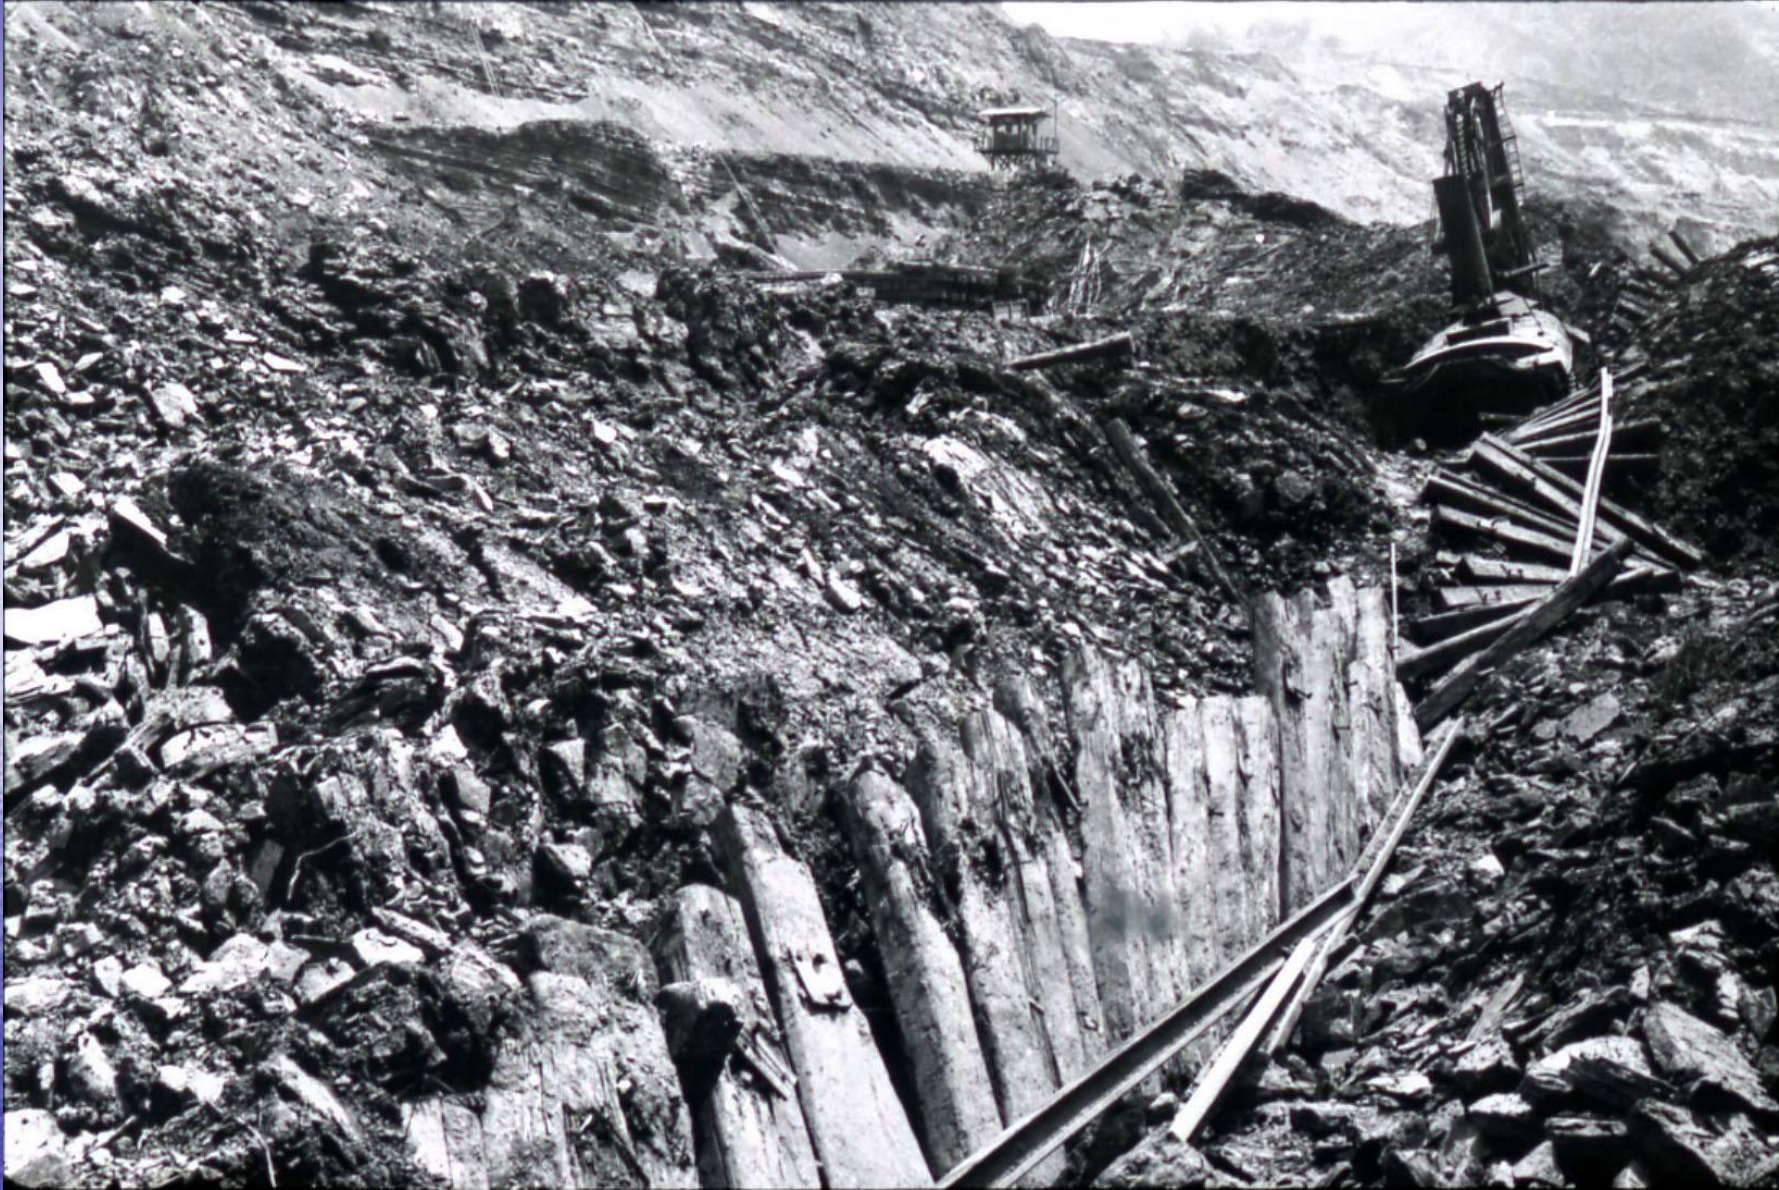
- **Buried steam shovel and shredded tracks at East Culebra.**

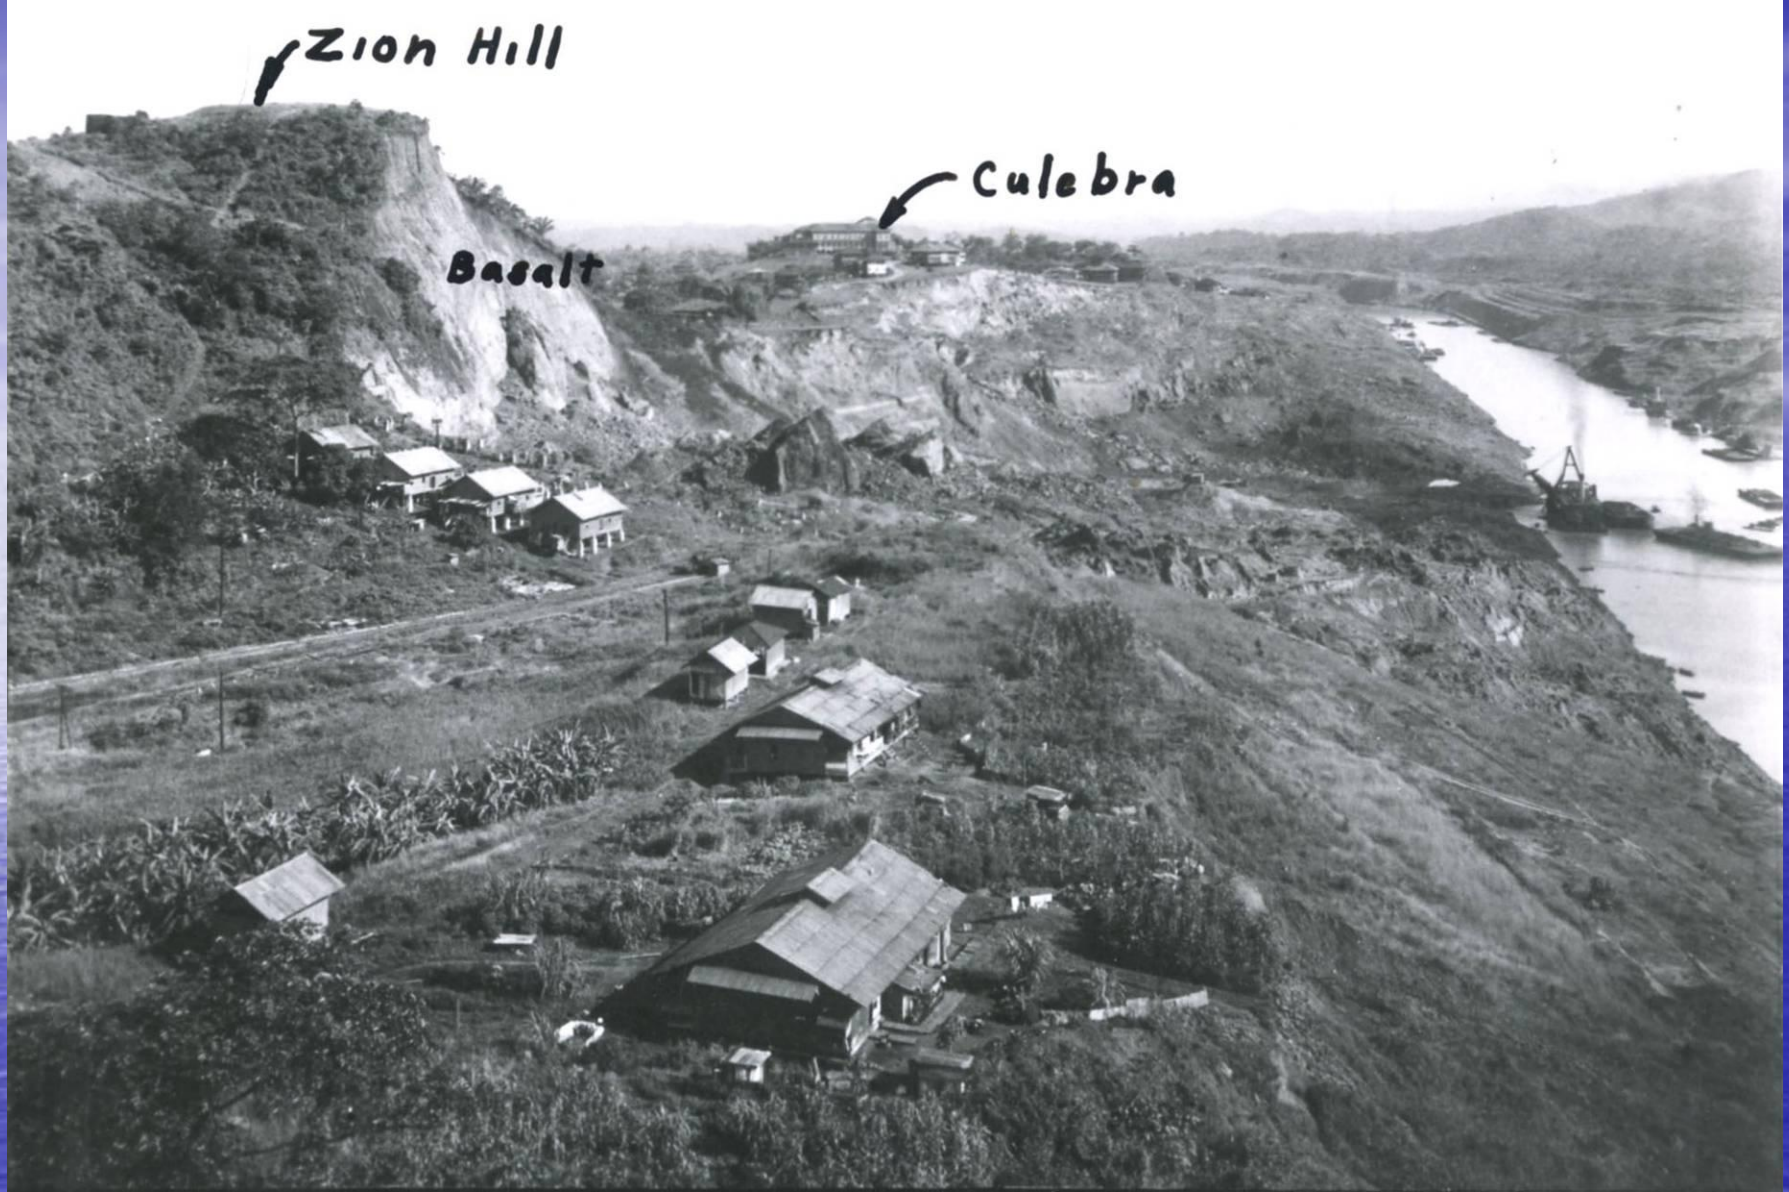
- Zion Hill and West Culebra Slide in July 1916, taken from Contractor's Hill, looking north.
