# **LANDSLIDES of the PANAMA CANAL**

**J. David Rogers, Ph.D., P.E., P.G.**

**2011 Pacific Section Meeting**

**American Association for the Advancement of Science  
San Diego, California  
June 13, 2011**

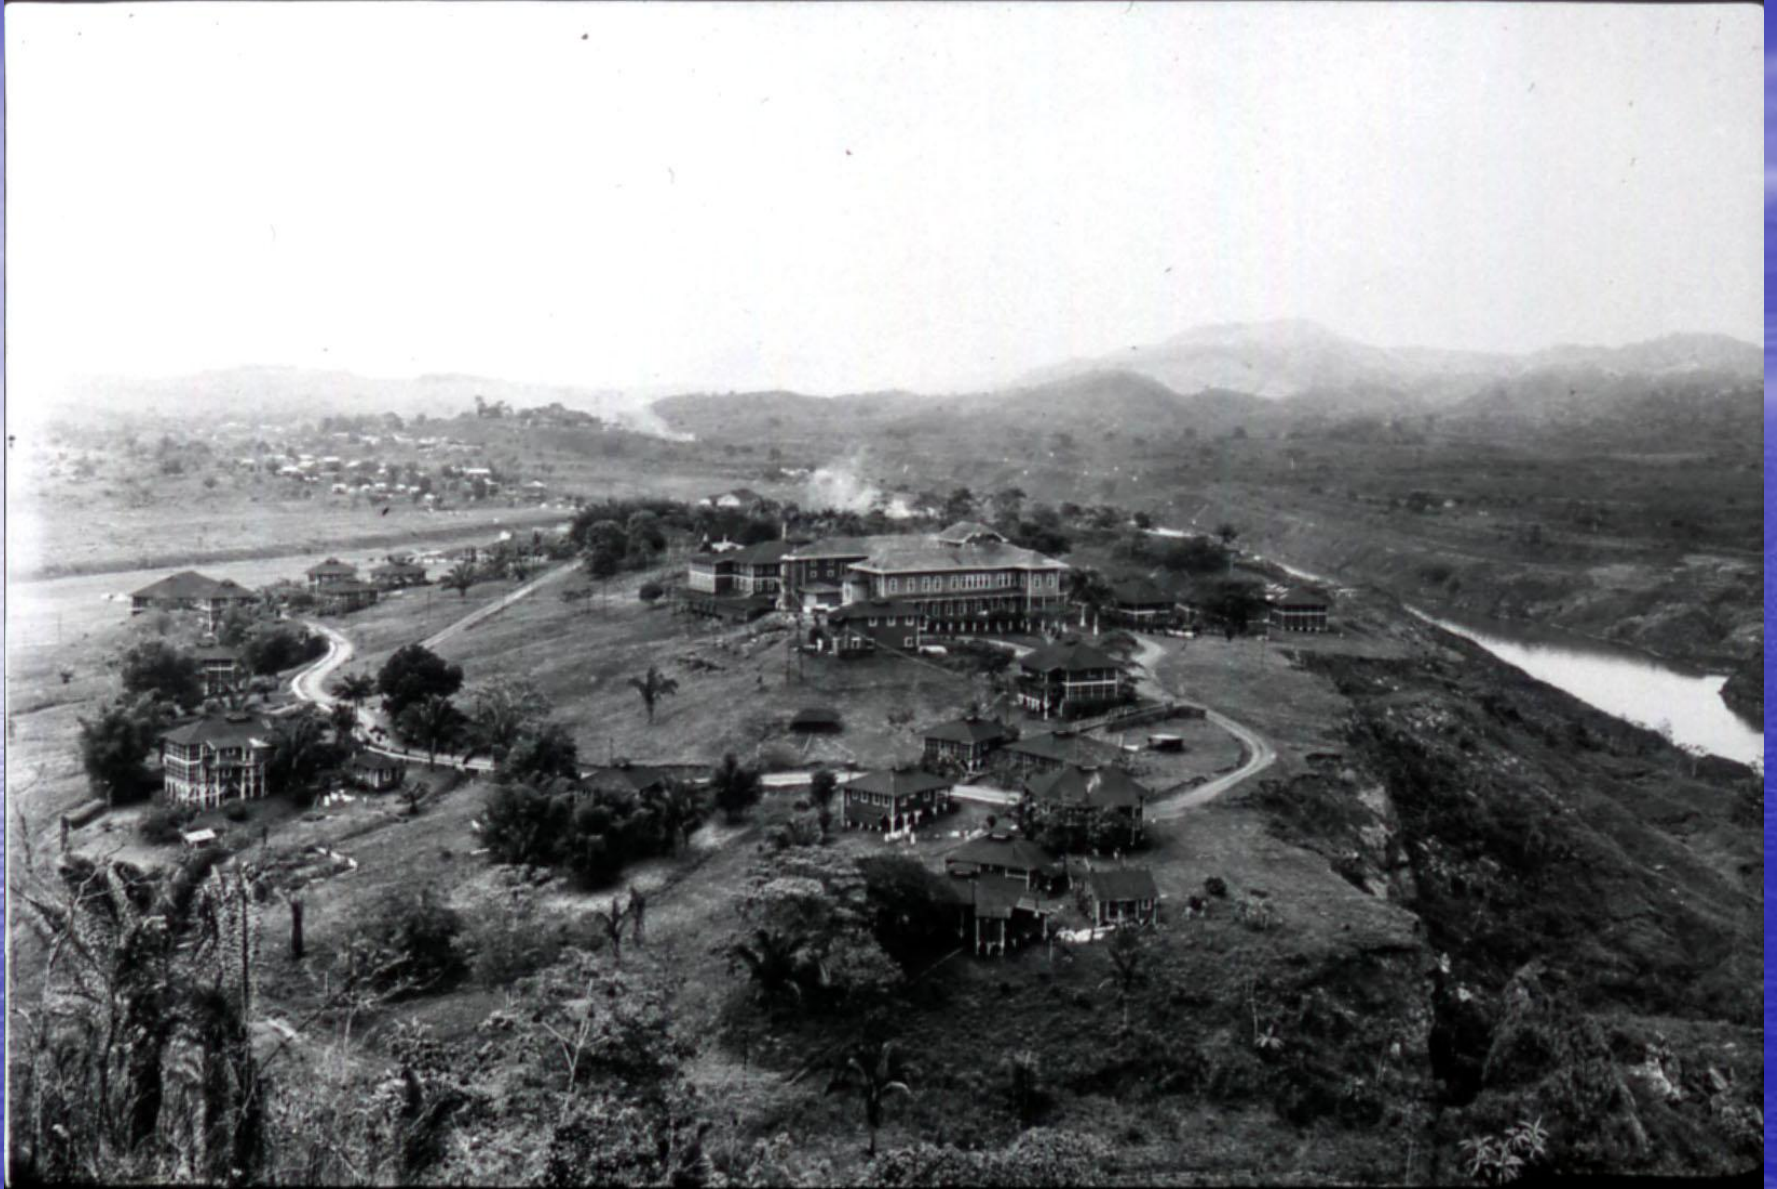
- **The headscarp of the West Culebra Landslide swallowed up part of the town of Culebra**

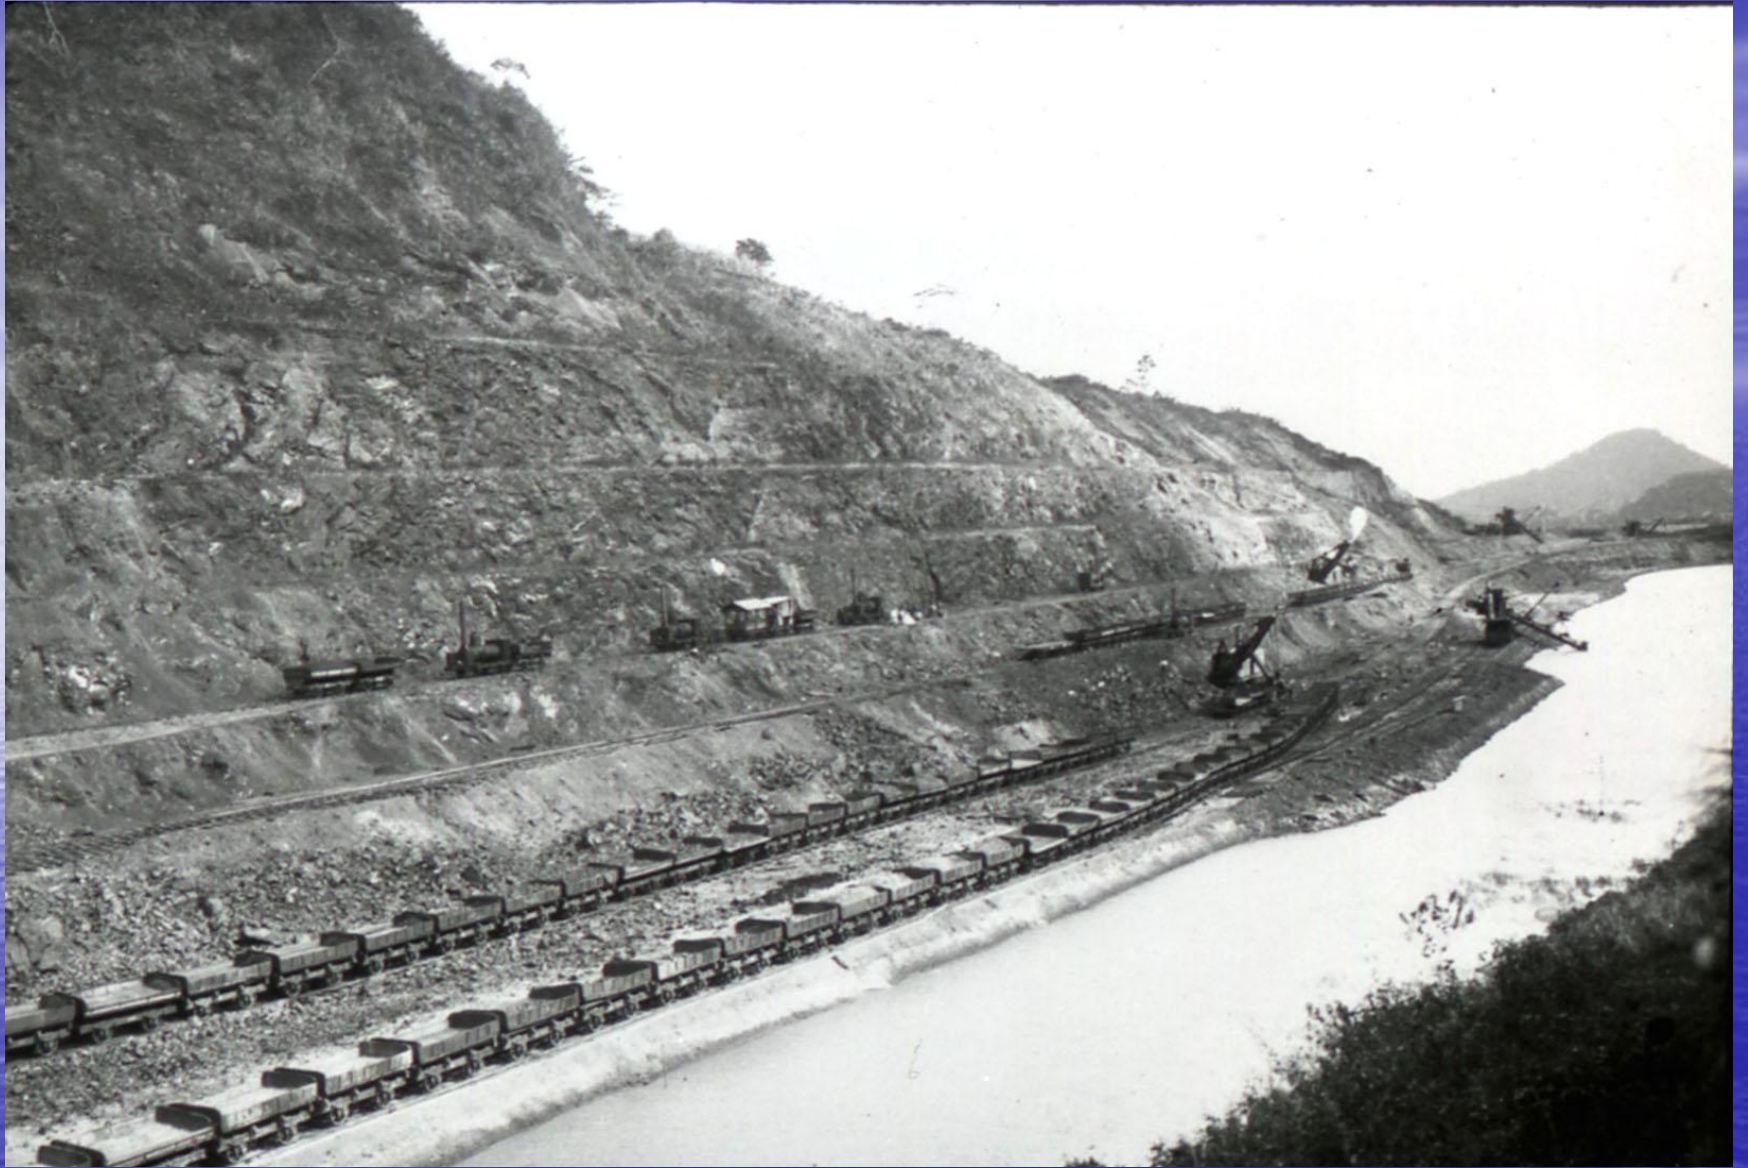
- **The massive cut at Gold Hill and Cucaracha, just before the first big slide**

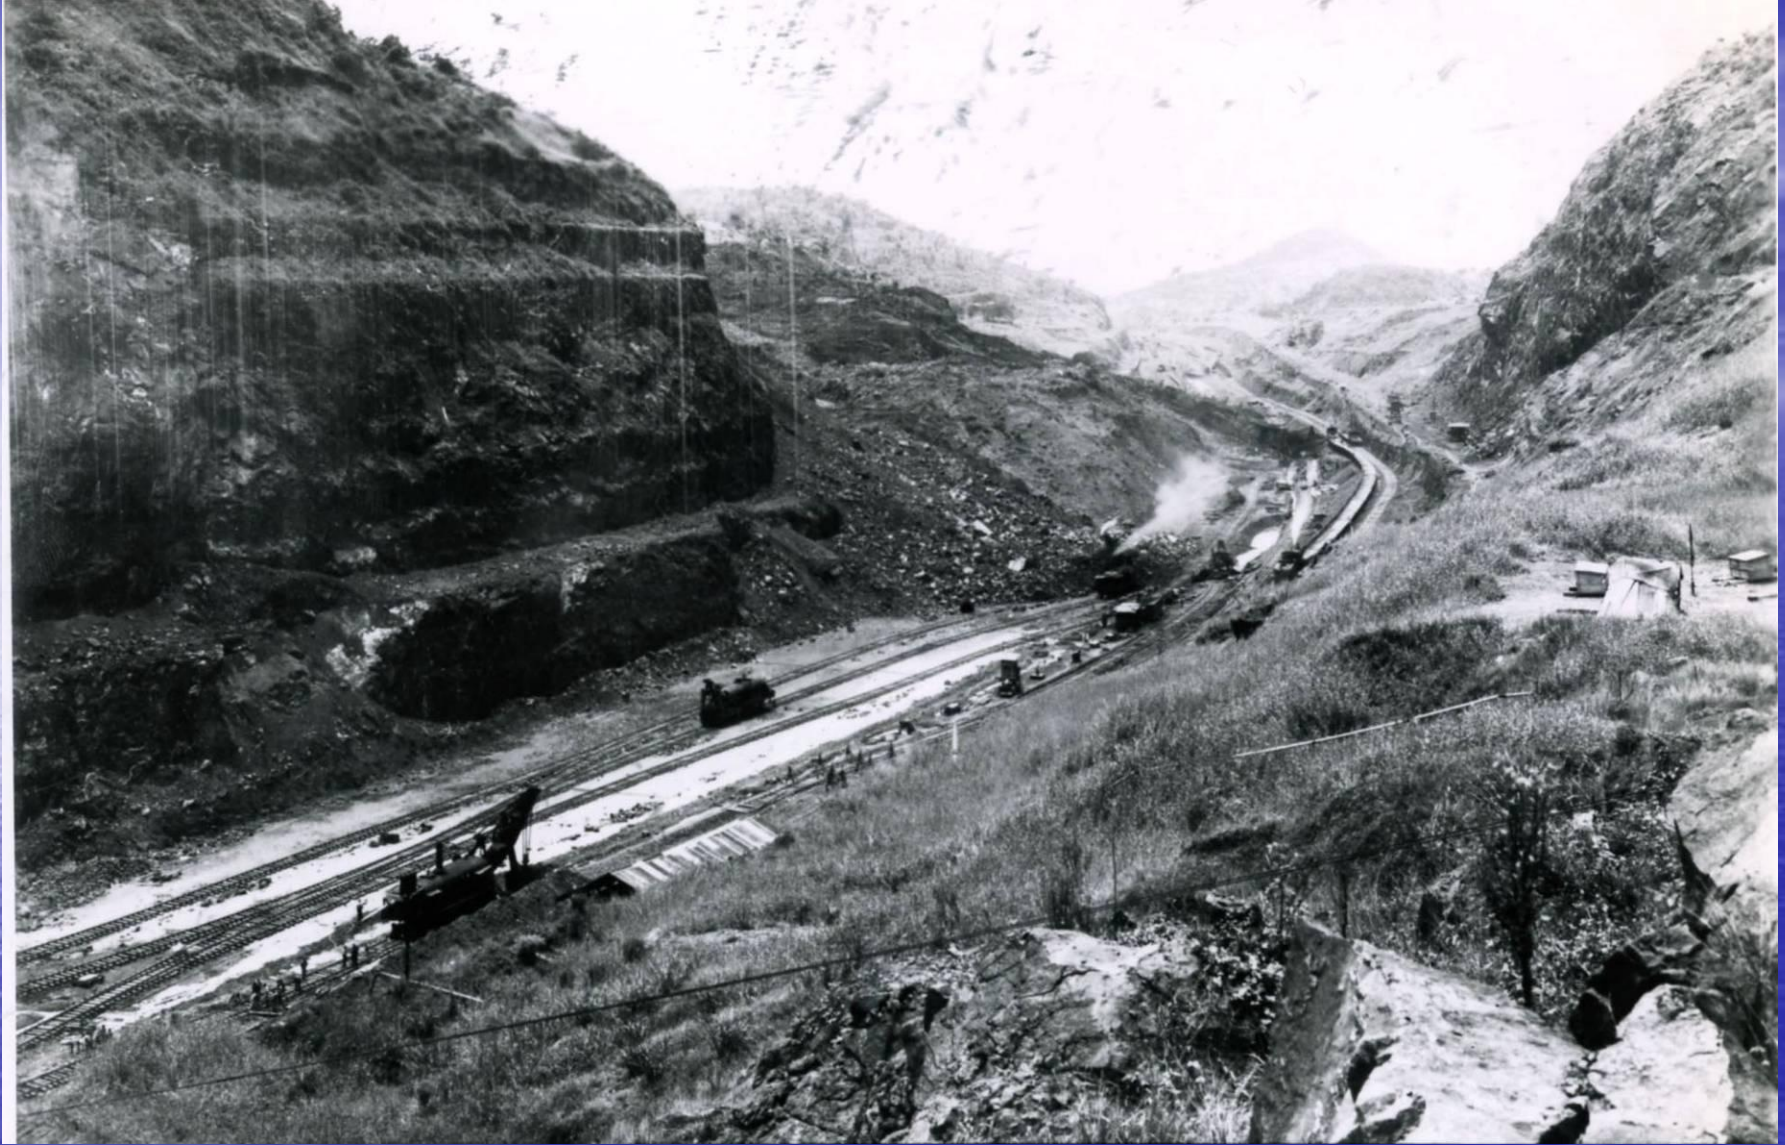
- **Excavating debris at the toe in the wake of the first massive slide at Cucaracha, on August 20, 1913.**

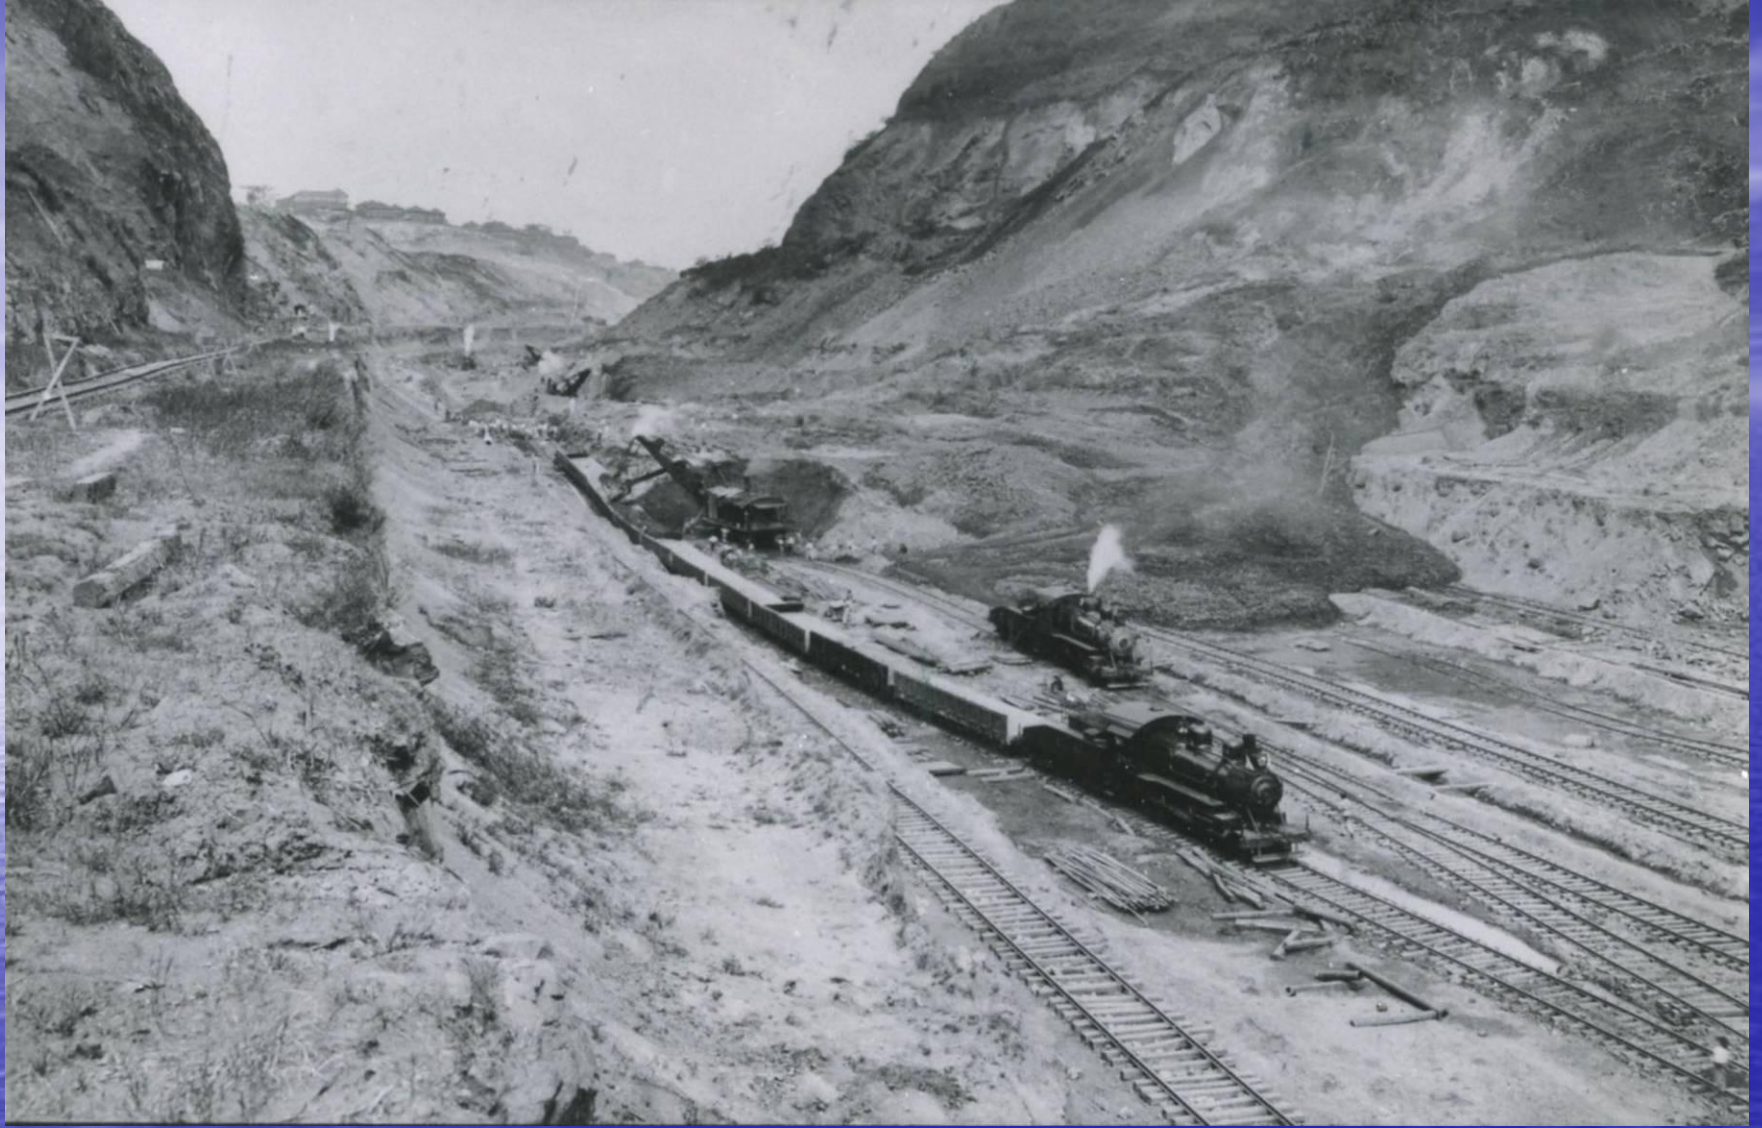
- **Flowage off the Cucaracha Landslide on February 2, 1913. A harbinger of what was to come...**

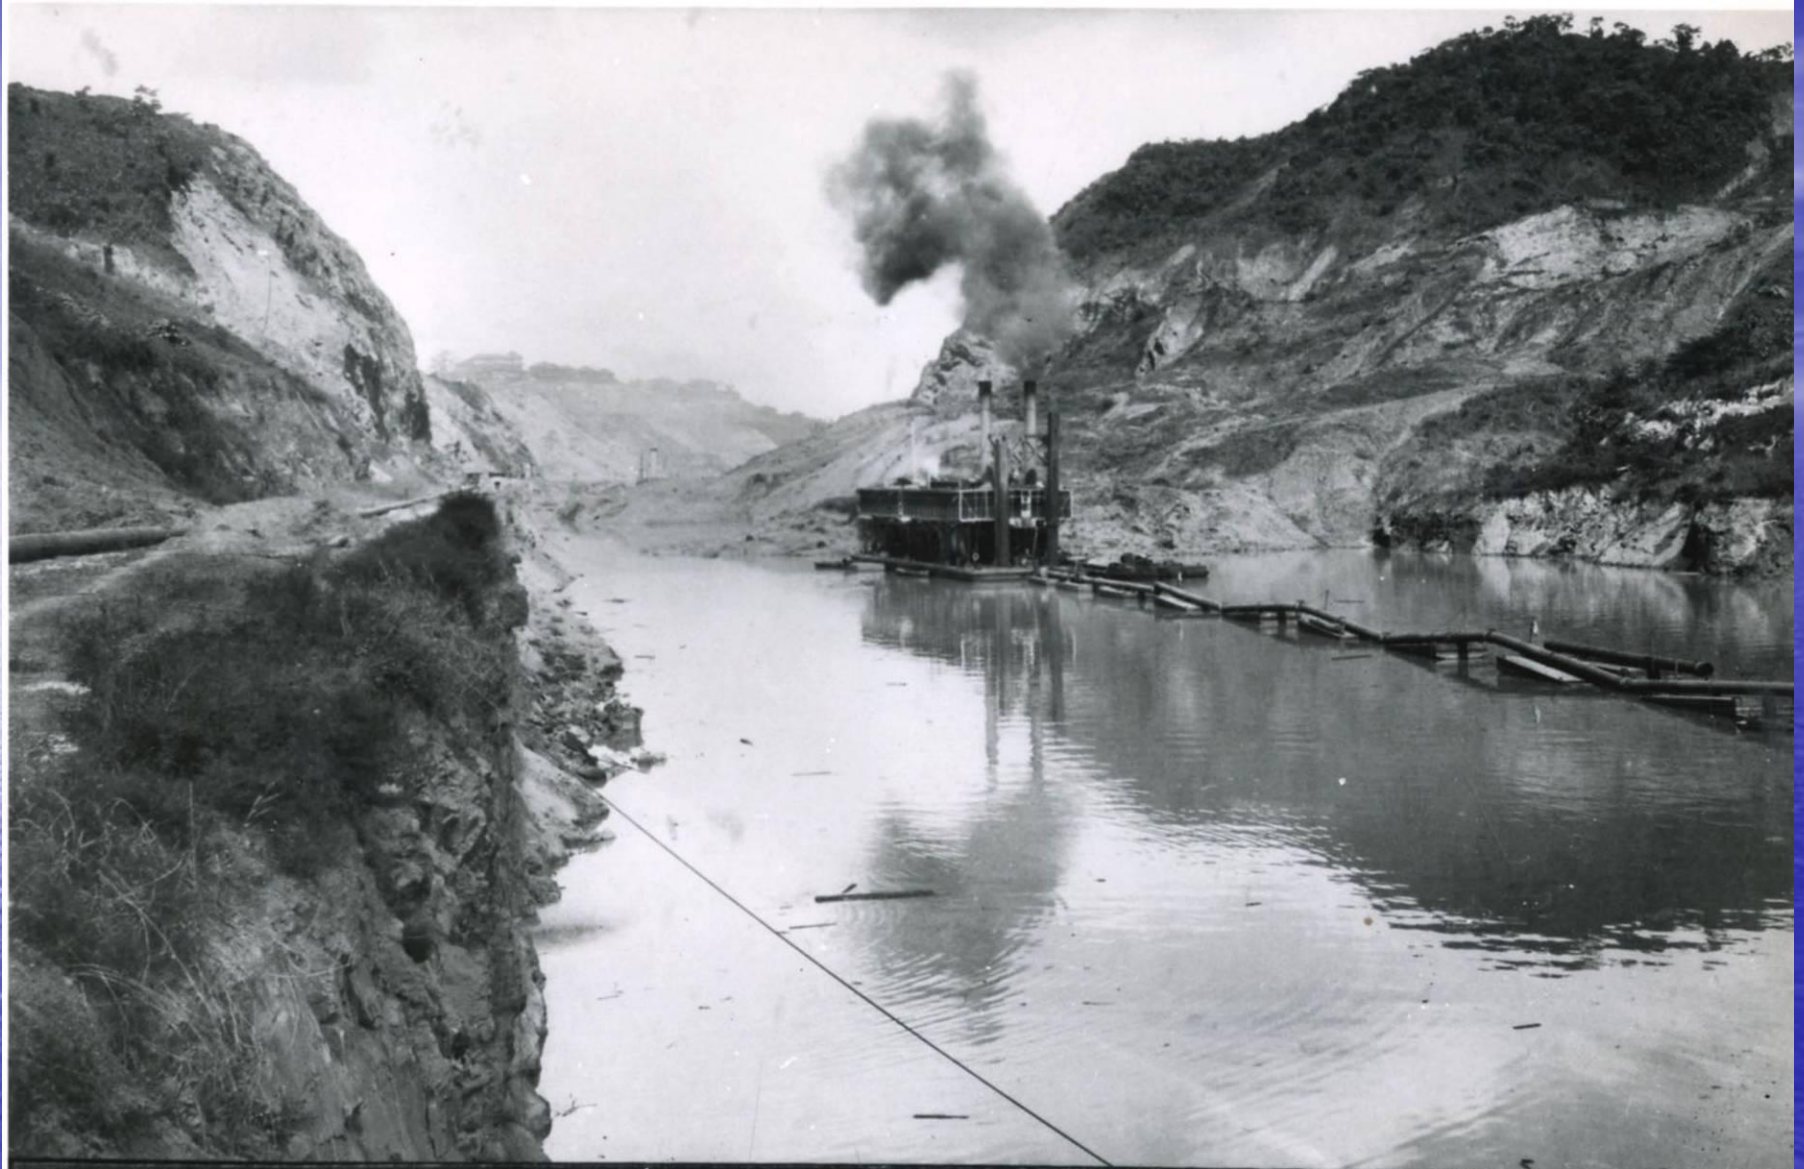
- **The south end of the canal is flooded as far as Cucaracha, October 28, 1913**

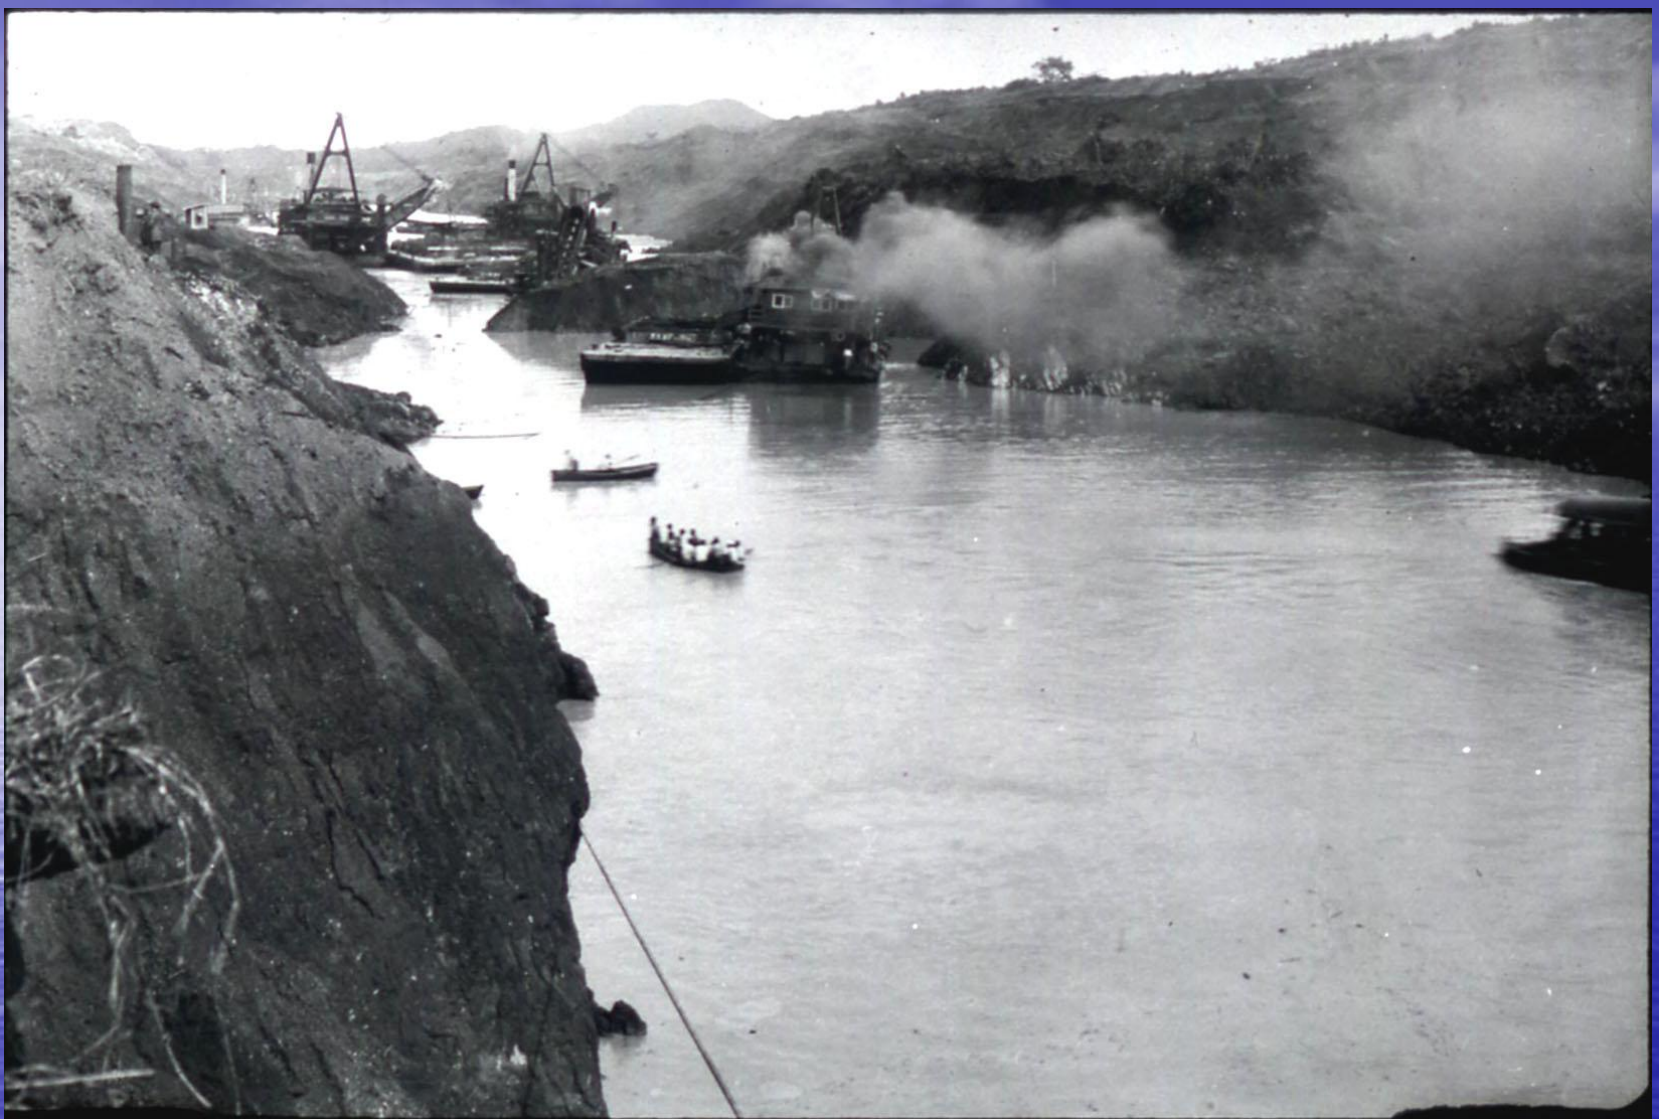
- **Colonel Goethals flooded the canal excavation across the Continental Divide to facilitate dredging and subaqueous excavation by shovels.**

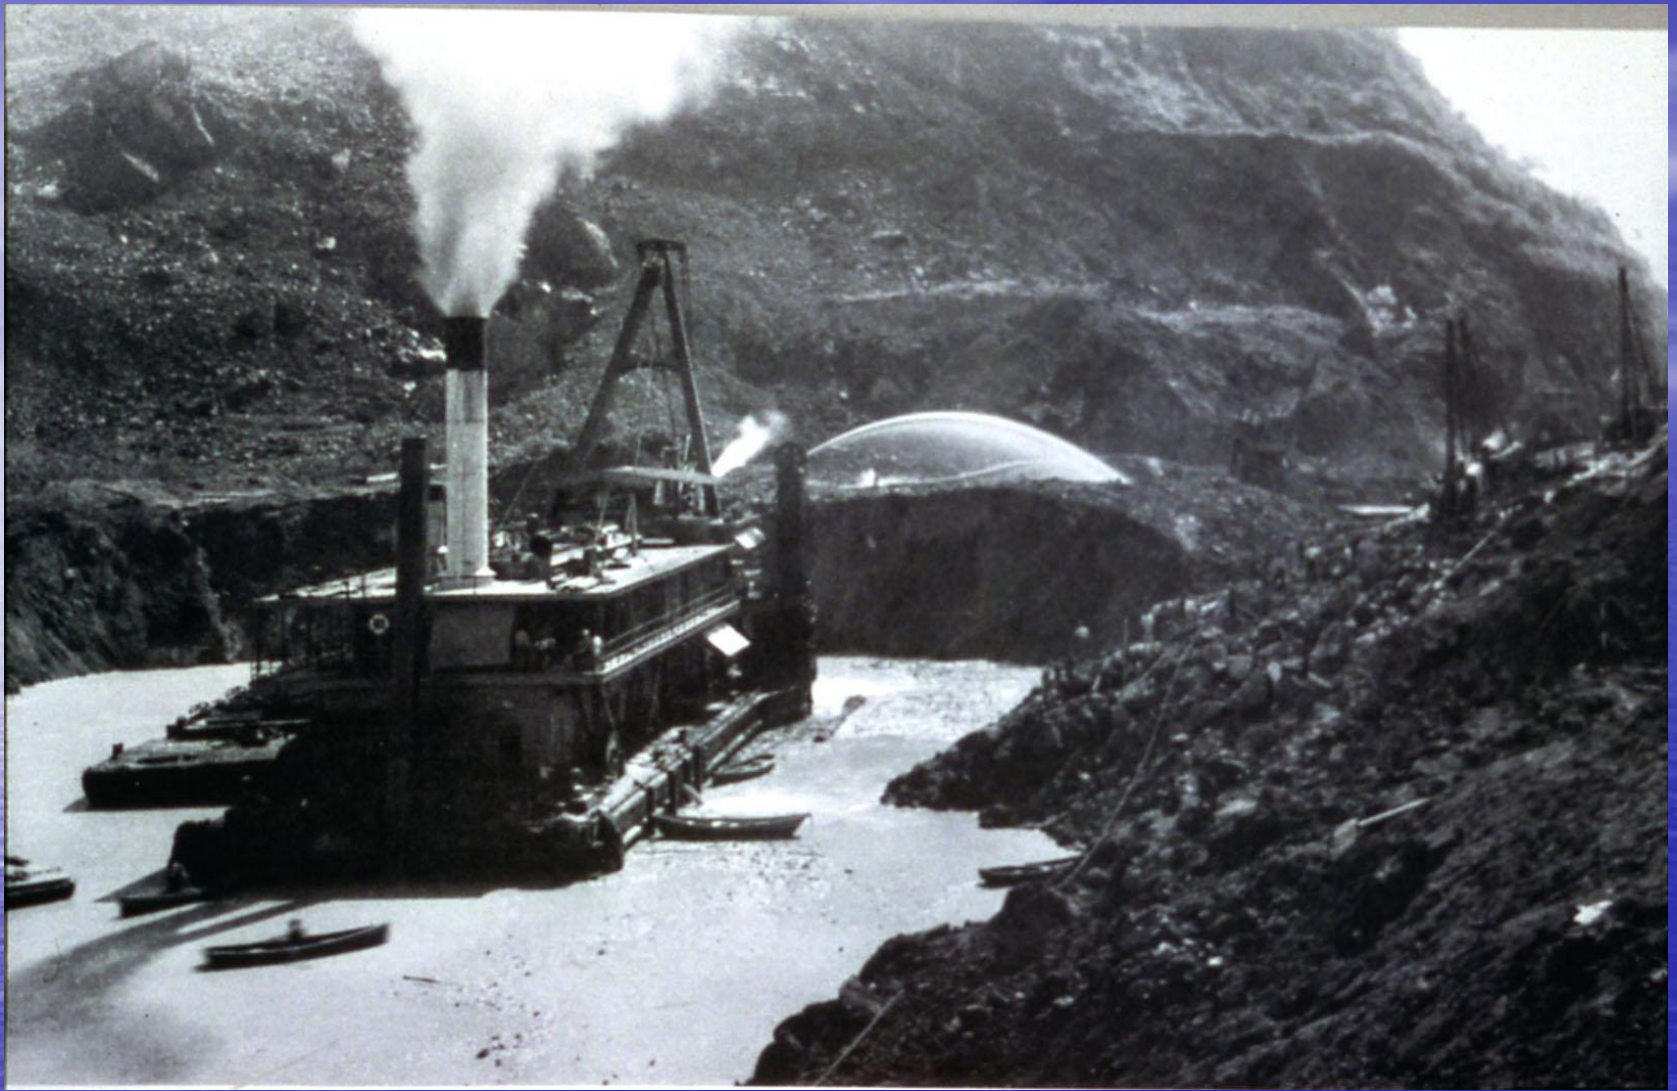
- **Shovel dredge working the face of the East Culebra Slide after the canal was flooded.**

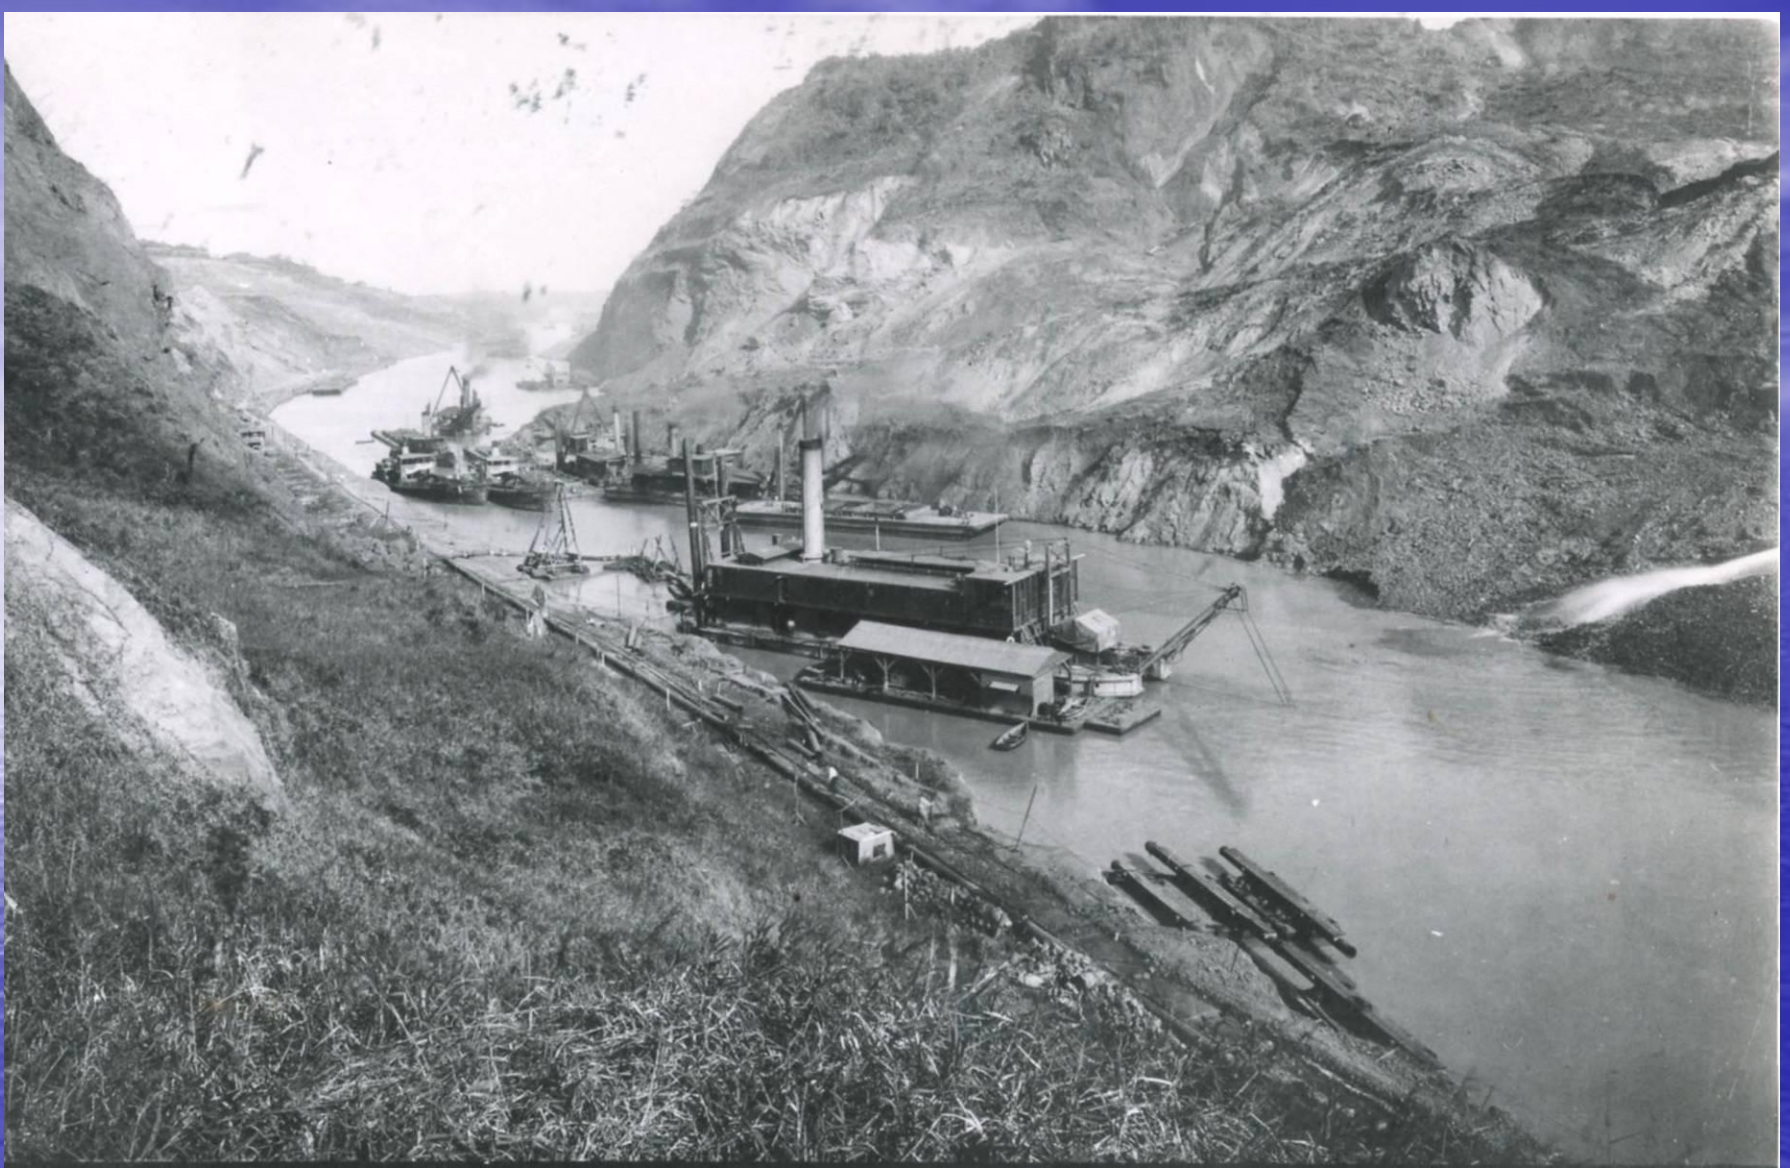
- **Fleet of suction dredges working the toe of the Cucaracha Slide - February 8, 1914**

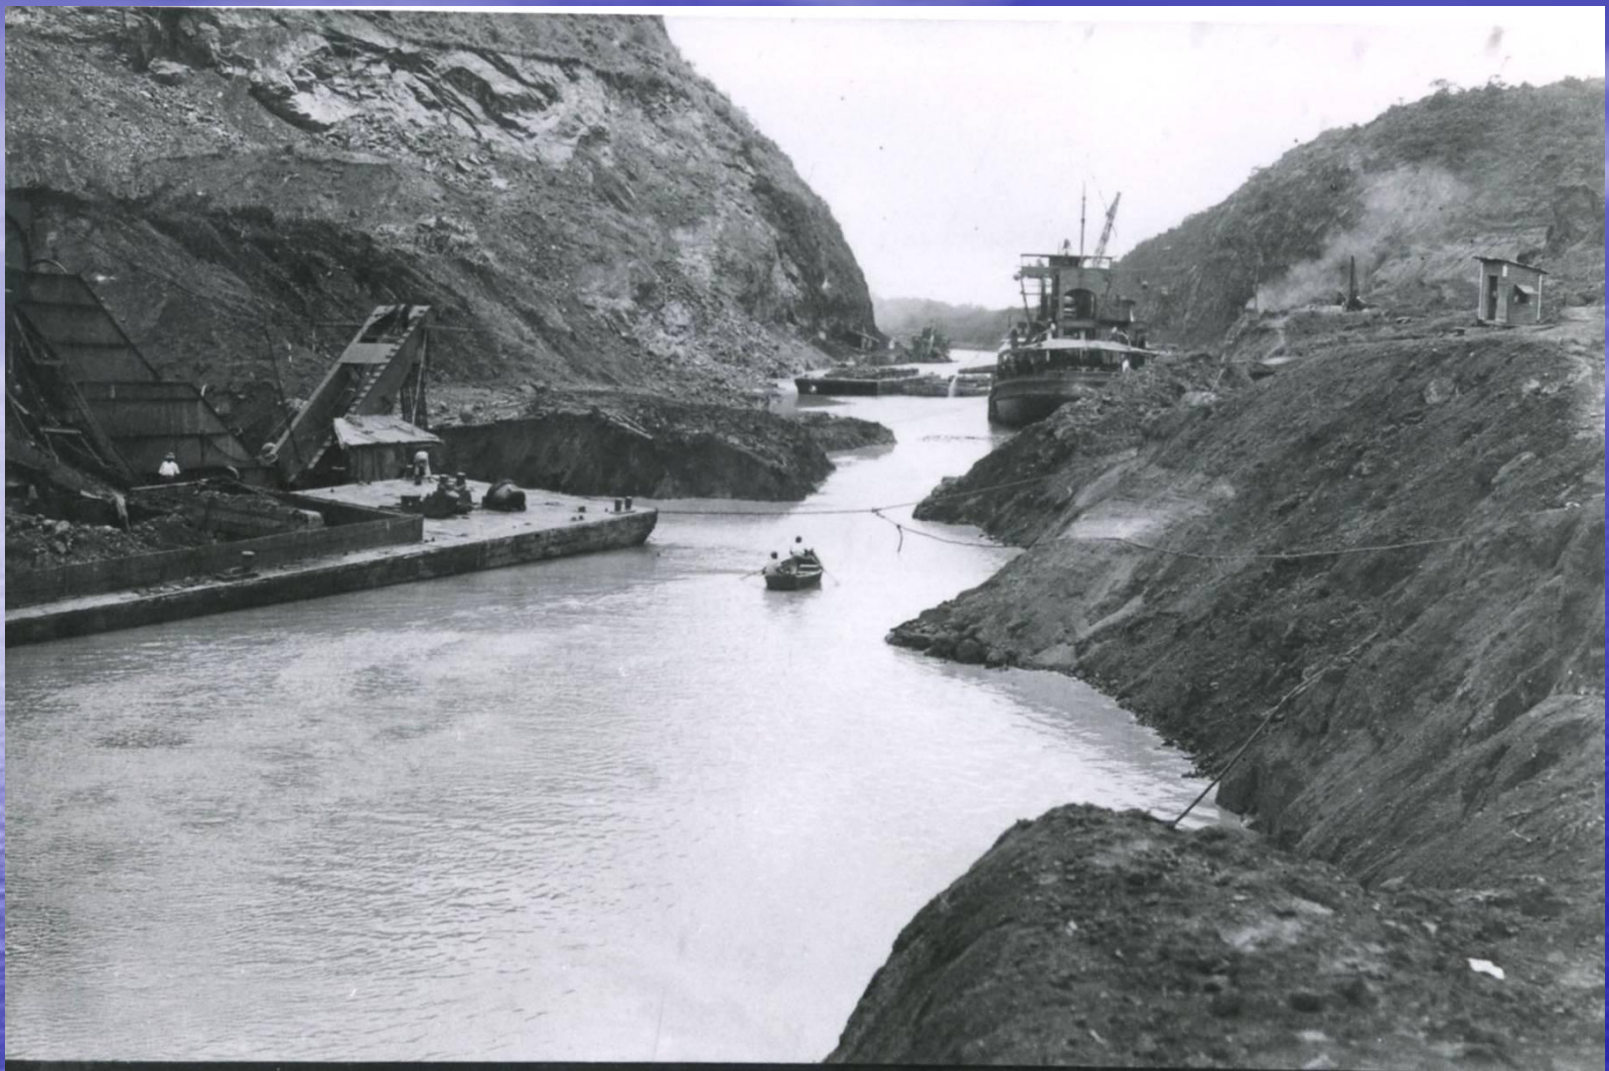
- Dredging the half-mile gap closed by landslides on September 18, 1915, which required excavation of 10 million cubic yards of slide debris over 9 months. This closure triggered the appointment of a commission drawn from the **National Academy of Sciences**, which reported to President Woodrow Wilson.

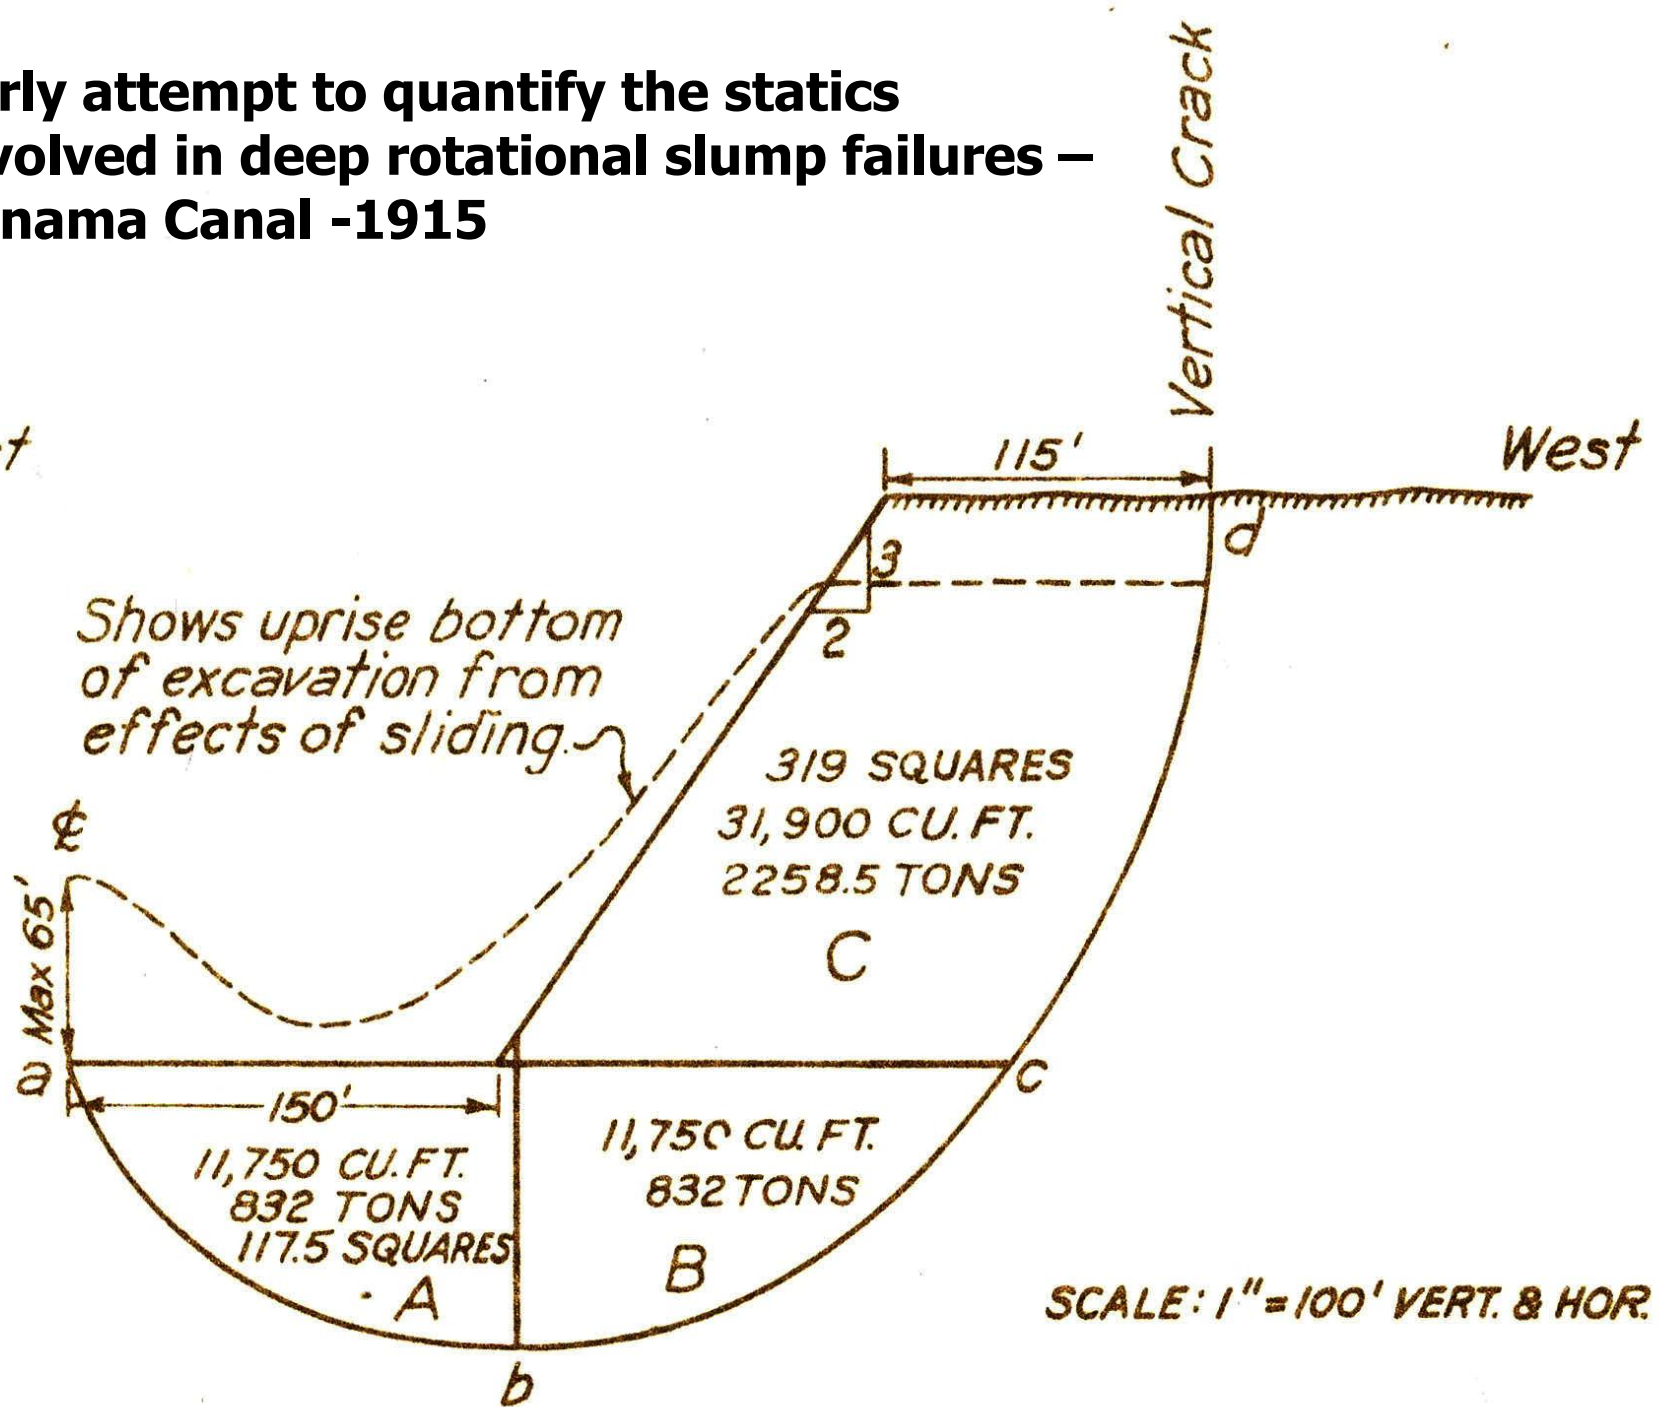
# Early attempt to quantify the statics involved in deep rotational slump failures – Panama Canal -1915

East

West

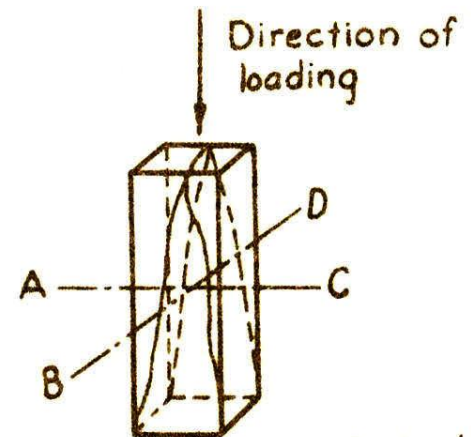
Diagram showing principal lines of rupture

Sample No. 11113-Y  
 Ultimate load, 490 lbs. per sq. in.  
 Elastic limit, 380 " " " "  
 Modulus of elasticity 165000.

- Early compressive strength tests on the Culebra formation

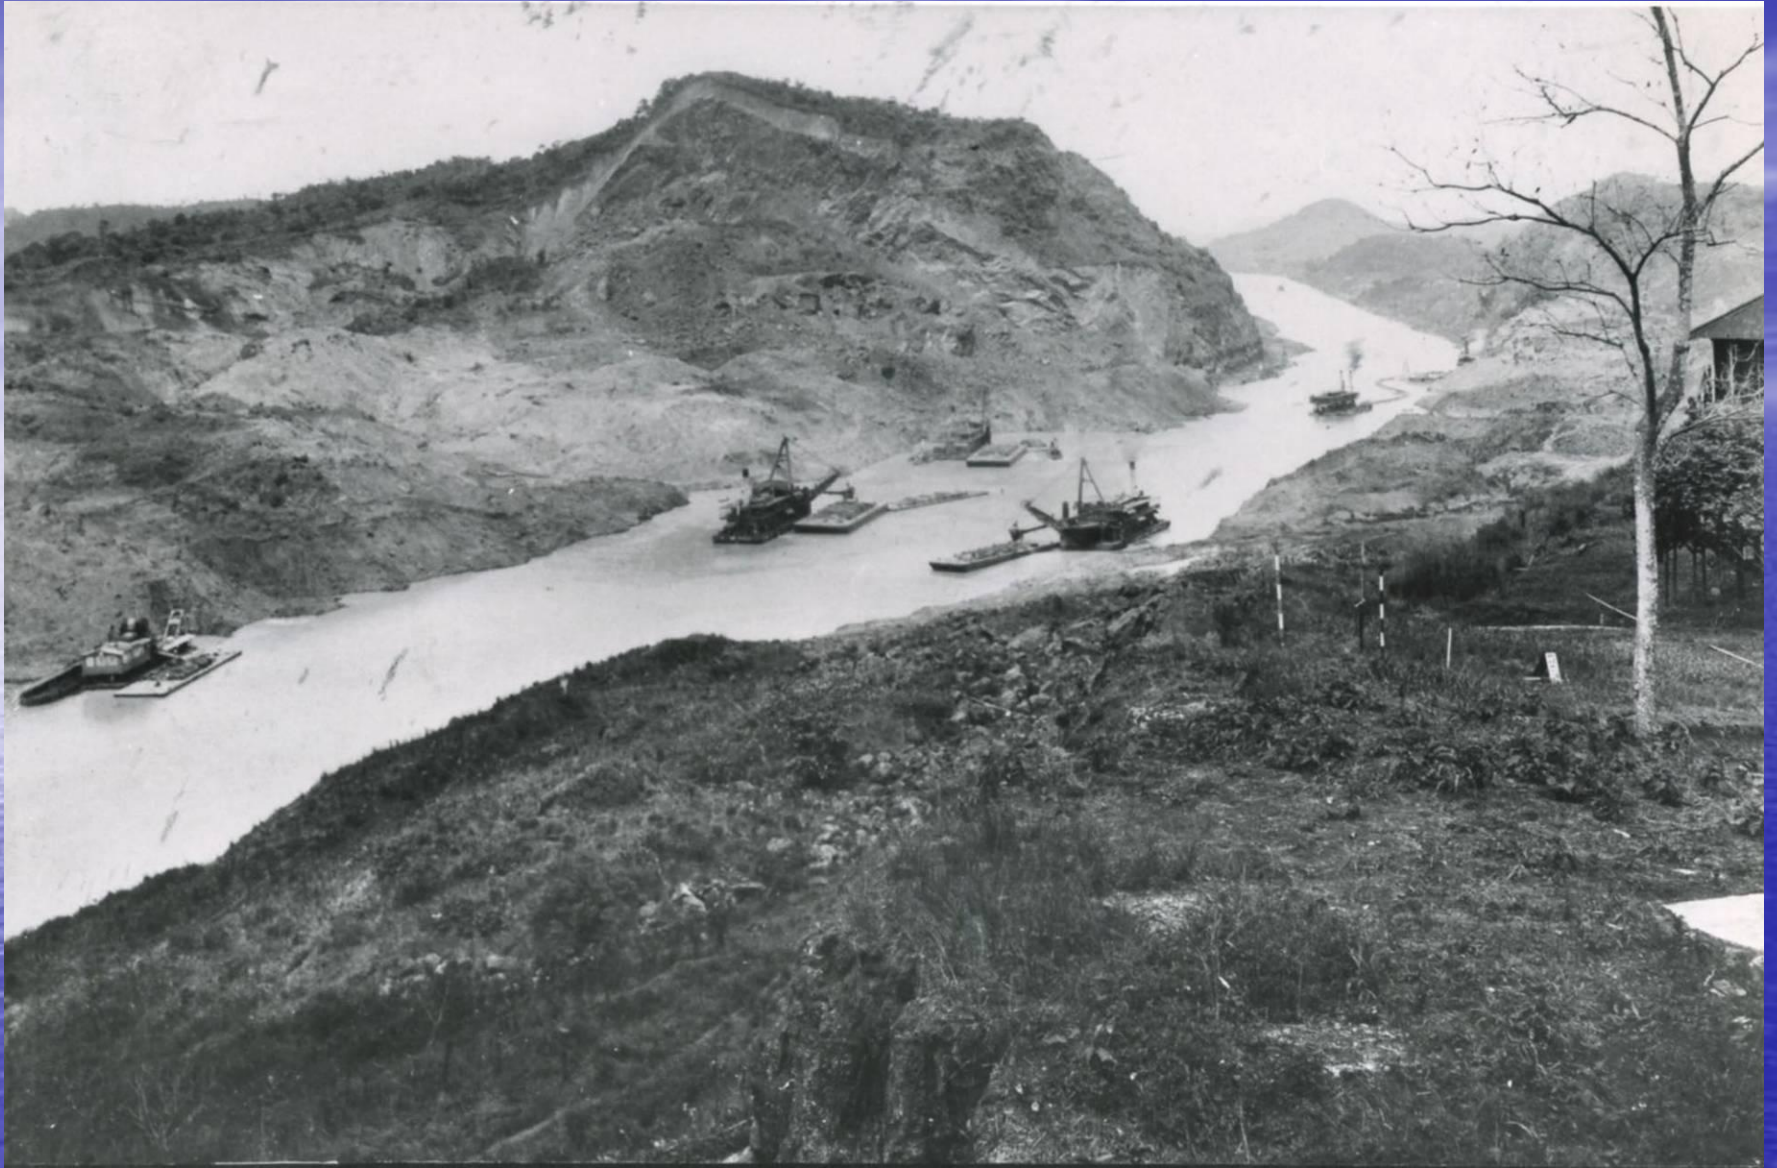
- **Barge shovels and suction dredges working the toe of the East Culebra Slide on July 3, 1916**
