# **LANDSLIDES of the PANAMA CANAL**

**J. David Rogers, Ph.D., P.E., P.G.**

**2011 Pacific Section Meeting**

**American Association for the Advancement of Science  
San Diego, California  
June 13, 2011**

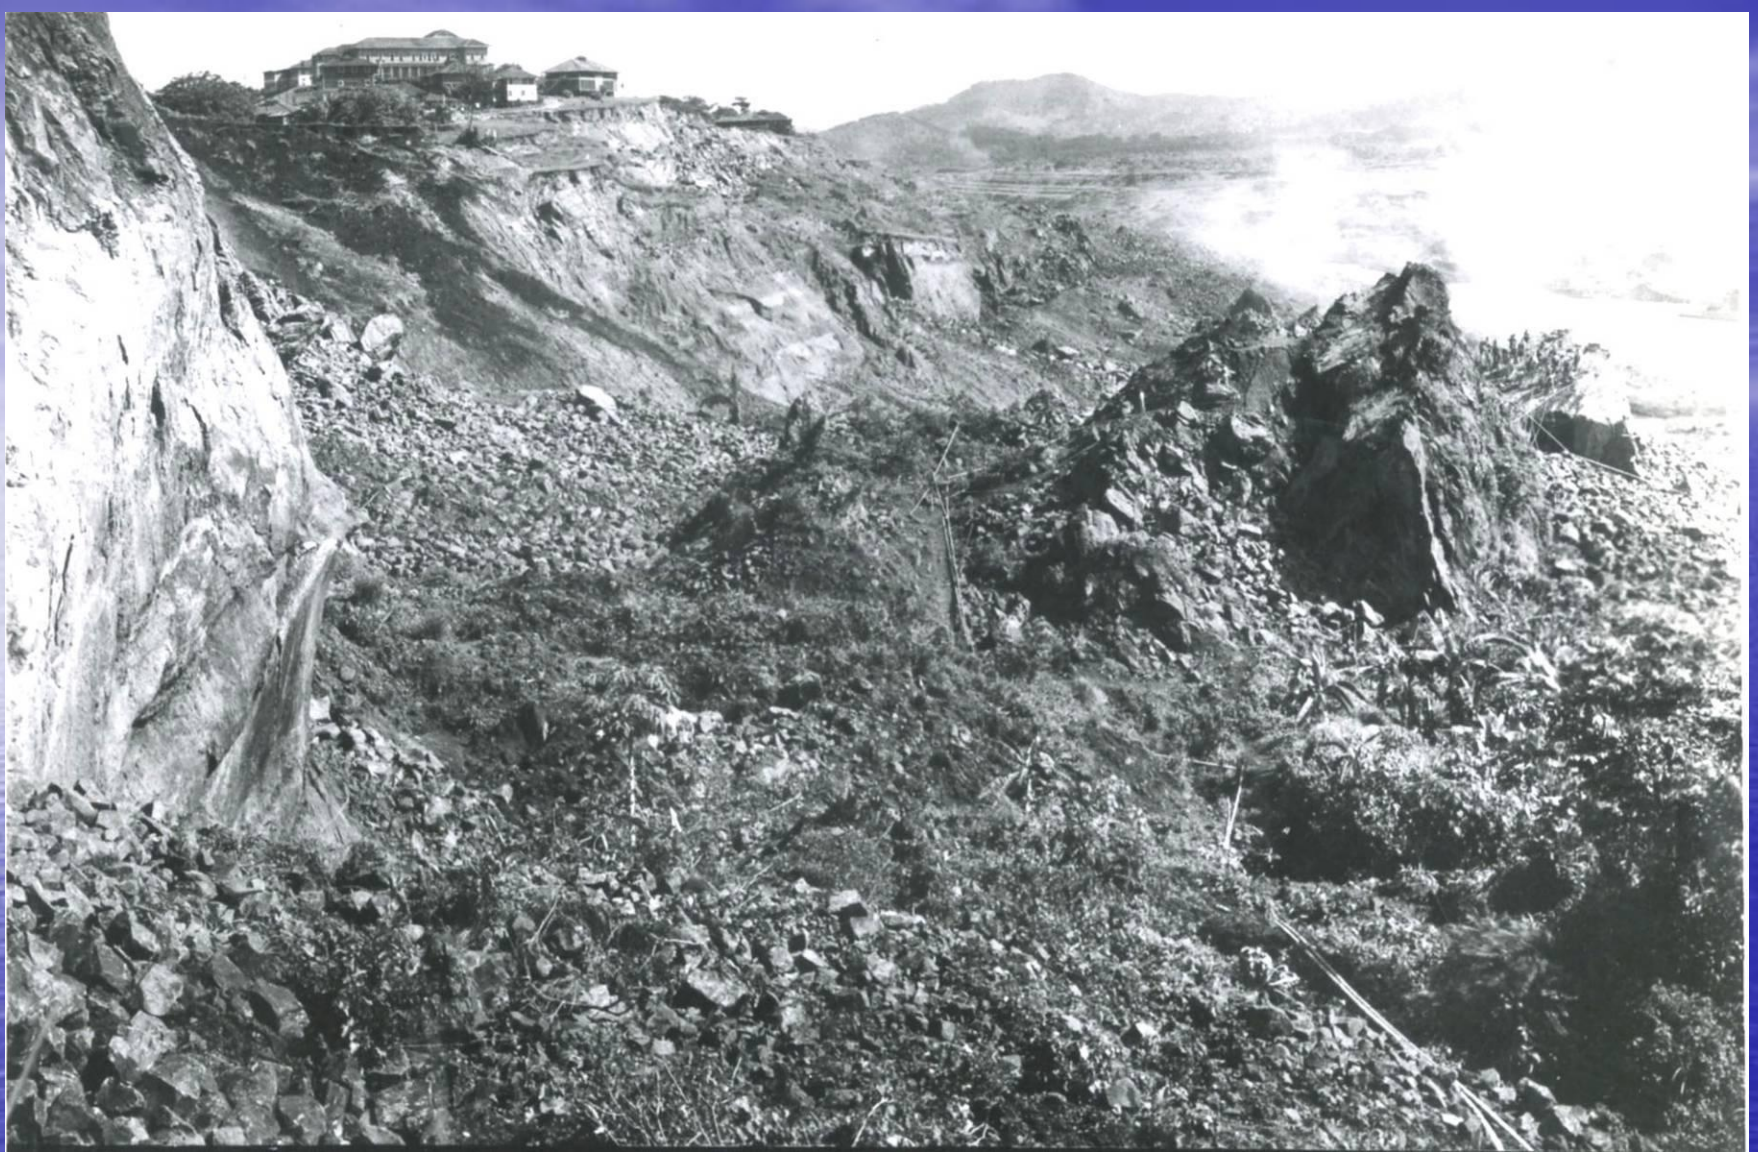
- **West Culebra slide activity viewed on July 3, 1916. Note emergence of 'Culebra Heights' in background.**

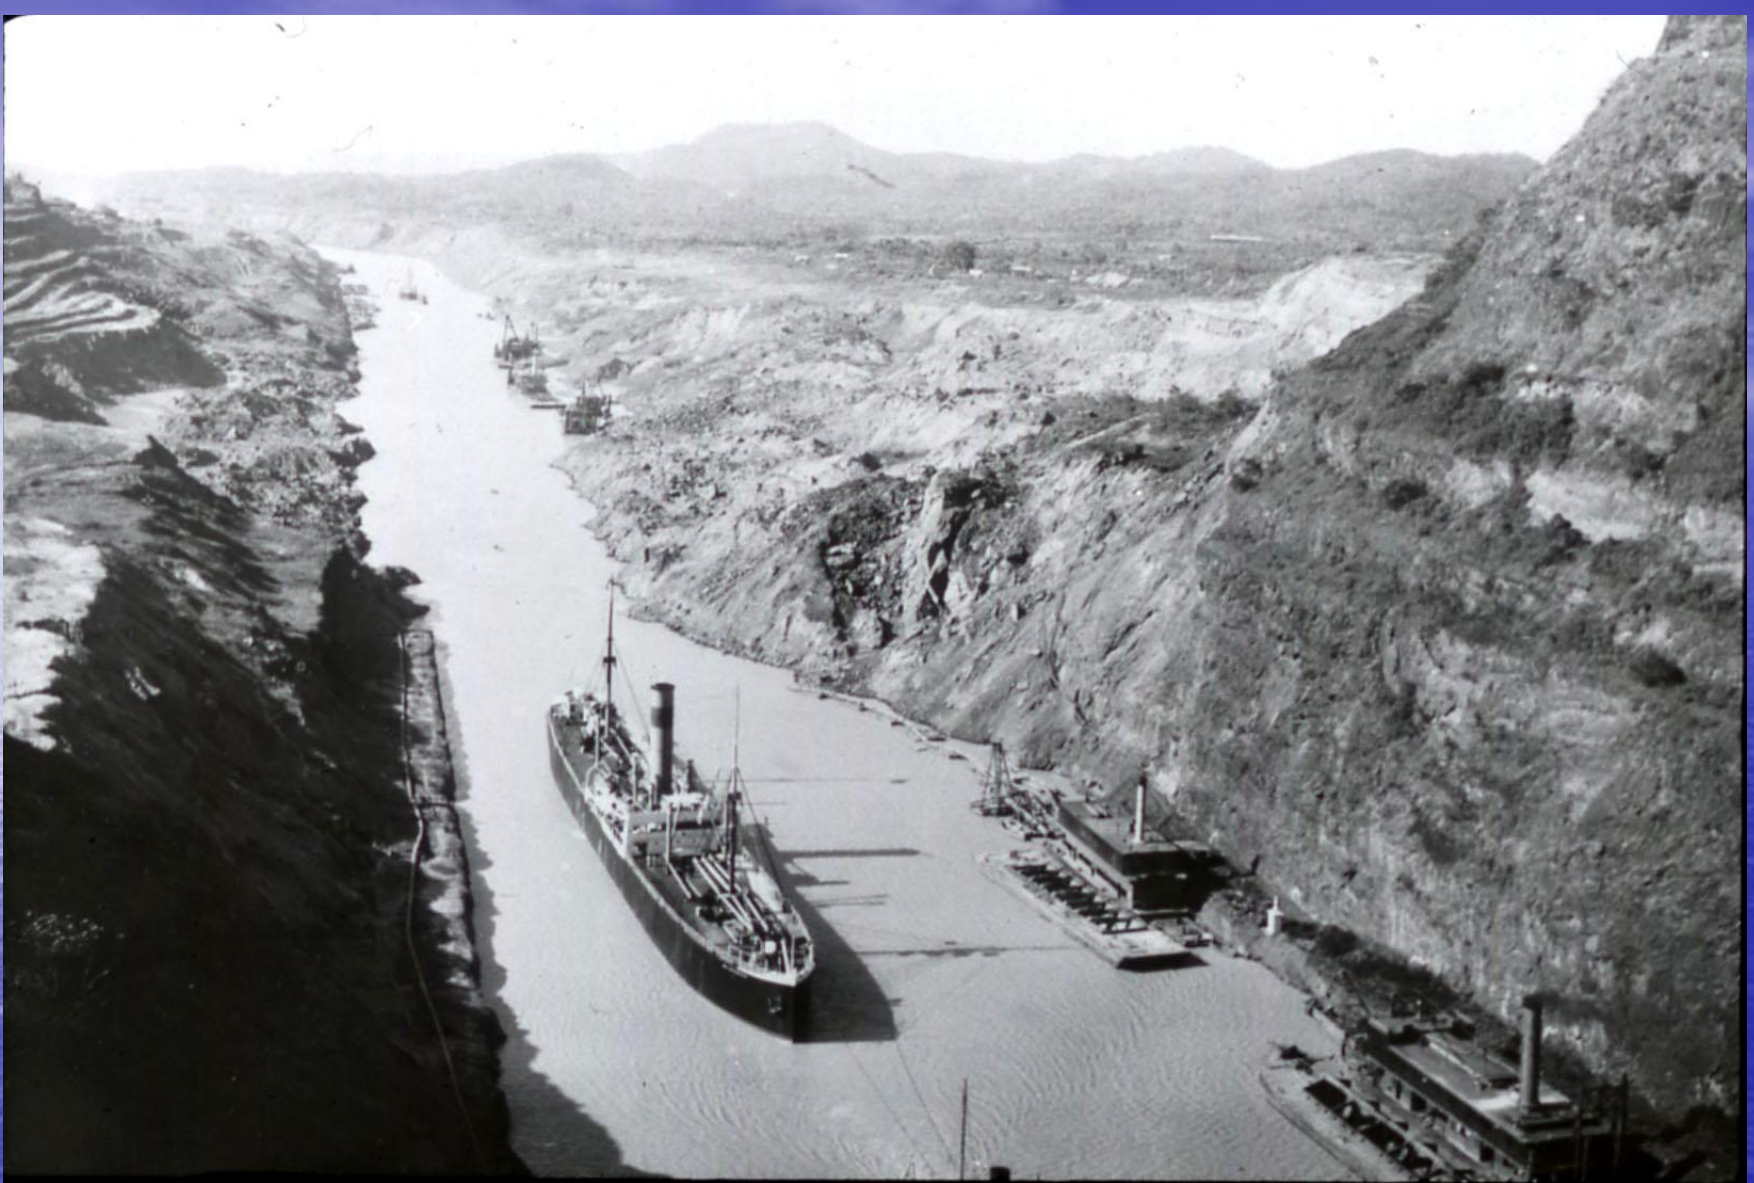
- **Ship transiting canal around the East Culebra Slide. Note dredges and muck barges**

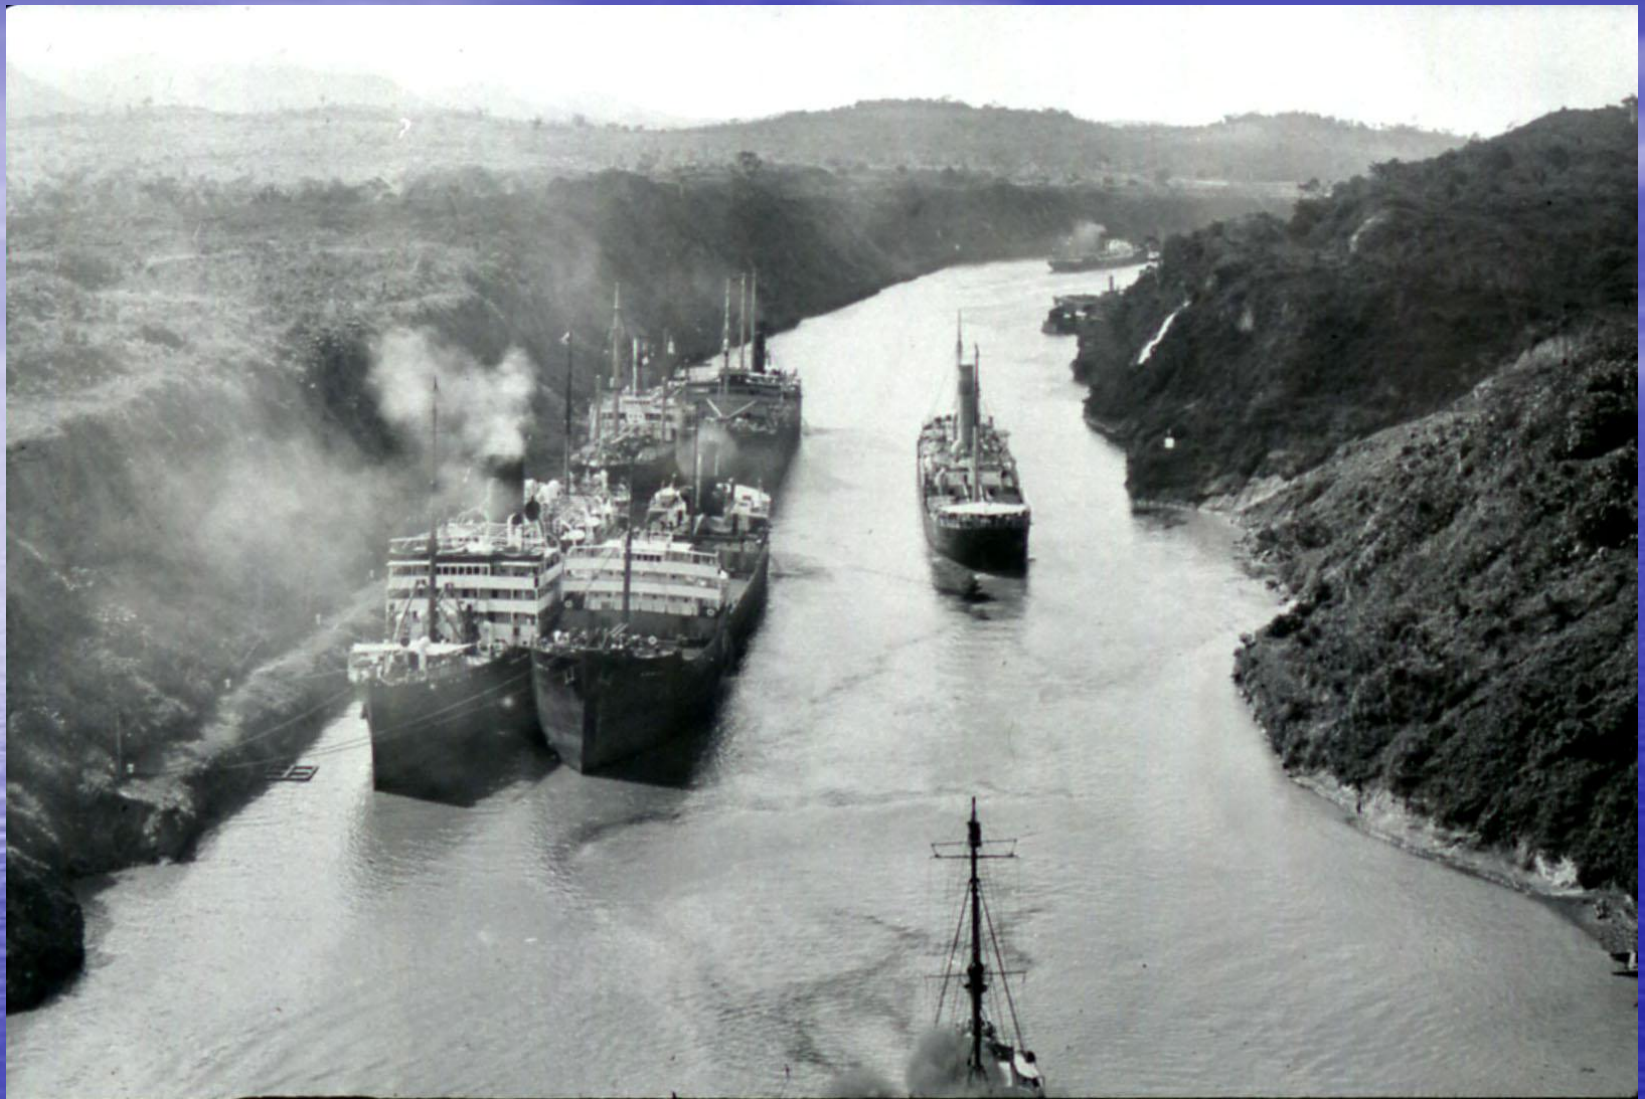
- **When landslides partially blocked the channel, ships were queued up on either side of the construction and escorted through the gap.**

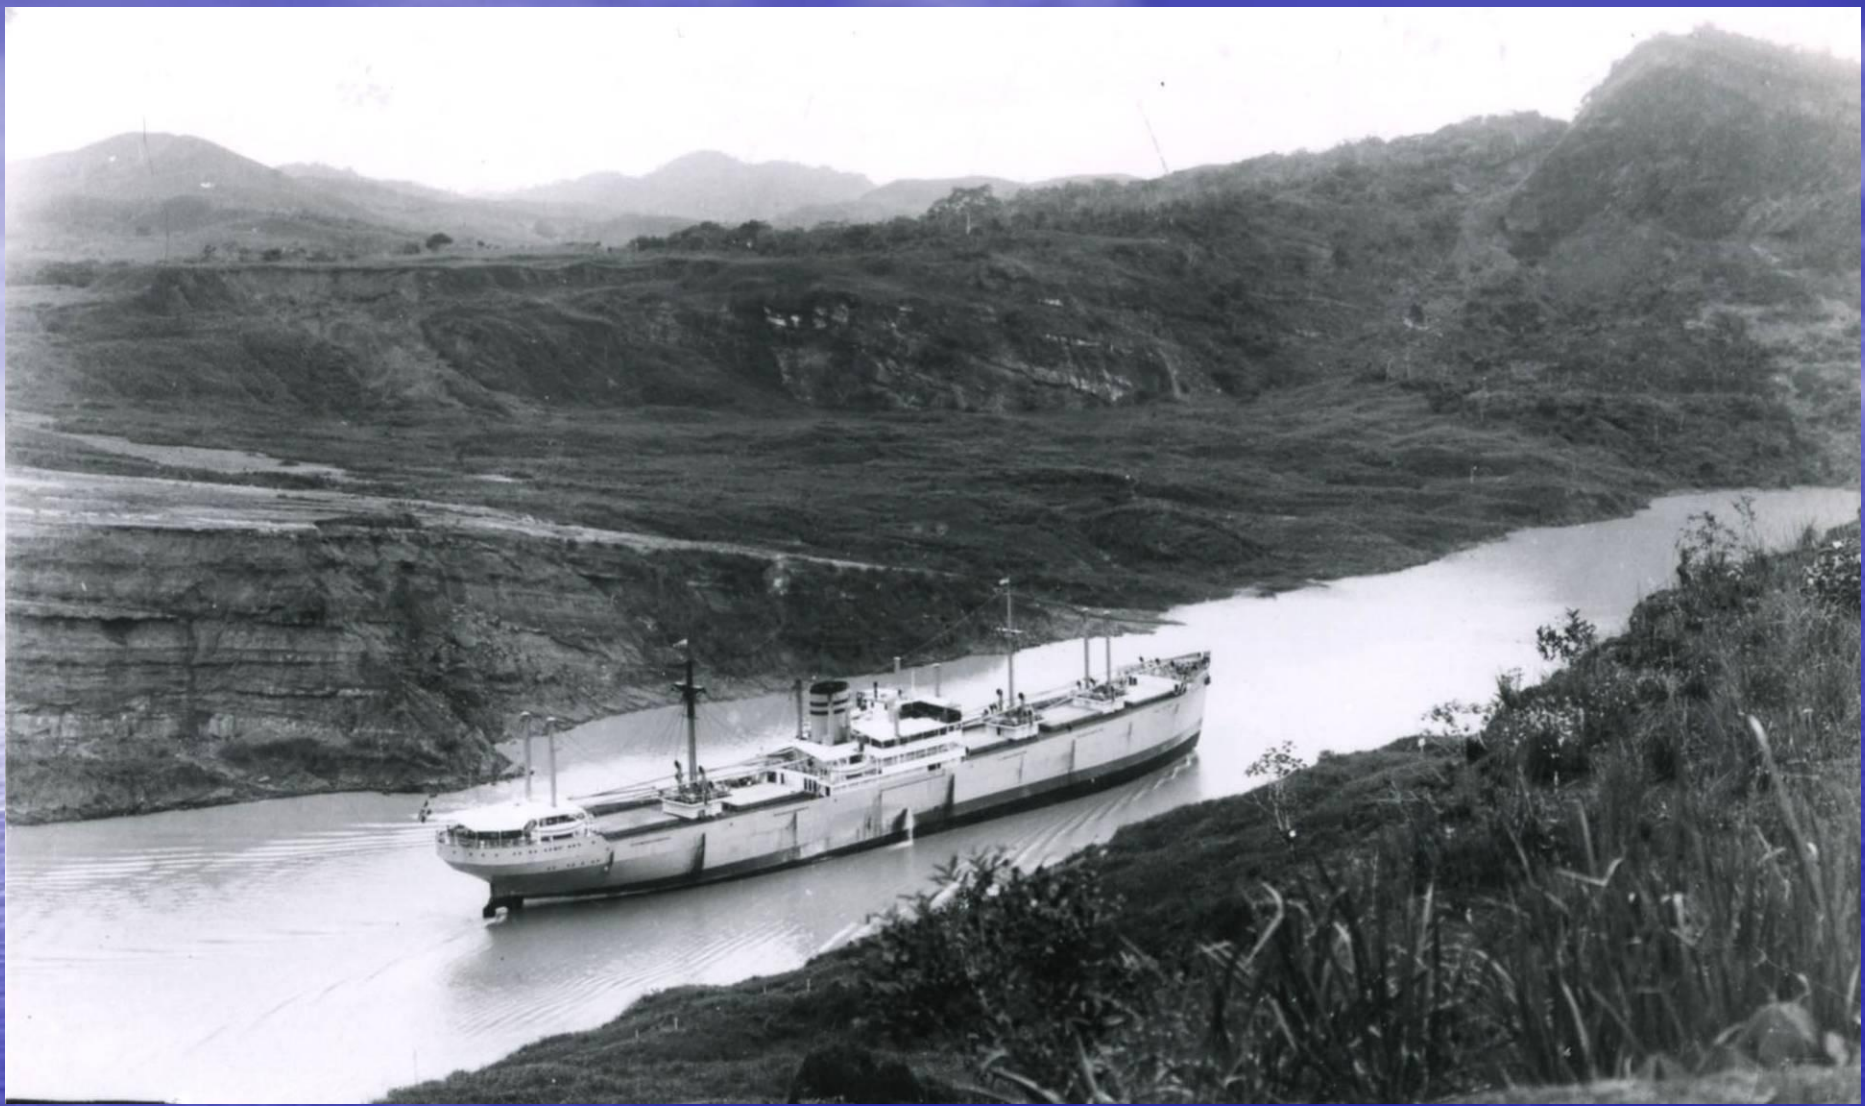
- **Still running one-way traffic on June 13, 1933-  
passing the dormant East Culebra Slide**

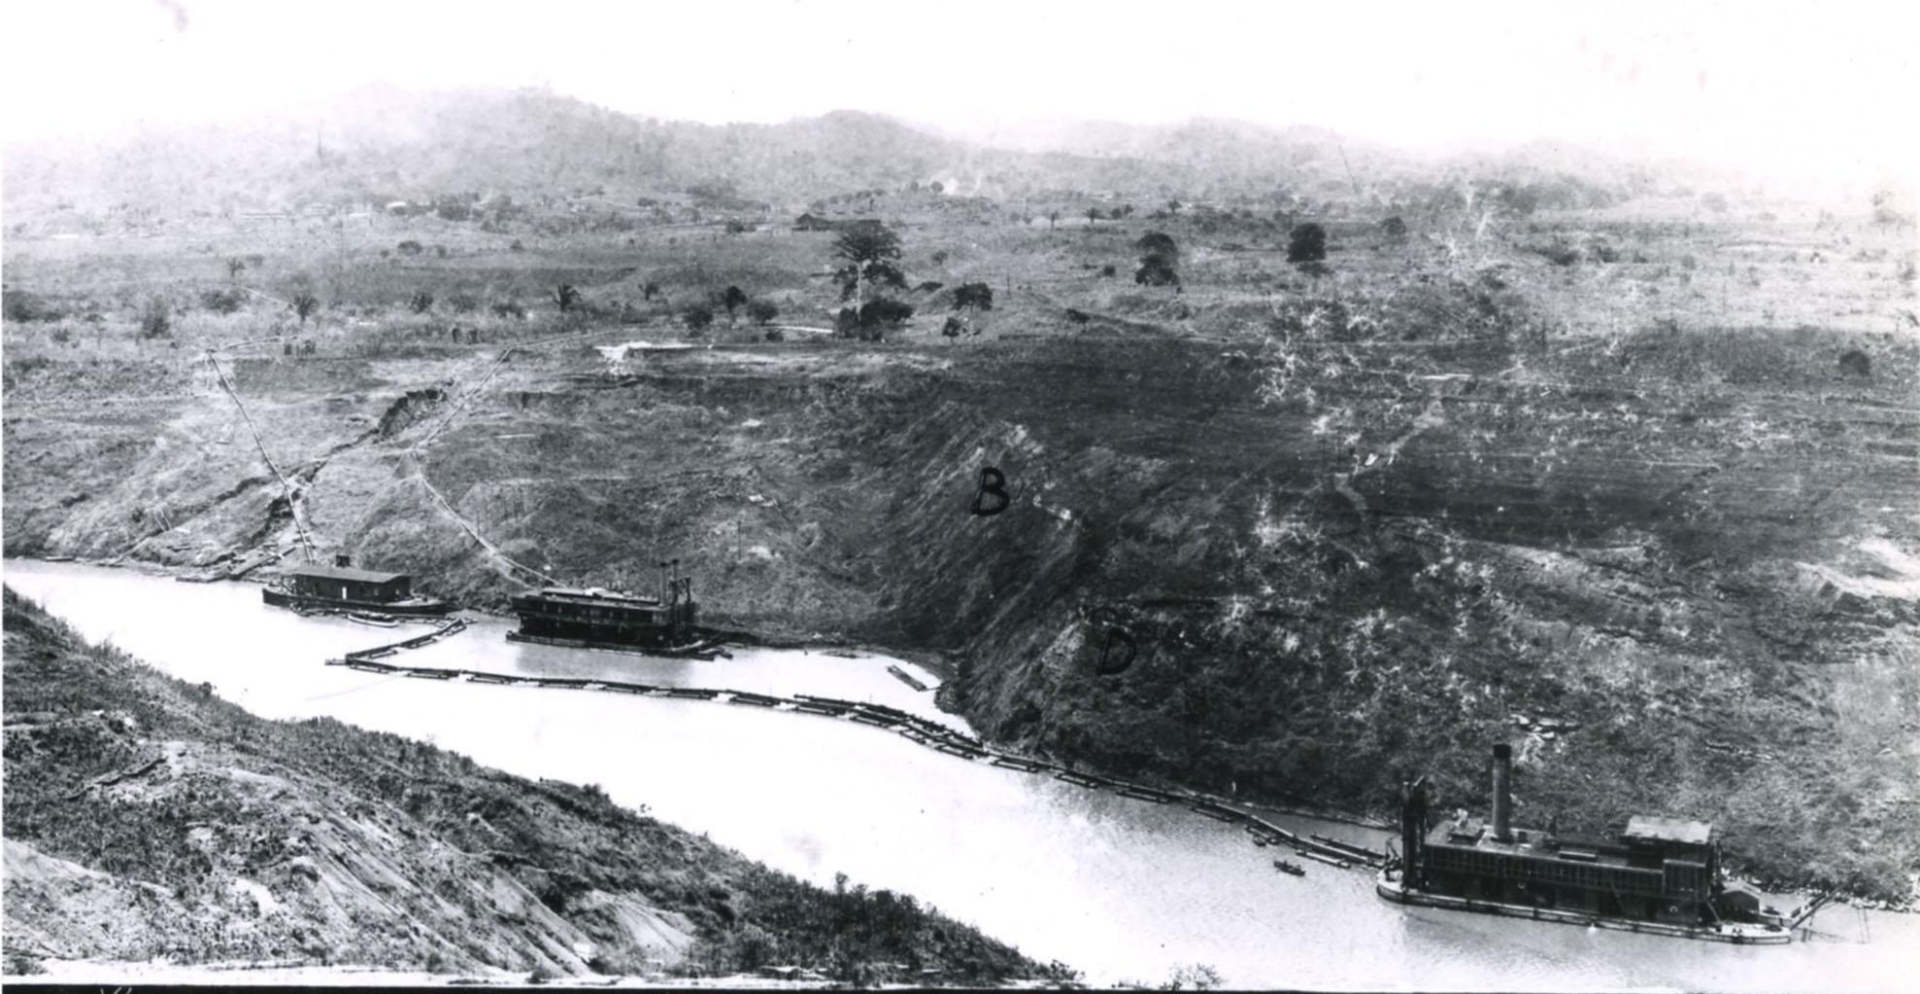
- **Dredges continue to work the zone between Obispo and East Culebra on April 25, 1924, ten years after the canal opened**

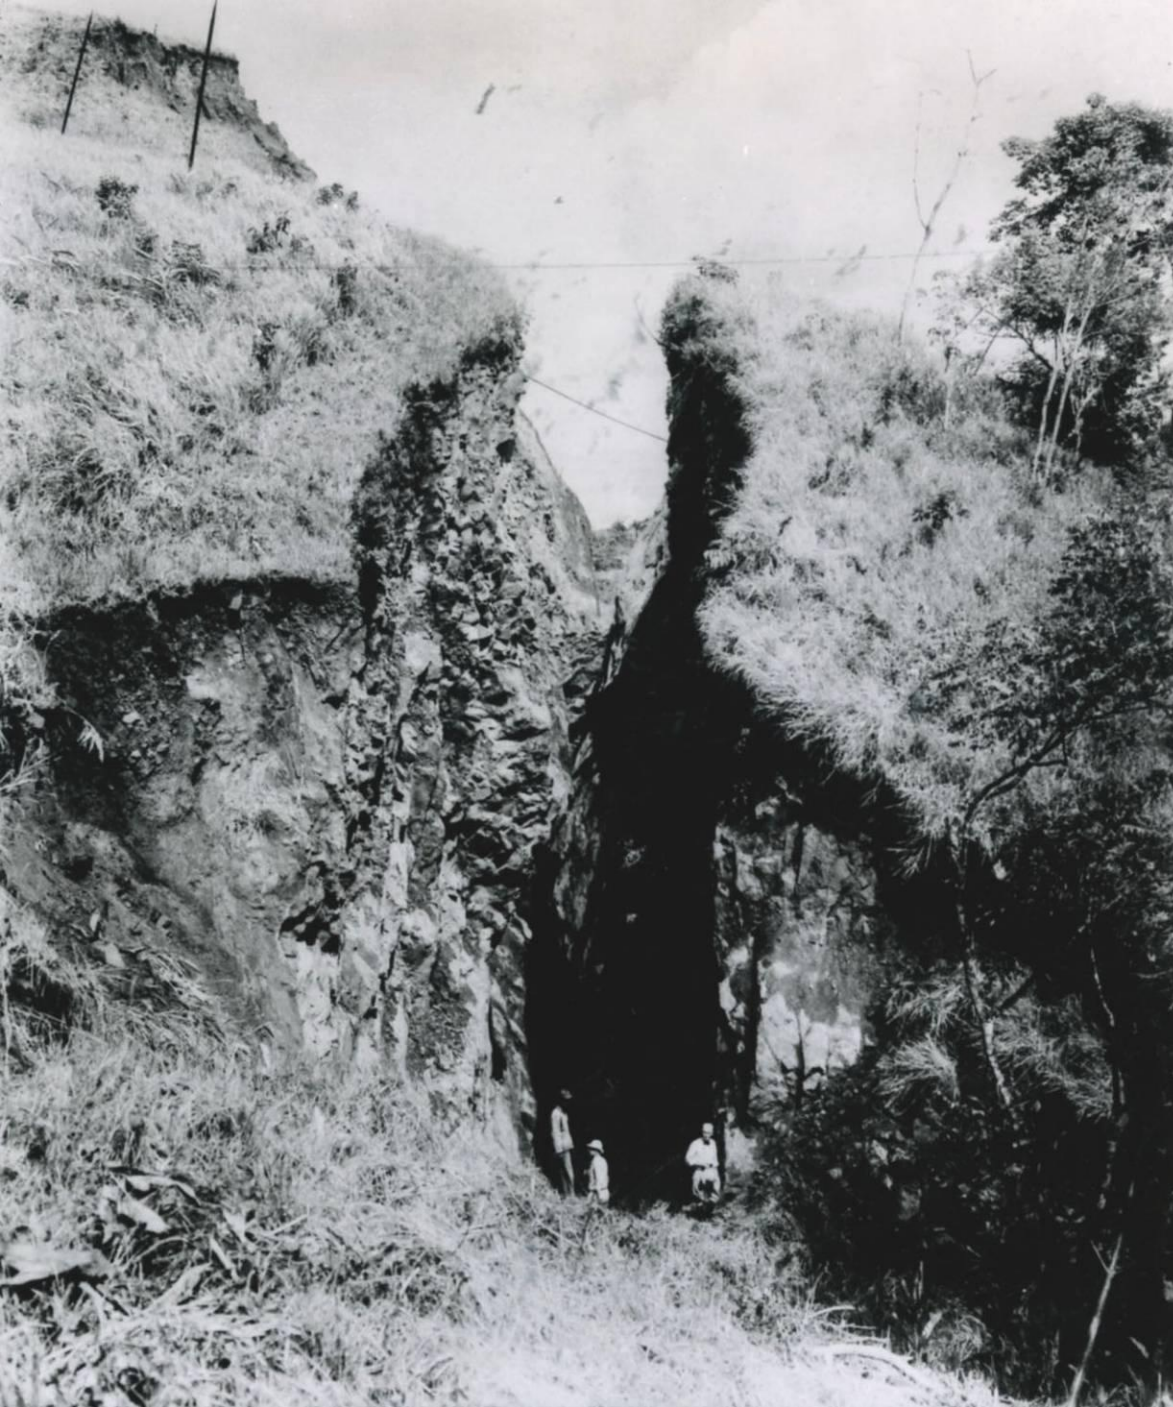
# Tensile scarps

- **Massive  
tension crack  
opening above  
the West  
Culebra  
Landslide on  
October 22,  
1936**

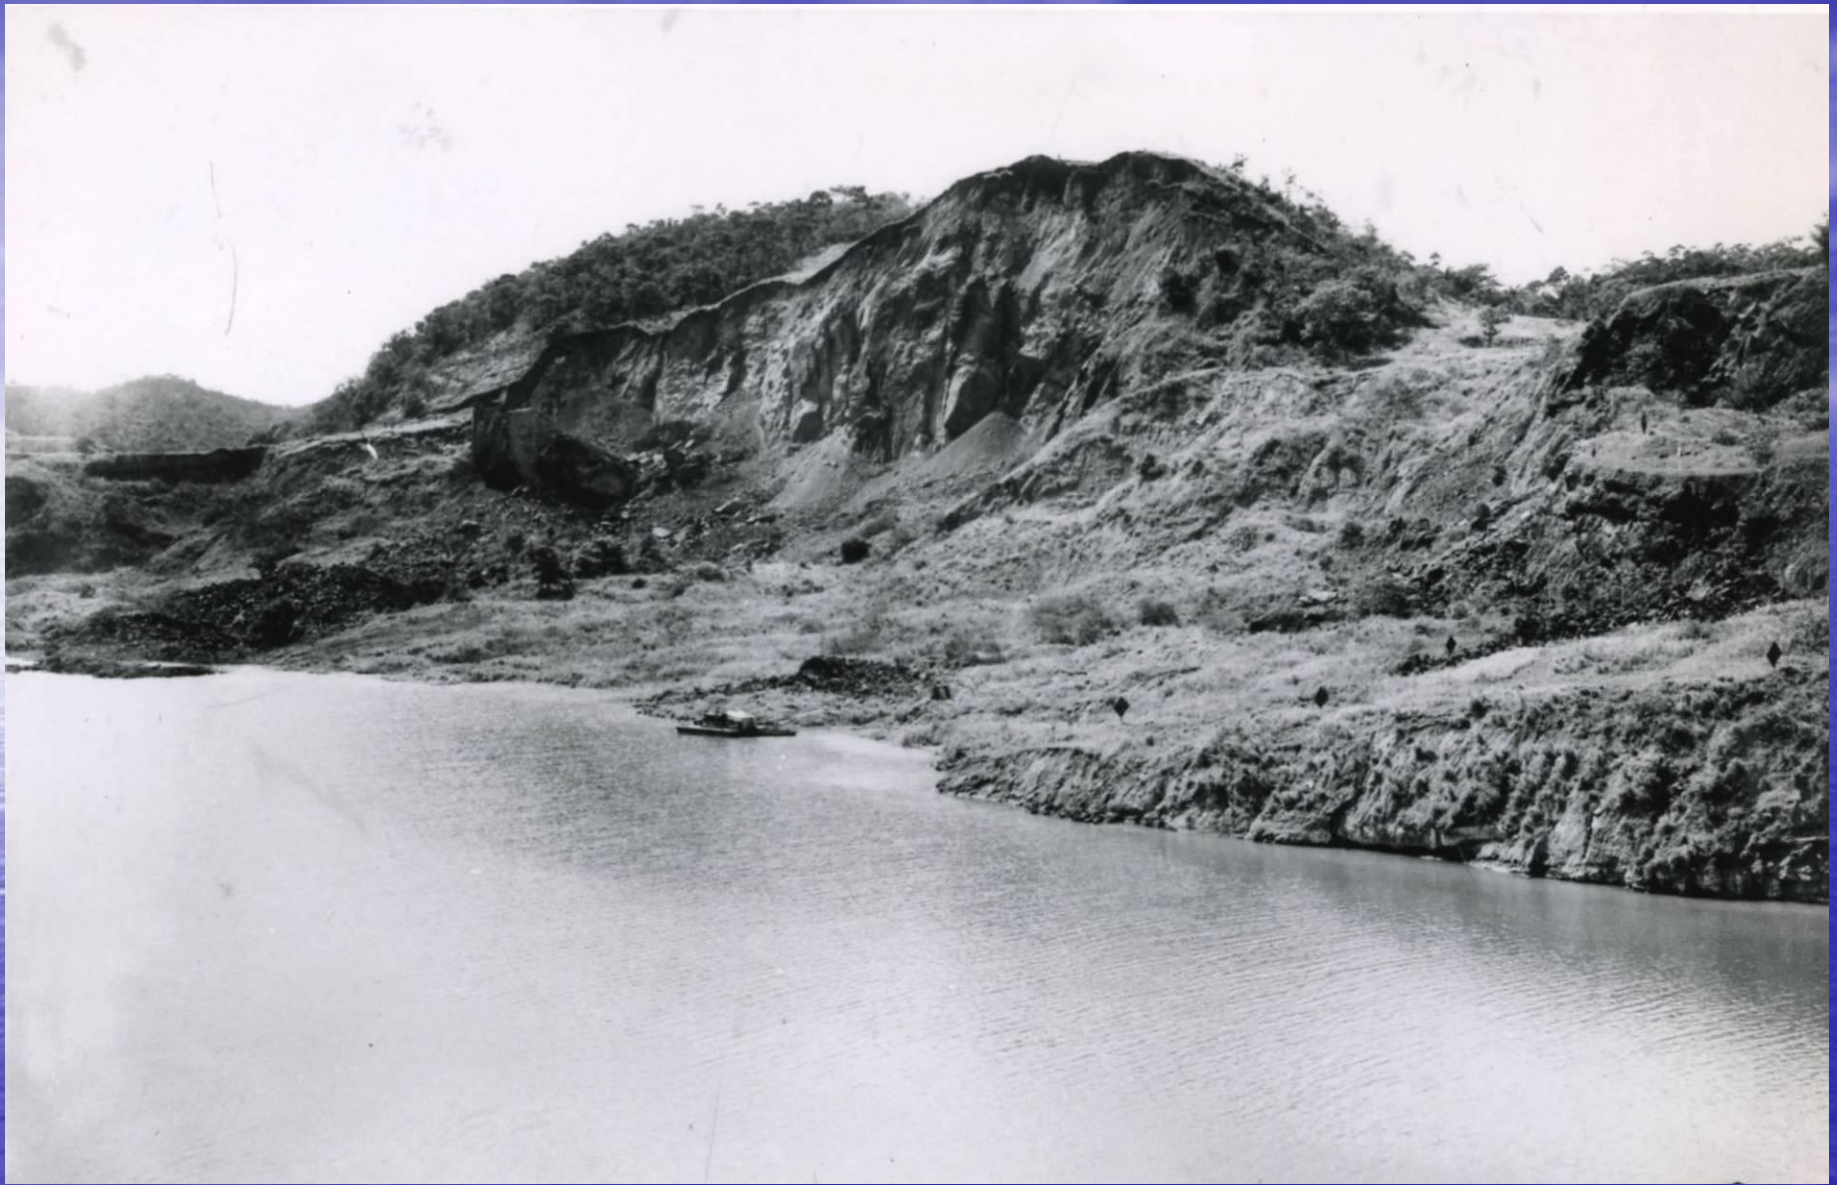
- **Head scarp of the West Culebra Slide, 25 years later, on January 26, 1937**

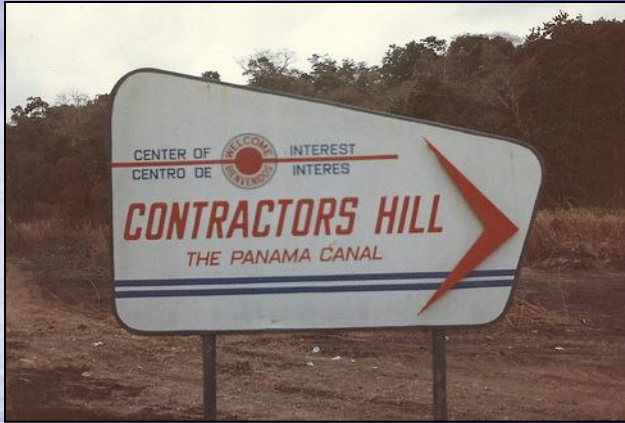
# Contractor's Hill

- In 1954 much concern was aroused when a series of tension cracks developed behind Contractor's hill, along the southwestern side of the Gaillard Cut, which rises 330 ft above the canal.
- Careful monitoring by the Corps of Engineers revealed that a block consisting of more than one million yds<sup>3</sup> of material was slowly moving towards the canal, each time the groundwater levels exceed a certain threshold level.
- The recommendation was made to cut the face back in a series of massive steps (shown above) to an average inclination of 45 degrees

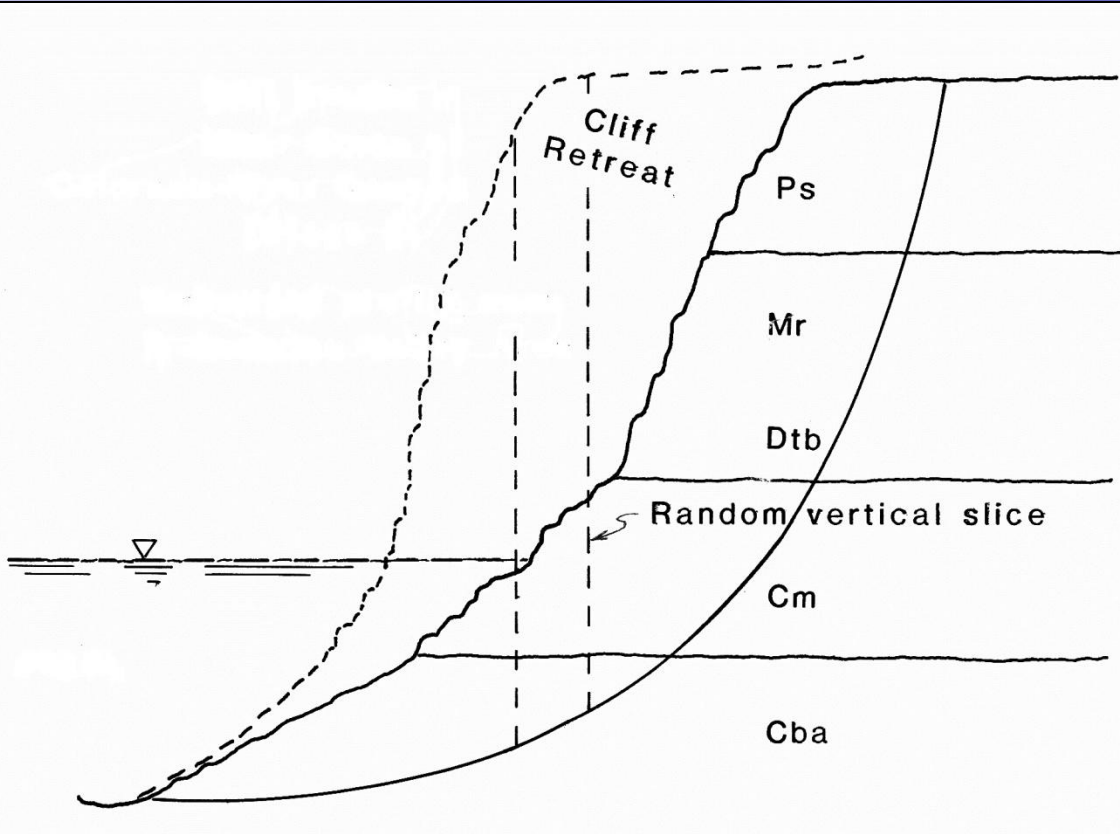
- Degradation of safety factor with decreasing slope when the cut slope is floored in *overconsolidated shales* that exhibit *strain-softening*.

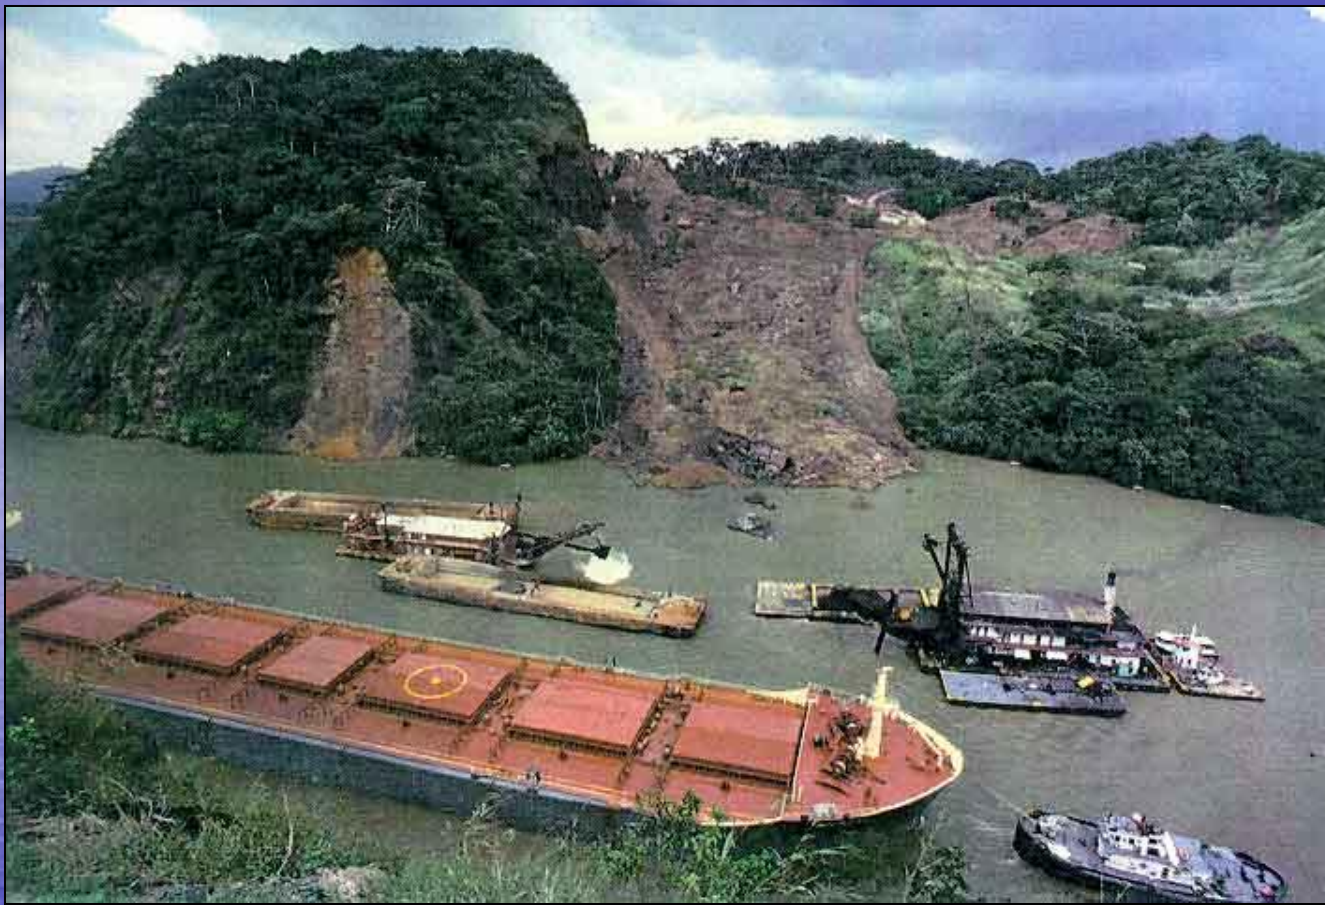
- On **October 13, 1986** the eastern side of the **Cucaracha Slide** reactivated, spilling 526,000 yds<sup>3</sup> of debris into the canal, narrowing the opening to just 115 ft! The slope had crept 13 ft towards the canal during the previous 4 years before rupturing.
- The Canal's experienced pilots were able to keep ships moving at a reduced speed and the debris was removed using dredges.

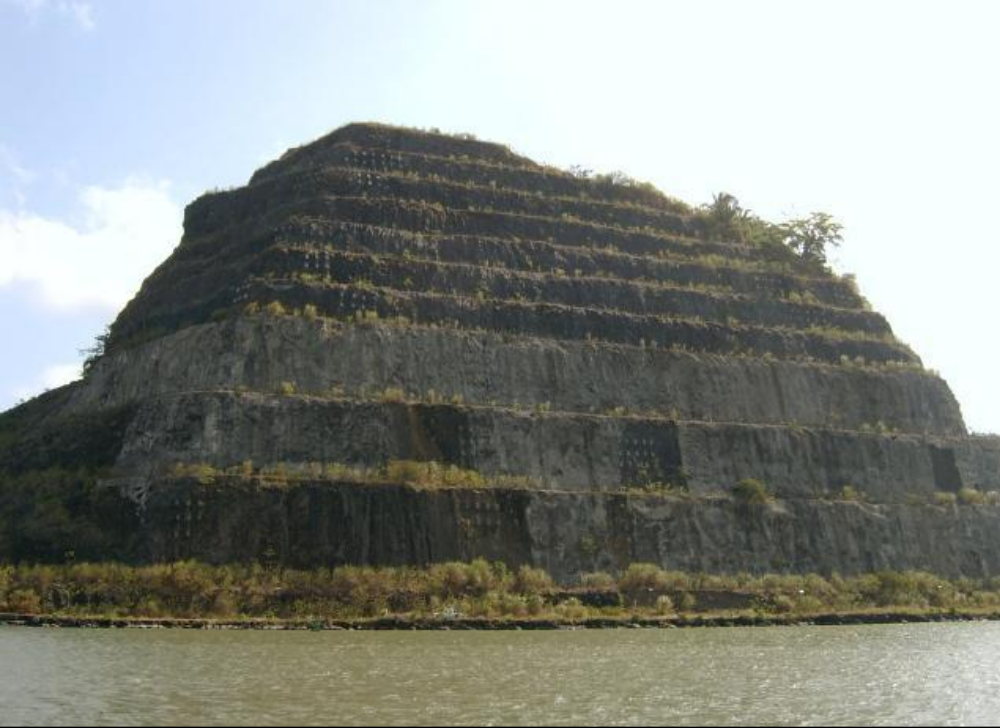
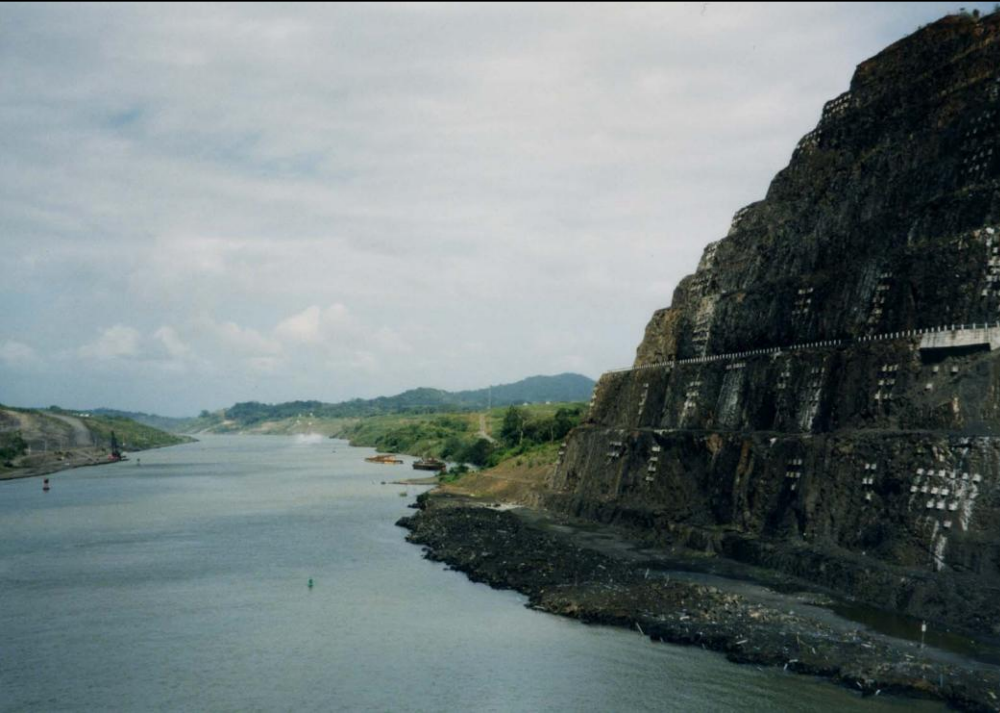
# **Saving Gold Hill and Contractor's Hill**

- For years Gold Hill and Contractor's hill were slowly slipping into the canal along the faults bordering their margins
- It was retrofitted with a series of drilled postensioned rock anchor tendons during the late 1990s to toe it together and retard its creep movement towards the canal.
