Lecture 4

SLOPE FACE TREATMENT

GE 441 Geotechnical Construction Practice

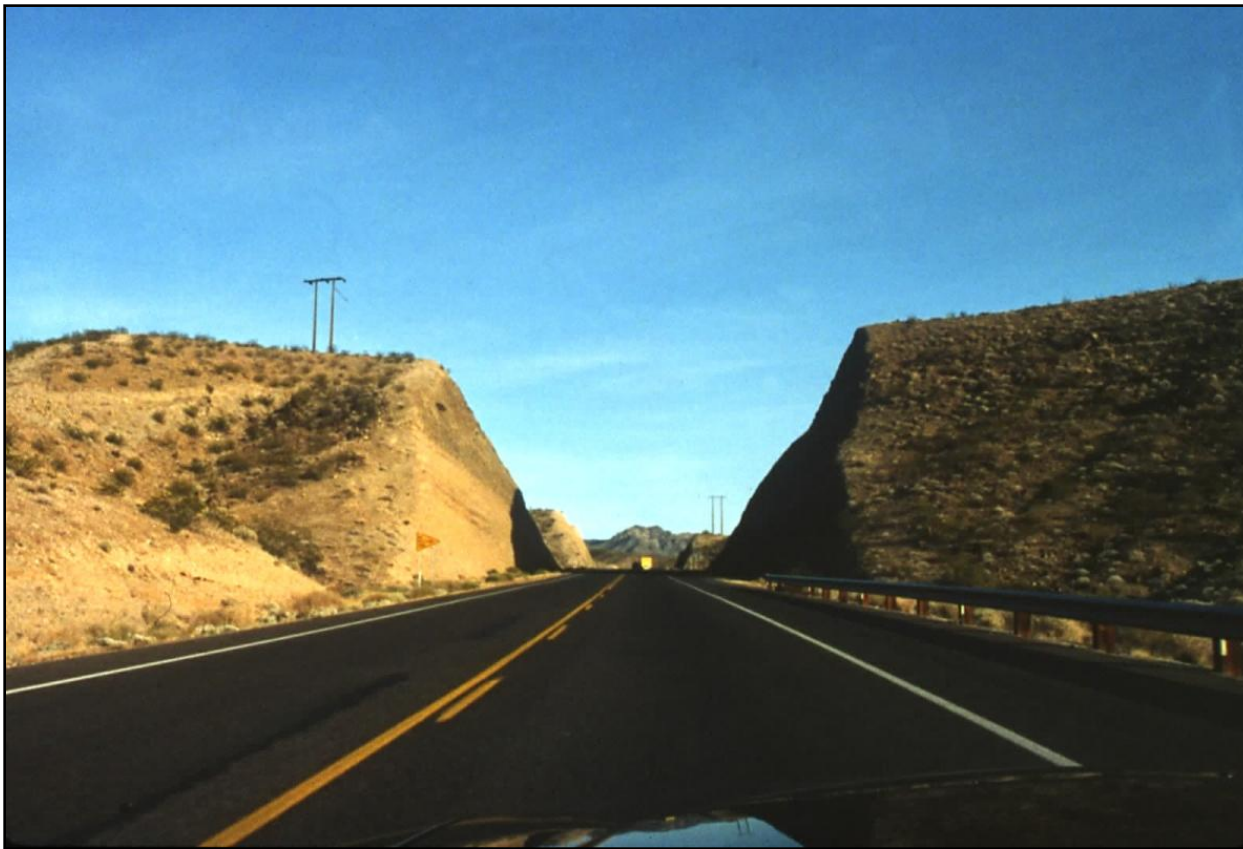
- **Steep cuts in competent rock may remain stable for long periods of time. Even so, a wide debris trough should be excavated at the foot of such cuts to catch falling rock and dissipate its energy.**

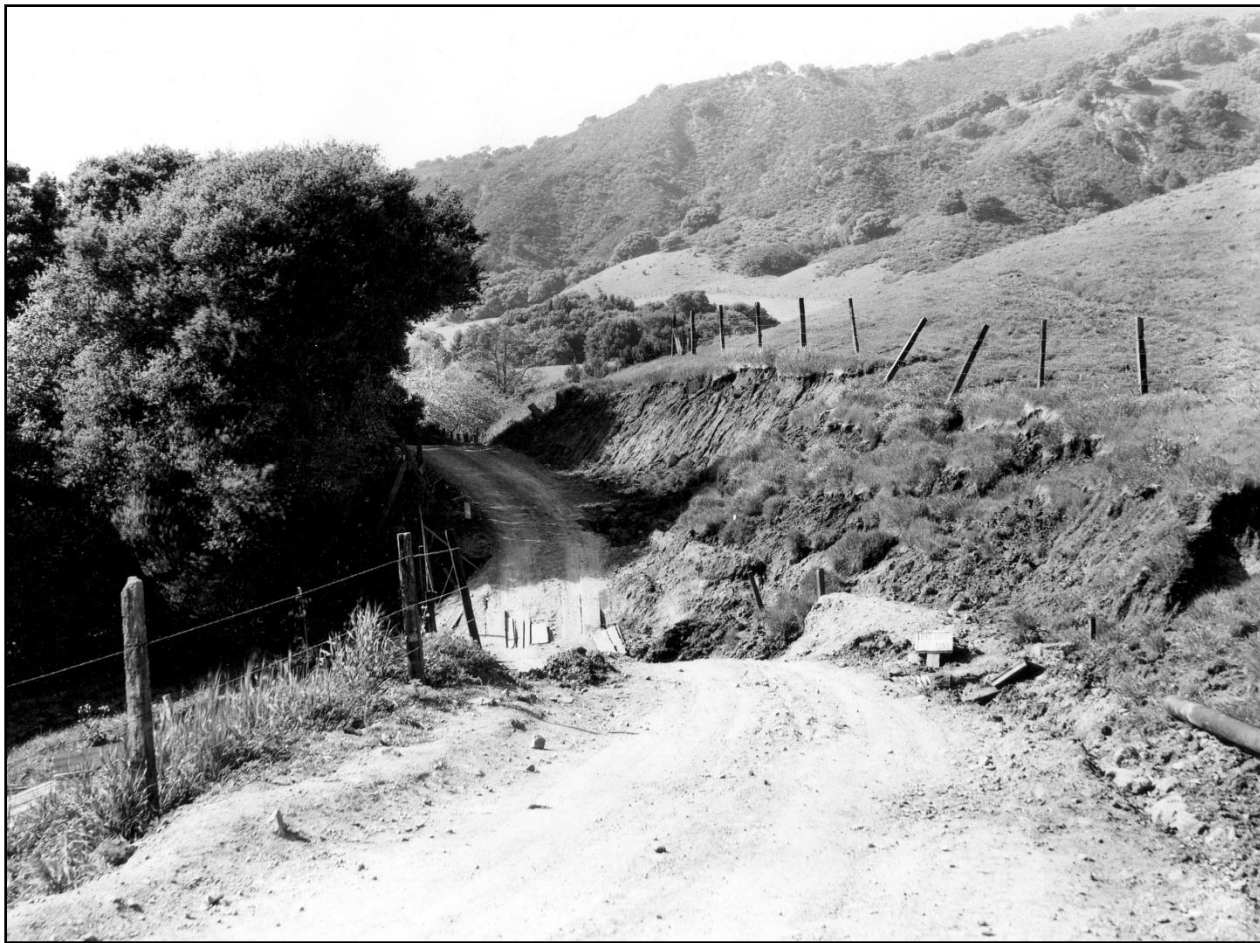
- **Steep cuts in weathered rock, shale or soil may degrade rapidly, especially during periods of sustained precipitation and runoff, as shown here (note tilted fence posts).**

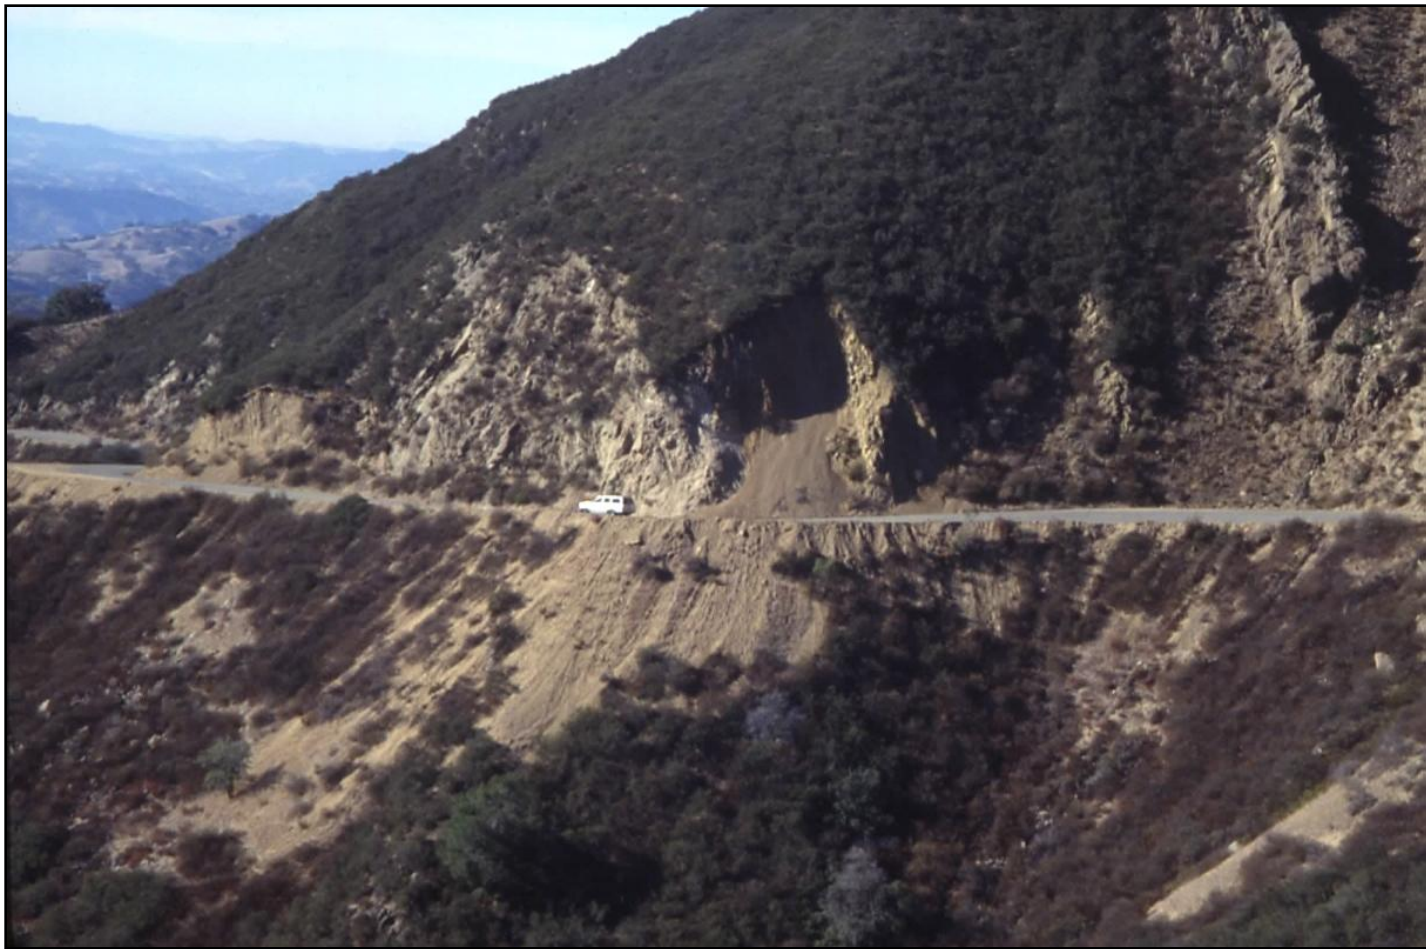
- **Selective raveling of steep cuts in competent rock are a recurring problem. Joint patterns and intensity generally control long-term behavior. Note the sawtooth shape of the raveling cut shown above, caused by the intersection of steeply-inclined bedding and one set of joints.**

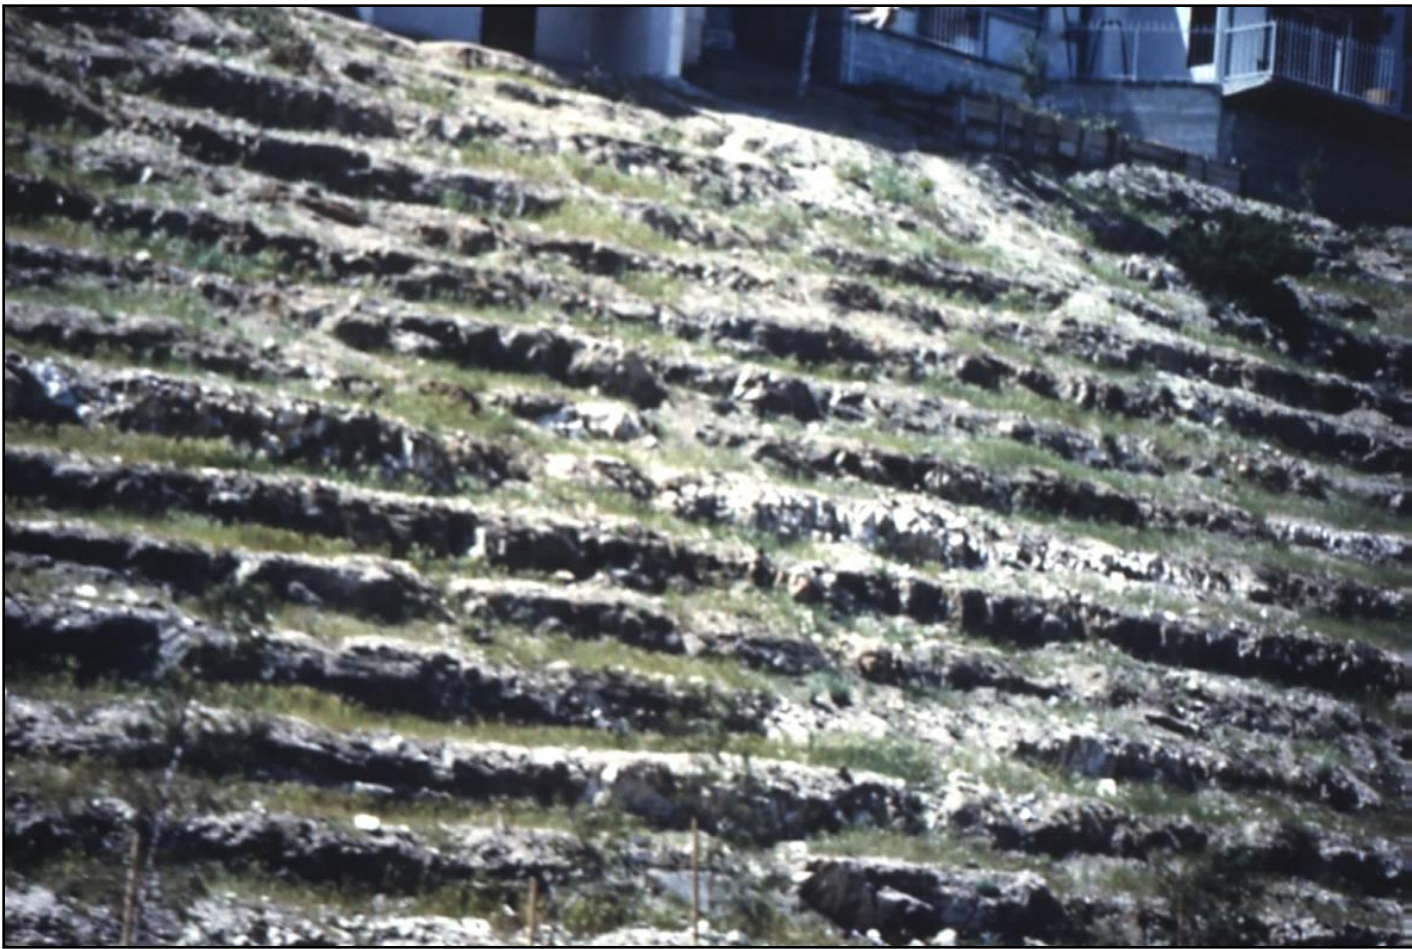
- **“Serrated cuts”, or “step cut” slopes are intended to retard rill erosion in semi-homogeneous materials. They are used chiefly in semi-arid climates.**

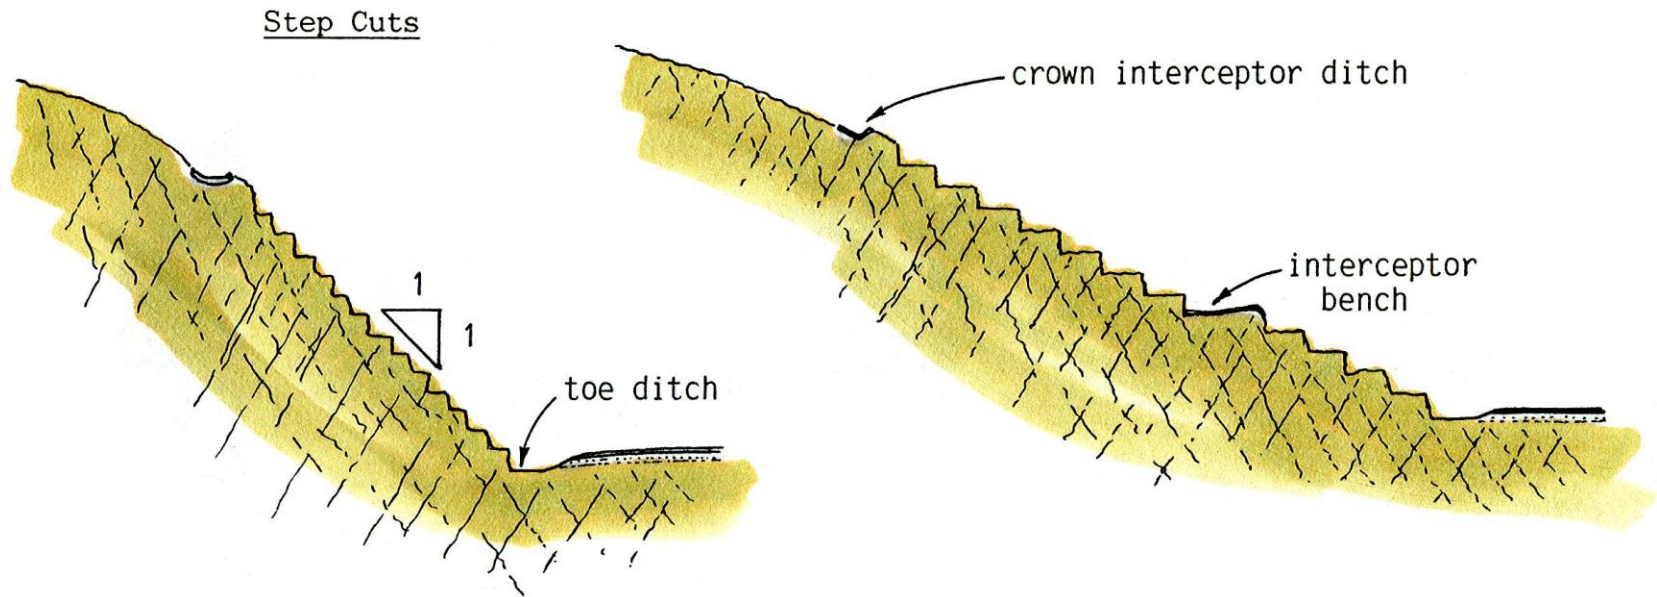
- **The Bureau of Public Roads introduced 1:1 step cuts in Arizona in the late 1920s. They have since been applied to slopes as flat as 2:1, as shown at right. A drainage interceptor bench must be inclined to provide gravity flow for drainage**

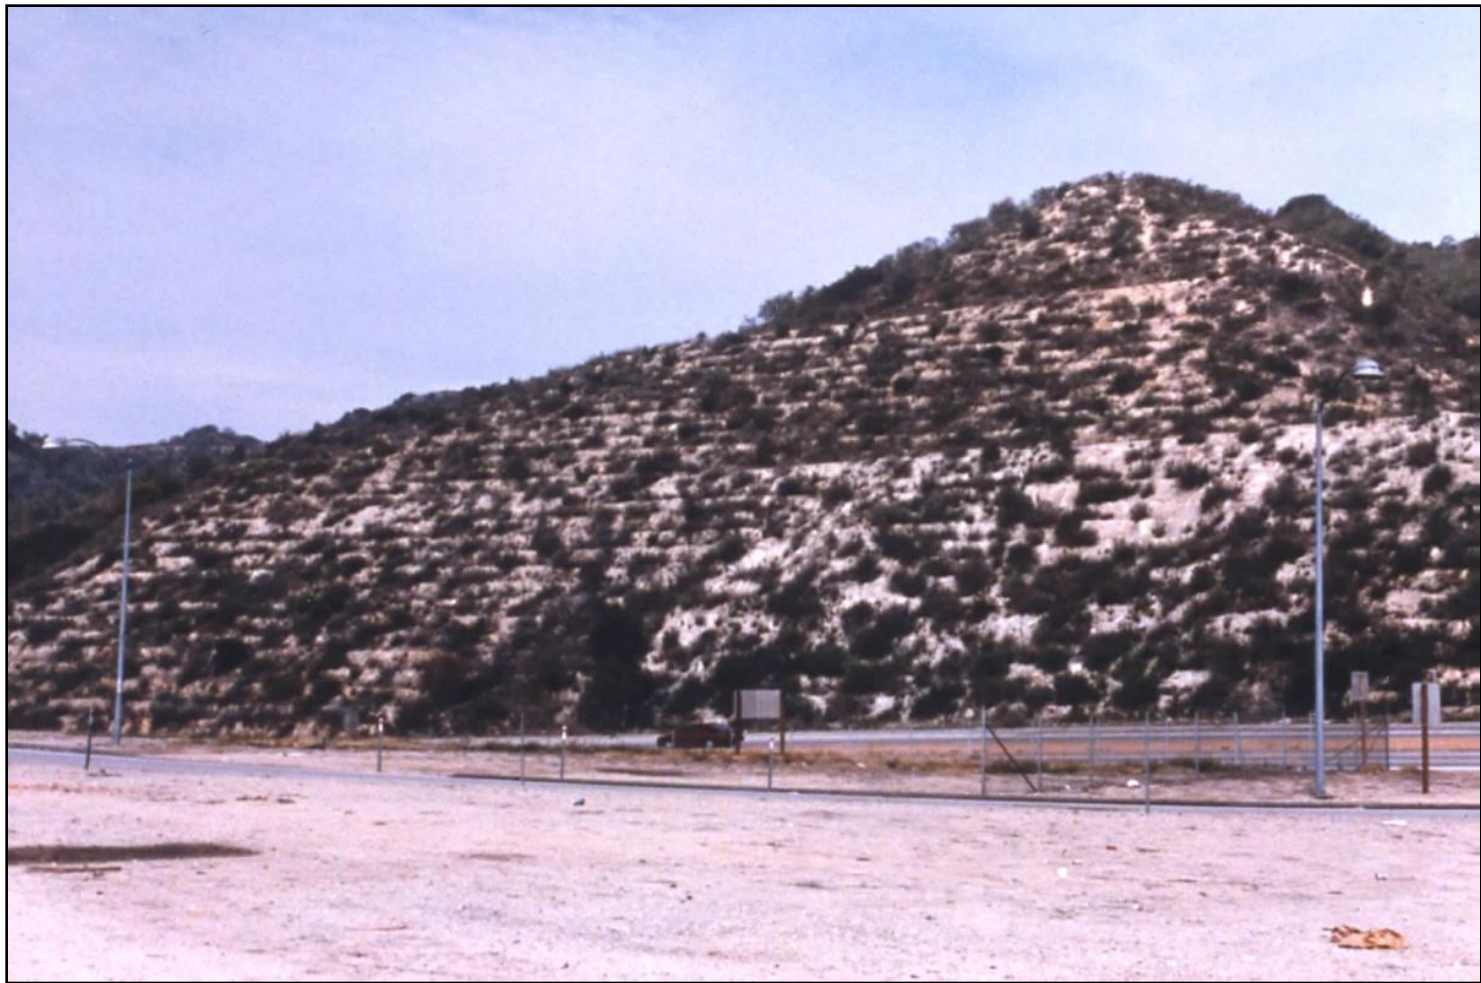
- **Stepped cut along Interstate 210 near Sunland, CA cut in preCambrian metamorphic gneiss complex in the mid-1970s. This cut is just over 150 feet high**

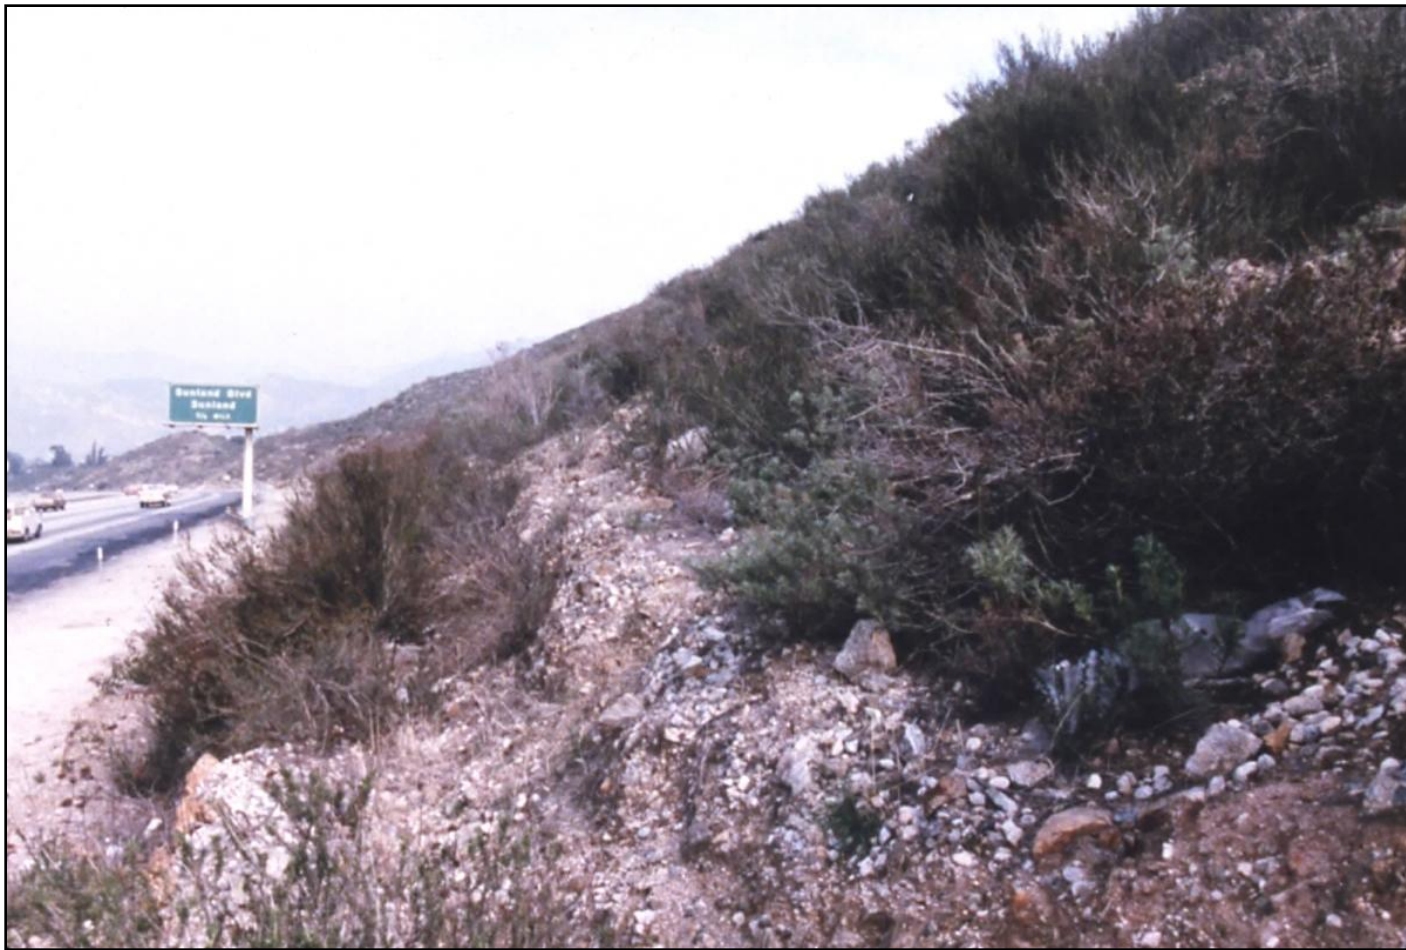
- **Detail of disintegrating steps in highly fractured metamorphic rock after 15 years (1990), along Interstate 210. The steps are 3 feet high and 4.5 feet wide. The vegetation is natural (volunteers), mostly creosote. The area receives about 20 inches of annual rainfall**

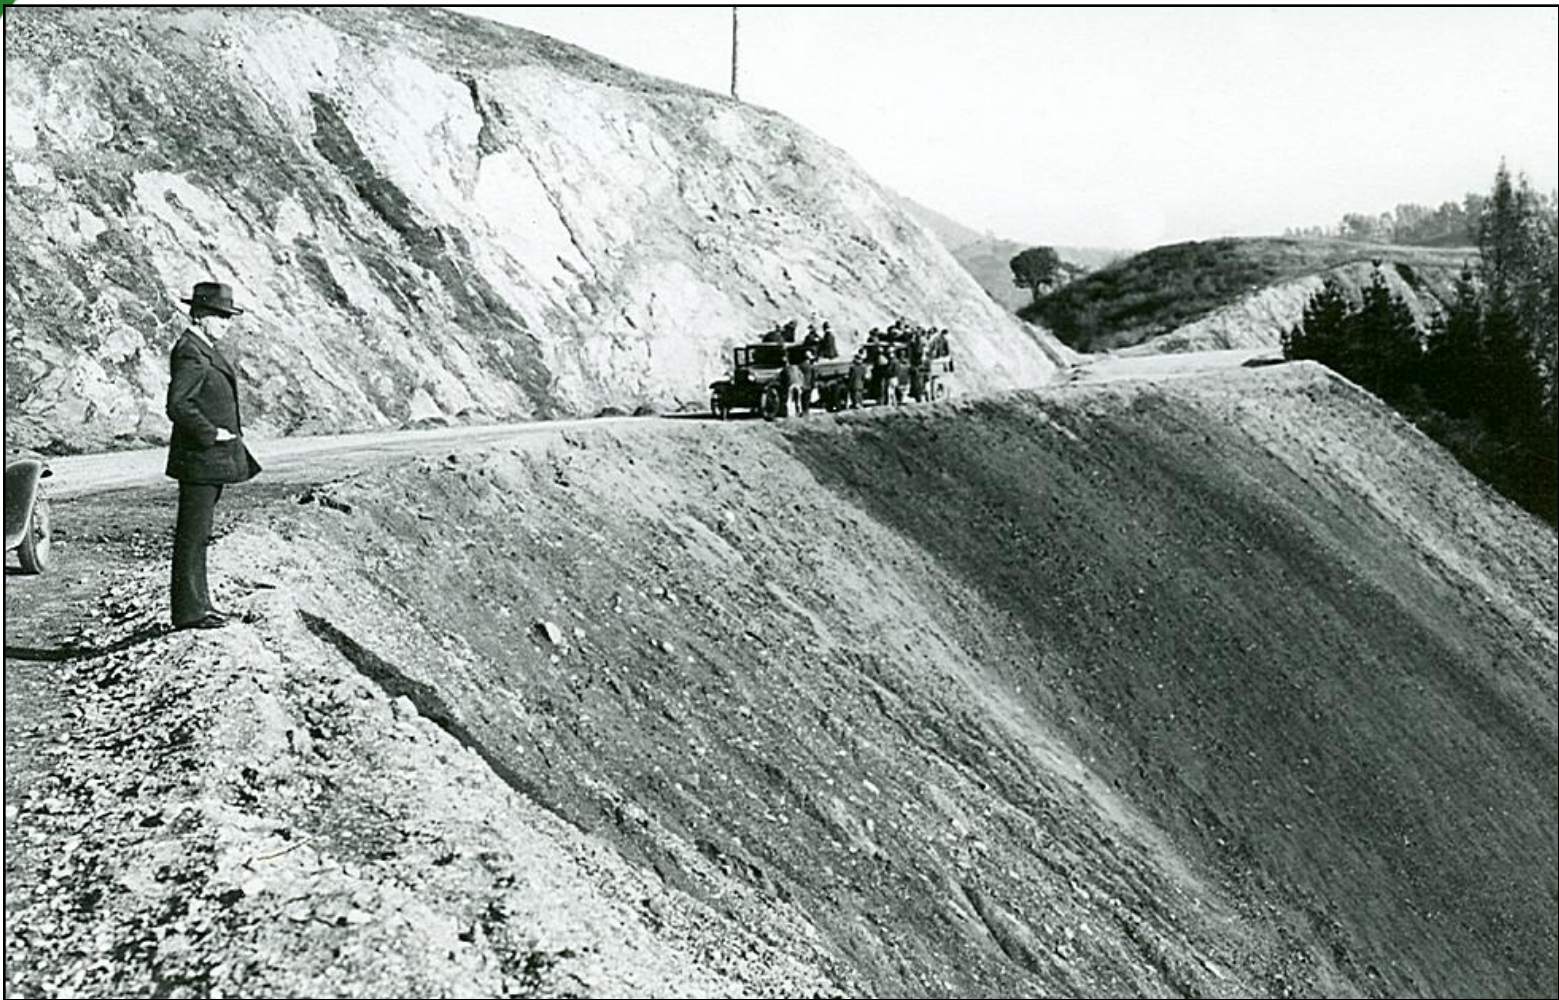
- **This shows a sidehill fill slope supporting a newly constructed road along the crest of the Berkeley-Oakland Hills, CA above Claremont Canyon in late 1934.**

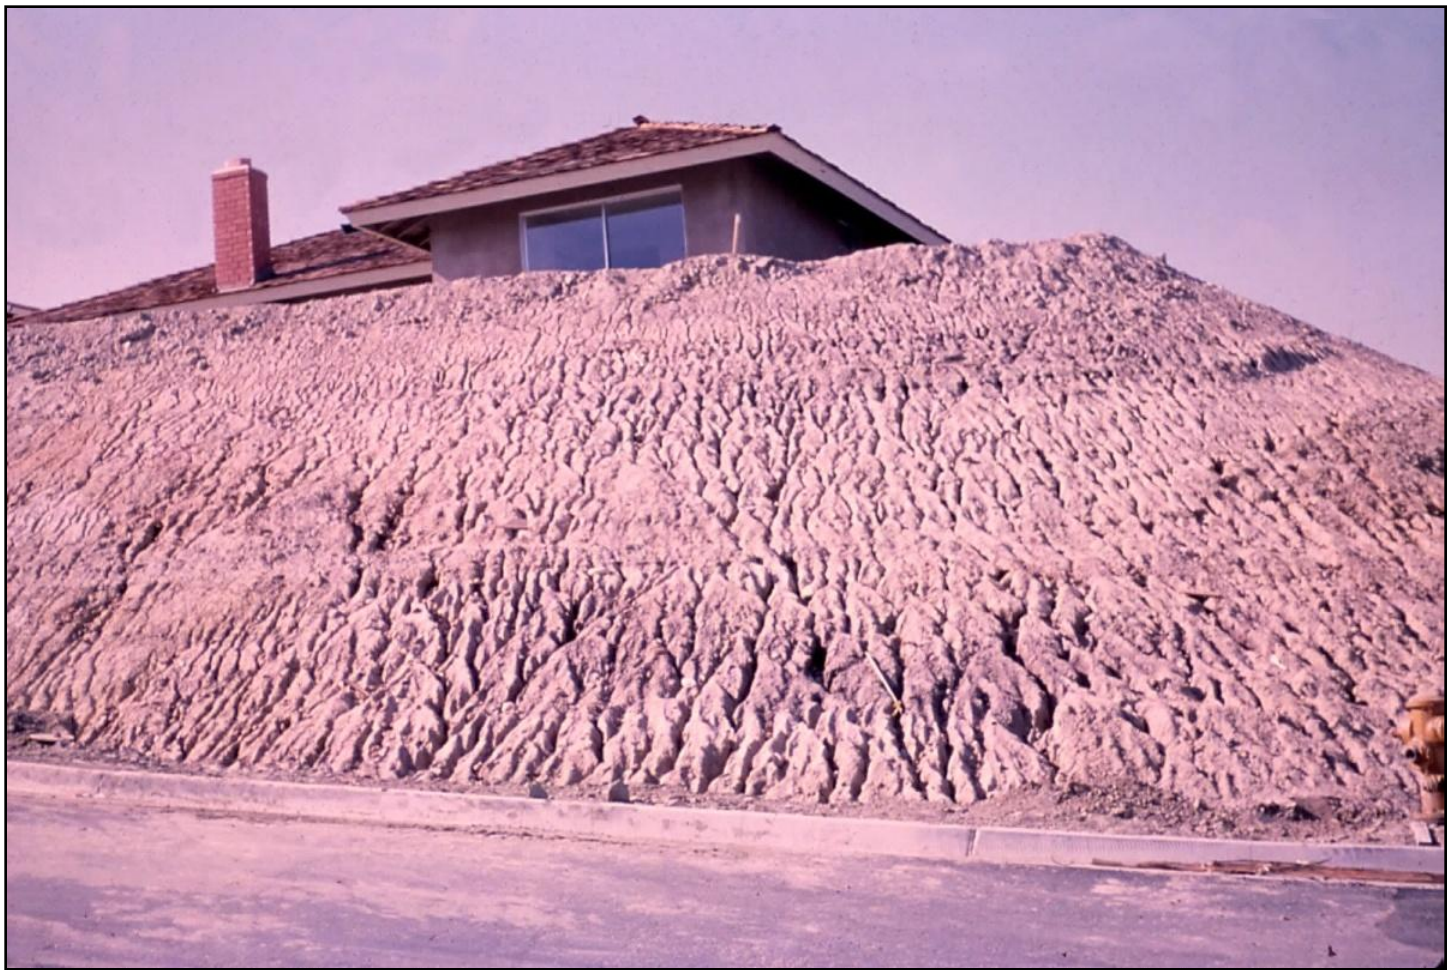
- **Rill erosion is common in low cohesion fill materials, like sands and silts. This photo shows the impact of a single series of storms on an unprotected fill slope**

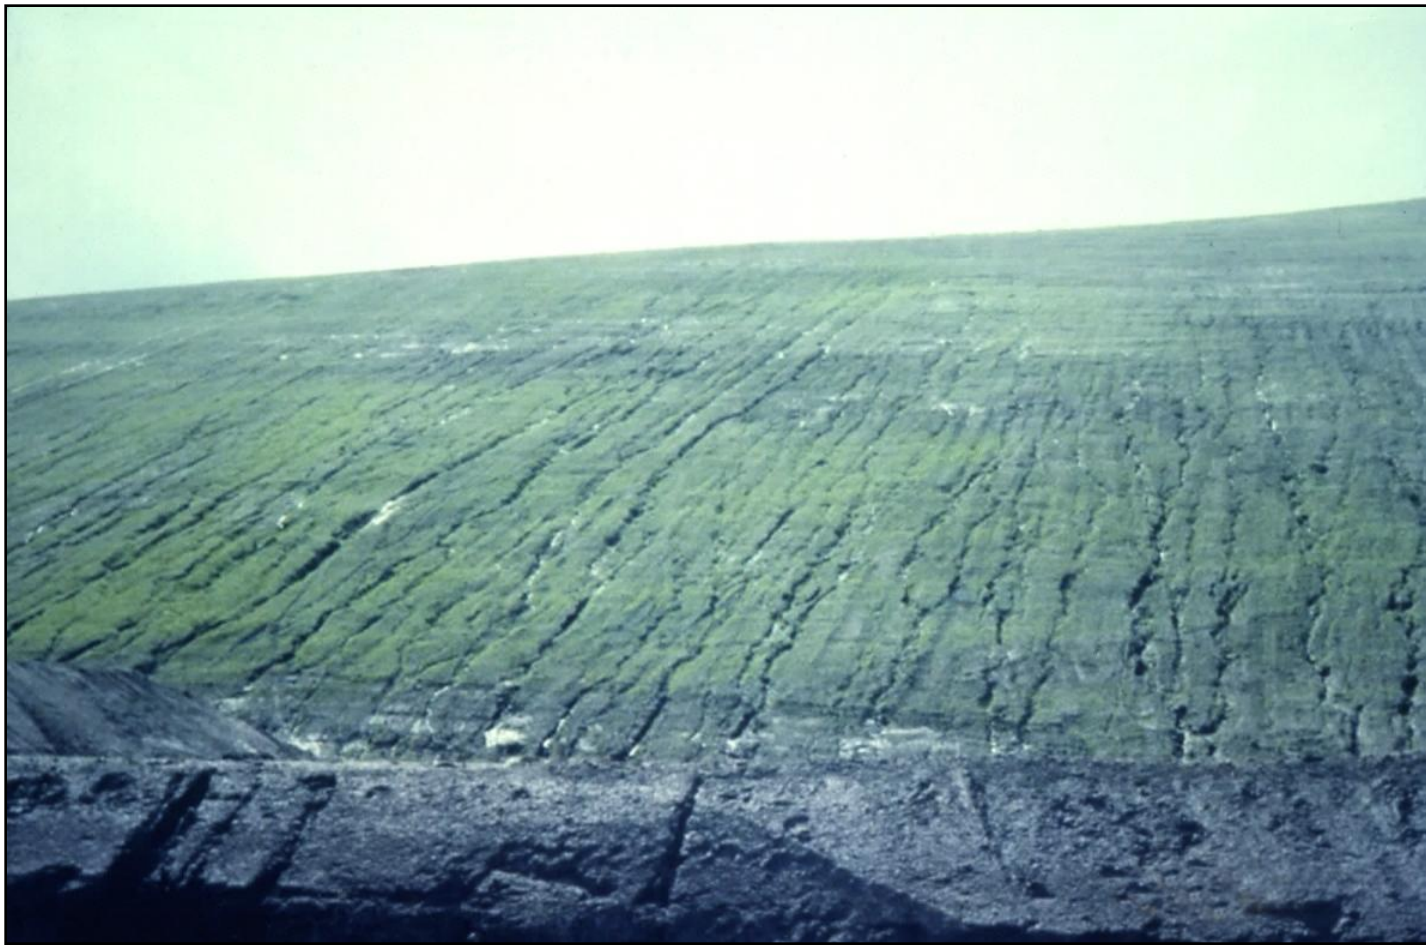
- **In the 1988 the old UBC an allowance was made waiving terrace drains for fill slopes inclined at 3:1 or flatter. This view shows rill erosion developed on such a slope, despite a healthy grass cover**

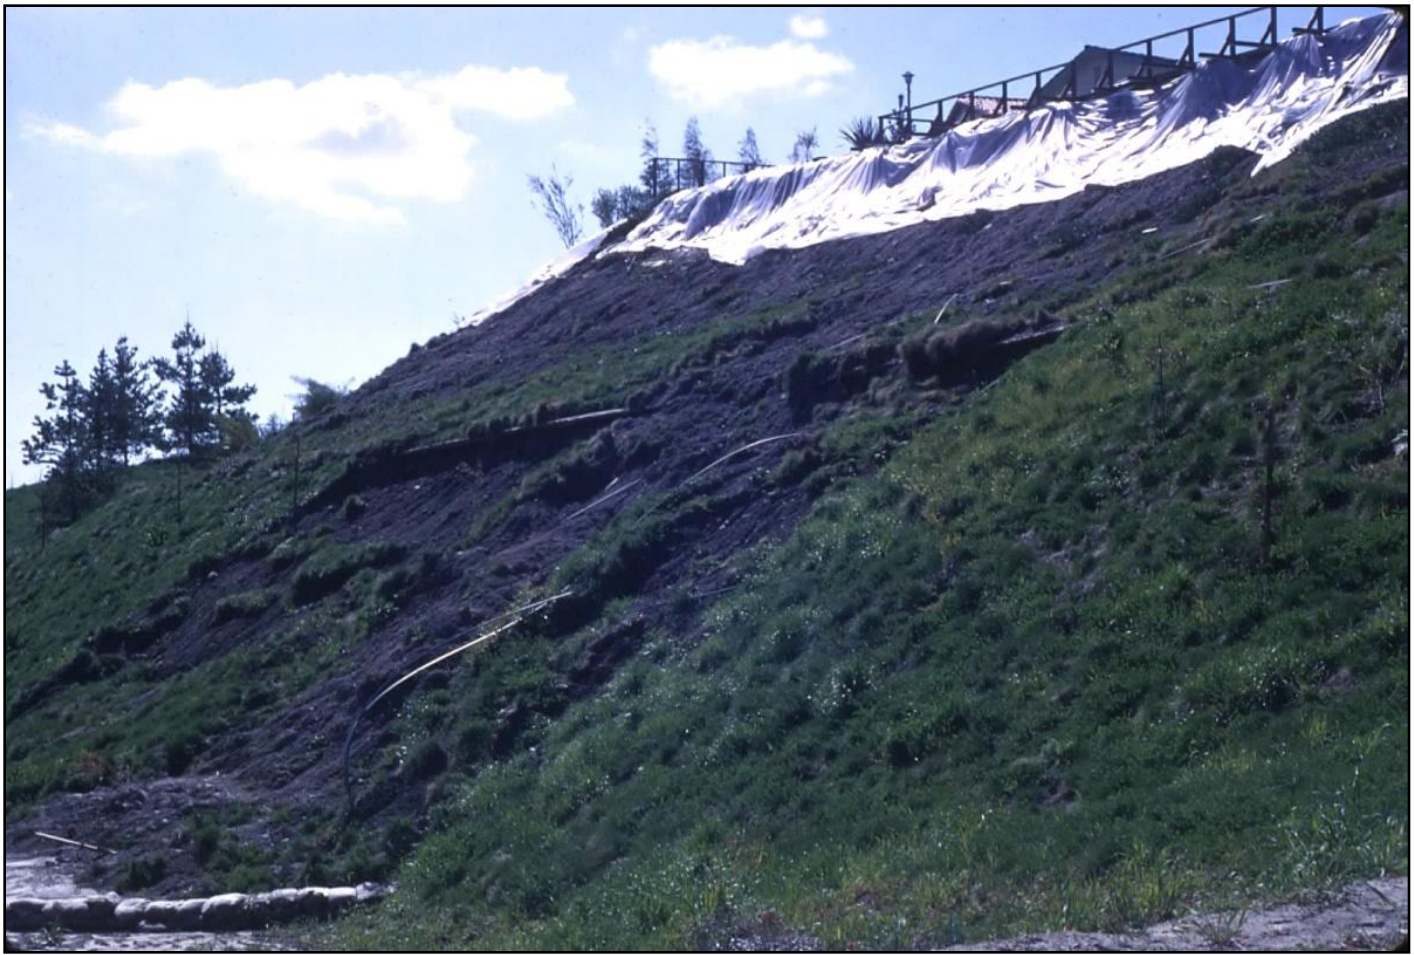
- **When this mat of vegetation is subjected to sustained intense precipitation, it tends to separate like a rug falling off a polished floor, as shown above.**

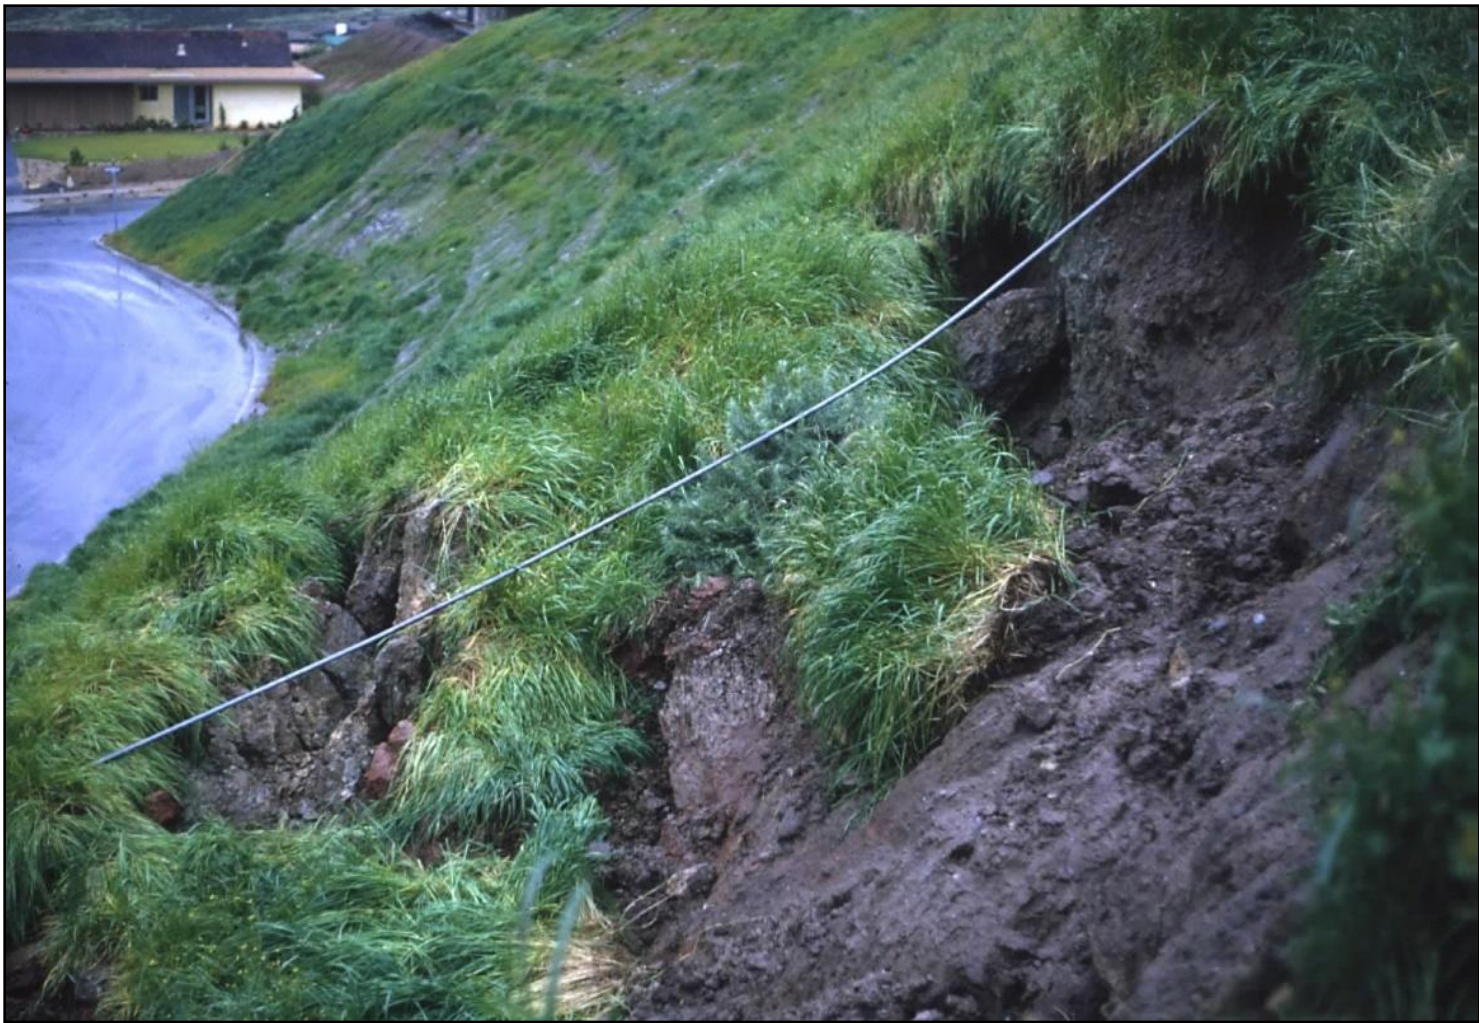
- **Cut slopes failures are usually shallow, involving a wet mat of organic material, which often detaches at the root line, within 1 to 3 feet of the ground surface**

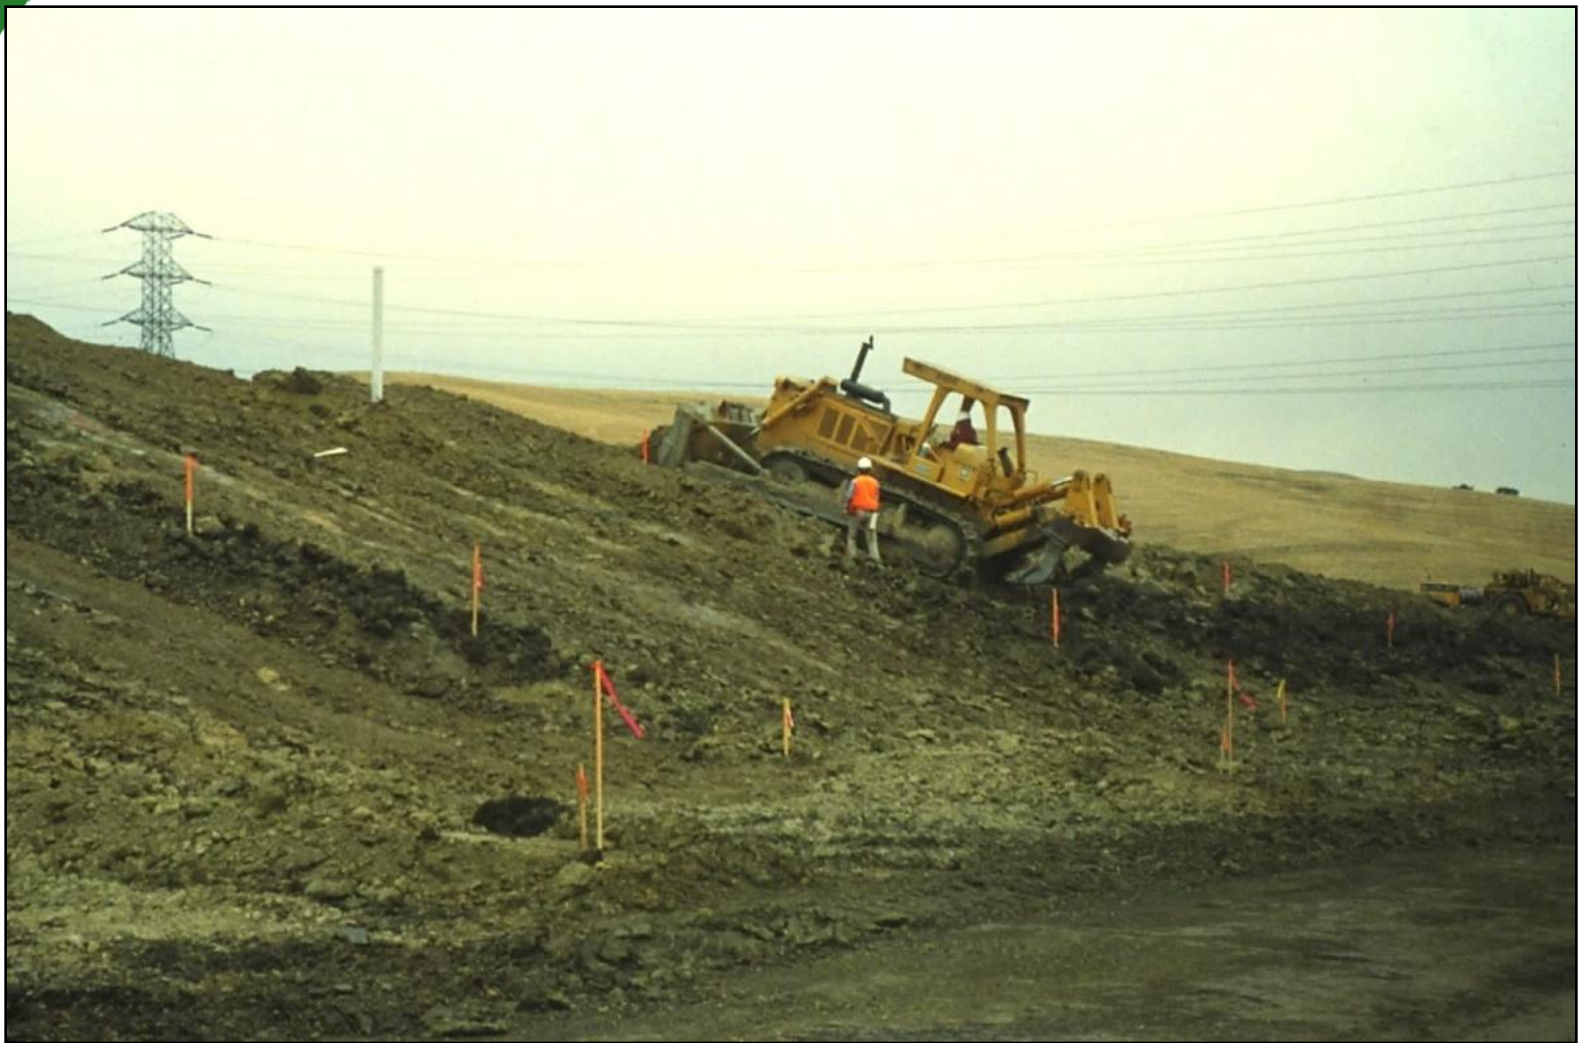
- **Dressing a fill slope is the process by which the slope is trimmed to its final inclination, as shown here. Note construction staking.**

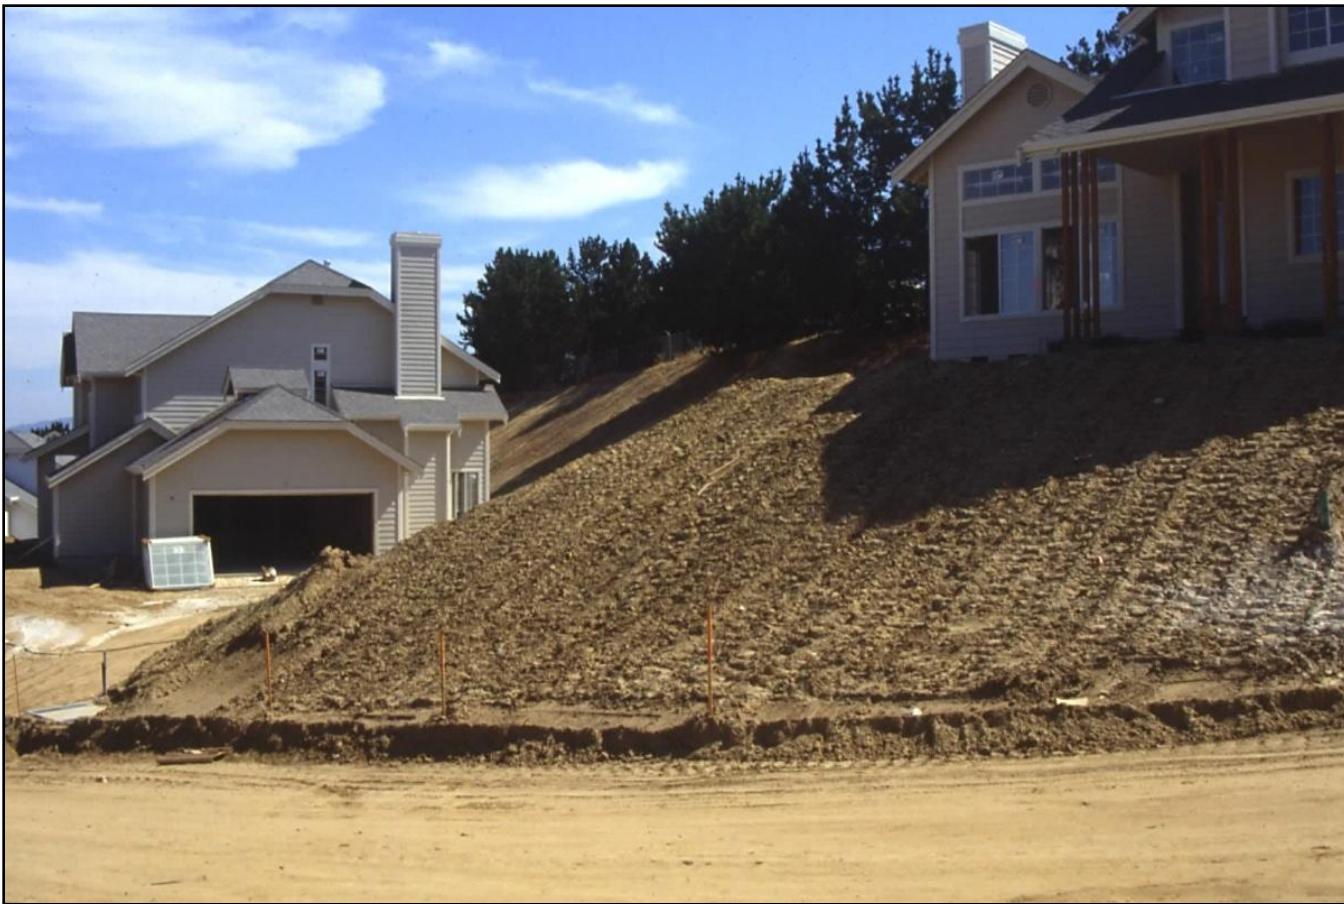
- **A “dressed slope” is usually walked by a tracked dozer, leaving the track marks. This serrated surface provides superior catchment for hydroseeding of most grasses**

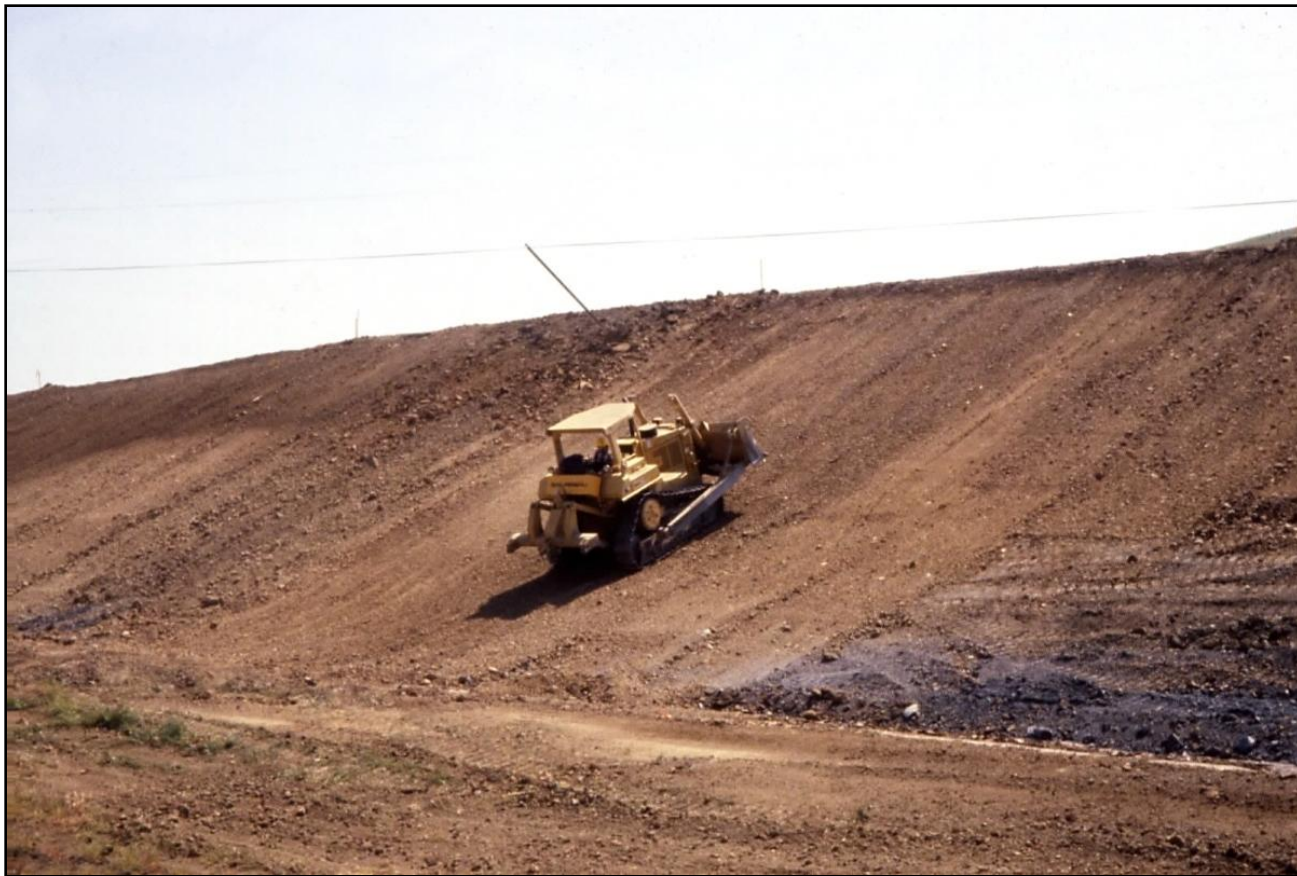
- **Track walking a fill slope will not compact it appreciably because the track contact pressures (between 5 and 10 psi) are well below those imparted by a mechanical compactor (>135 psi for a pad roller)**

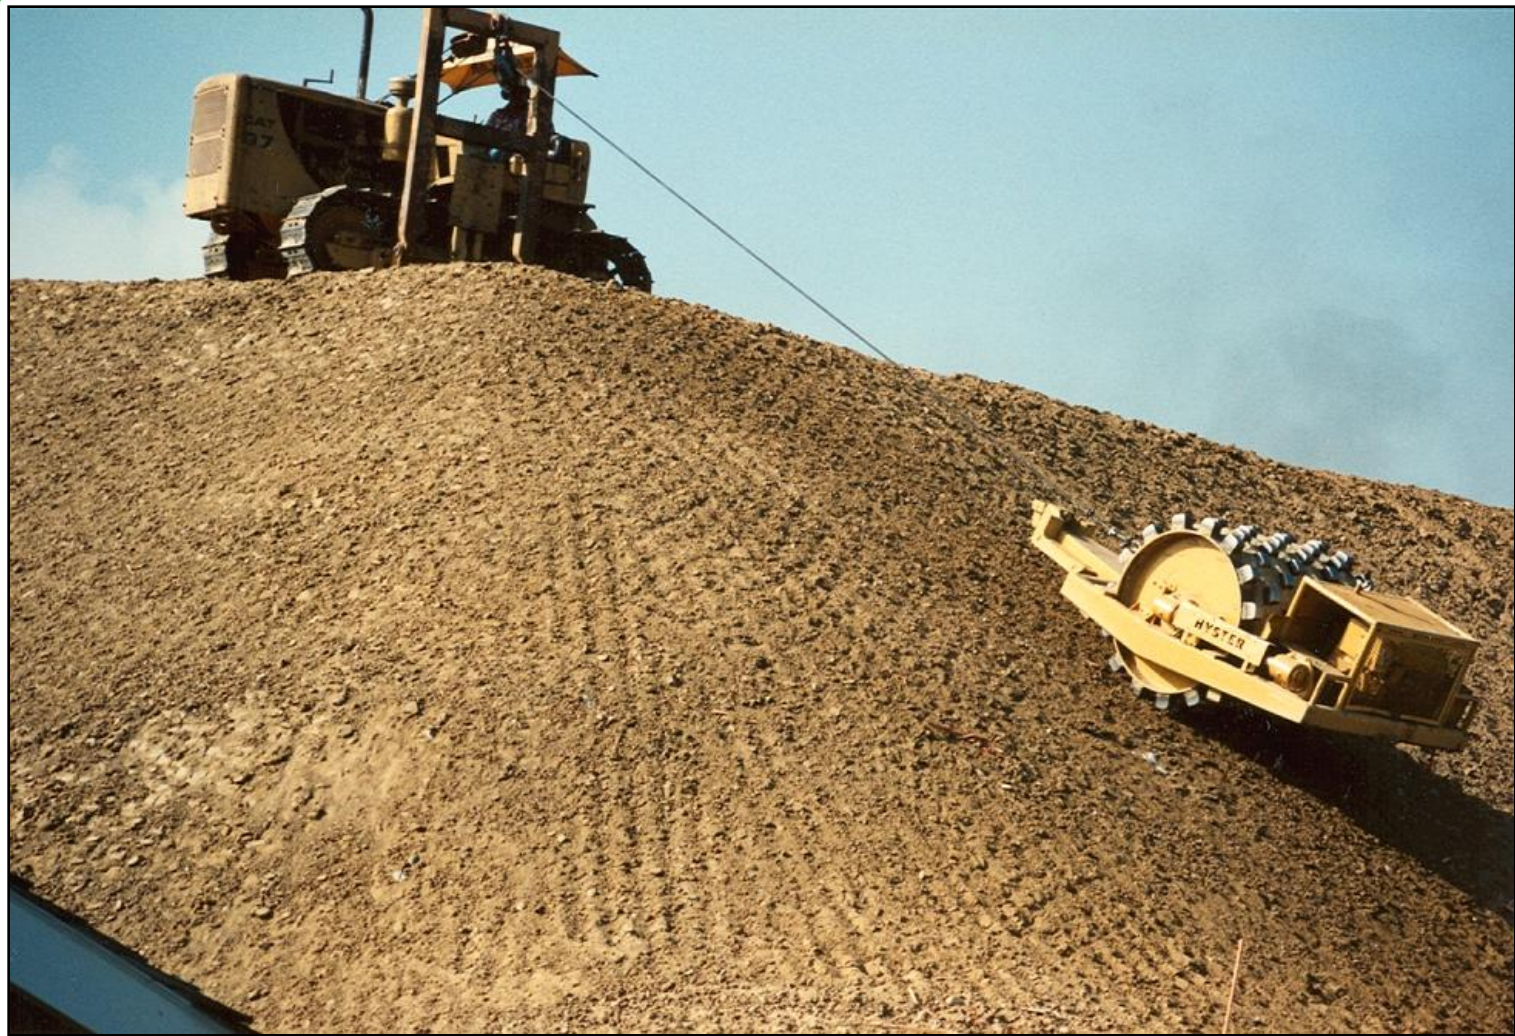
- **Rolling a fill slope with a pad roller imparts between 135 and 175 psi contact pressure beneath the roller teeth**
