Lecture 4

SLOPE FACE TREATMENT

GE 441 Geotechnical Construction Practice

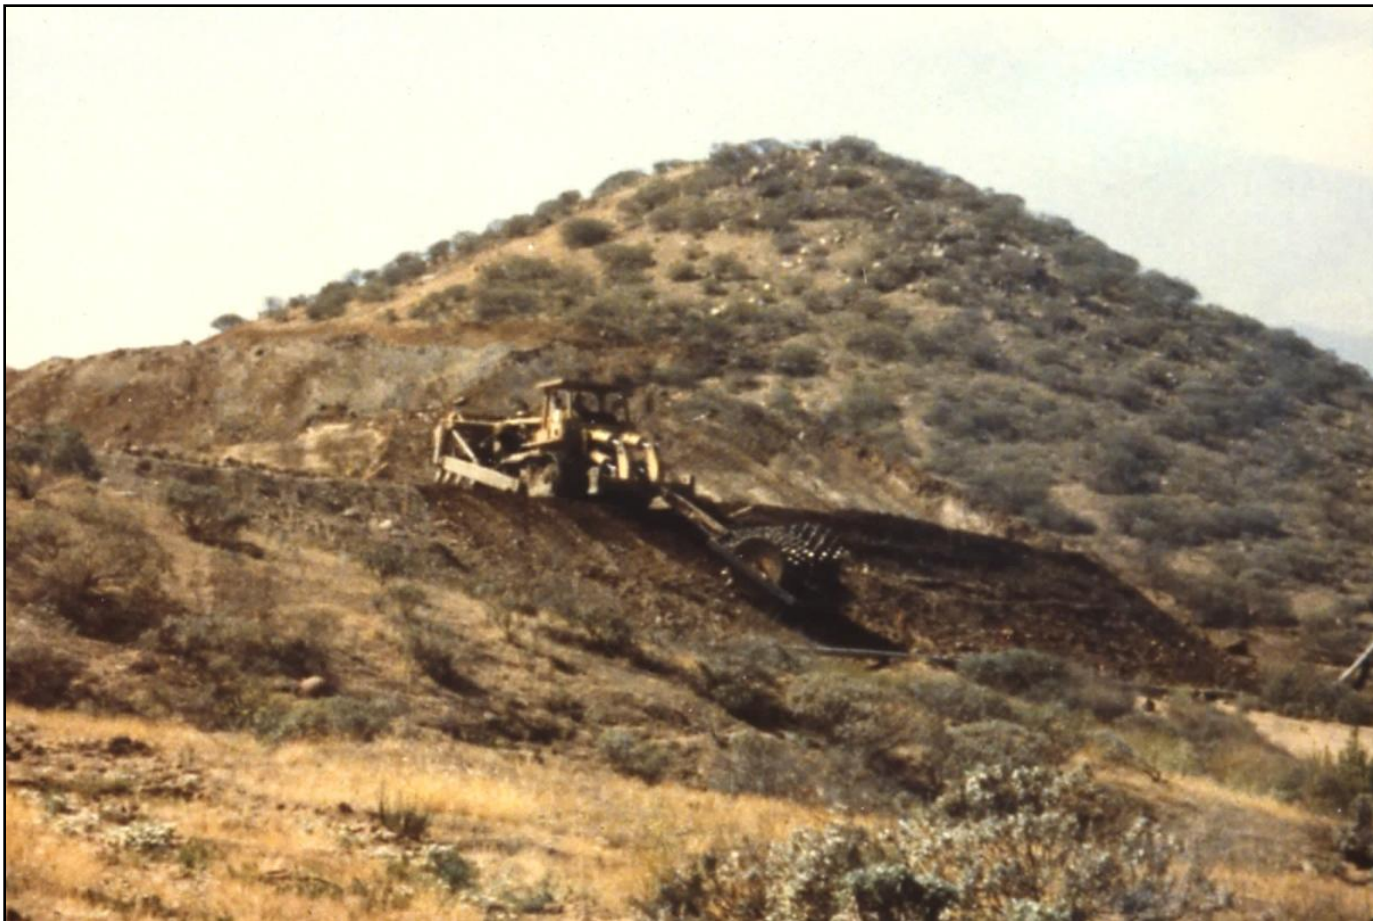
- **The contact pressure is the roller weight on the teeth multiplied by the cosine of the slope inclination (about 11% reduction on a 2:1 slope).**
