Part 6

SEEPAGE FILTERS

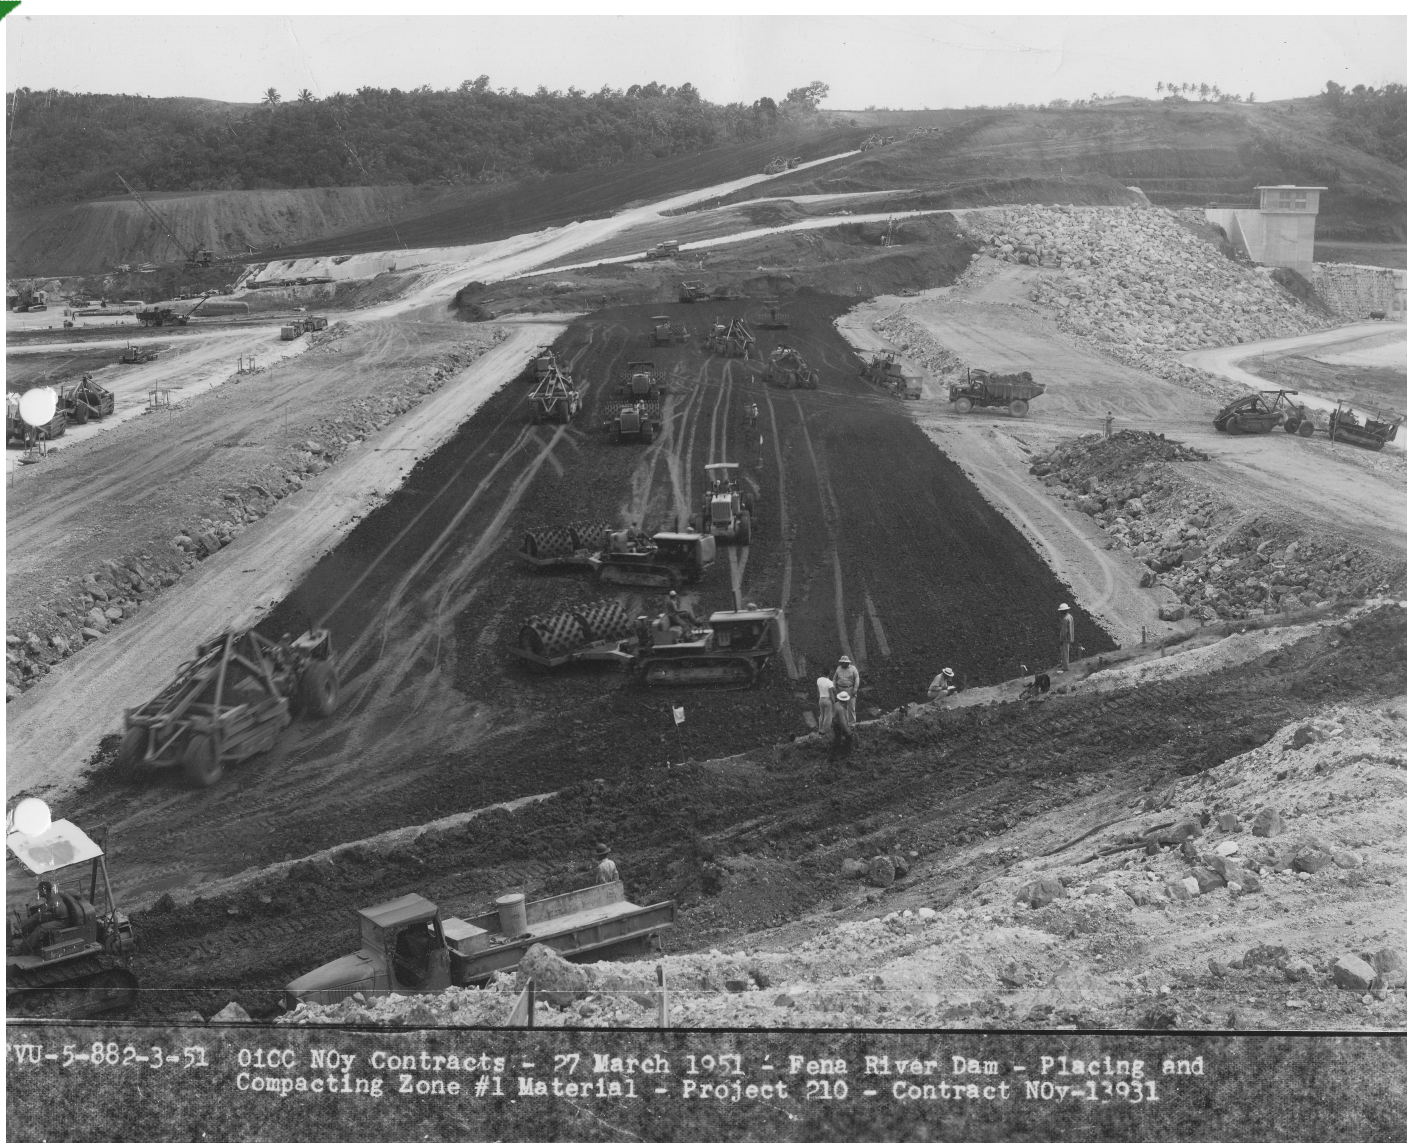
- **Placement of earthen clay core, up and downstream filters, and rockfill shells at Fena Dam on Guam by Navy Seabees in 1951. Upstream is to the right.**

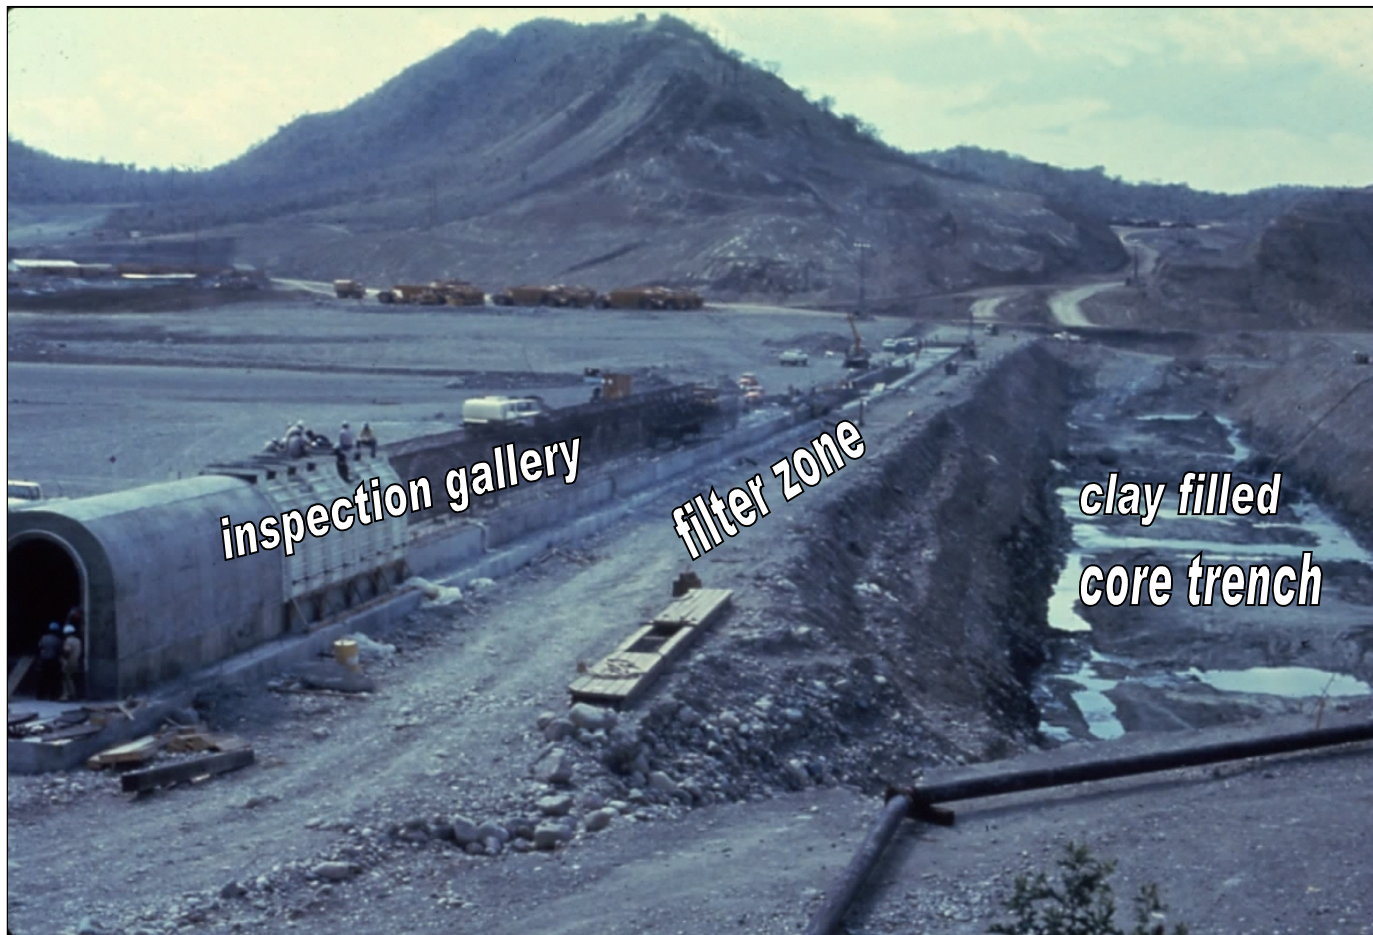
- Hydraulic piping/soil erosion can be prevented by the placement of filter layers of intermediate size material between the soil and the drain rock, if their particle sizes are dramatically different. This is a common precaution when constructing earth dams, like that shown here (Sabena Yegua Dam in the Dominican Republic).

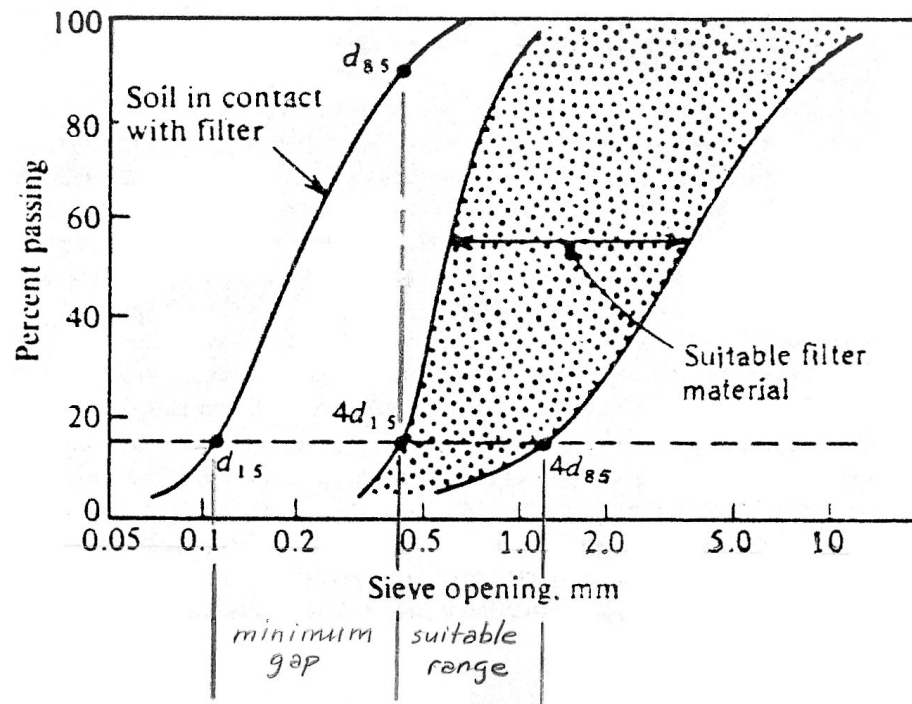
The basic filter criteria are given as:

- $D_{15} \text{ (filter)}/D_{85} \text{ (soil)} < 4 \text{ to } 5 < D_{15} \text{ (filter)}/D_{15} \text{ (soil)}$
- $D_{15} \text{ (filter)}$ must not be more than 4 or 5 X $D_{85} \text{ (soil)}$
- The ratio $D_{15} \text{ (filter)}/D_{85} \text{ (soil)}$ is the *piping ratio*
- The $D_{15} \text{ (filter)}$ must be 4 to 5X the $D_{15} \text{ (soil being protected)}$

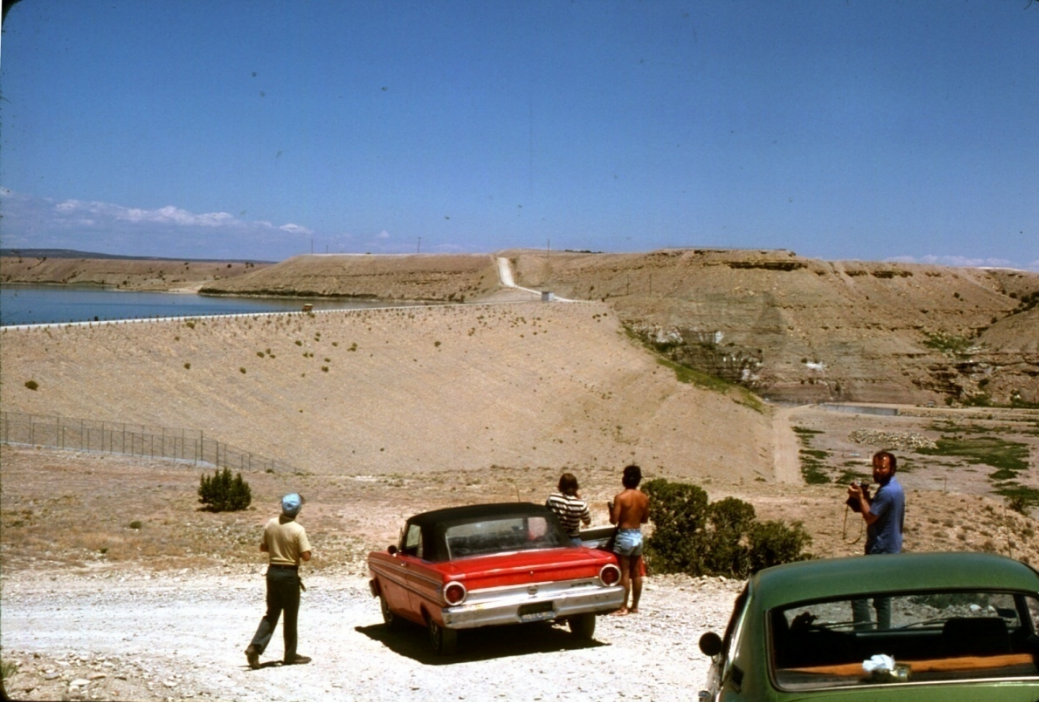
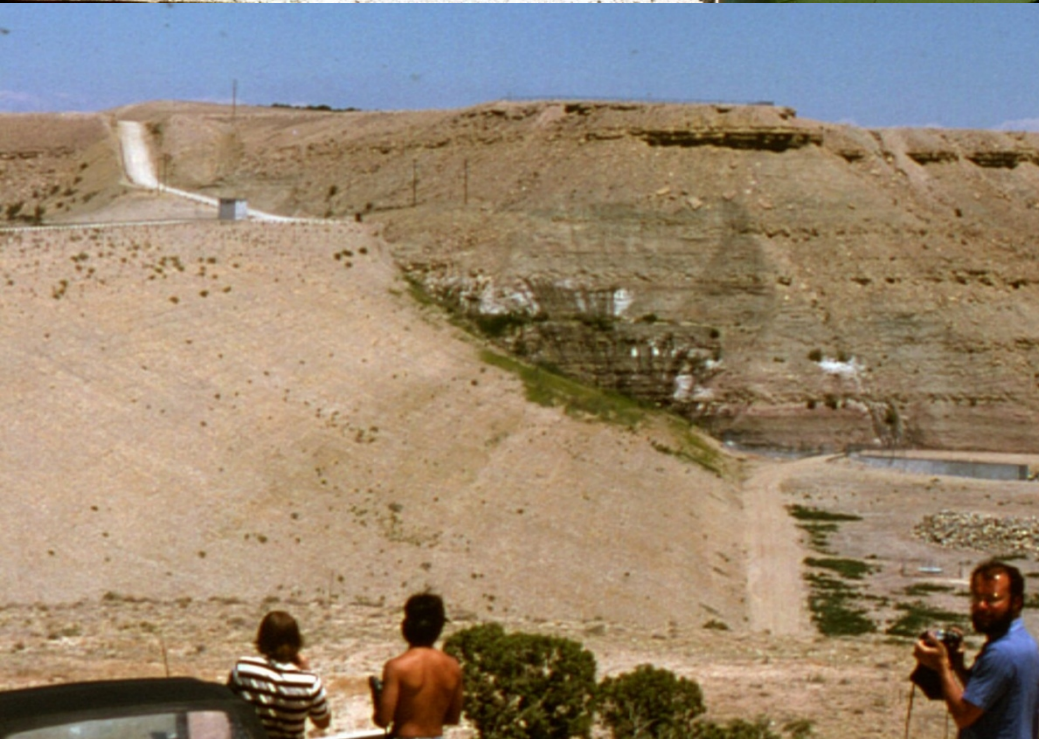
Abutment Seepage

Abutment seepage at Starvation Dam and Reservoir near Duchesne, Utah, as viewed in 1977. This dam had recently been built by the Bureau of Reclamation, between 1967-70. The Bureau of Reclamation undertook a thorough study of the seepage problems and corrected them in the 1980s.

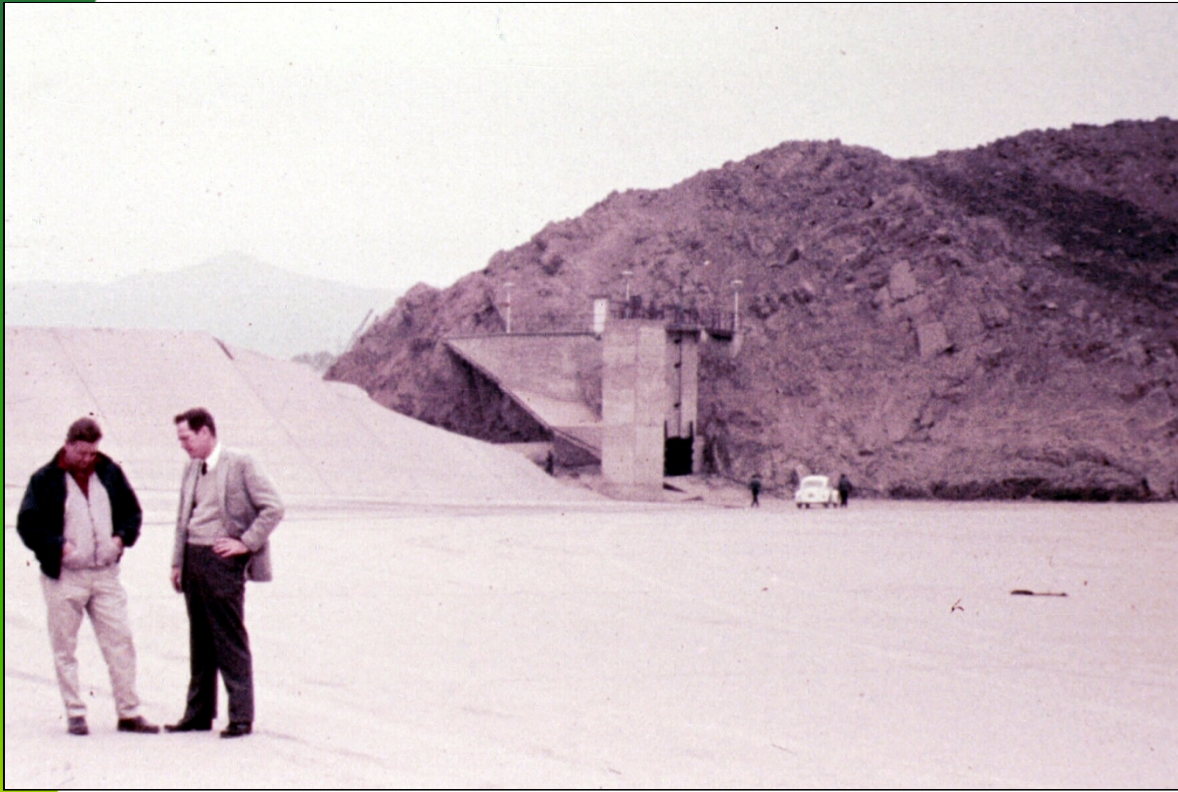
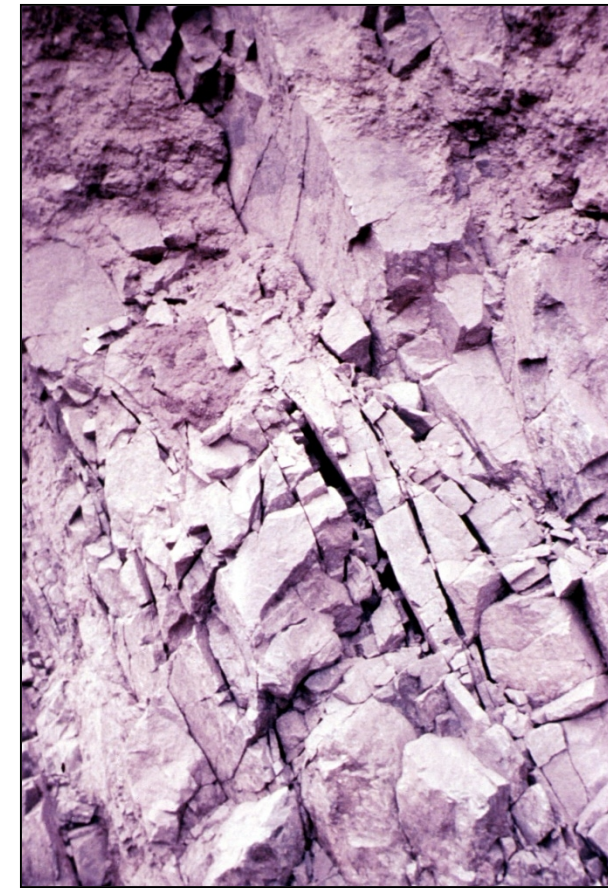
- **Most seepage-related failures of dams have occurred via percolation through fractured bedrock abutments, or along outlet conduits. This concrete-faced earthfill dam near Lima, Peru failed upon its initial filling because of inadequate seepage collars along the outlet works conduit on the right abutment.**

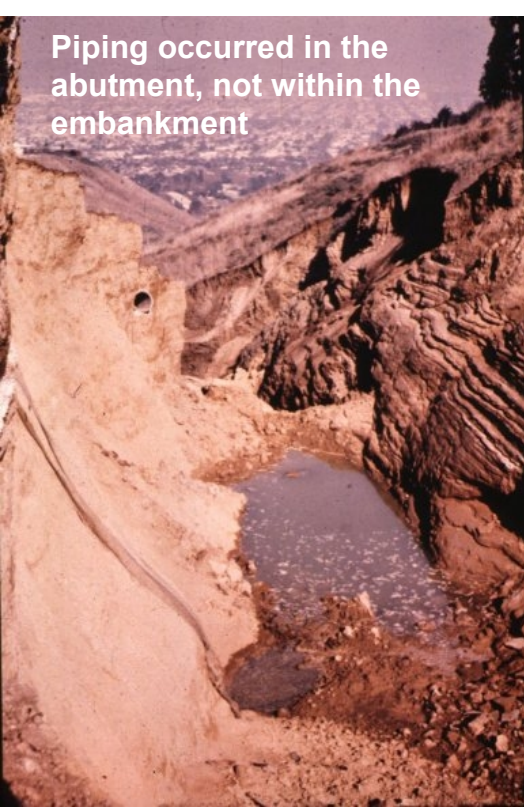
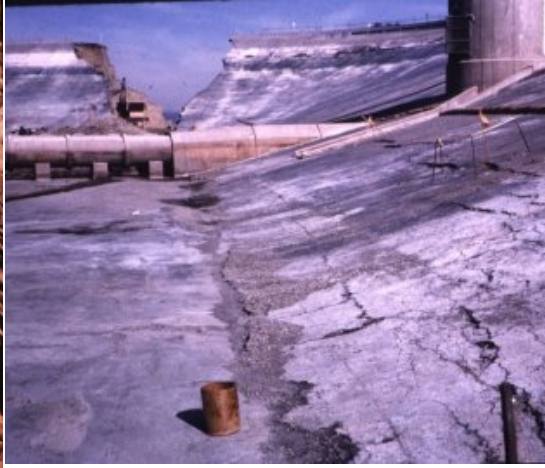
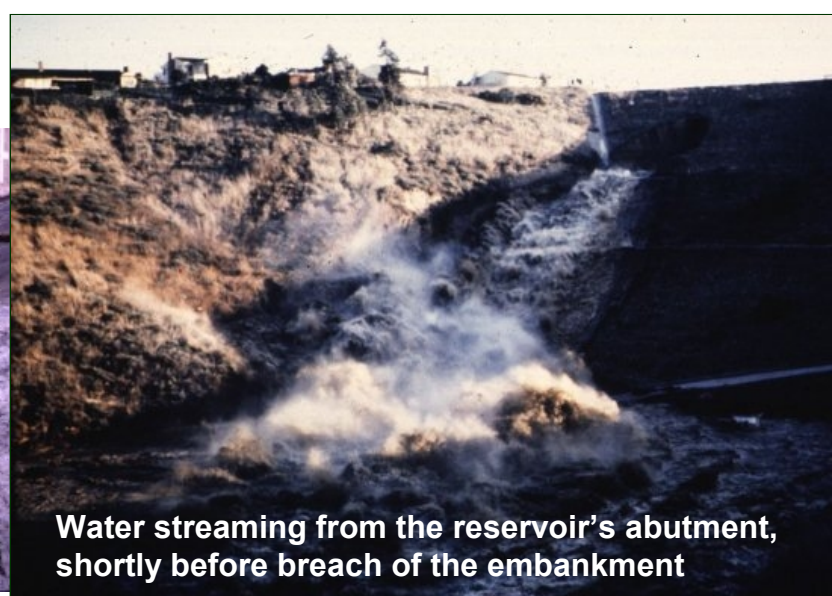
Piping occurred in the abutment, not within the embankment

Piping occurred along a branch of the Newport-Inglewood fault, shown below

Water streaming from the reservoir's abutment, shortly before breach of the embankment

- The **Baldwin Hills Reservoir** in Los Angeles failed in Dec. 1963 by hydraulic piping through the rock abutment, along an active fault that had shifted about 1.5 feet over the previous decade

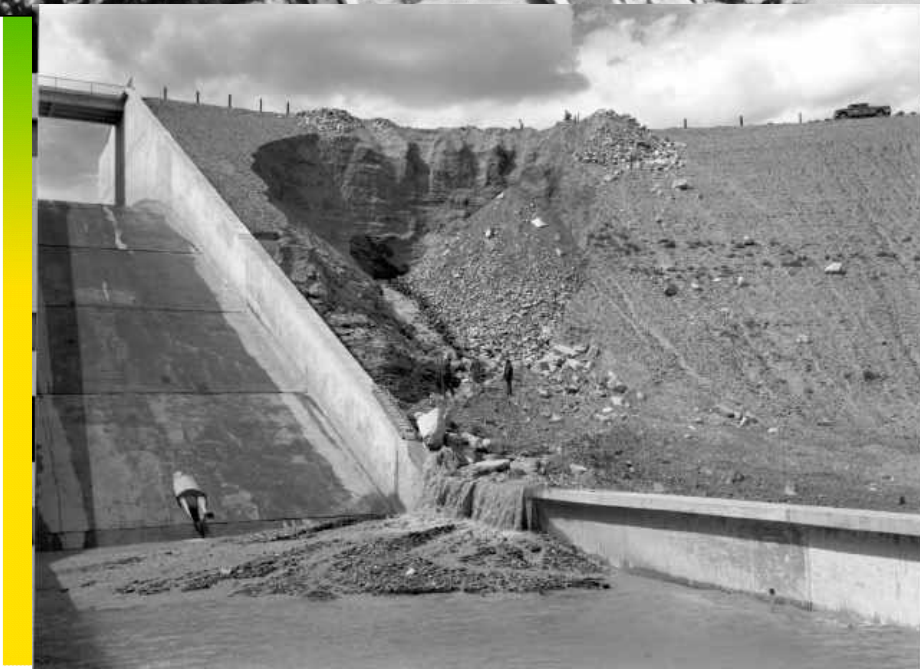
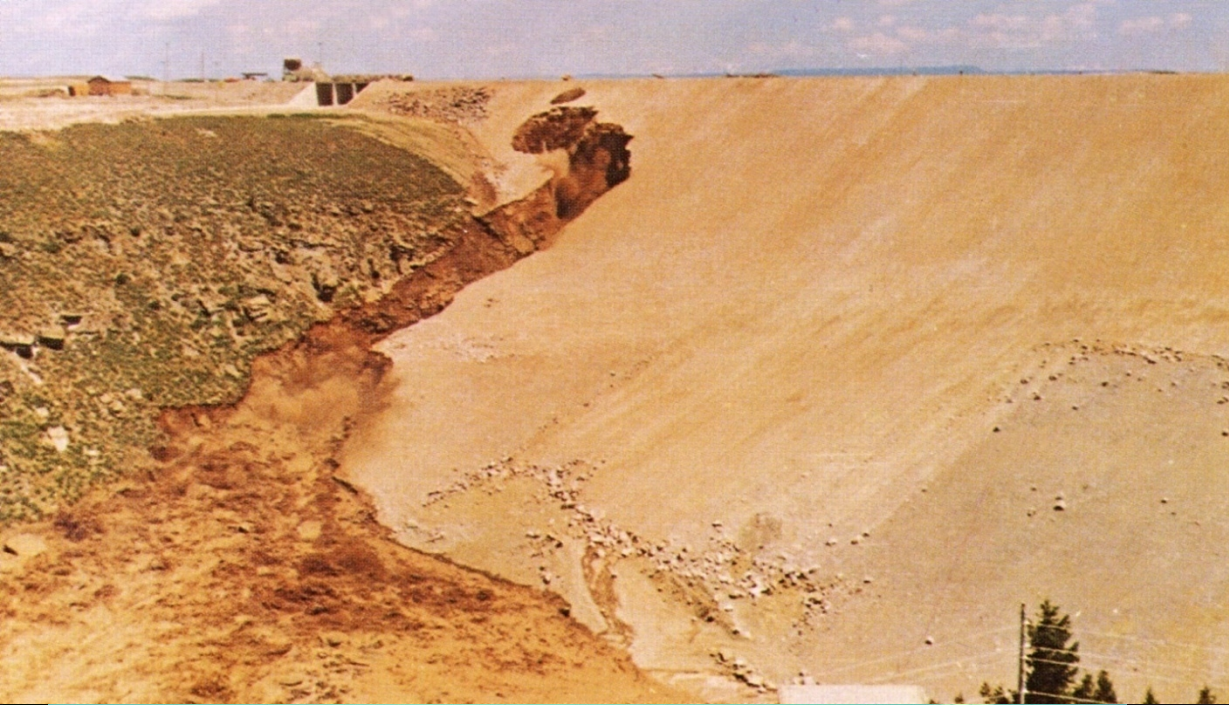
- The **Teton Dam** near Rexburg, Idaho failed by hydraulic piping through the fractured rhyolitic ignimbrite in the right abutment keyway on June 5, 1976, during its initial filling.

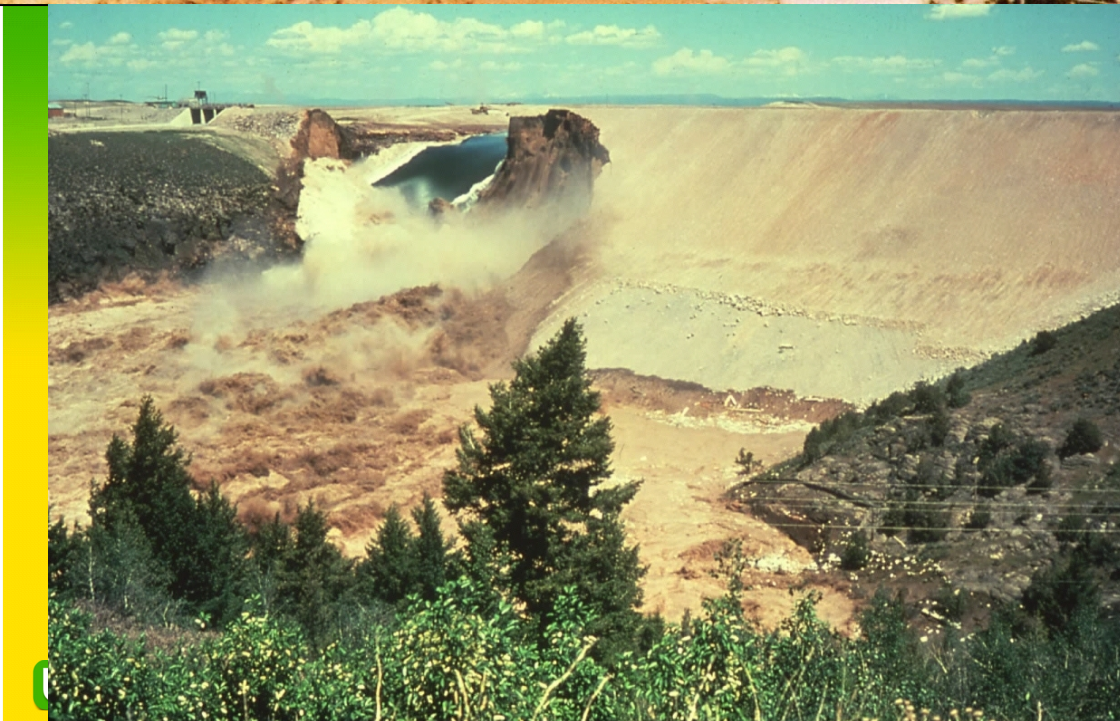
- This could have been prevented by installing a filter between the fill and the fractured rhyolite exposed in the right abutment keyway.

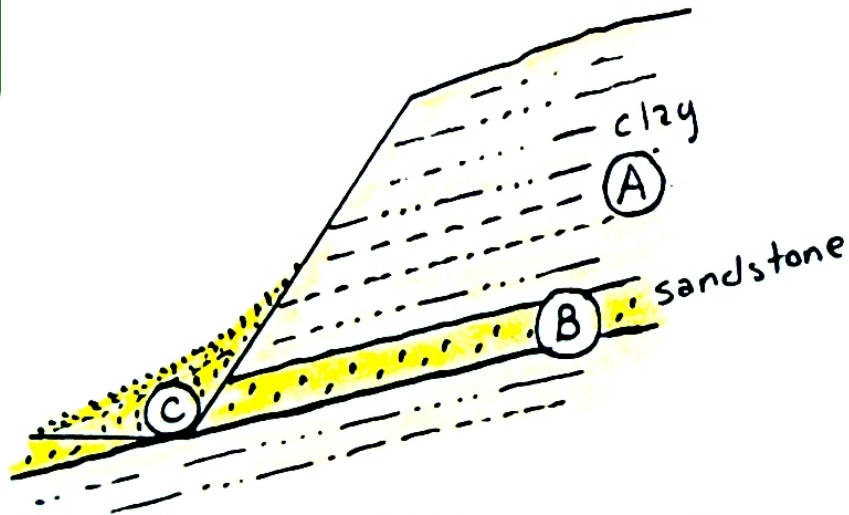
If the groundwater is coming out of the sandstone and not the clay, match filter to the sandstone.

- Filter criteria** should be compared between the aquifers producing seepage and the soil being protected. In this case, the sandstone (B) is producing seepage and the subdrain is comprised of Material C. Material A (shale) may not be a factor if it does not produce moisture

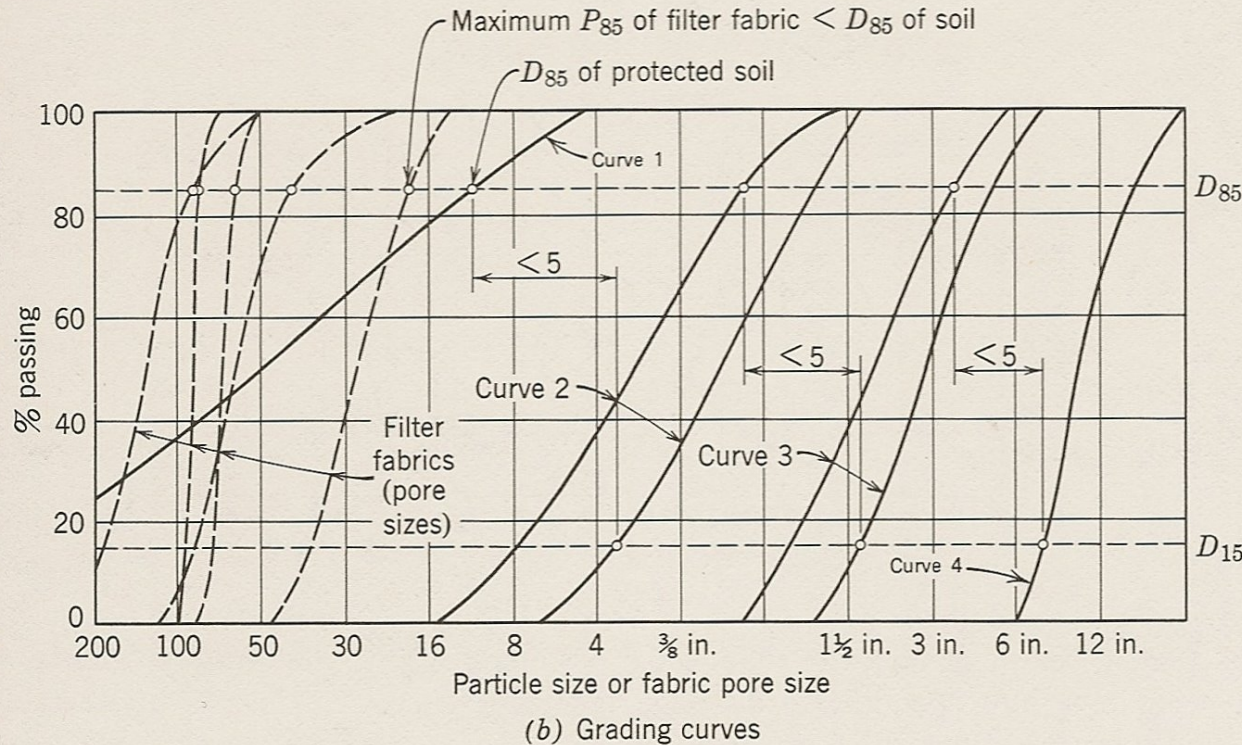
Filter criteria for riprap slope protection of earthen embankments, from Cedergren (1989). Intermediate Filter Curve 2 prevents soil of Curve 1 from washing through the rock cushion (Curve 3) or through the armor rock (Curve 4)

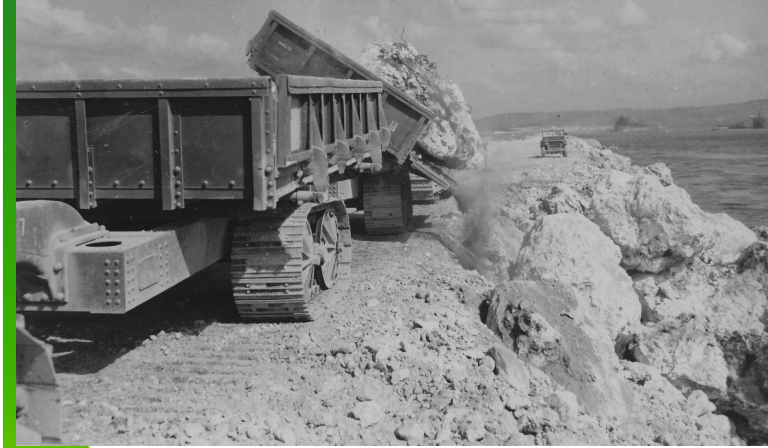
Note size of coral boulders comprising the core of the breakwater fill

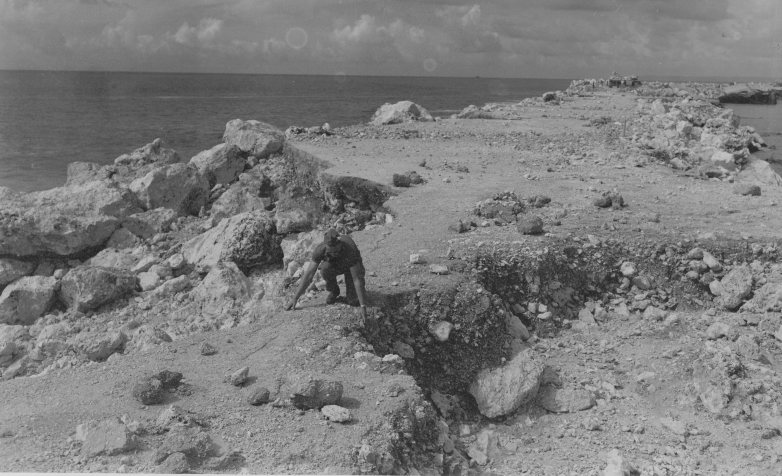
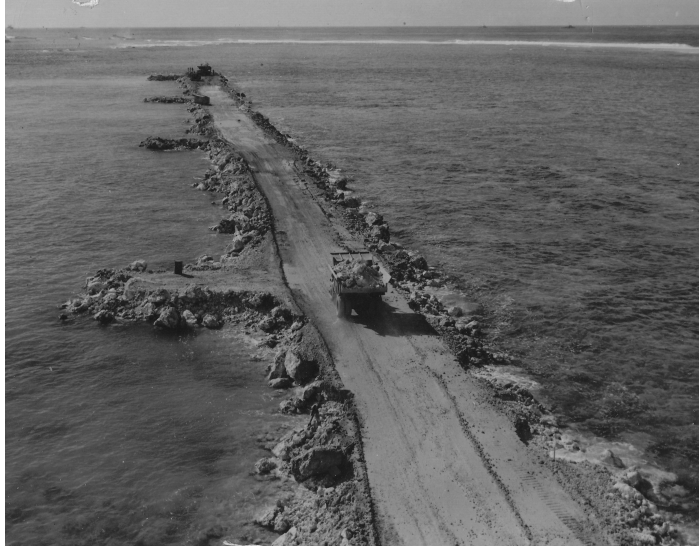
50 ft wide bench on crest of the breakwater was eroded down to 3 feet, only one month after placement!

The Apra Harbor breakwater on Guam constructed by the Navy's 76th NCB in July 1945 – lasted just one month

Fines are easily expunged from a heterogenous rockfill by the pumping action of waves pounding against the breakwater, as seen at right.

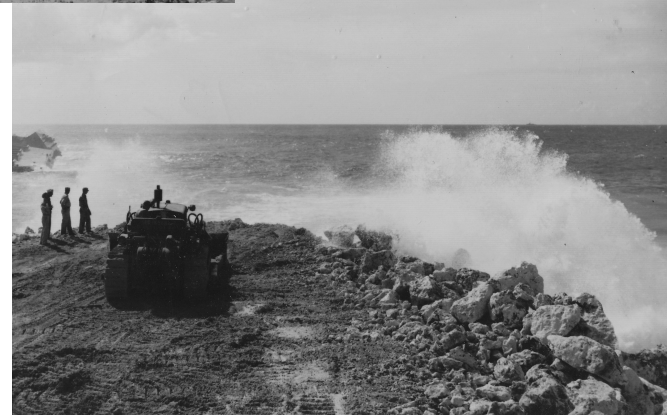
Two months after placement the seaward end of the Apra Harbor breakwater was completely washed away because of lack of filters between massive armor rock and the interstitial fill

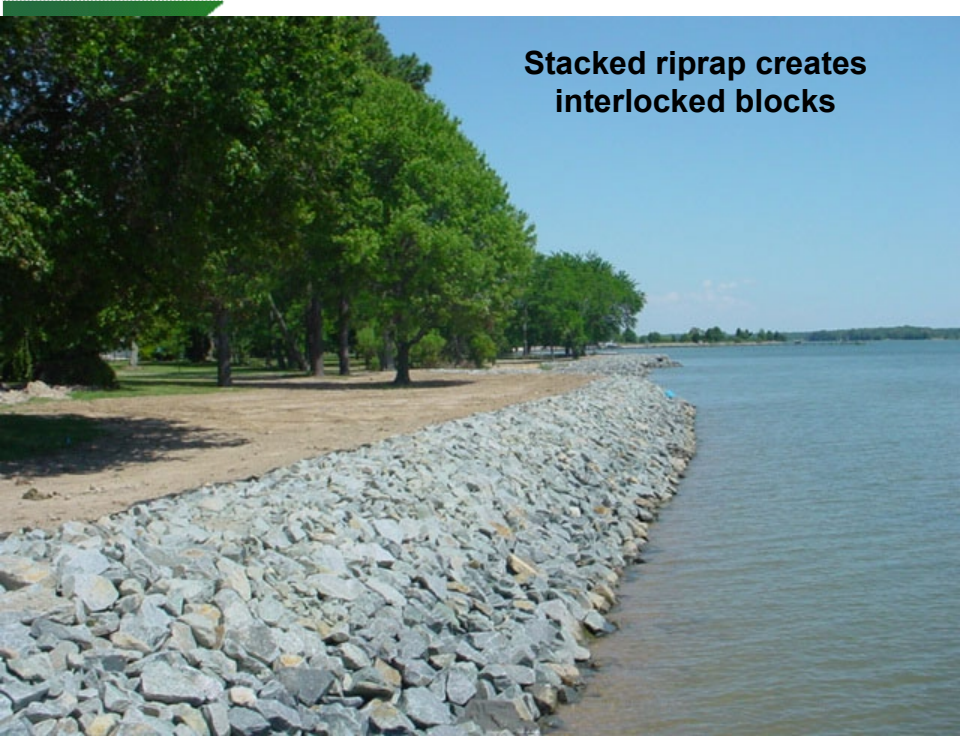
Stacked riprap creates interlocked blocks

- **Upper left:** If riprap is to protect against near-constant wave action, it should be carefully placed, *stacked to interlock*.
- **Lower left:** Rip rap is often *loose dumped* and spread over the downstream face of embankment dams and levees where it is assumed the it retard face erosion, if and when the structure is overtopped
- **Lower right:** *Vegetated boulder revetments*, like this one in Madison, Wisconsin, can be constructed to provide adequate protection and be aesthetically pleasing, important in an urban environment.

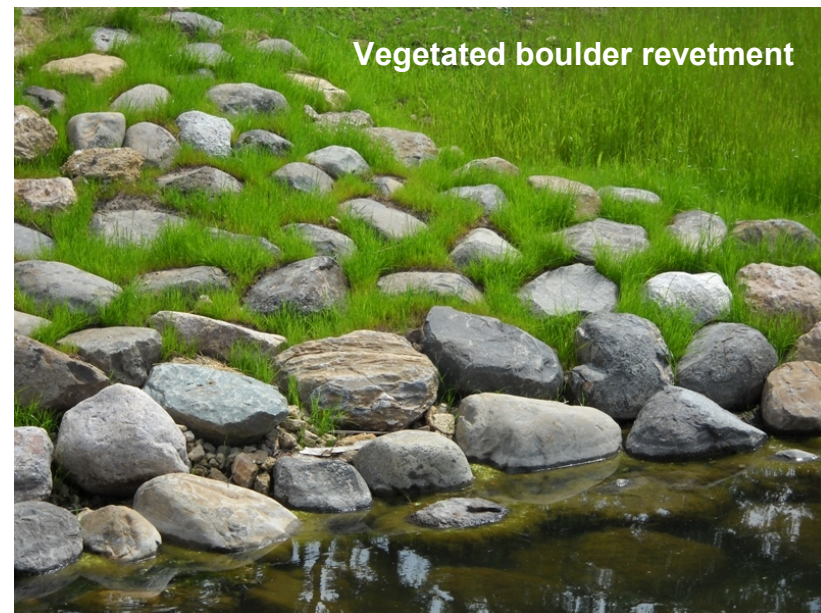
Vegetated boulder revetment

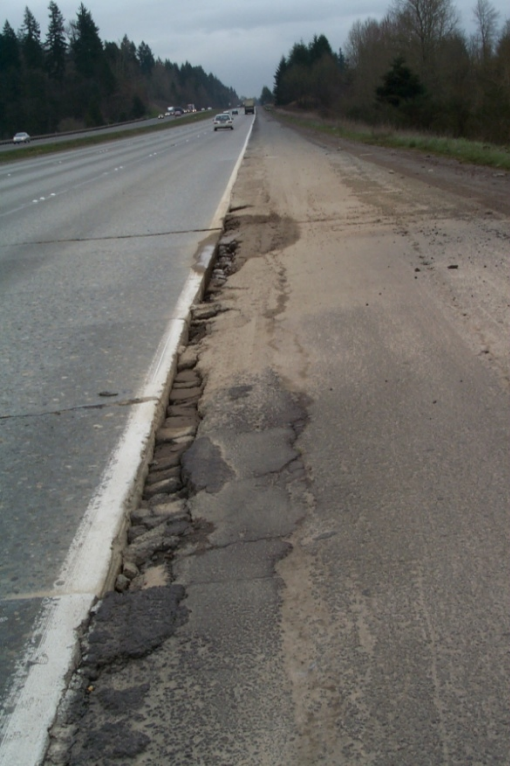
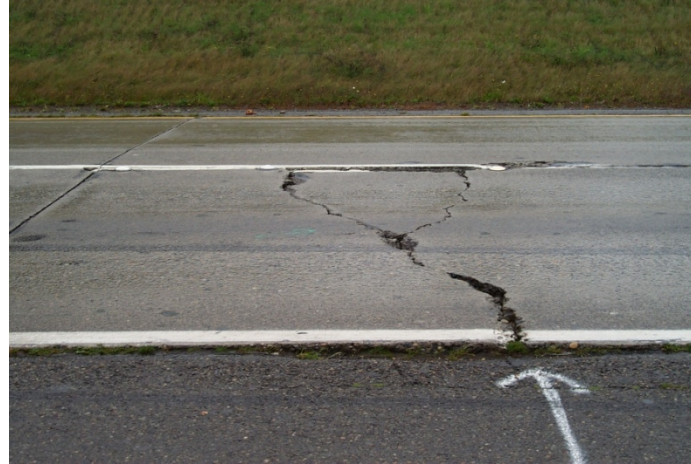
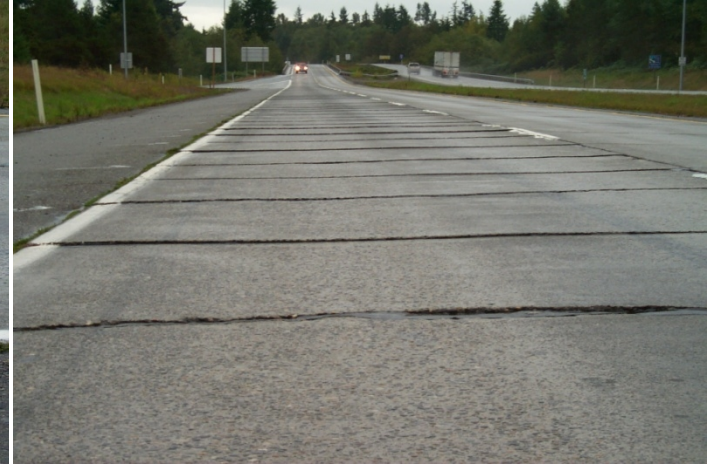
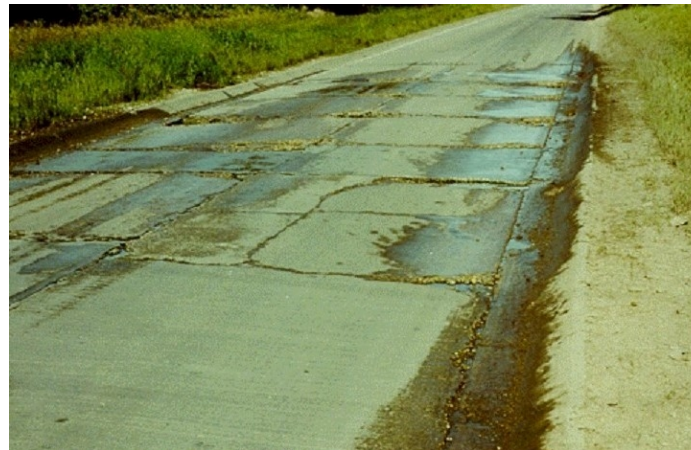
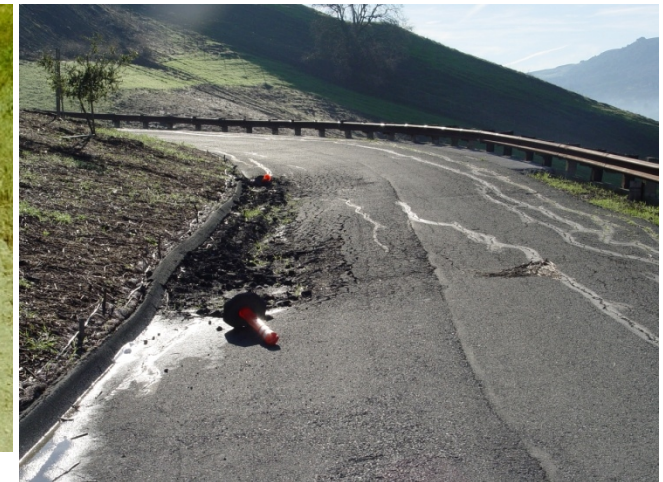
***Pavement Distress* is almost always related to a lack of subdrainage**

- When we see *water seeping up out of the pavement*, this indicates an **inadequate pavement design**. This is particularly problematic in shales and clayey soils.

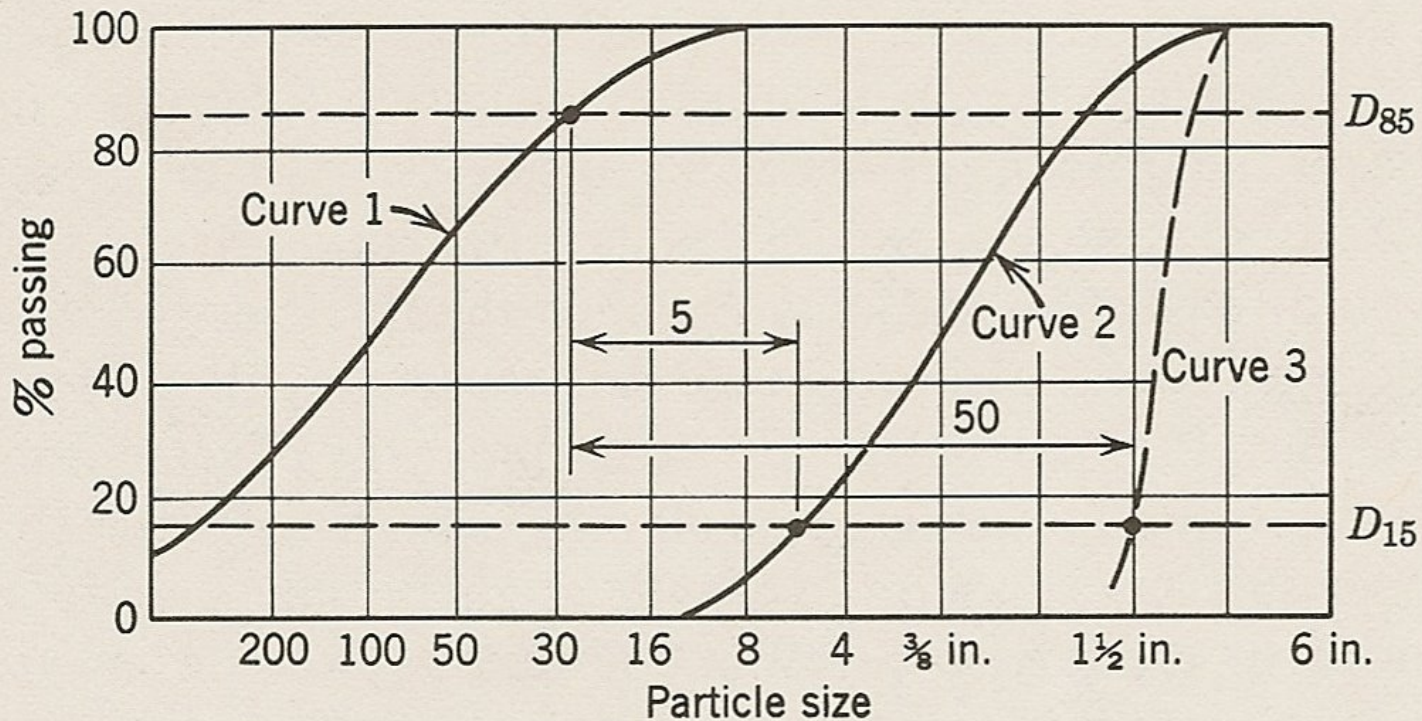
Segregated filter materials are very common if the material is excavated from a river or stream bed. Segregated materials can also cause problems. The D_{15} of the unsegregated filter aggregate (Curve 2) should be no more than $5D_{85}$ of the soil (Curve 1), but the D_{15} of segregated pockets of coarse filter material (curve 3) is actually $50D_{85}$ of the soil! This problem occurs more often than most engineers realize, and leads to poor pavement performance.

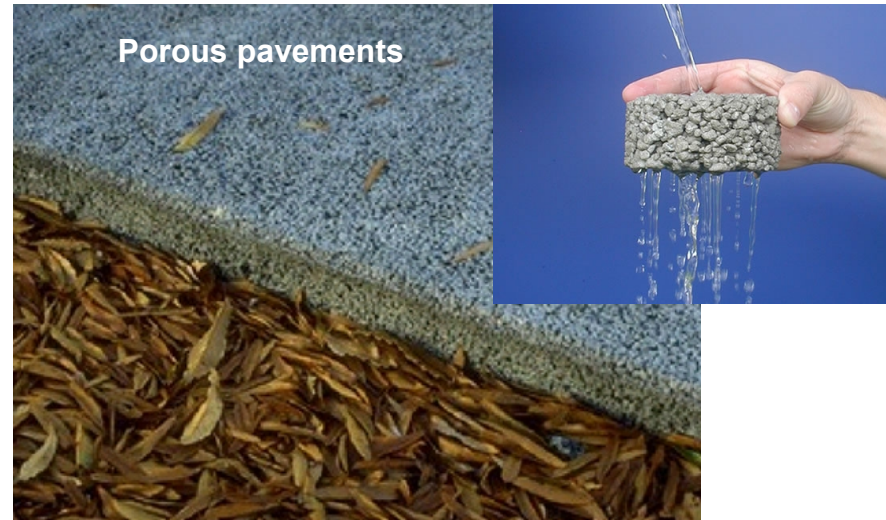
Pervious pavement subgrade beneath paving stones by Vermont DOT

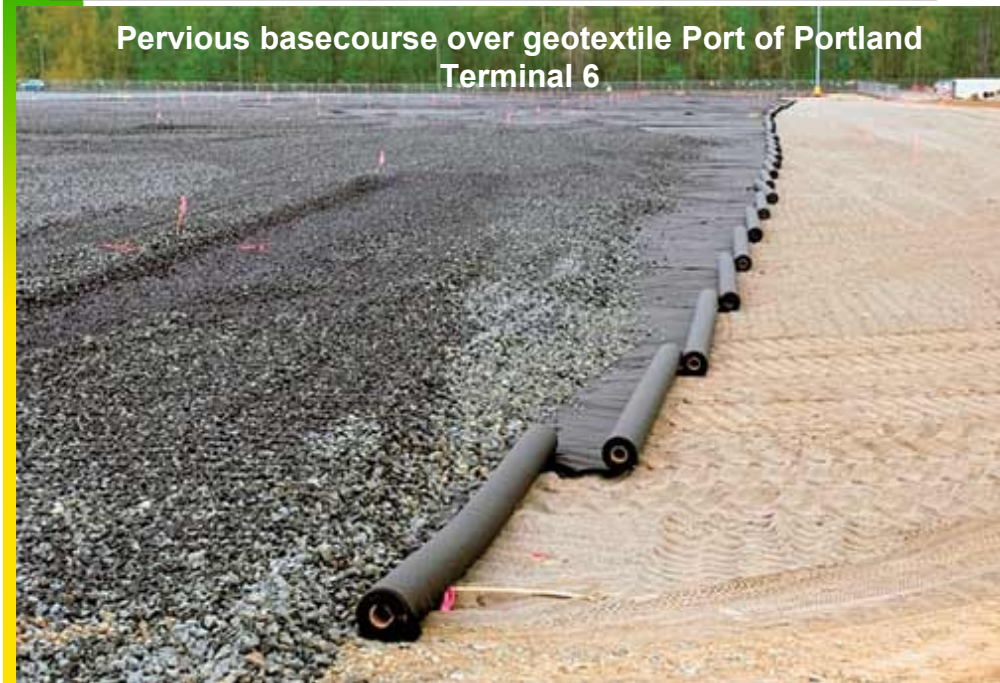
Pervious basecourse over geotextile Port of Portland Terminal 6

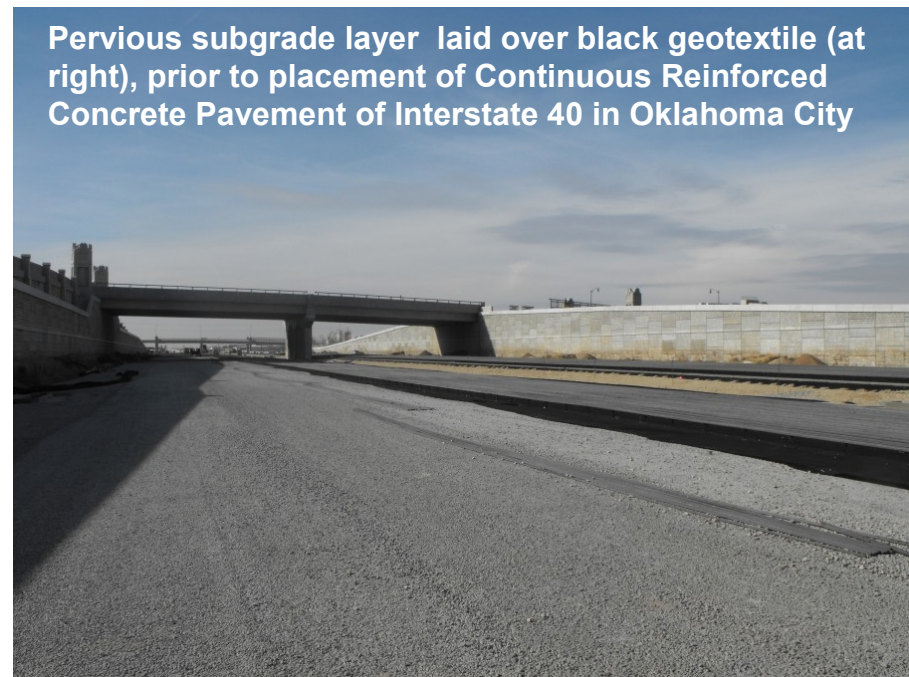
Pervious subgrade layer laid over black geotextile (at right), prior to placement of Continuous Reinforced Concrete Pavement of Interstate 40 in Oklahoma City
