# Earth Fissures in Wadi Najran, Kingdom of Saudi Arabia

**Abstract** The formation of earth fissures due to groundwater depletion has been reported in many places in North America, Europe, and Asia. Najran Basin is in the southern part of the Kingdom of Saudi Arabia, and agricultural activities and other groundwater uses have caused significant groundwater depletion there. The basin recently experienced a sudden appearance of numerous earth fissures. An interdisciplinary study consisting of an evaluation of land-use changes, and hydrological, hydrogeological, and geophysical investigations was conducted to determine the reason for the formation of the earth fissures. The hydrological analysis strongly revealed that the groundwater level is decreasing with time. Groundwater depletion would lead to the accumulation of subsurface stress, causing soil hydro-consolidation which creates the ideal condition for the formation of earth fissures. Electrical resistivity, data indicated that there are anomalies in the profiles, which are most probably due to the presence of subsurface topography, another key factor for the formation of the earth fissures.

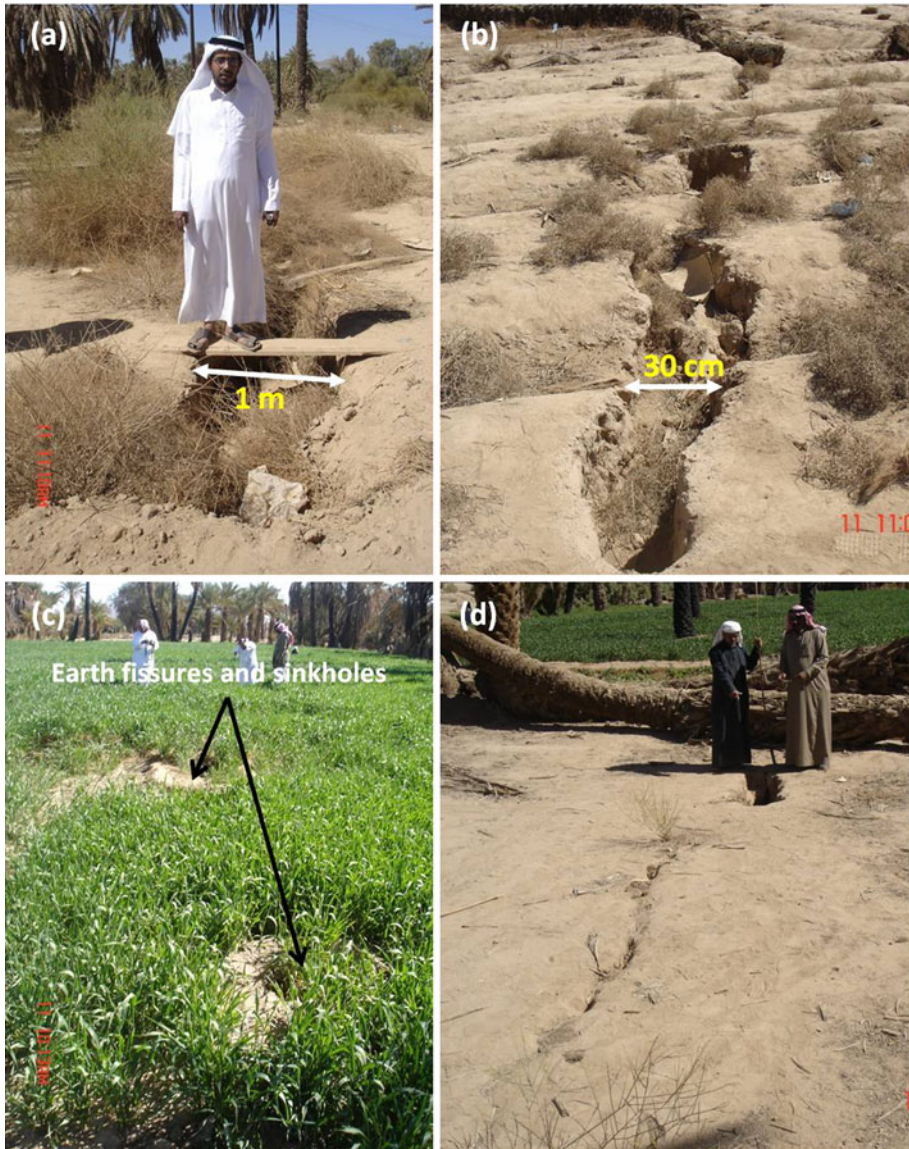
**Fig. 2** Fissuring associated with subsidence due to groundwater withdrawal in Najran (**a** and **b**) in an uninhabited area and (**c** and **d**) in agricultural fields

Earth fissures have suddenly appeared in agricultural and barren areas in the central part of the northern edge of Wadi Najran (Fig. 2). The affected area is privately owned and mainly used for agriculture. The earth fissures have various lengths; one of them extended in a northeast direction for a distance of 600 m and has widths that vary between 30 and 50 cm, and depths of 50–400 cm. The unexpected appearance of the earth fissures caused panic among the farmers and people in the area due to concern that the fissures might interfere with future land use.
