Debris flow impact assessment caused by 14 April 2012 rainfall along the Al-Hada Highway, Kingdom of Saudi Arabia using high-resolution satellite imagery

Ahmed M. Youssef · Biswajeet Pradhan ·
Norbert H. Maerz

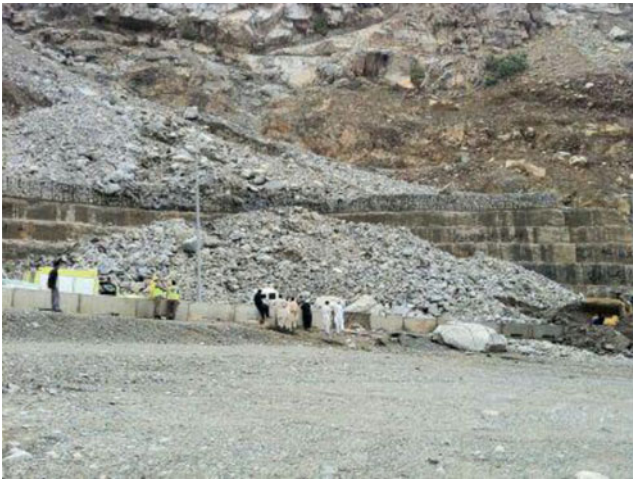
Fig. 4 Debris flow along site 1 in Al-Hada highway and the existing bulkhead type barriers

These debris flows covered the entire road (all four lanes) and led to the closure of the road in both directions for 2 weeks in order to remove the debris along site number 1. One vehicle was trapped by the debris in site 1 (Figs. 4, 5, 6). In site 2, the debris filled up the channel and the entire area behind the jersey barrier walls that were designed to contain the debris flow (Fig. 7).

For this project, the recommended solution involves increasing the volume capacity of the bulkhead type barriers (as shown in Fig. 4) by raising the height of the barriers. We recommend that the structural concrete barriers be designed with appropriate factors of safety against sliding and toppling (based on dynamic loading of the debris flow) with horizontal drain holes along both the length and height of the barrier to reduce pore water pressures and decrease the mobility of the debris flow as it approaches the barrier. The use of techniques to block debris emanating above the highway will also serve to starve the debris flow channels below the highway from mobilizing and affecting the switch back below. It also can be recommended to implement a method for periodically removing the debris from behind the barriers so that debris can be removed following flow events, creating more catchment space for future flow

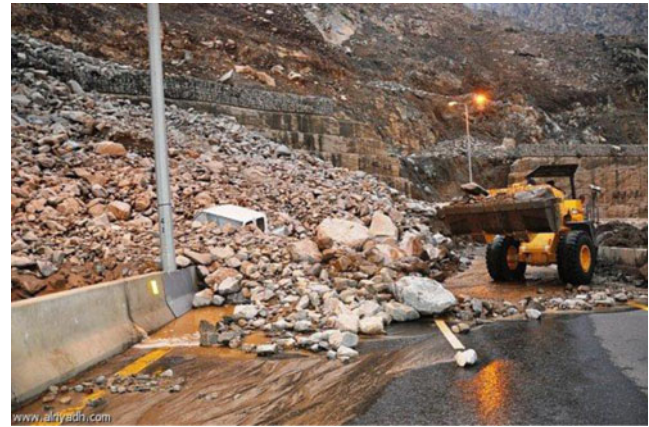
Fig. 6 Removing the debris from the road along site 1

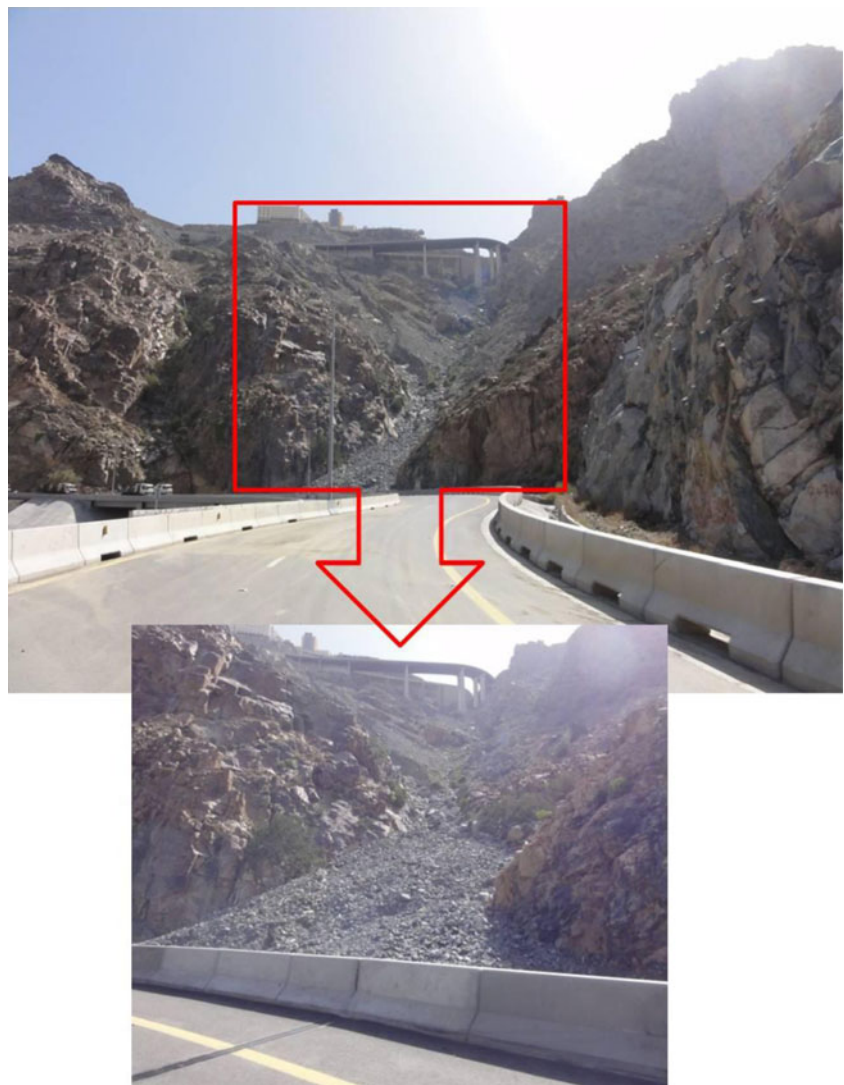
Fig. 7 Debris flow along site 2

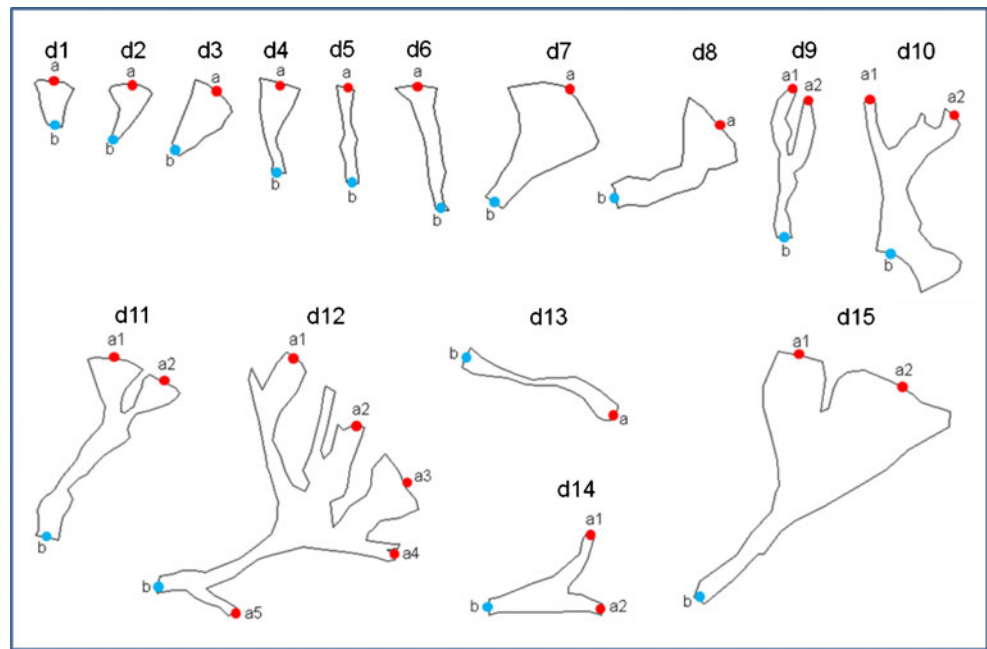
Fig. 9 Outline of the debris flow channels that intersect the Al-Hada highway. Note that the red points indicate the highest elevation on the flow while the blue points indicate the lowest elevation

The debris flow channels were mapped using high-resolution satellite images (QuickBird® imagery with a ground resolution of ~ 61 cm/pixel acquired at the end of 2011) (Fig. 8b) and have been verified during field investigations. Debris flows from the basins may have entrained material along their travel paths; these events were generated from the discrete landslides. The mapped areas and the data collected from the field investigation showed that more than 15 debris flow channels are present (Fig. 9).
