FACTORS CONTRIBUTING TO THE 2005 TAUM SAUK UPPER RESERVOIR FAILURE

December 14, 2005

Reynolds County, Missouri

RECONSTRUCTED FAILURE SEQUENCE

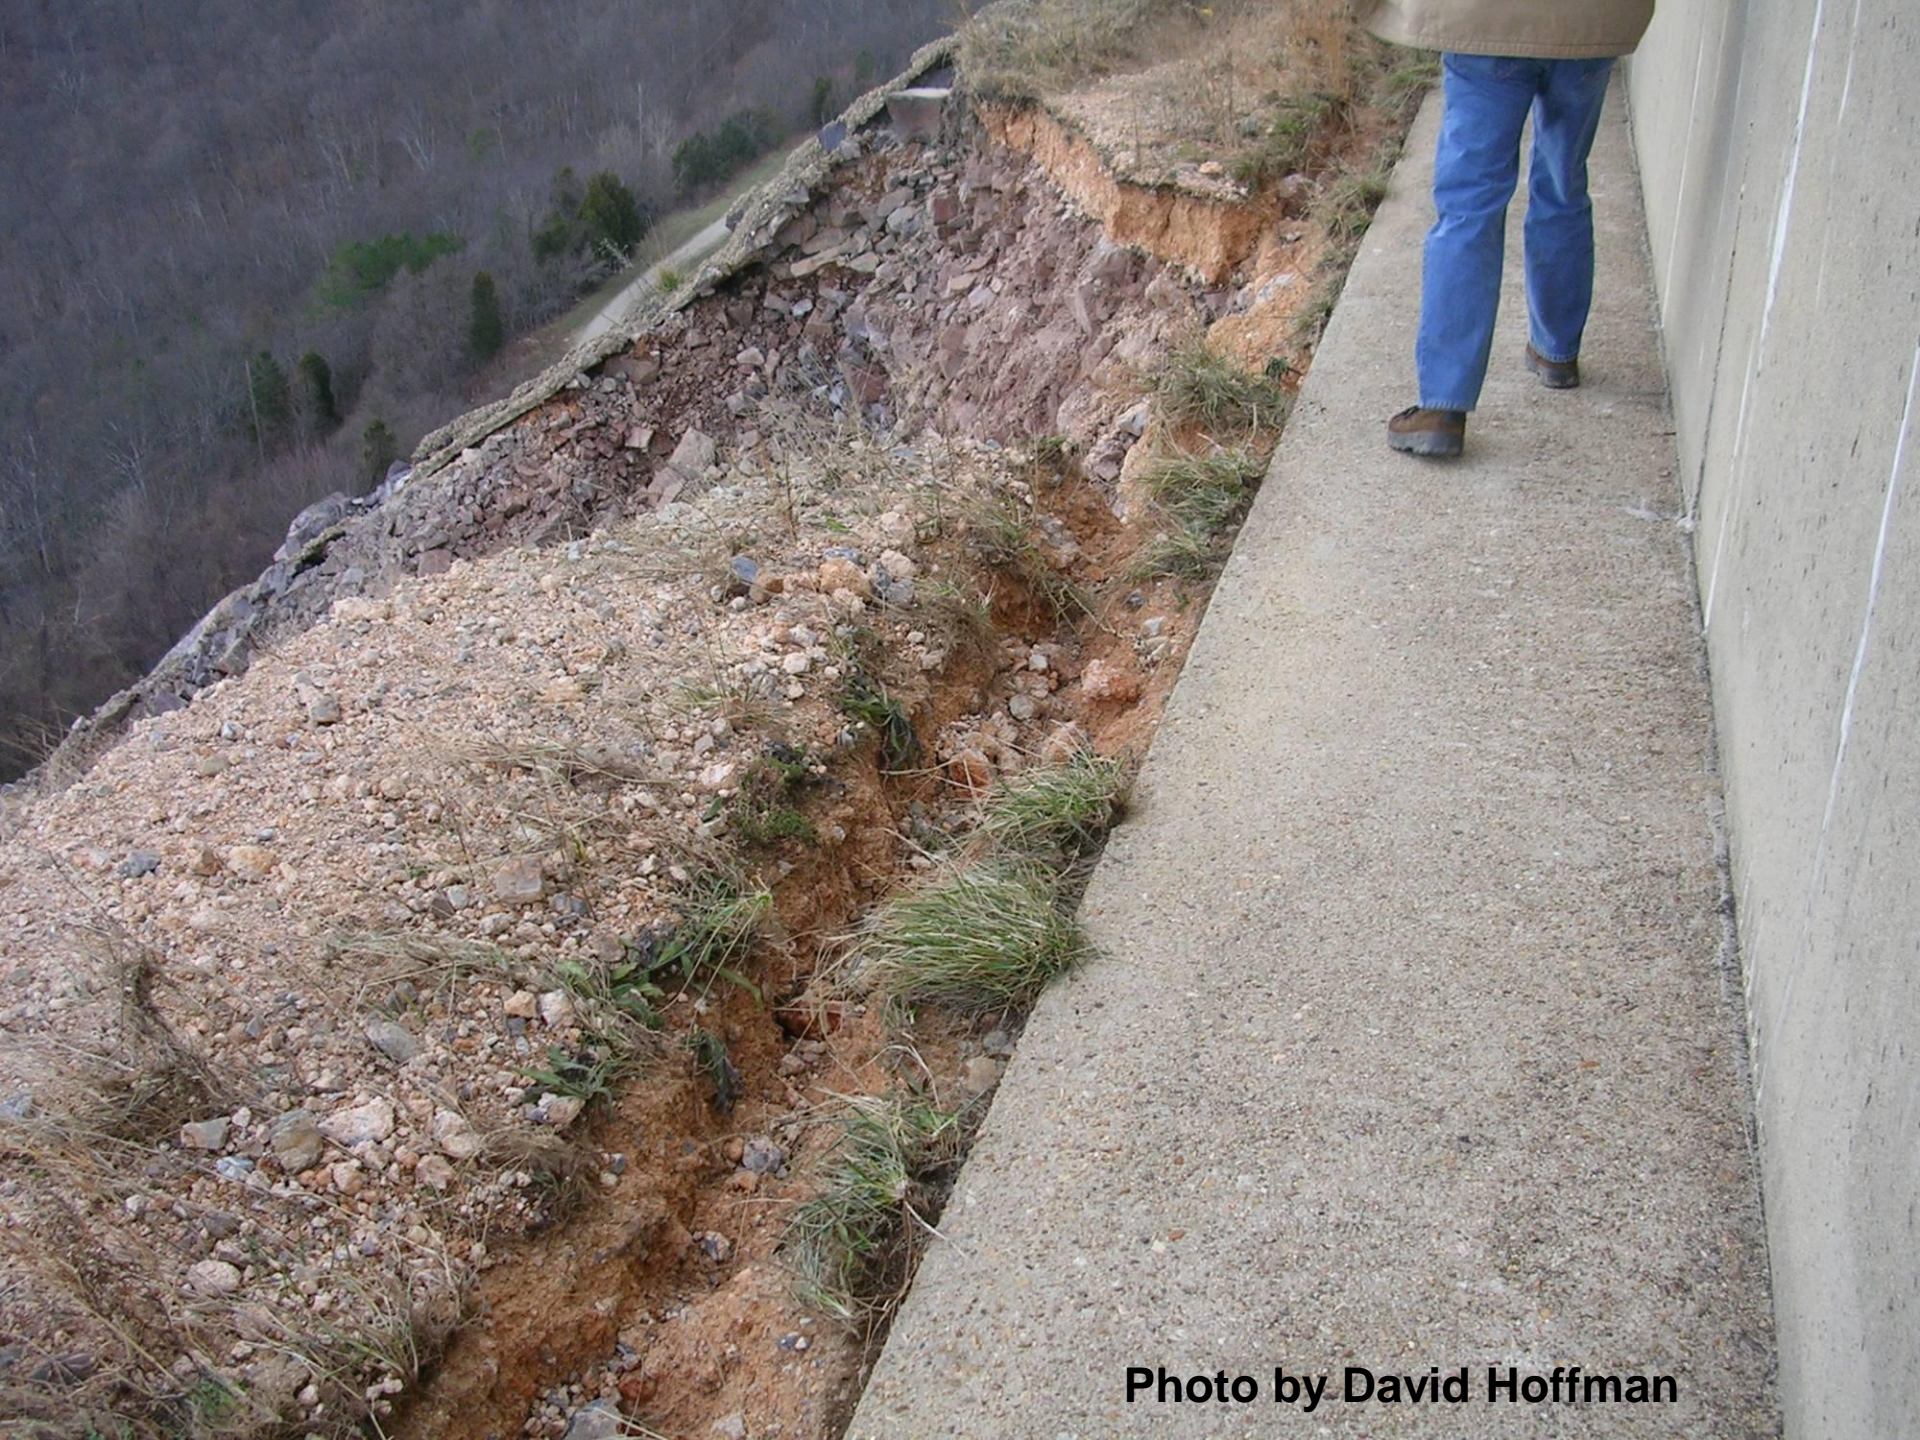
**STEP 4: Overtopping depth of 4.0 inches
- lower nappe offset 2.95 ft**

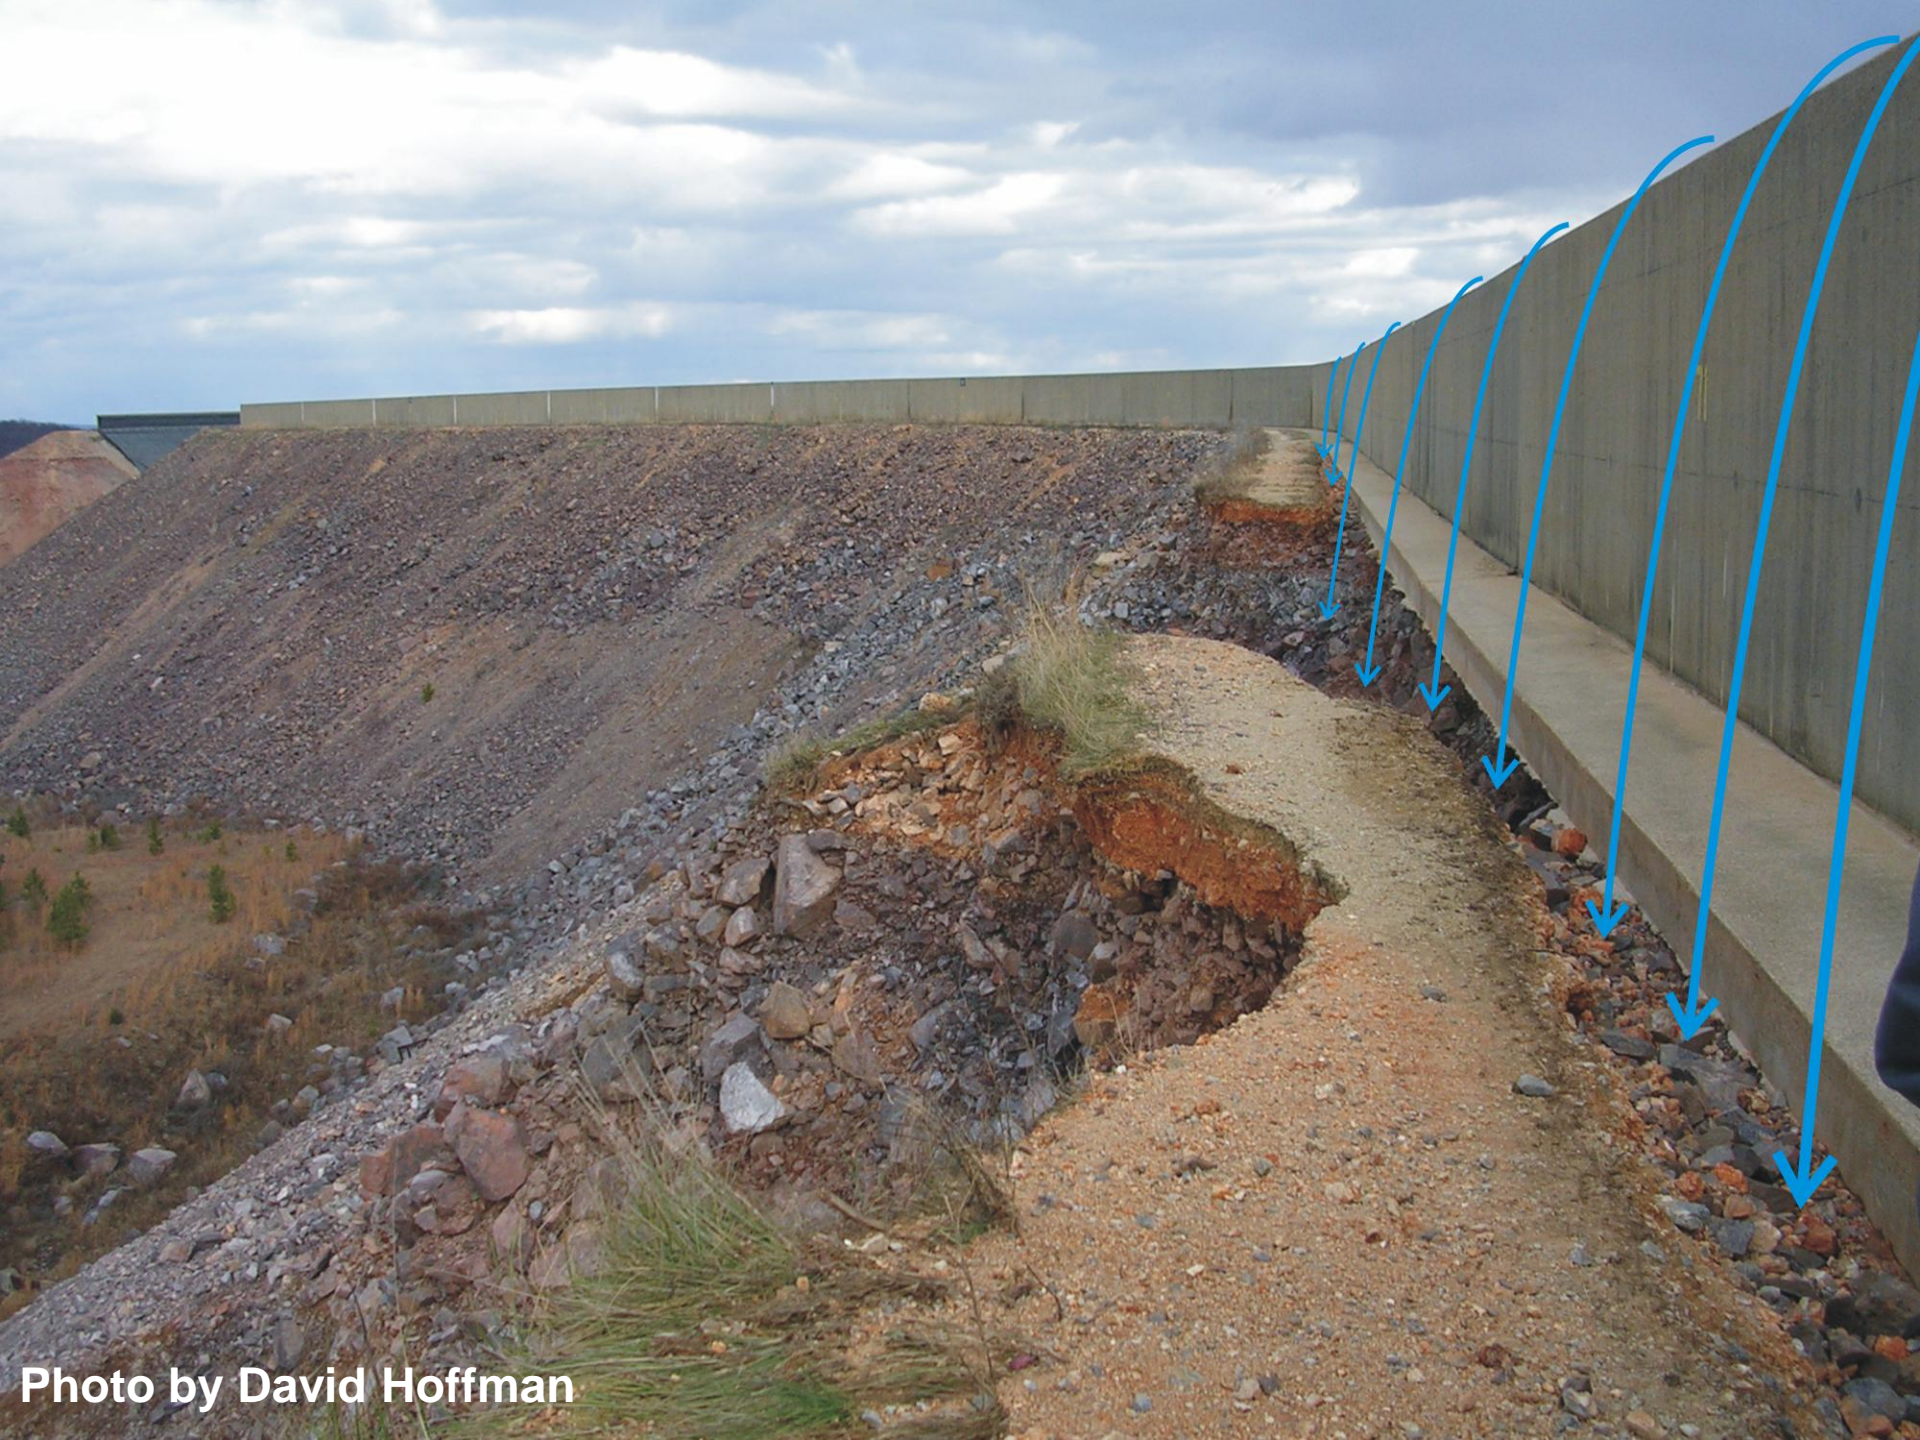
**STEP 5: Overtopping depth of 4.6 inches
- lower nappe offset 3.15 ft, just beyond
wall footing**

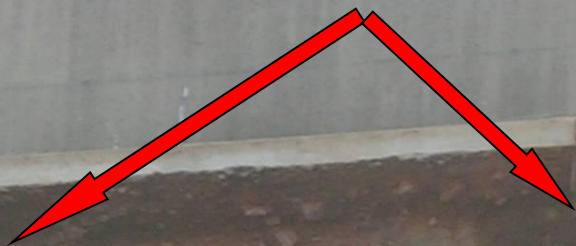
72

**Exposed foundation
of parapet wall**

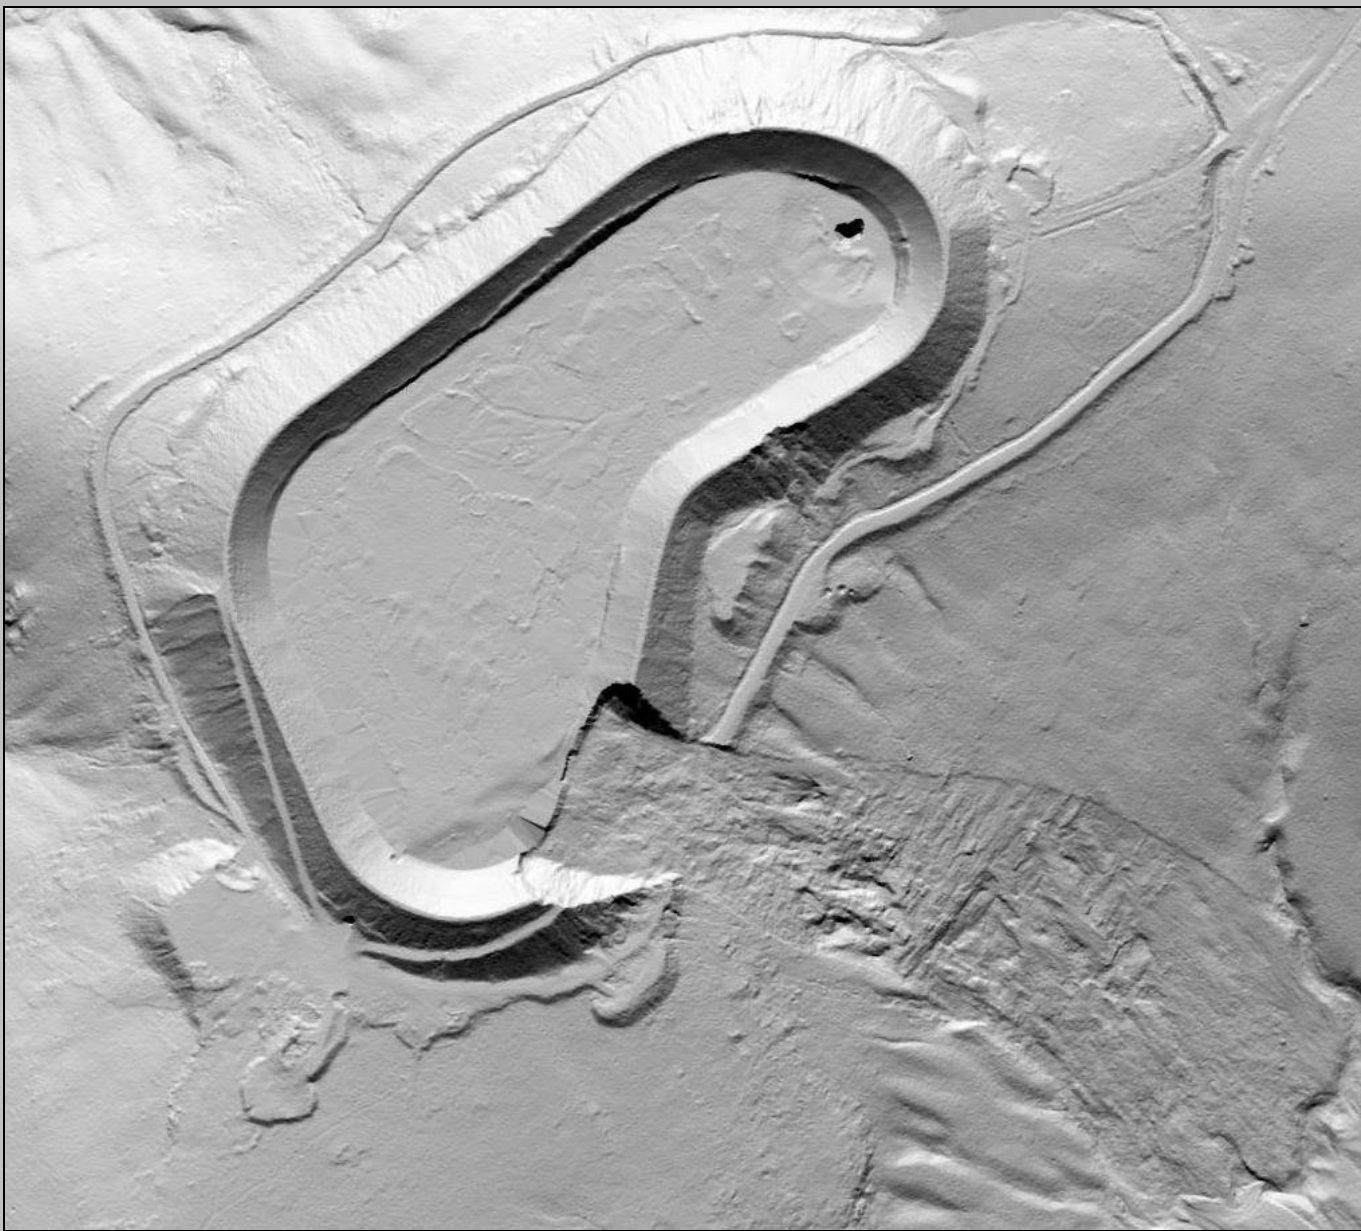
- **Note details in LiDAR derived digital elevation model, and scour of the outbreak flood path.**

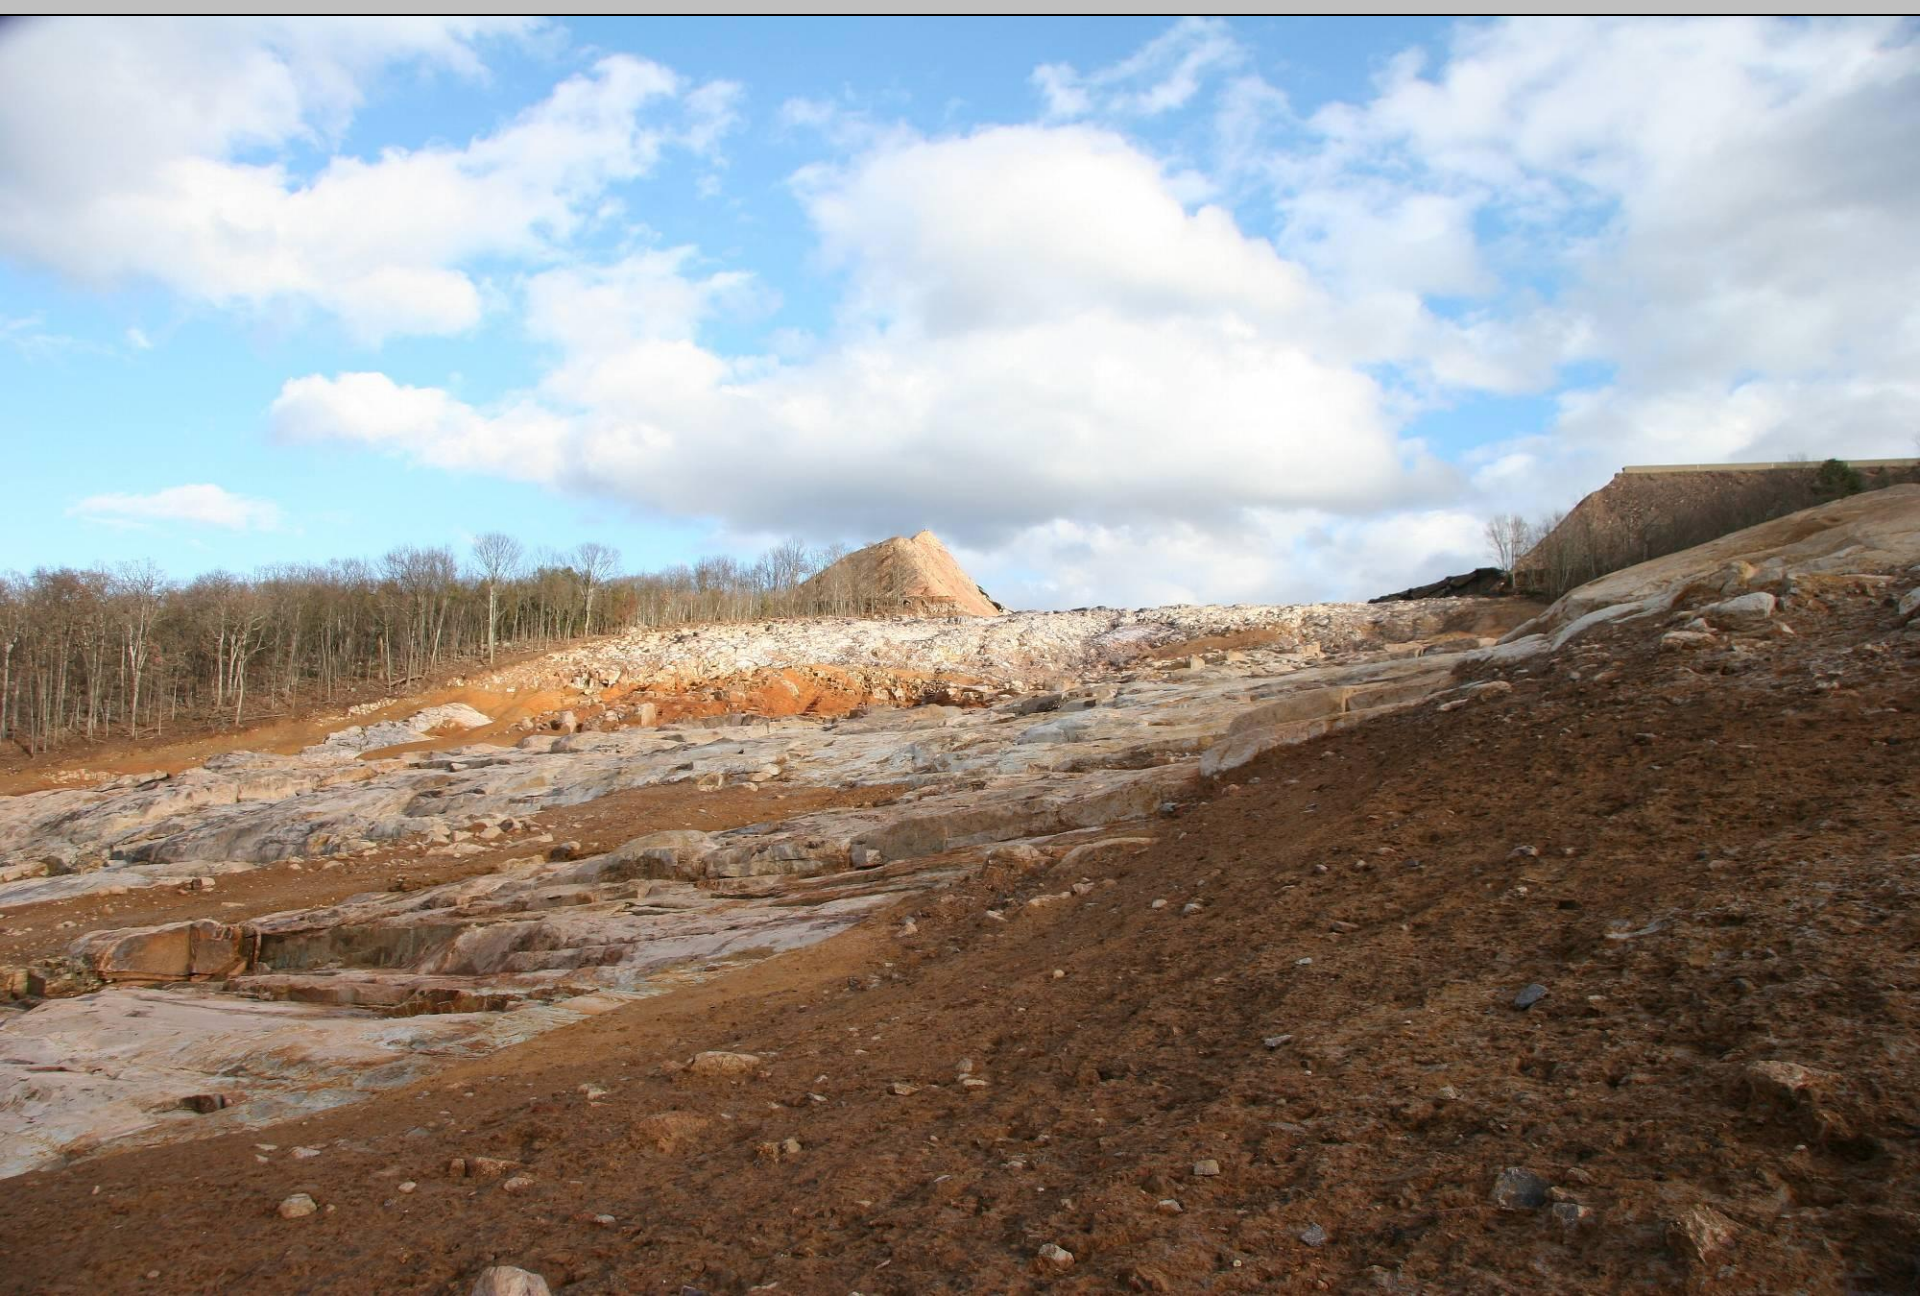
Standing on residuum looking at exposures of the Munger Granite.

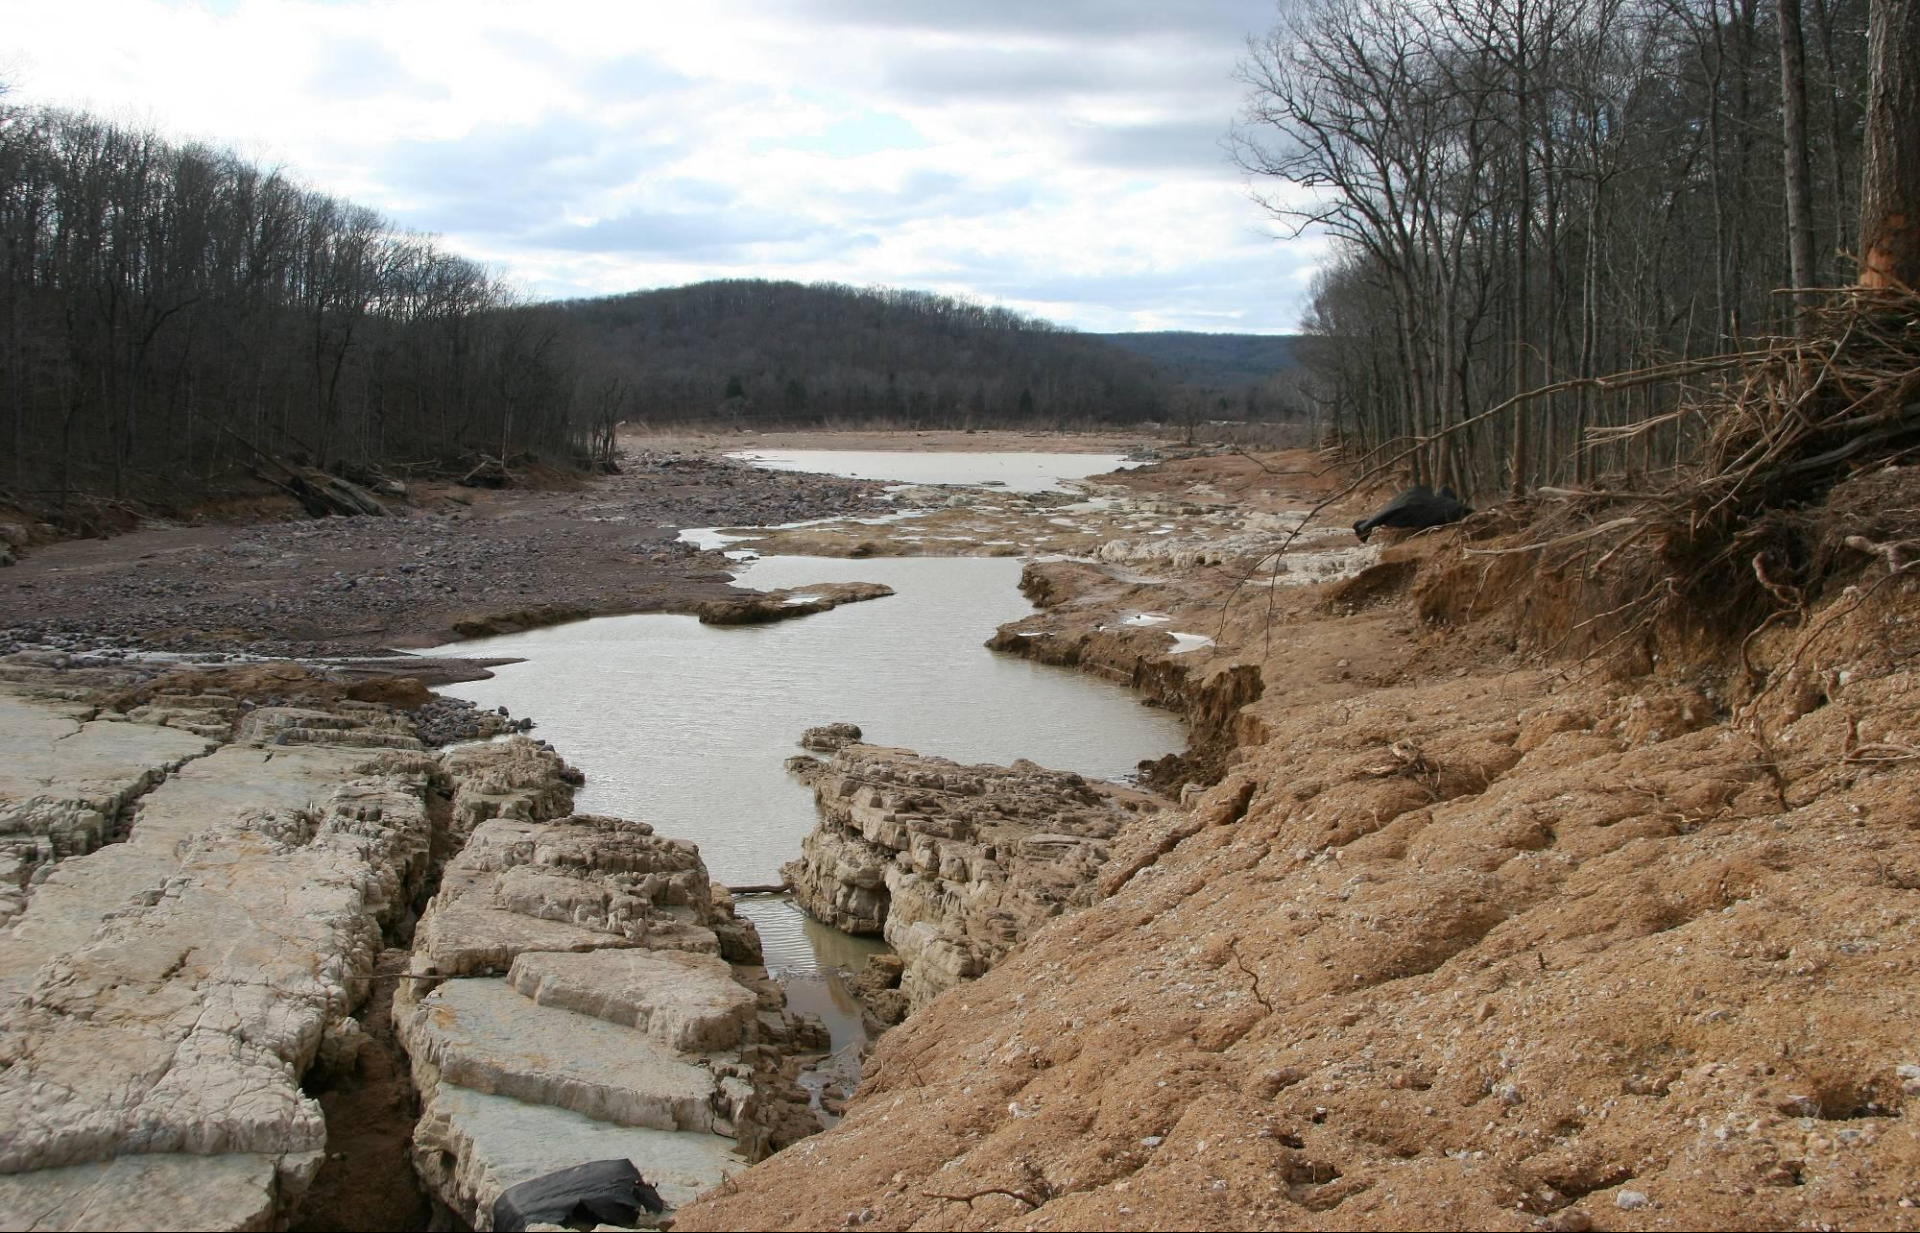
Concrete and rebar from the dike littered the scour channel.

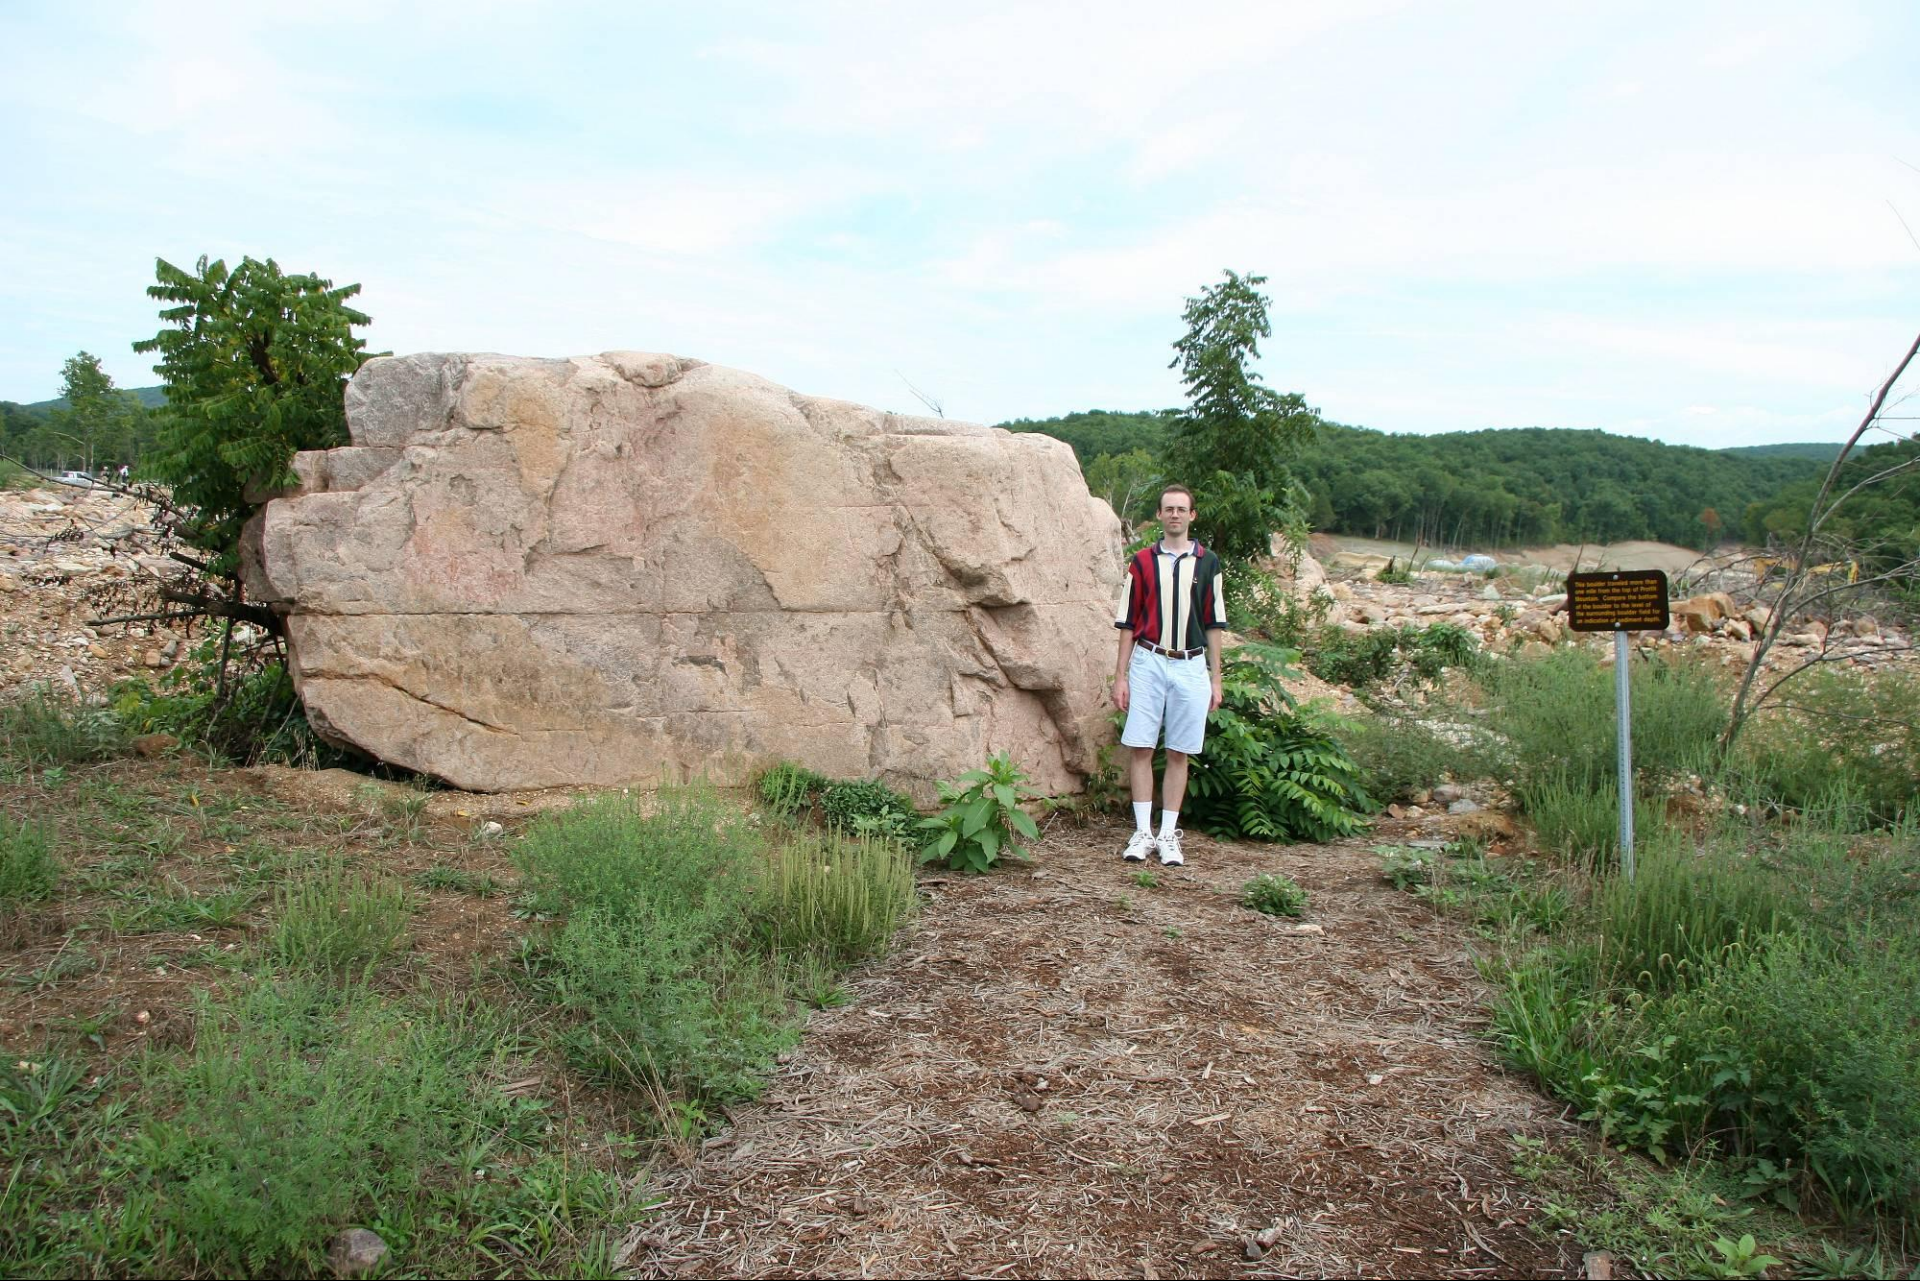
This boulder was carried over a down the slopes of Proffit Mountain and was deposited a few hundred feet from the Superintendent's home.

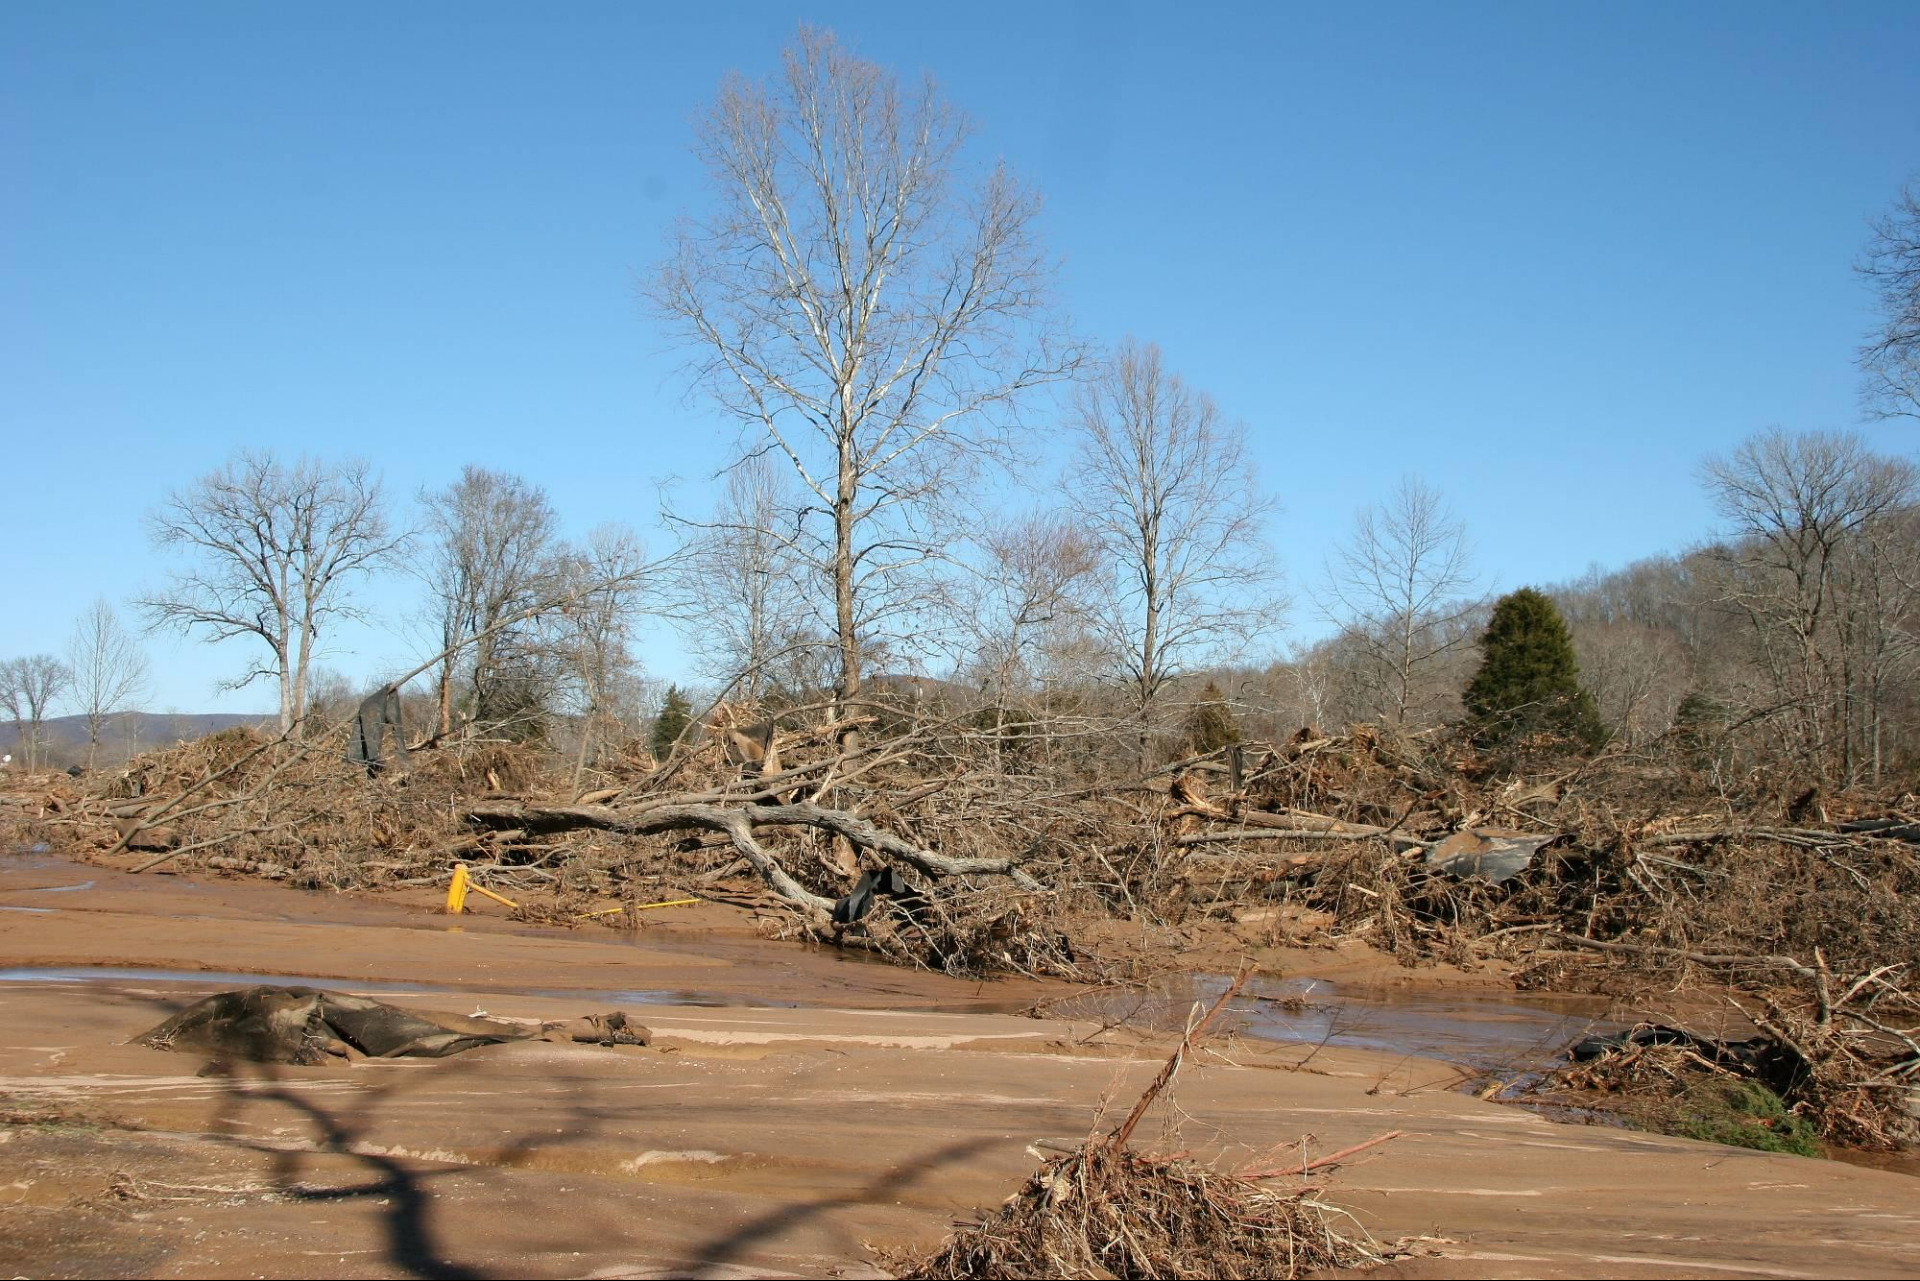
Had campers been in the state park campground during the flood, they would have almost certainly been swept into the shut-ins and killed.

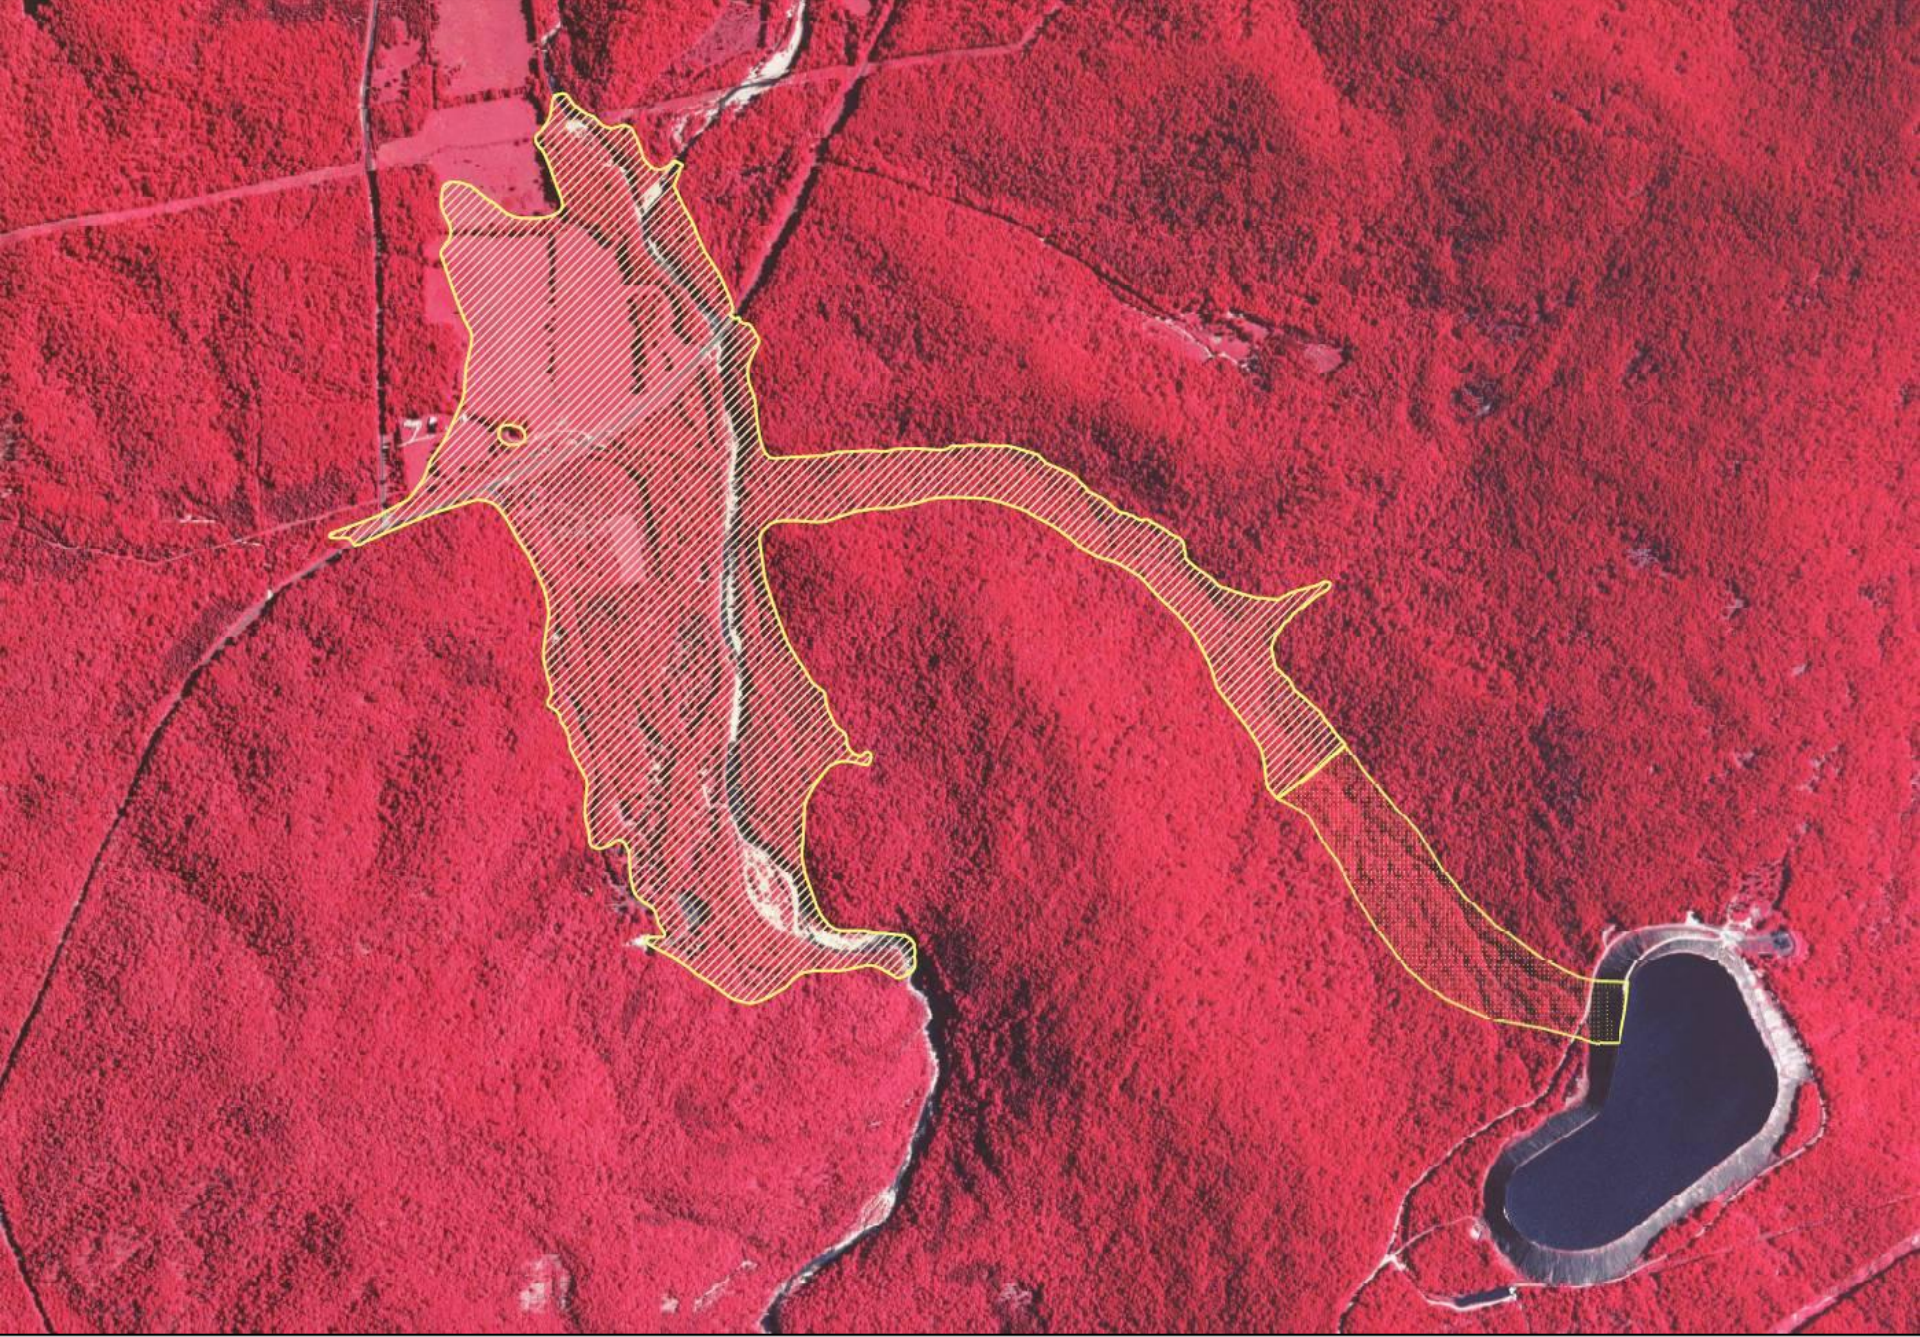
Areas inundated by the flood, as mapped by the USGS-MCGSC team.
