PANAMA CANAL: THE WORLD'S LANDSLIDE LABORATORY

J. David Rogers, Ph.D., P.E., P.G.

2007 Annual Meeting

Association of Environmental and Engineering Geologists

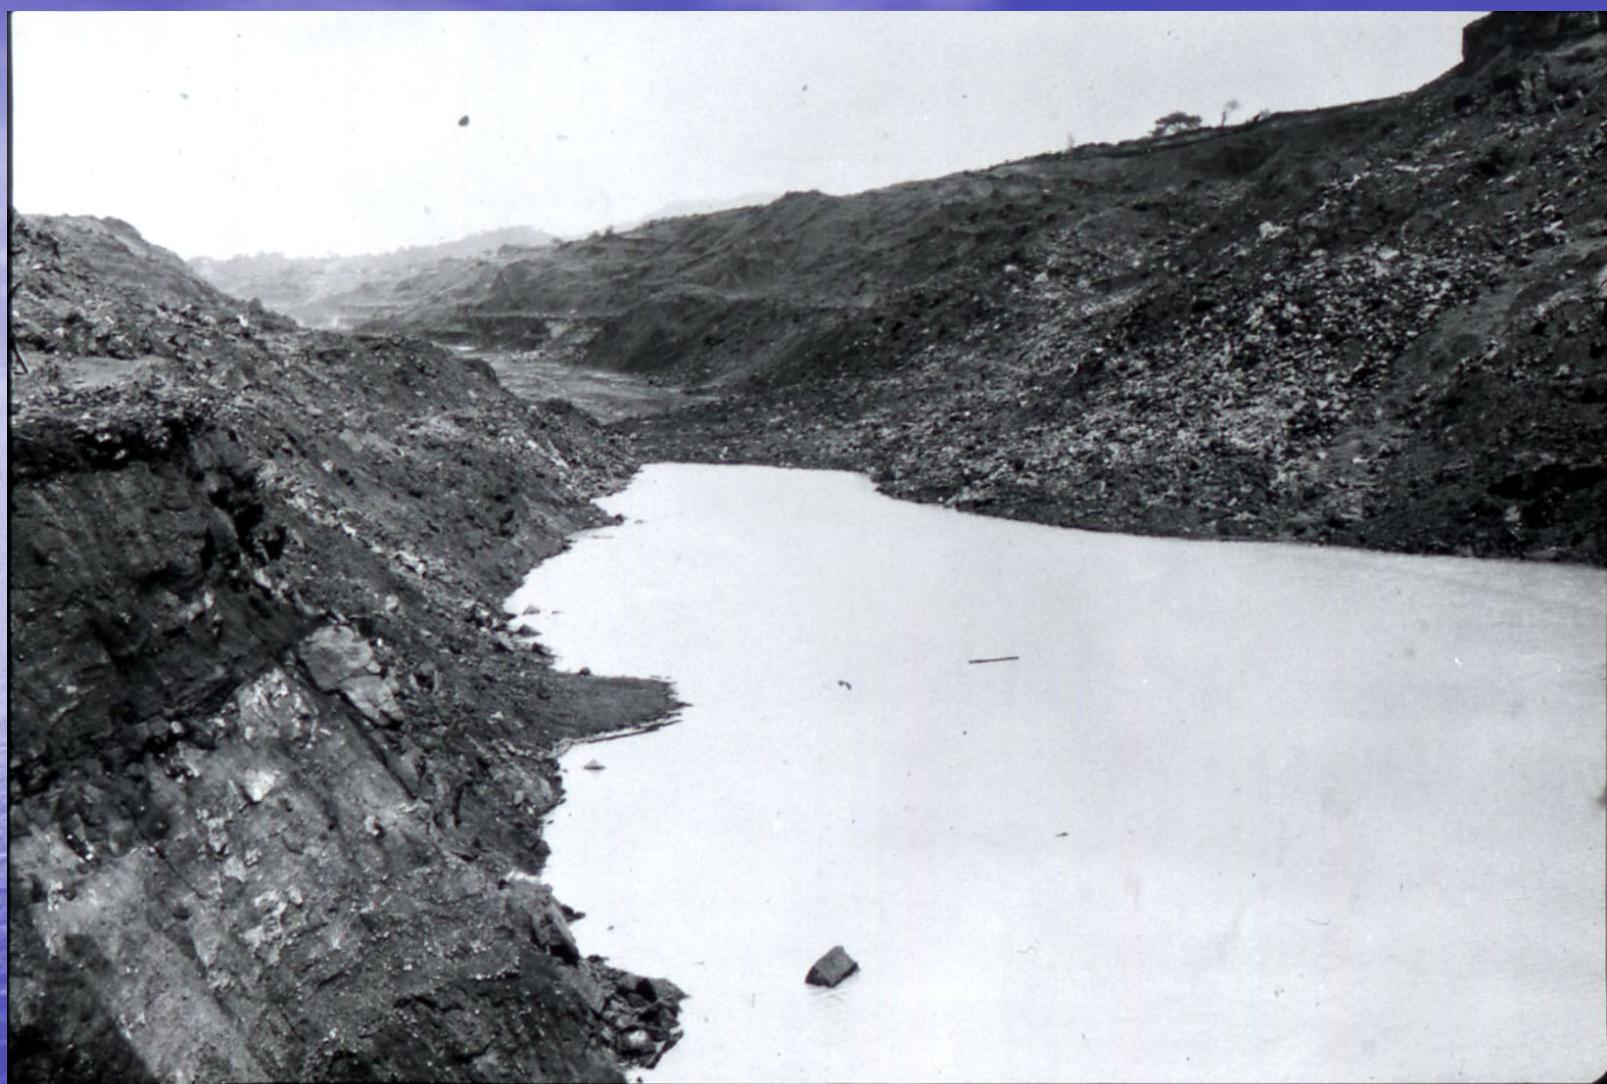
- Landslides began to plague the French excavations in the vicinity of Cucaracha and Culebra in 1886, severing their trunk rail lines. In addition to slides, they fought a losing battle with Yellow Fever and Malaria, and went bankrupt in 1889.

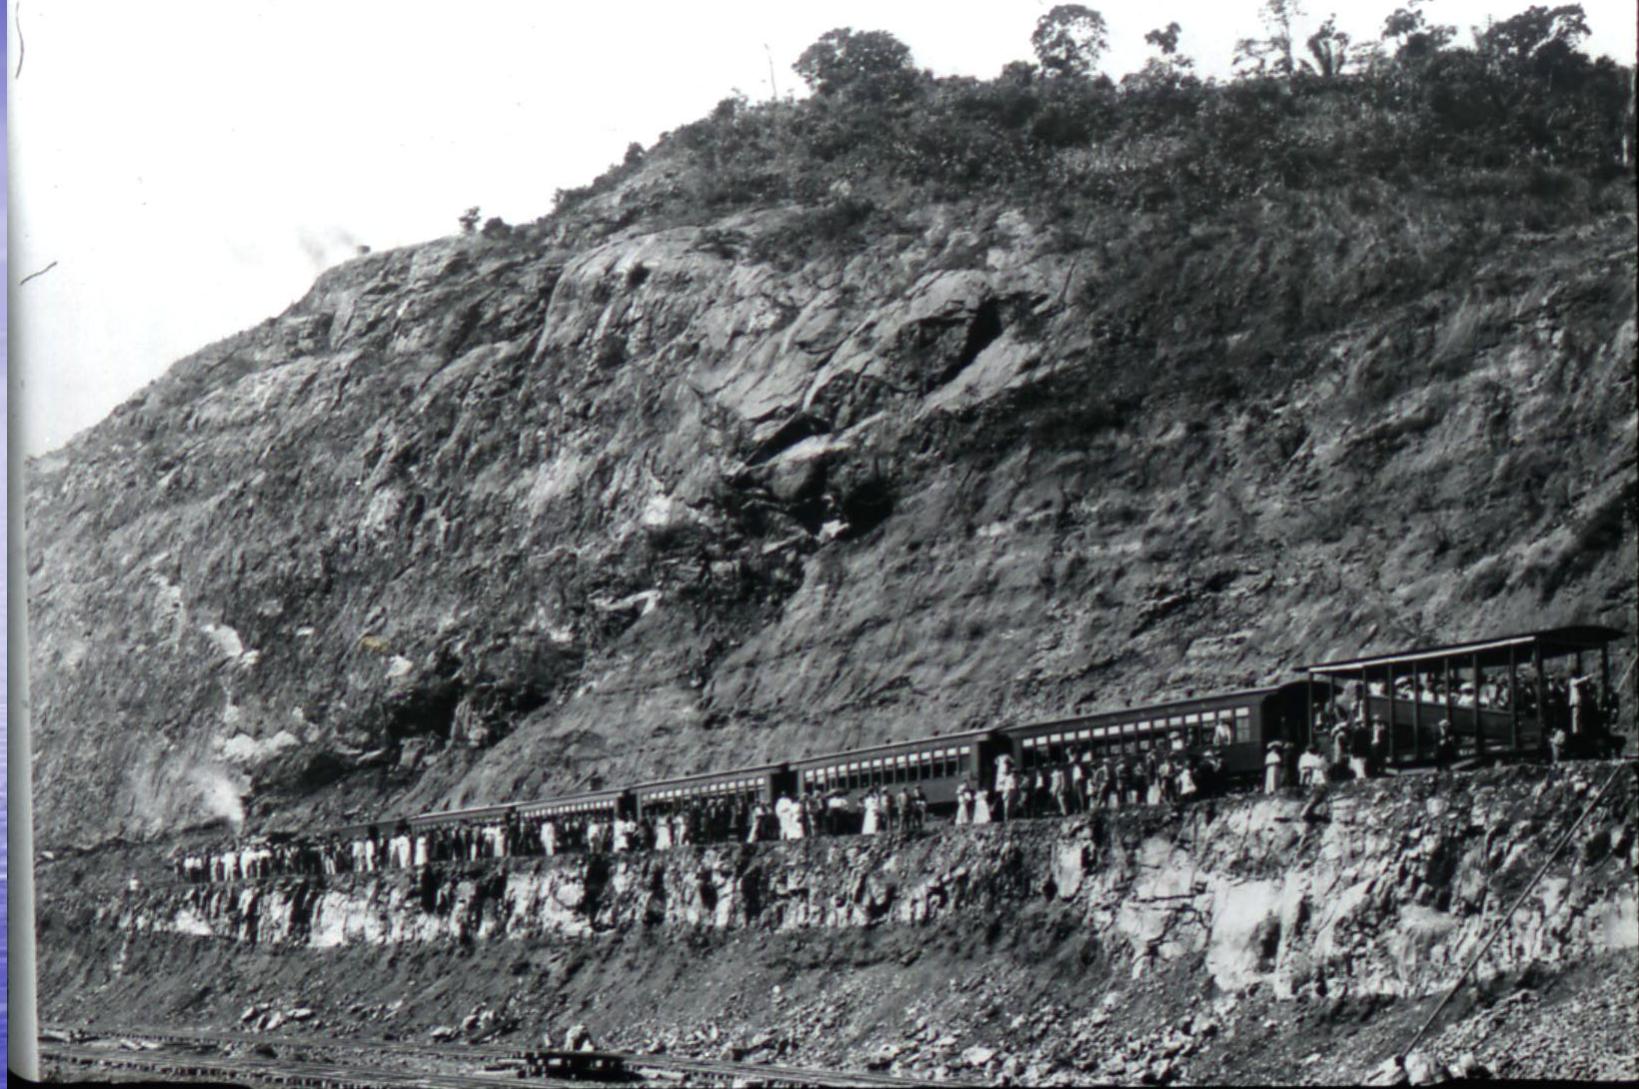
- Stevens said the canal job was all about *logistics, logistics, and logistics*... This shows the morning work train delivering Caribbean workers. Note the faulted contact between the resistant hill and adjacent slopes.

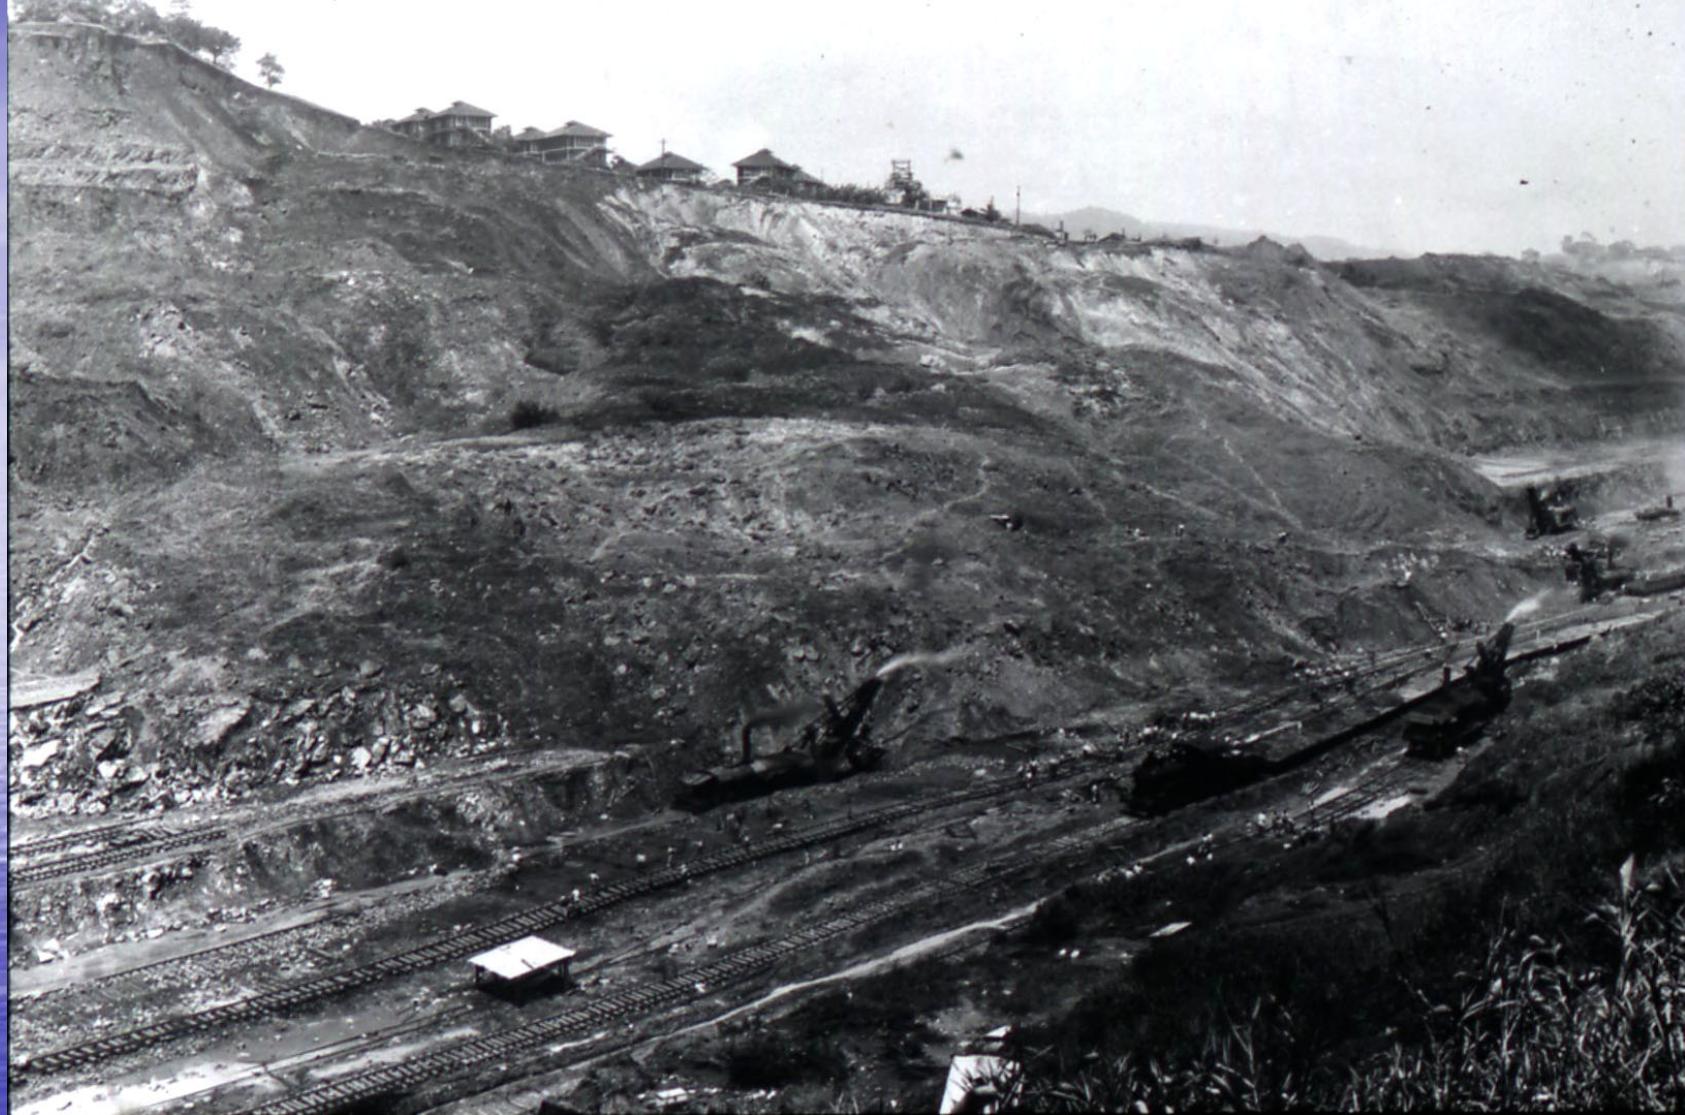
- Excavating the toe of the West Culebra slide with steam shovels, and allowing the slide debris to disintegrate and slide into the hole.

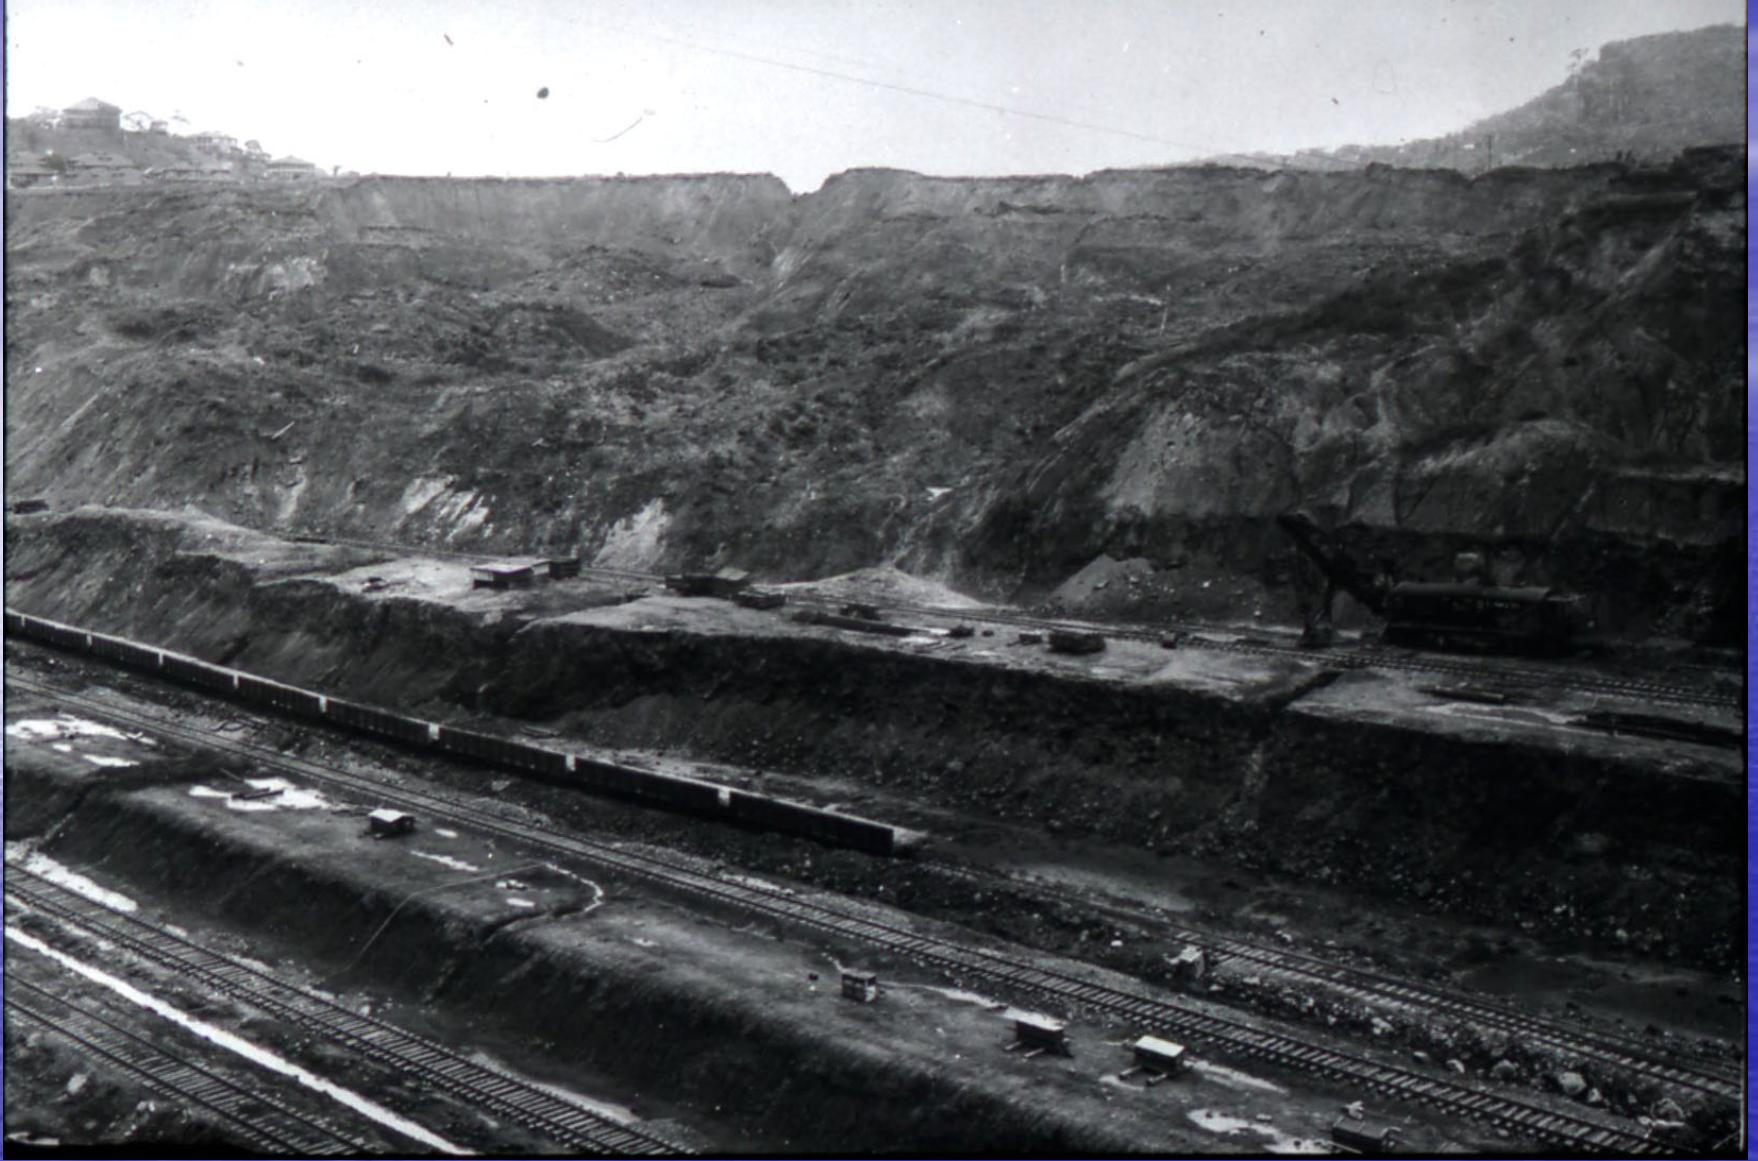
- **The shovels work desperately to fill side-dumping gondola cars and keep pace with the onslaught of earthen debris.**

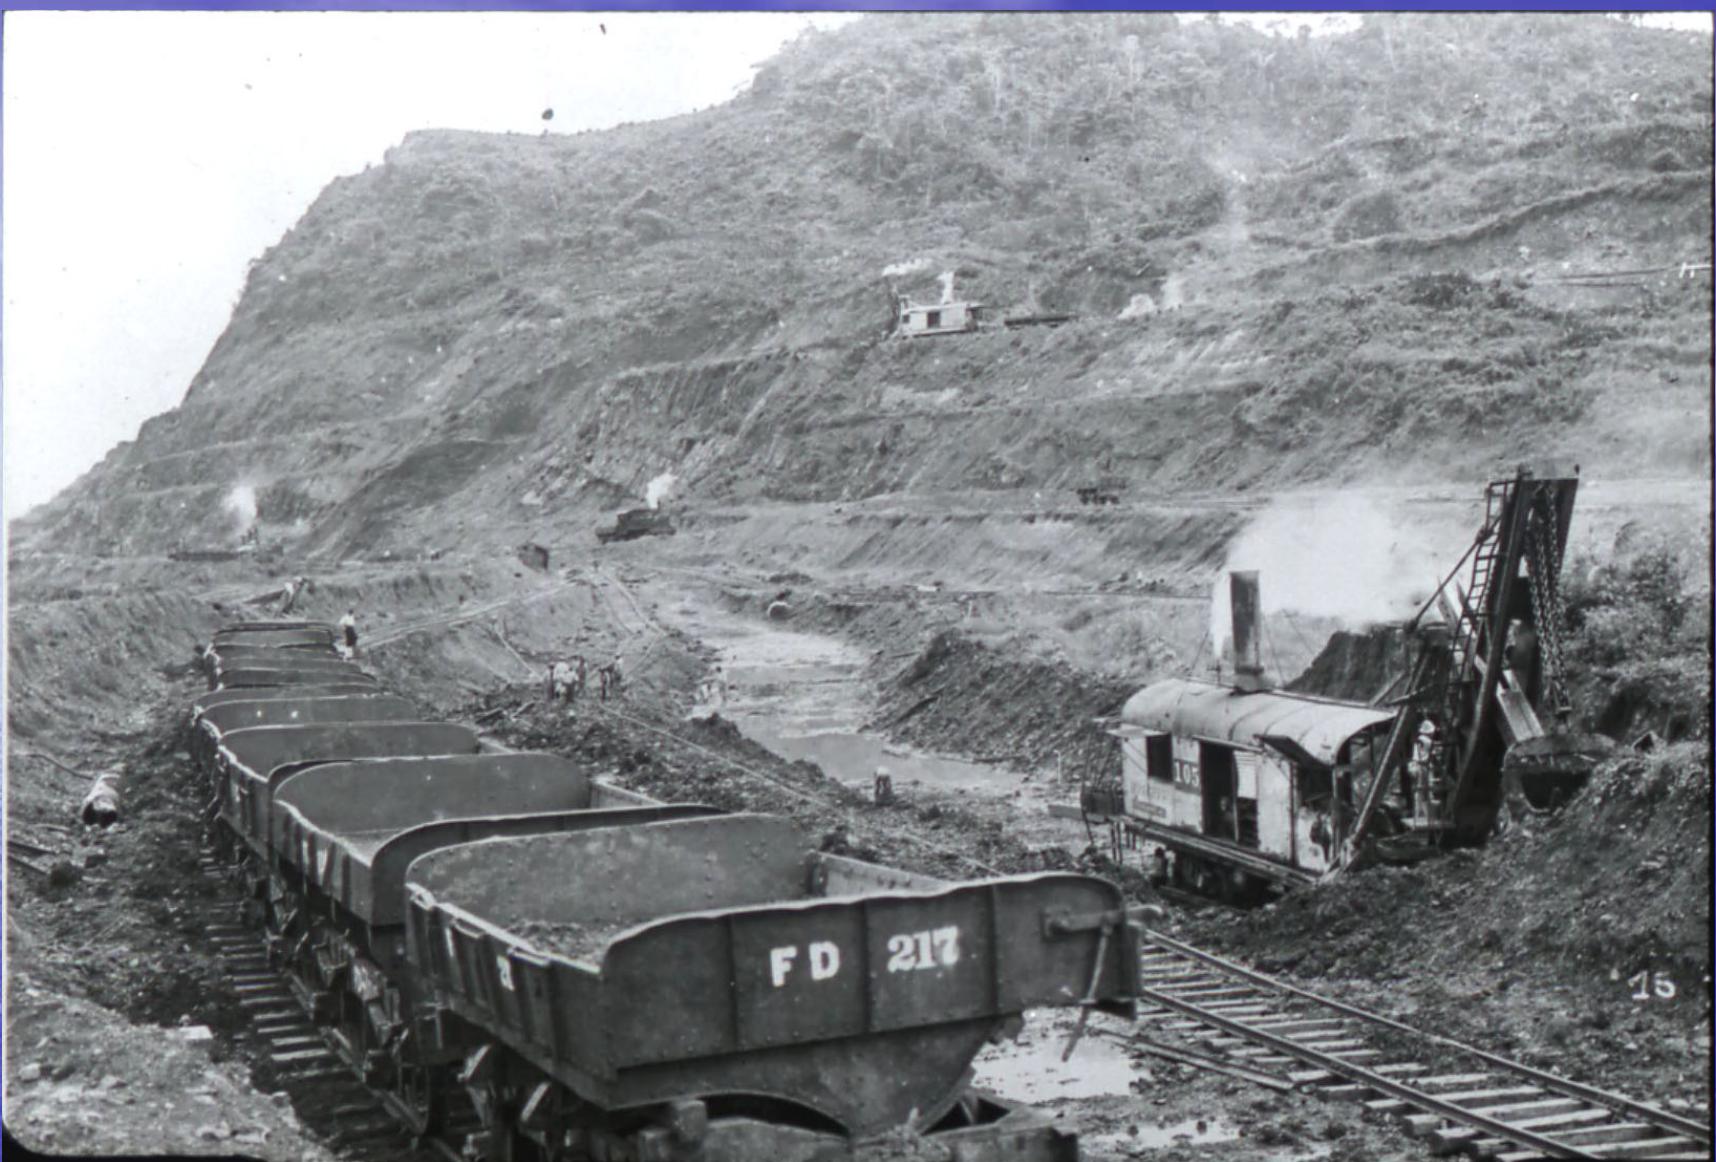
- Close-up view of the rail-mounted shovels excavating slide debris at Culebra. Side-dumping gondola cars in foreground.

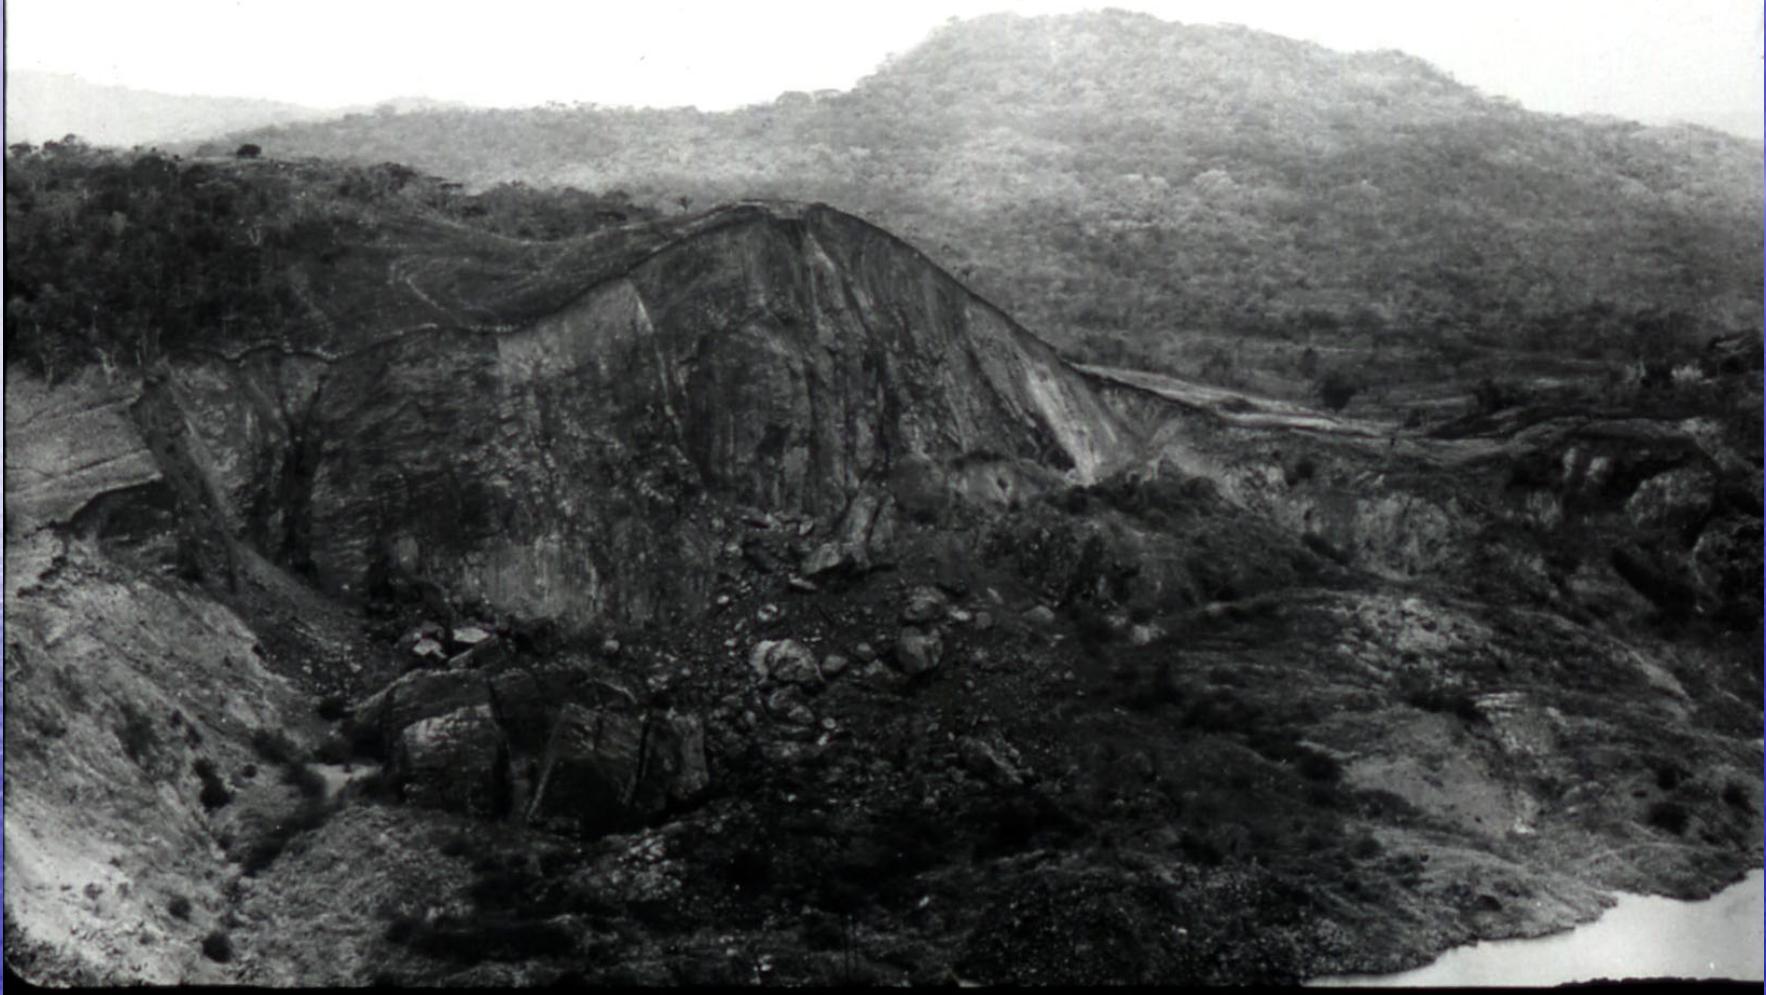
- The awesome massif of Zion Hill on the West Culebra Slide

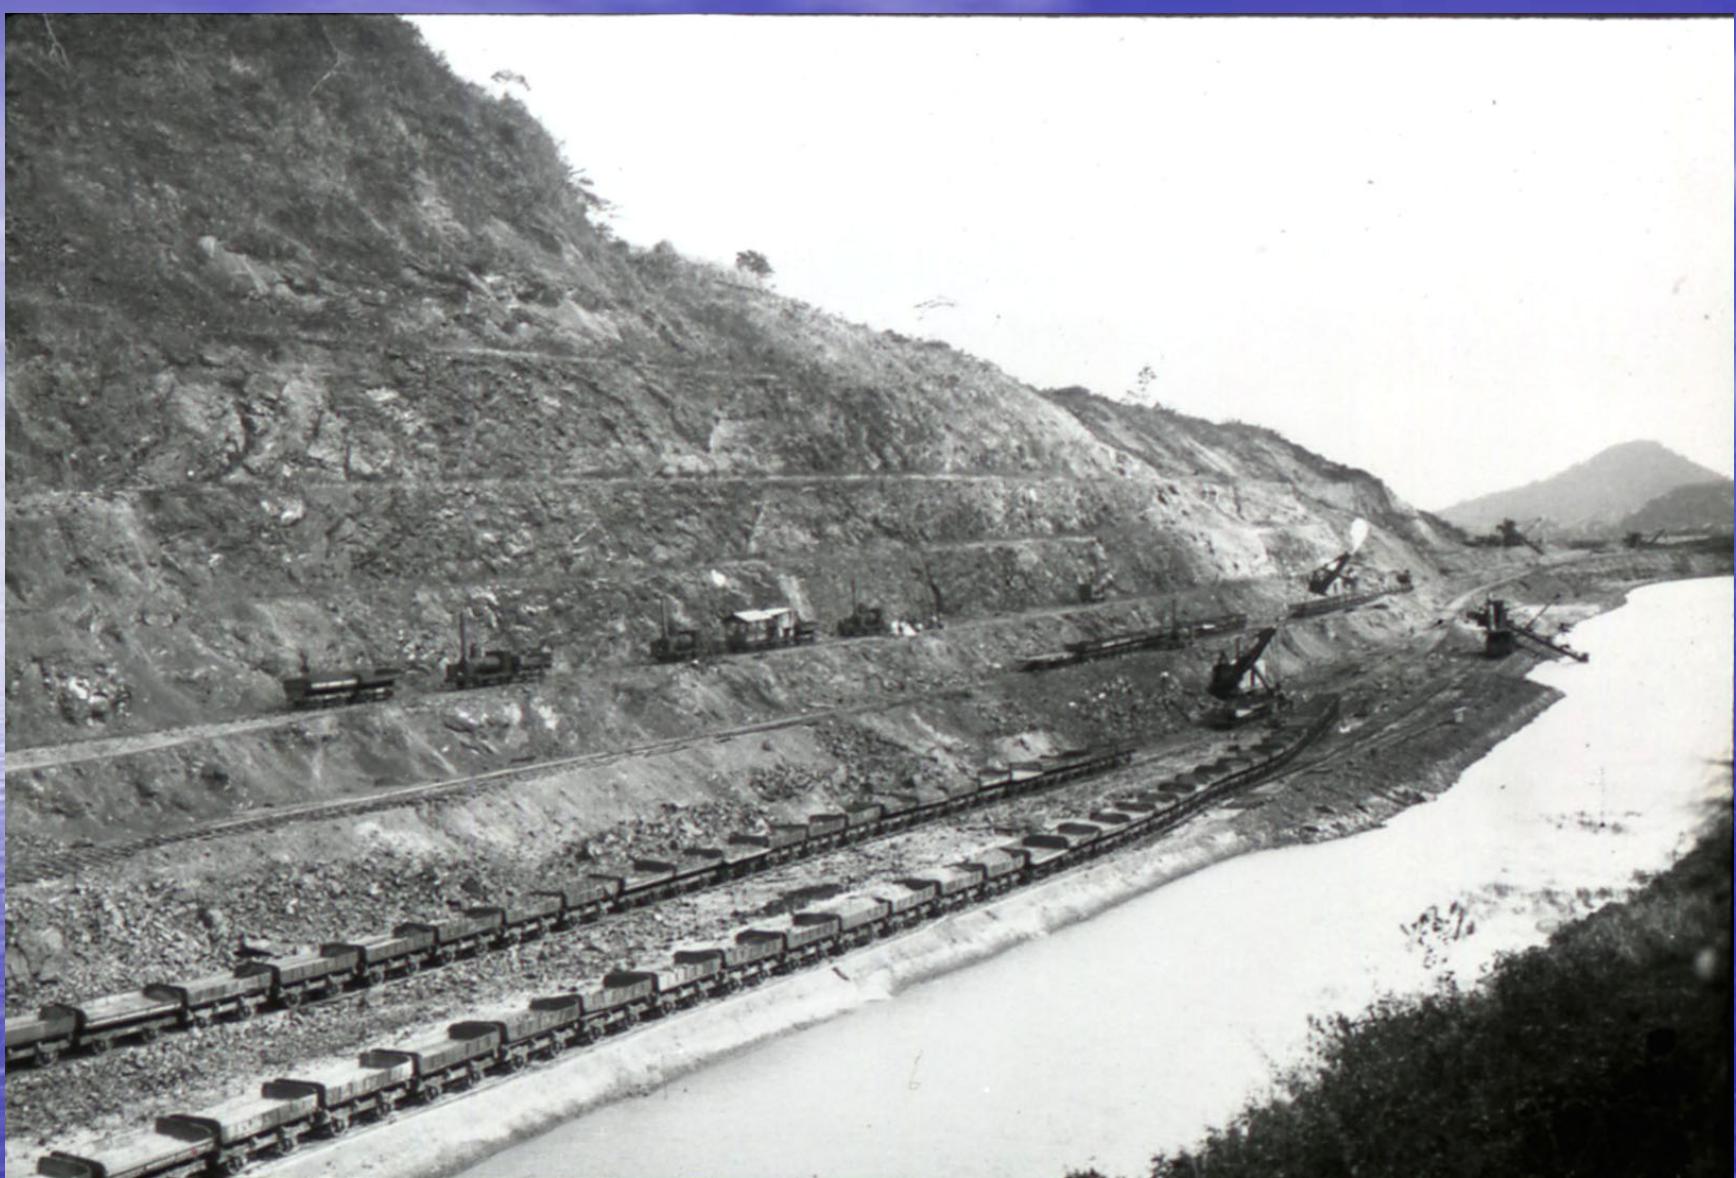
- The massive cut at Gold Hill and Cucaracha, just before the first big slide

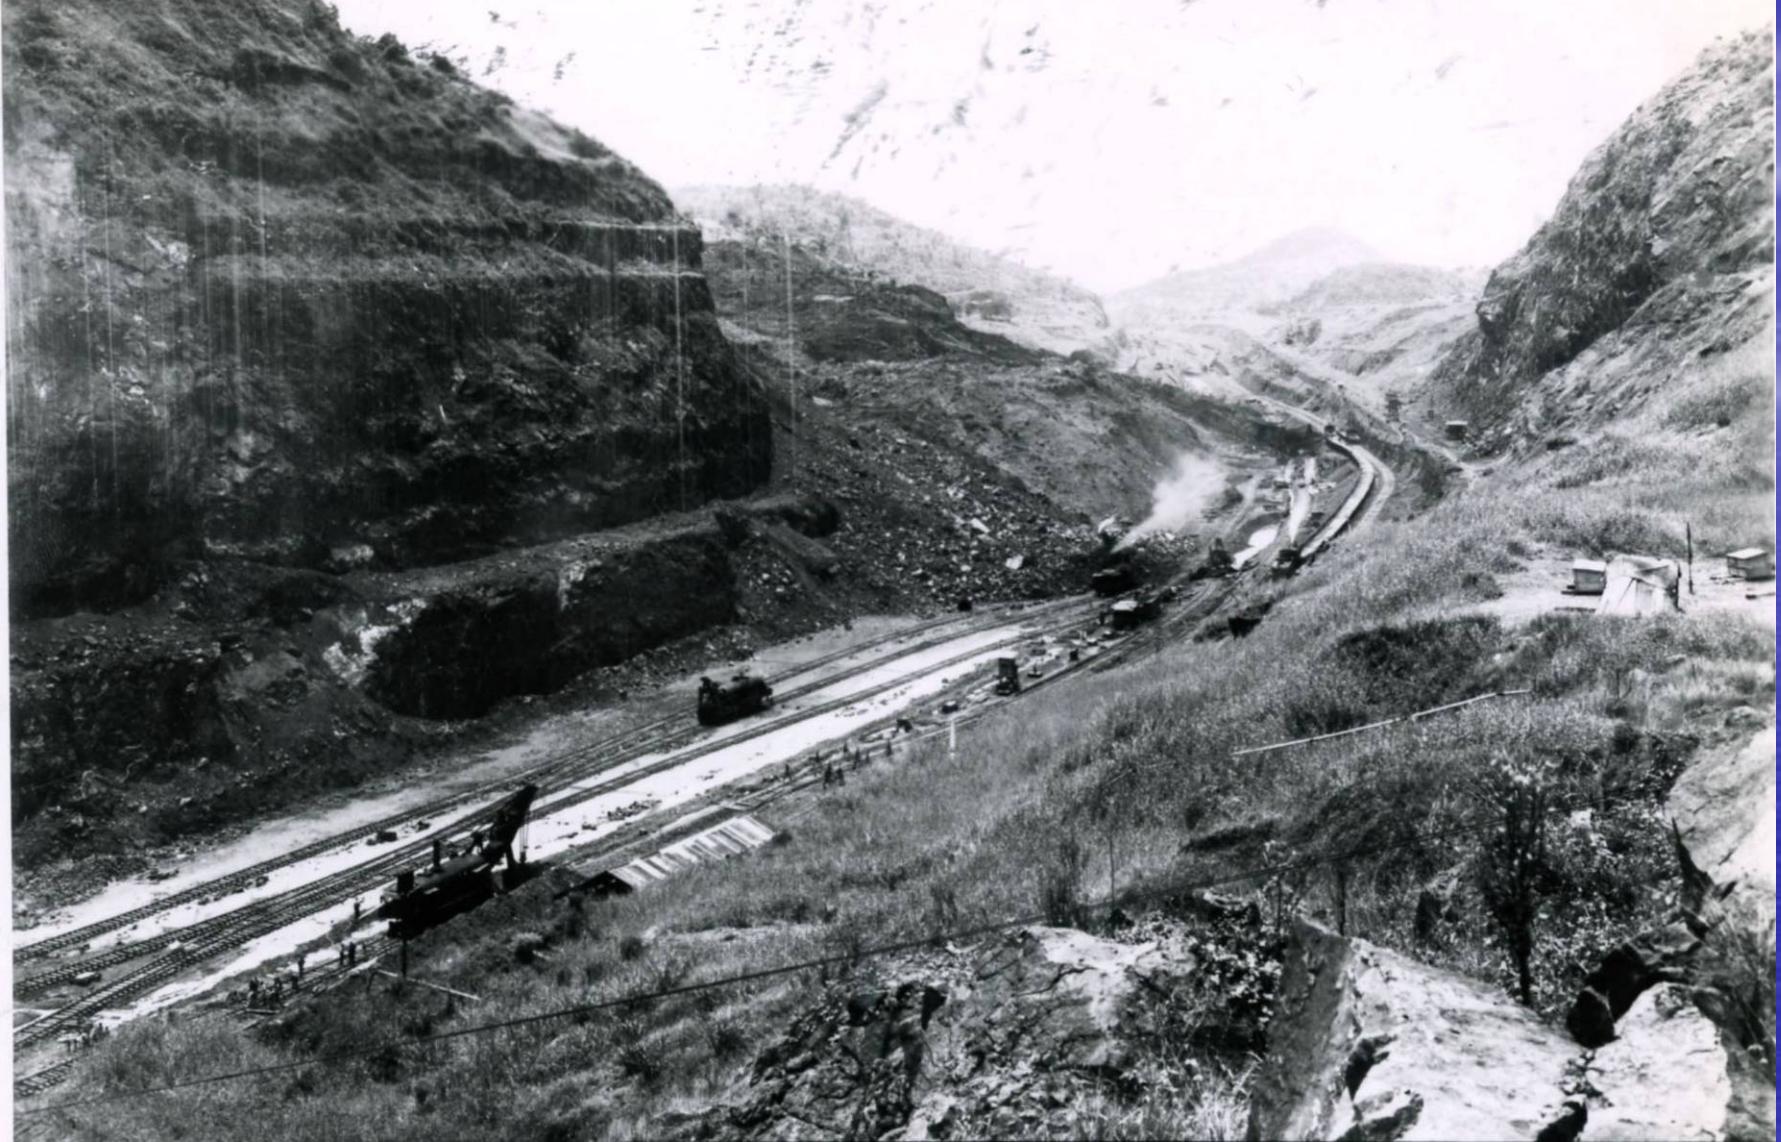
- **Excavating debris at the toe in the wake of the first massive slide at Cucaracha, on August 20, 1913.**

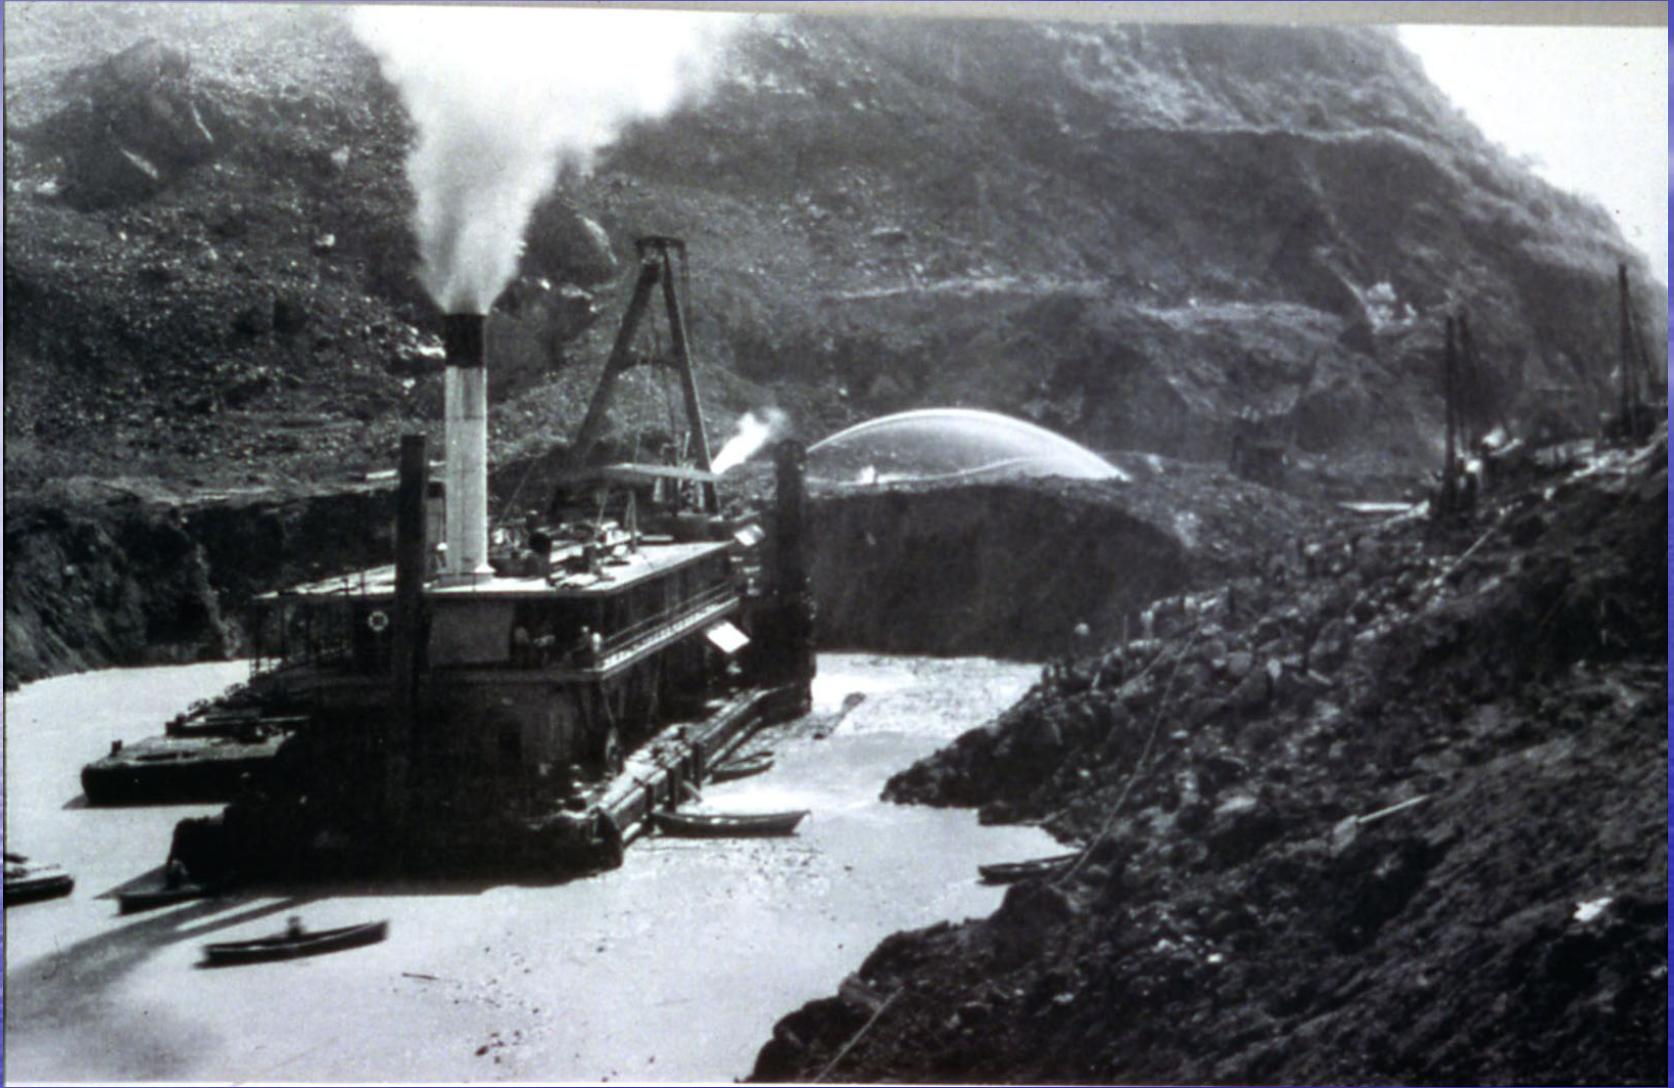
- Shovel dredge working the face of the East Culebra Slide after the canal was flooded.

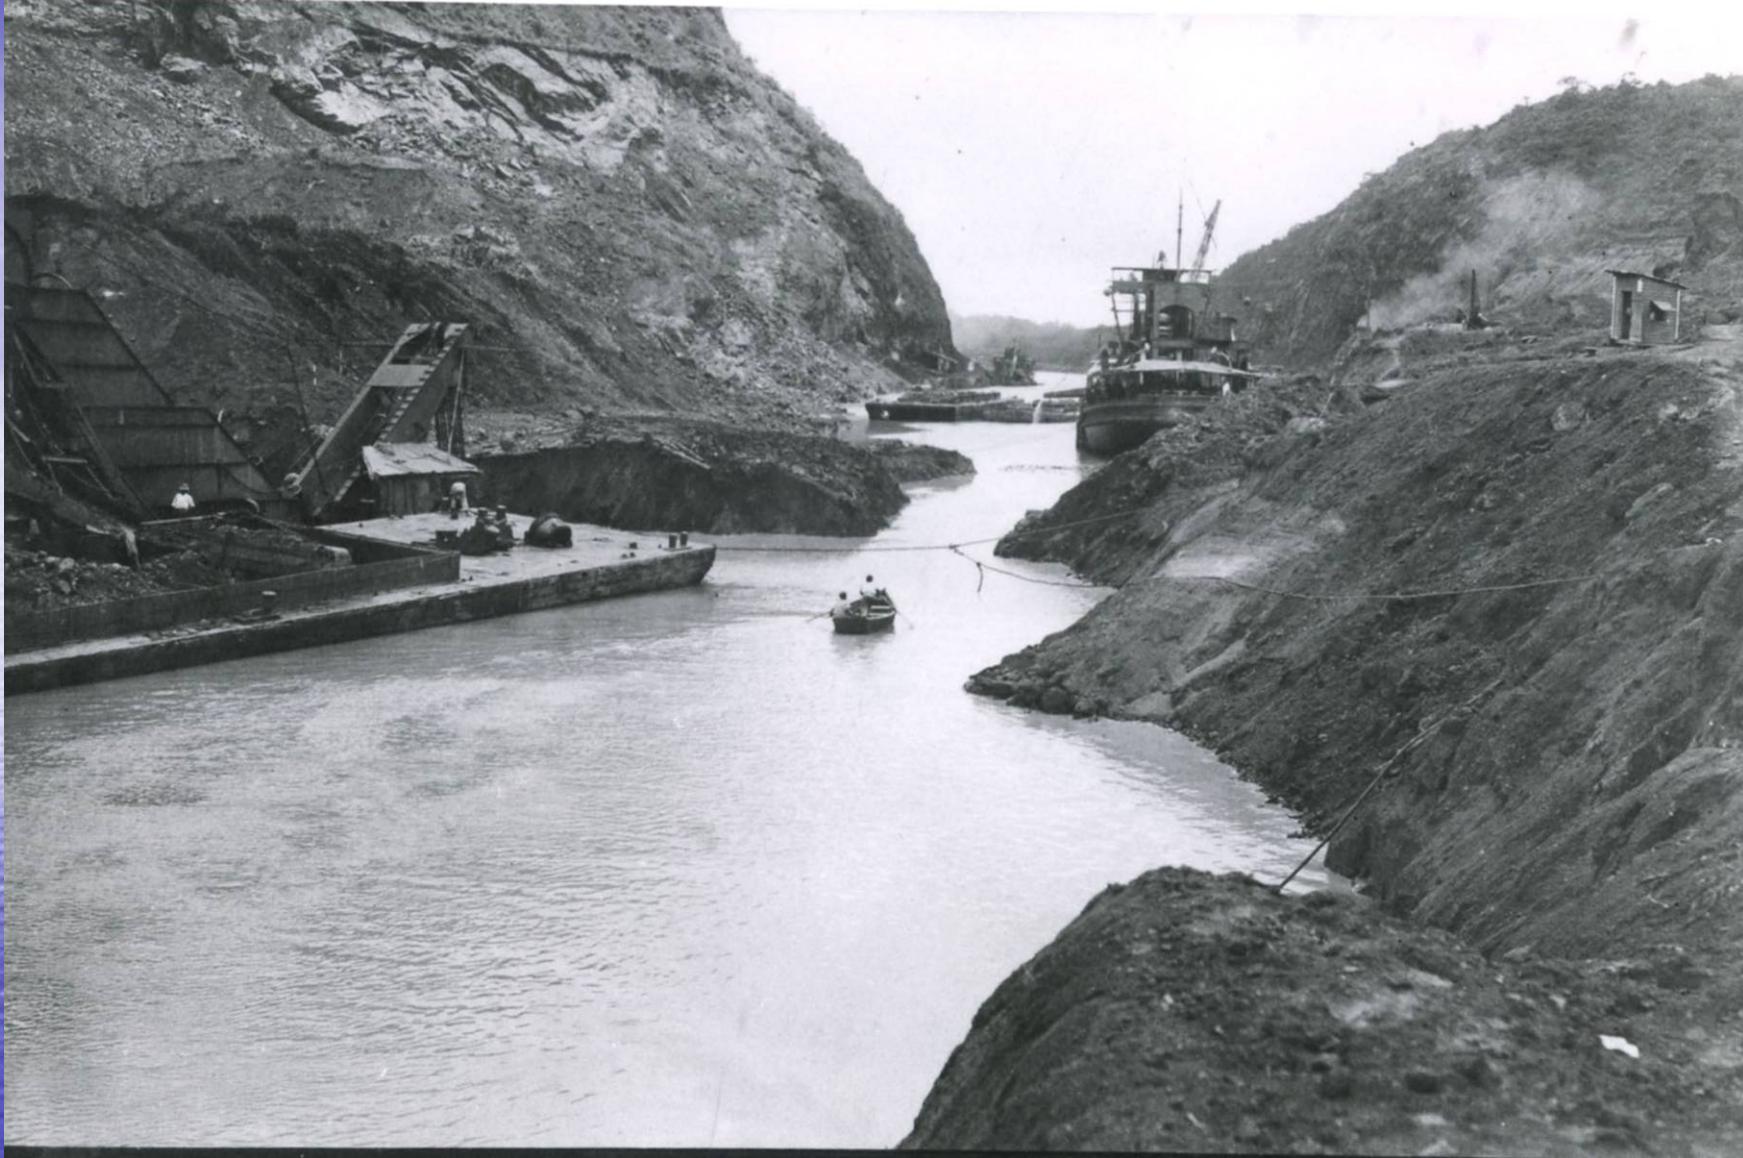
- Dredging the gap closed by landslides on October 5, 1915

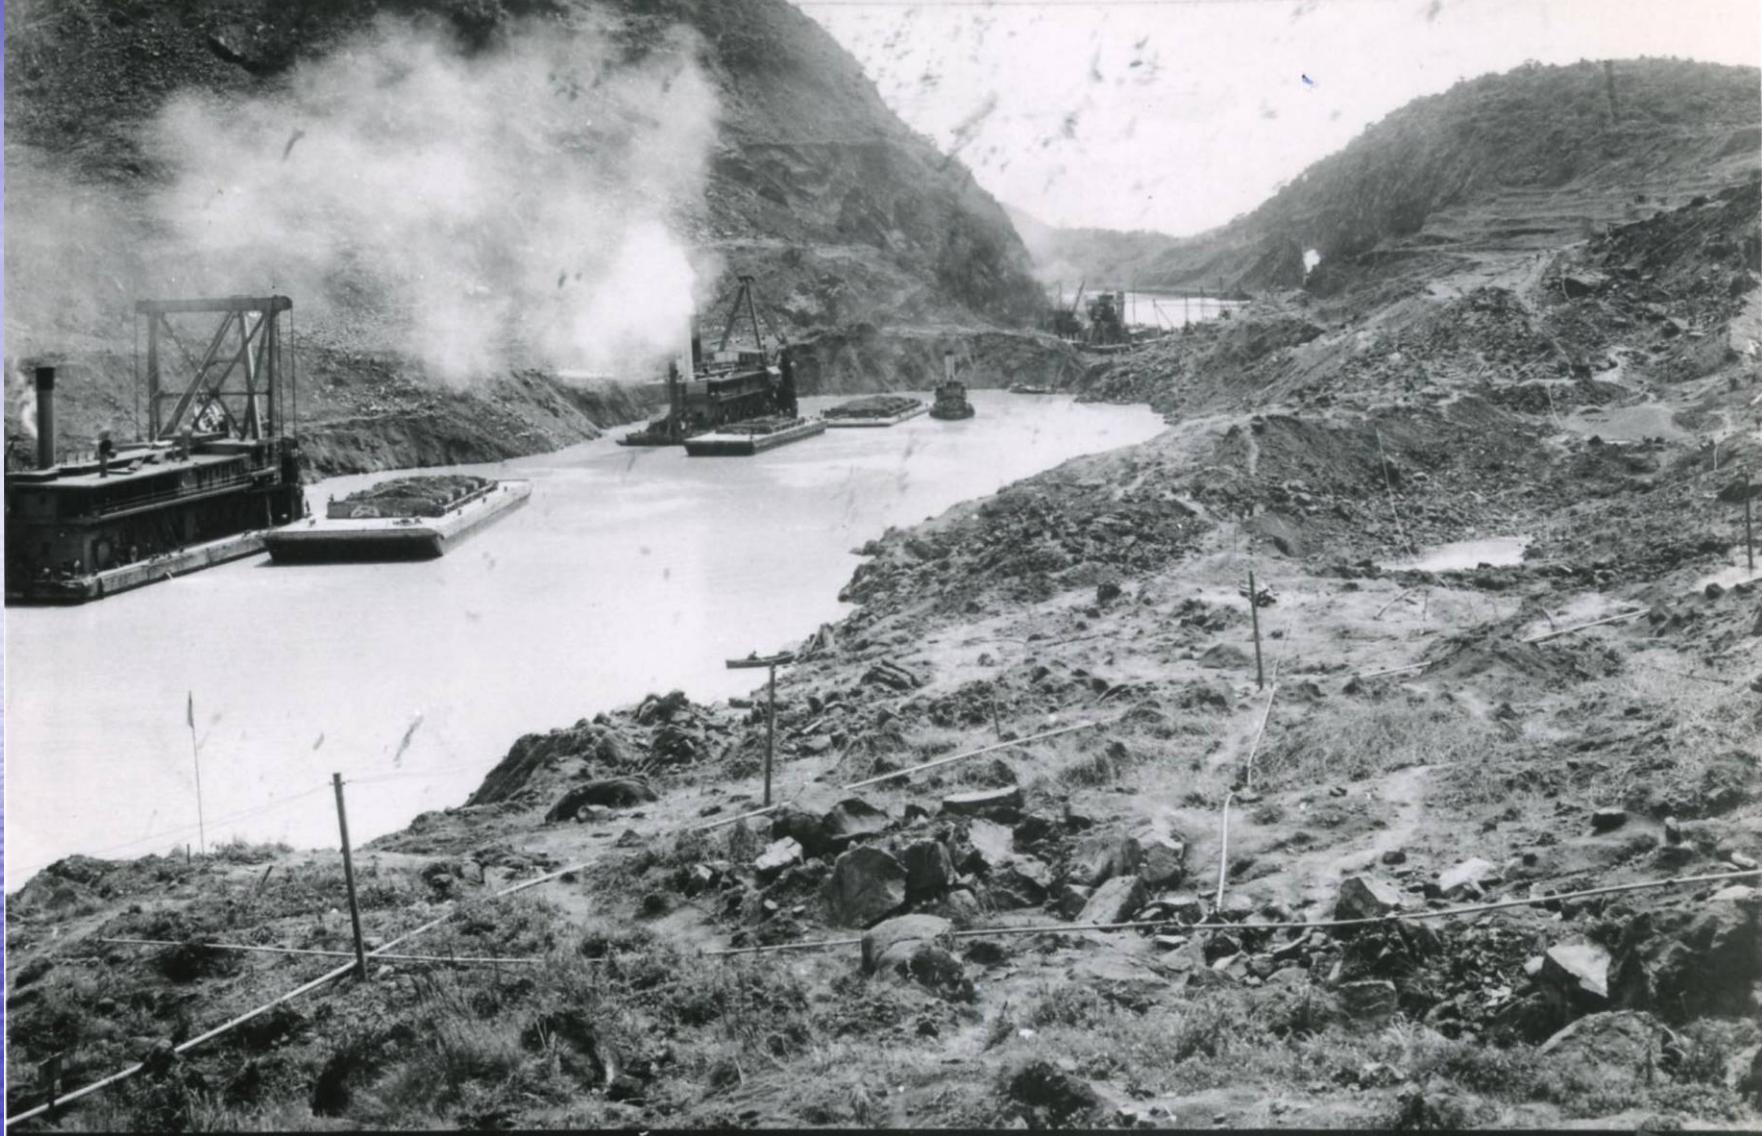
- Dredges battling with the slides at Culebra on November 8, 1915
