PANAMA CANAL: THE WORLD'S LANDSLIDE LABORATORY

J. David Rogers, Ph.D., P.E., P.G.

2007 Annual Meeting

Association of Environmental and Engineering Geologists

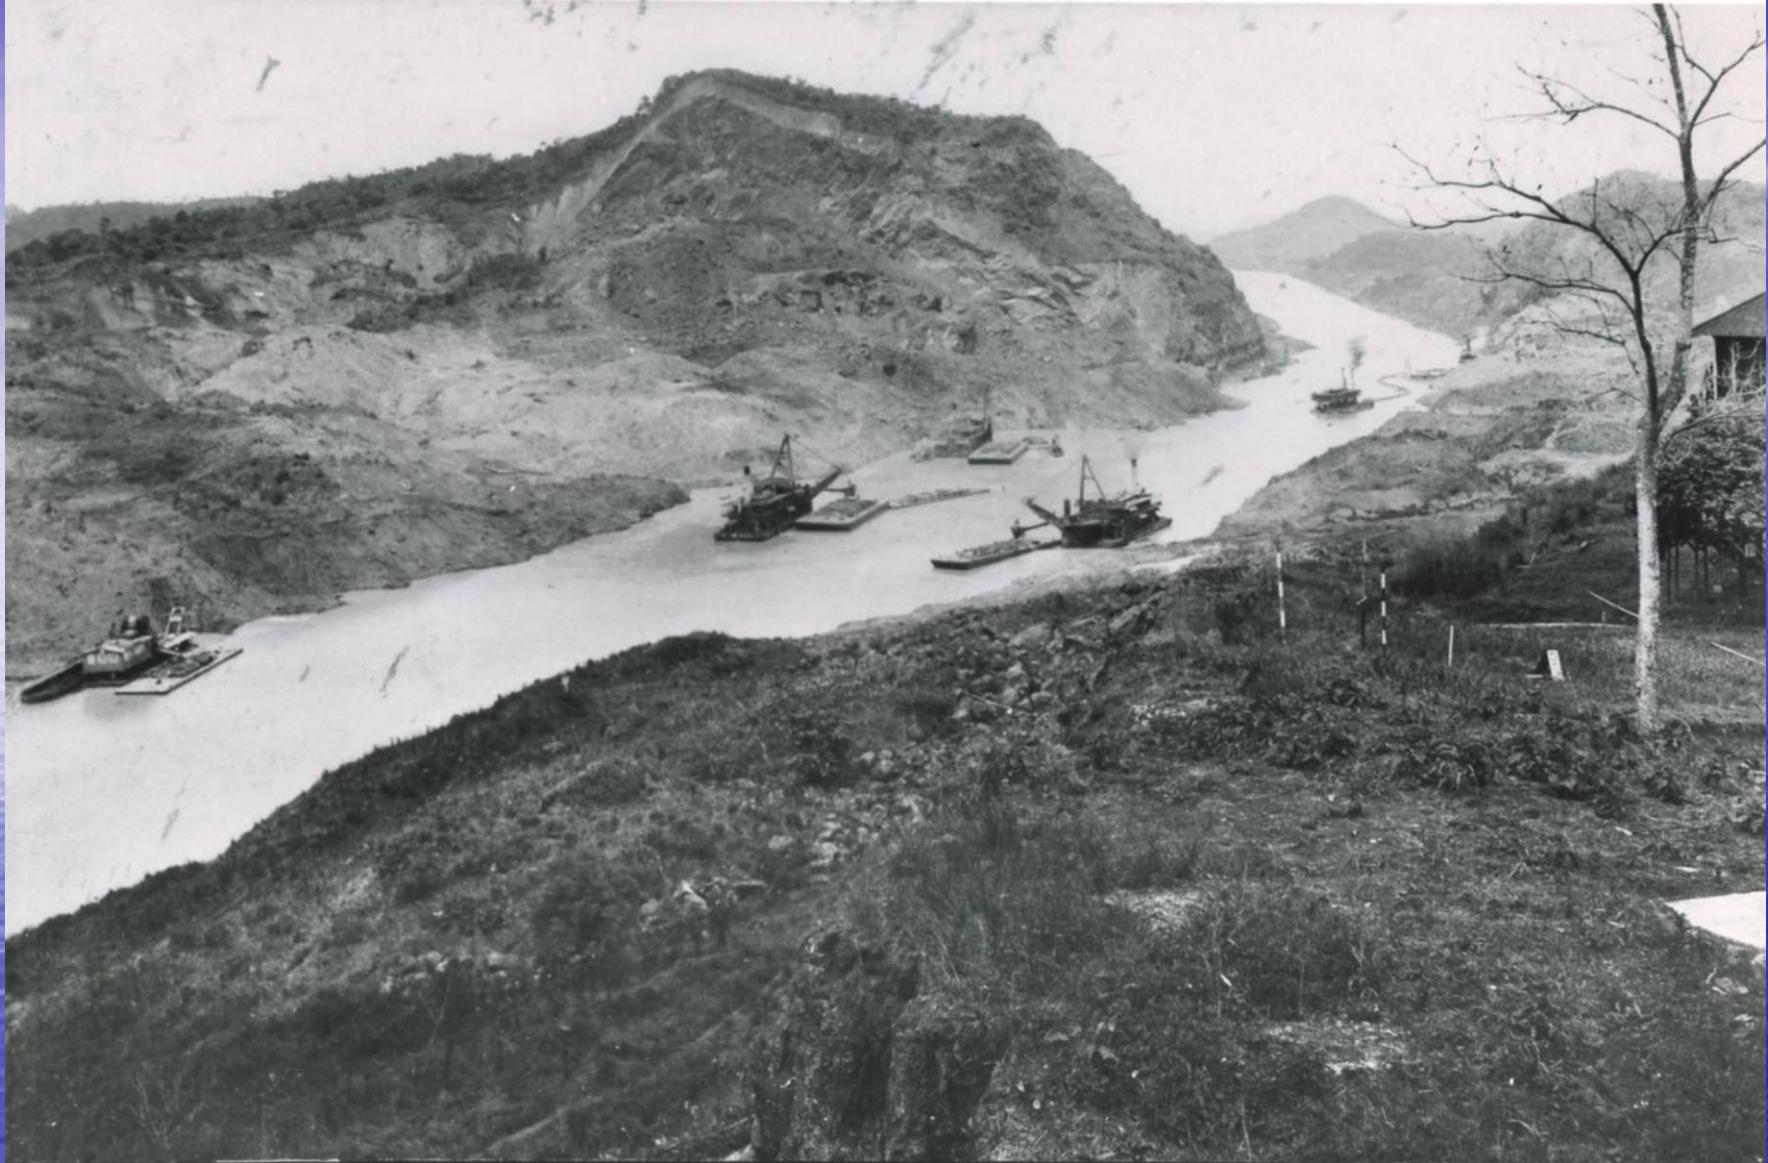
- **Barge shovels and suction dredges working the toe of the East Culebra Slide on July 3, 1916**

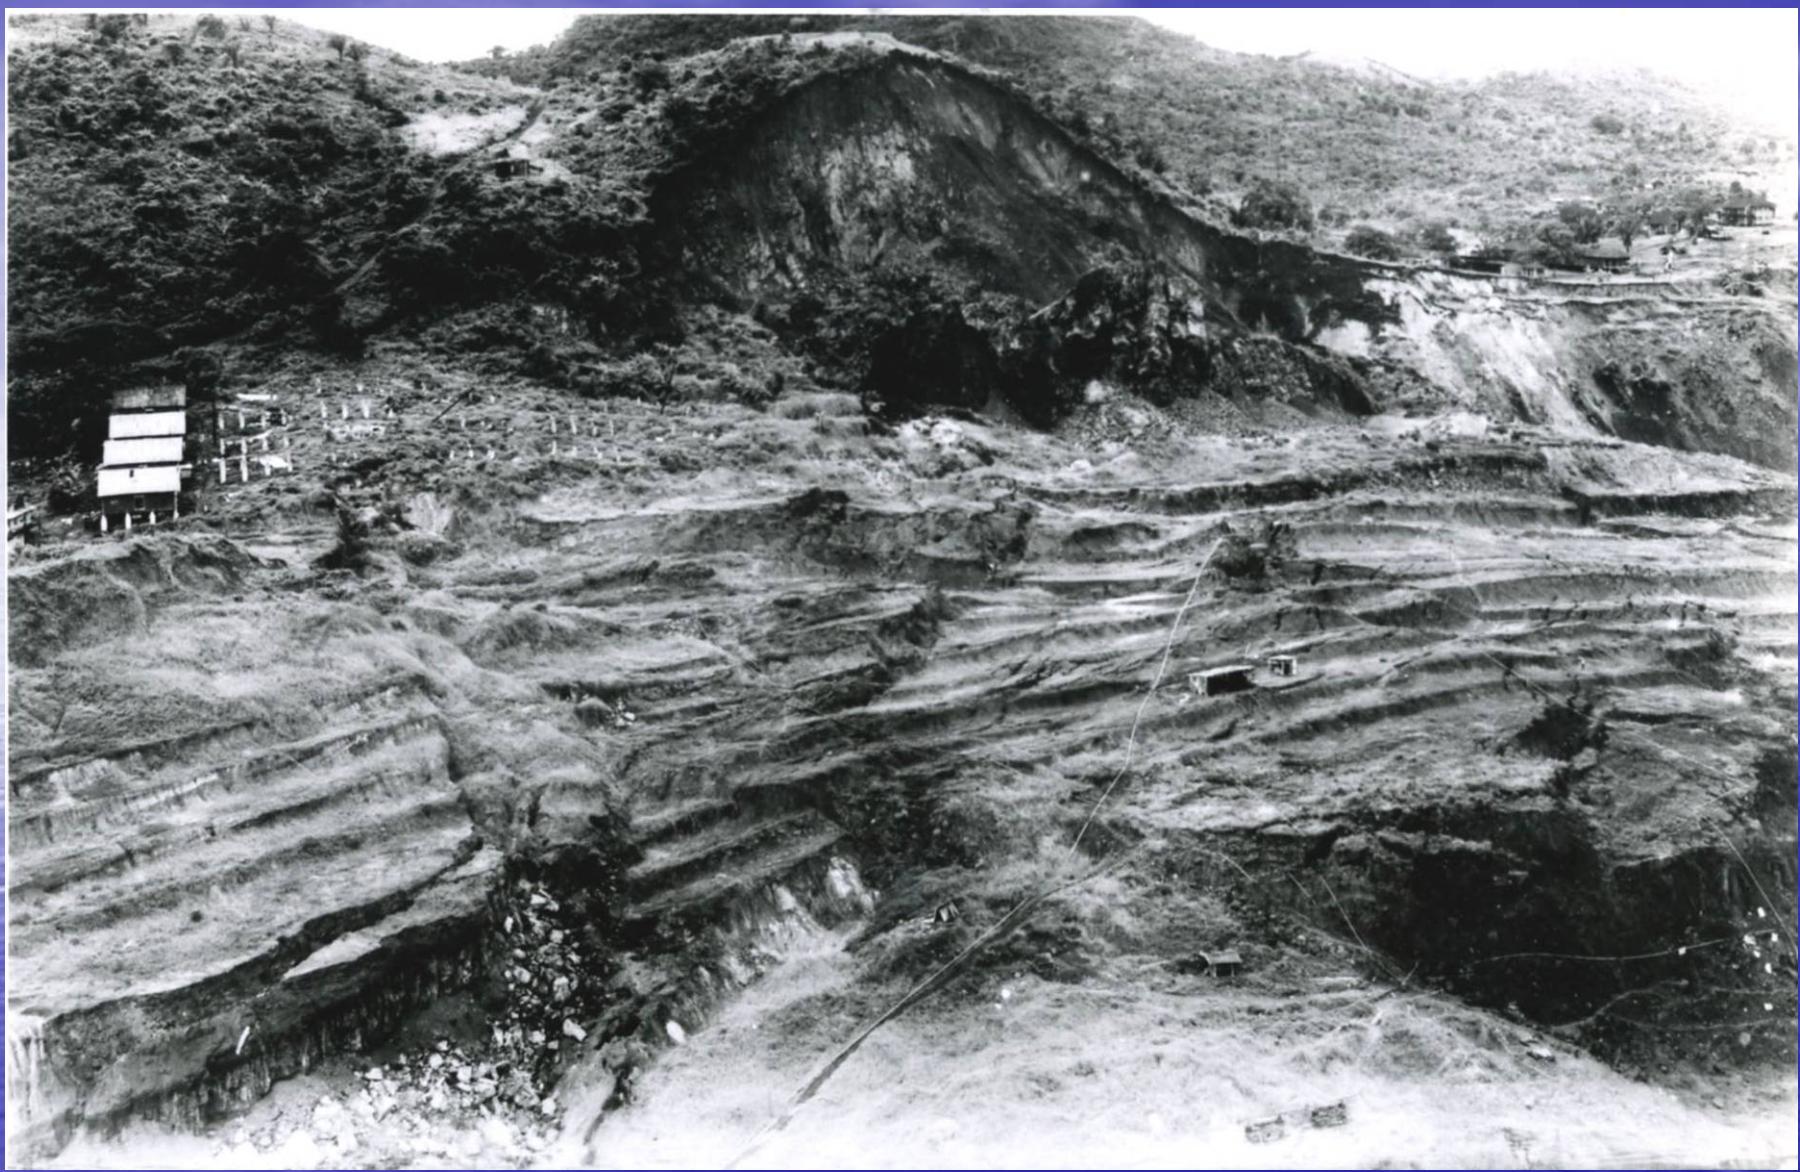
- Zion Hill and the West Culebra Slide on October 24, 1915

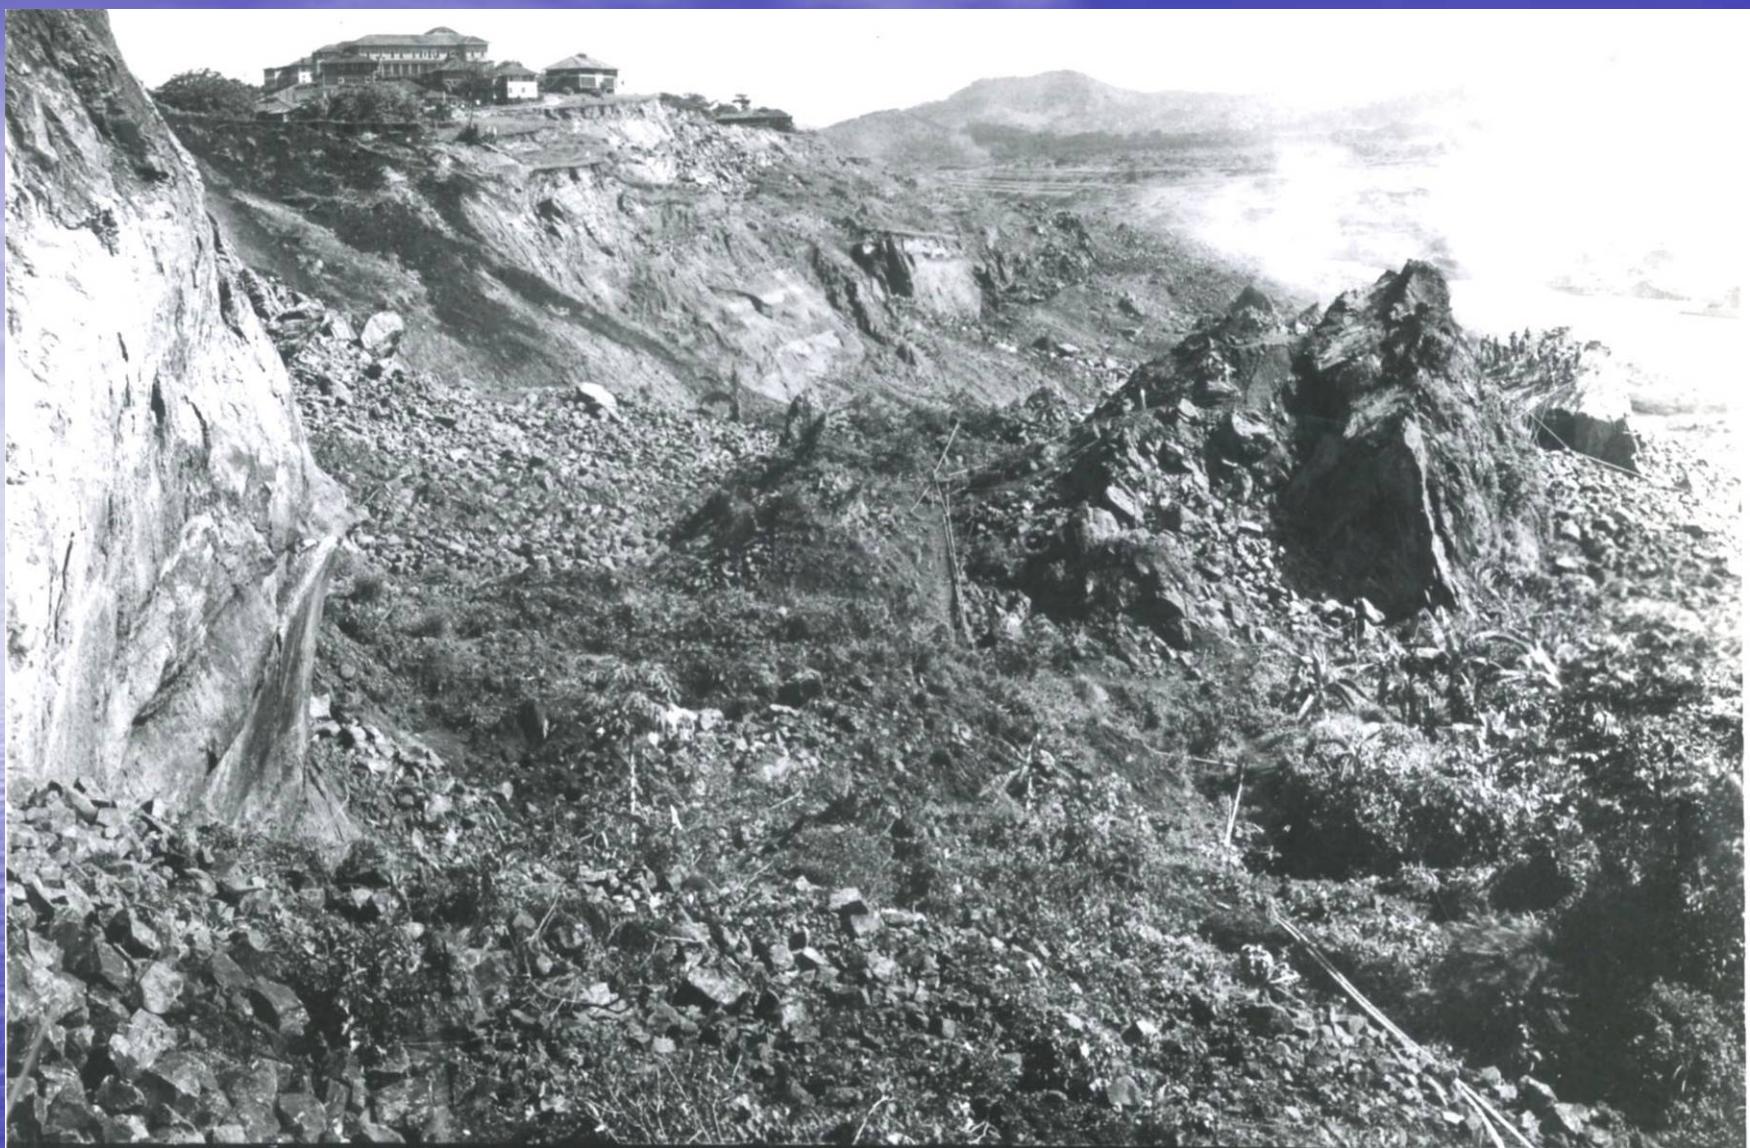
- West Culebra slide activity viewed on July 3, 1916. Note emergence of 'Culebra Heights' in background.

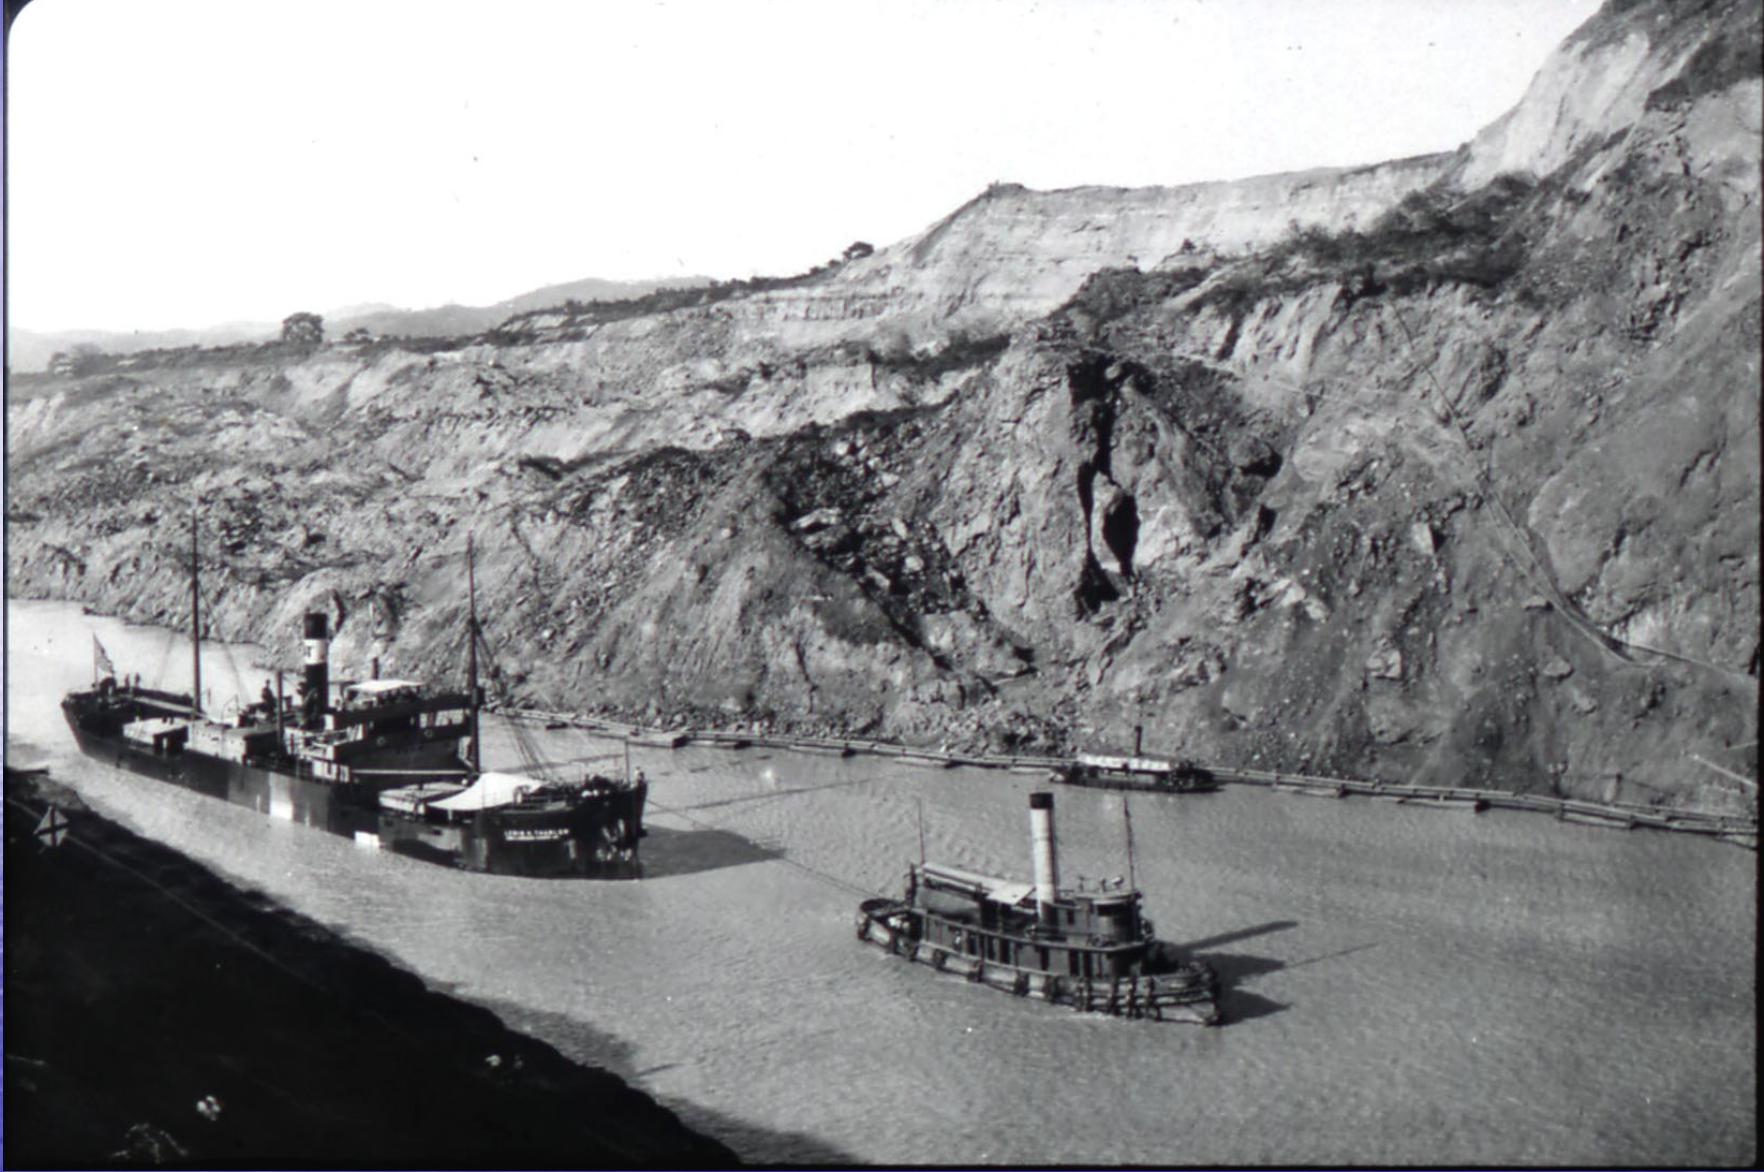
- Landslides shut down the canal on 26 occasions between 1914 and 1986. This shows a tug assisting a coastal freighter passing through the canal in 1917.

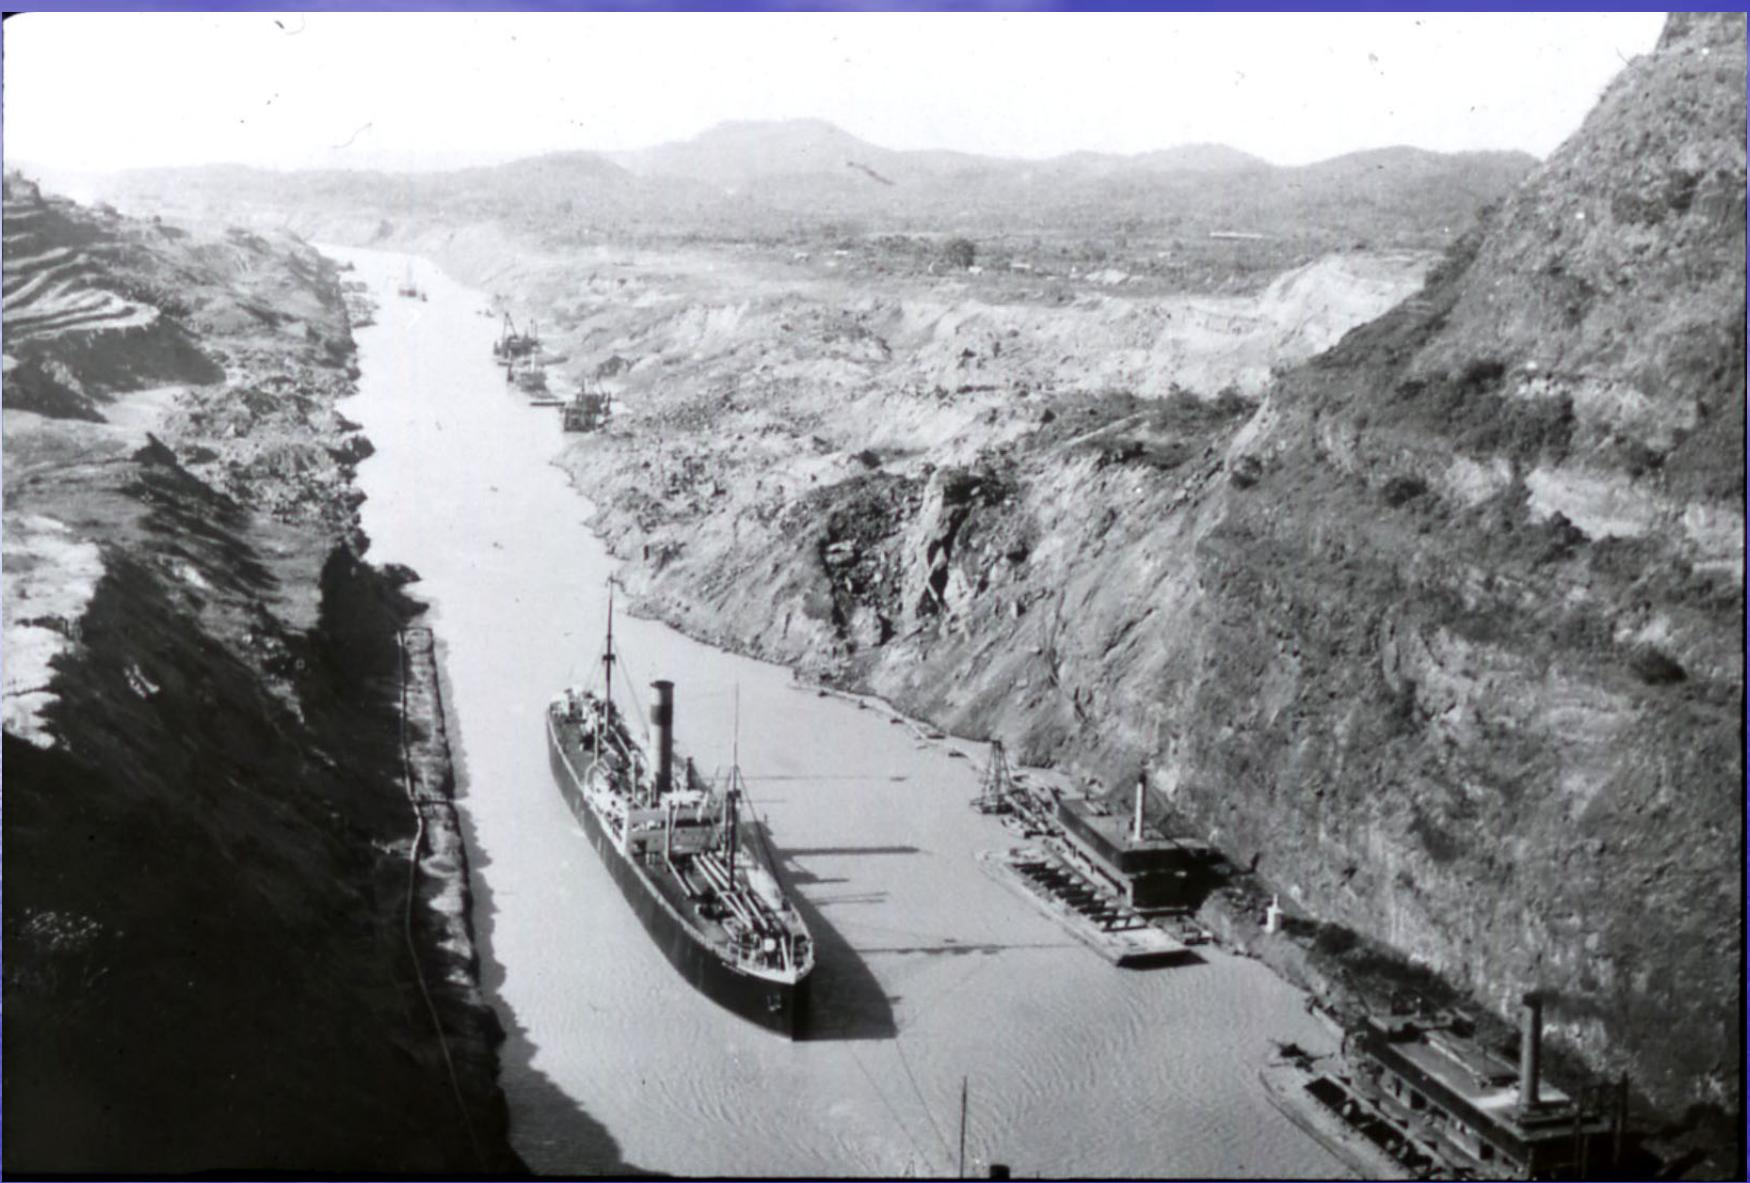
- Ship transiting canal around the East Culebra Slide. Note dredges and muck barges

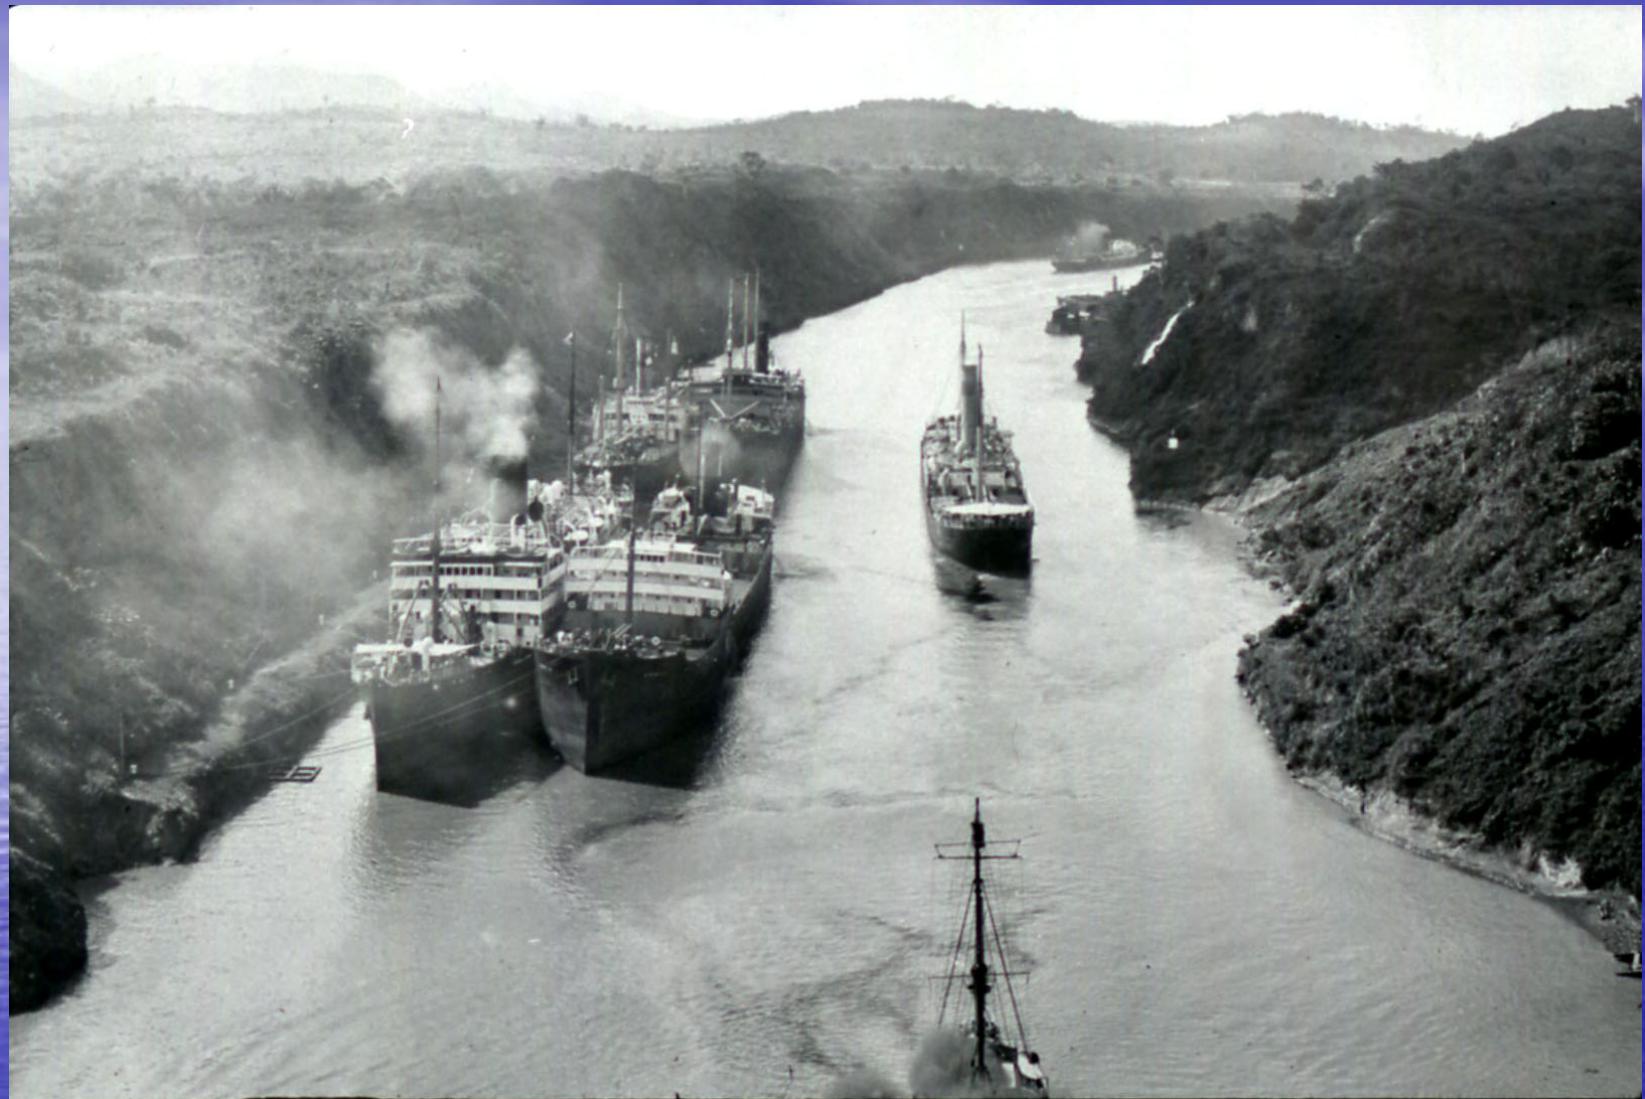
- When landslides partially blocked the channel, ships were queued up on either side of the construction and escorted through the gap.

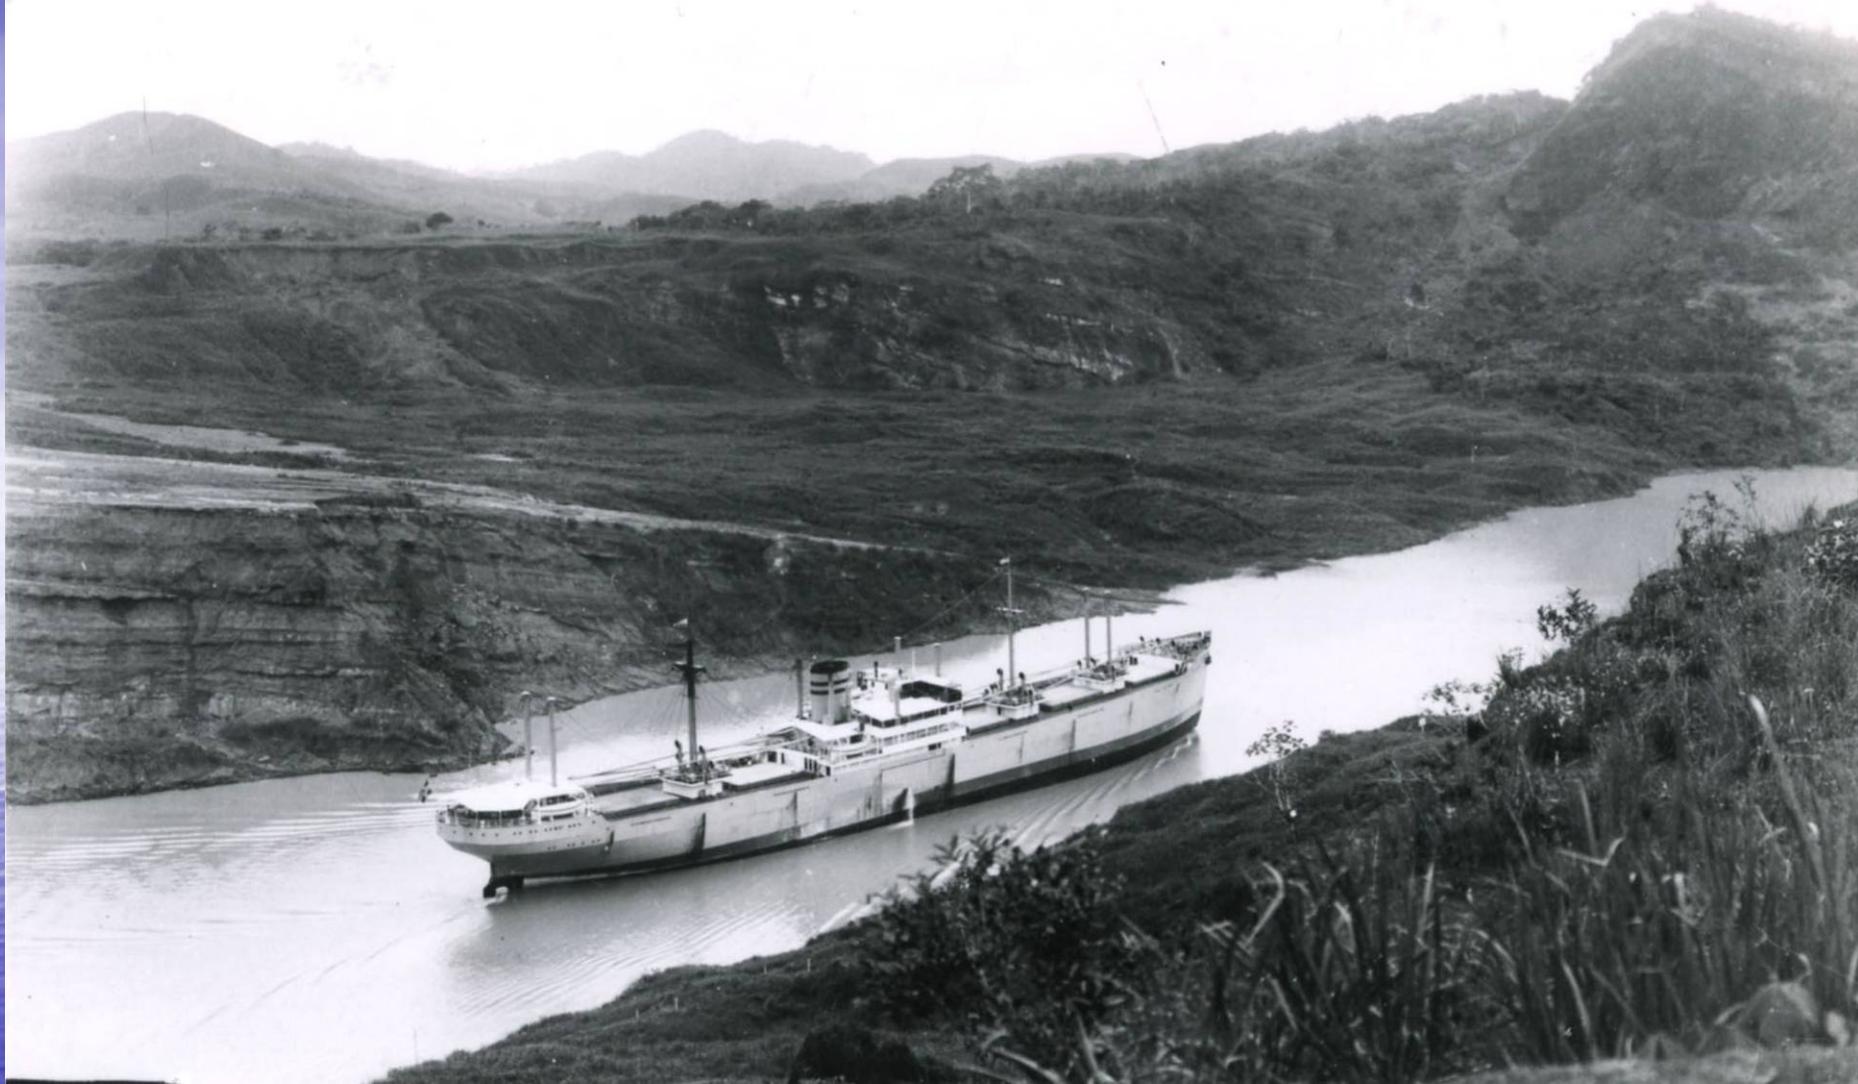
- Still running one-way traffic on June 13, 1933-
passing the dormant East Culebra Slide

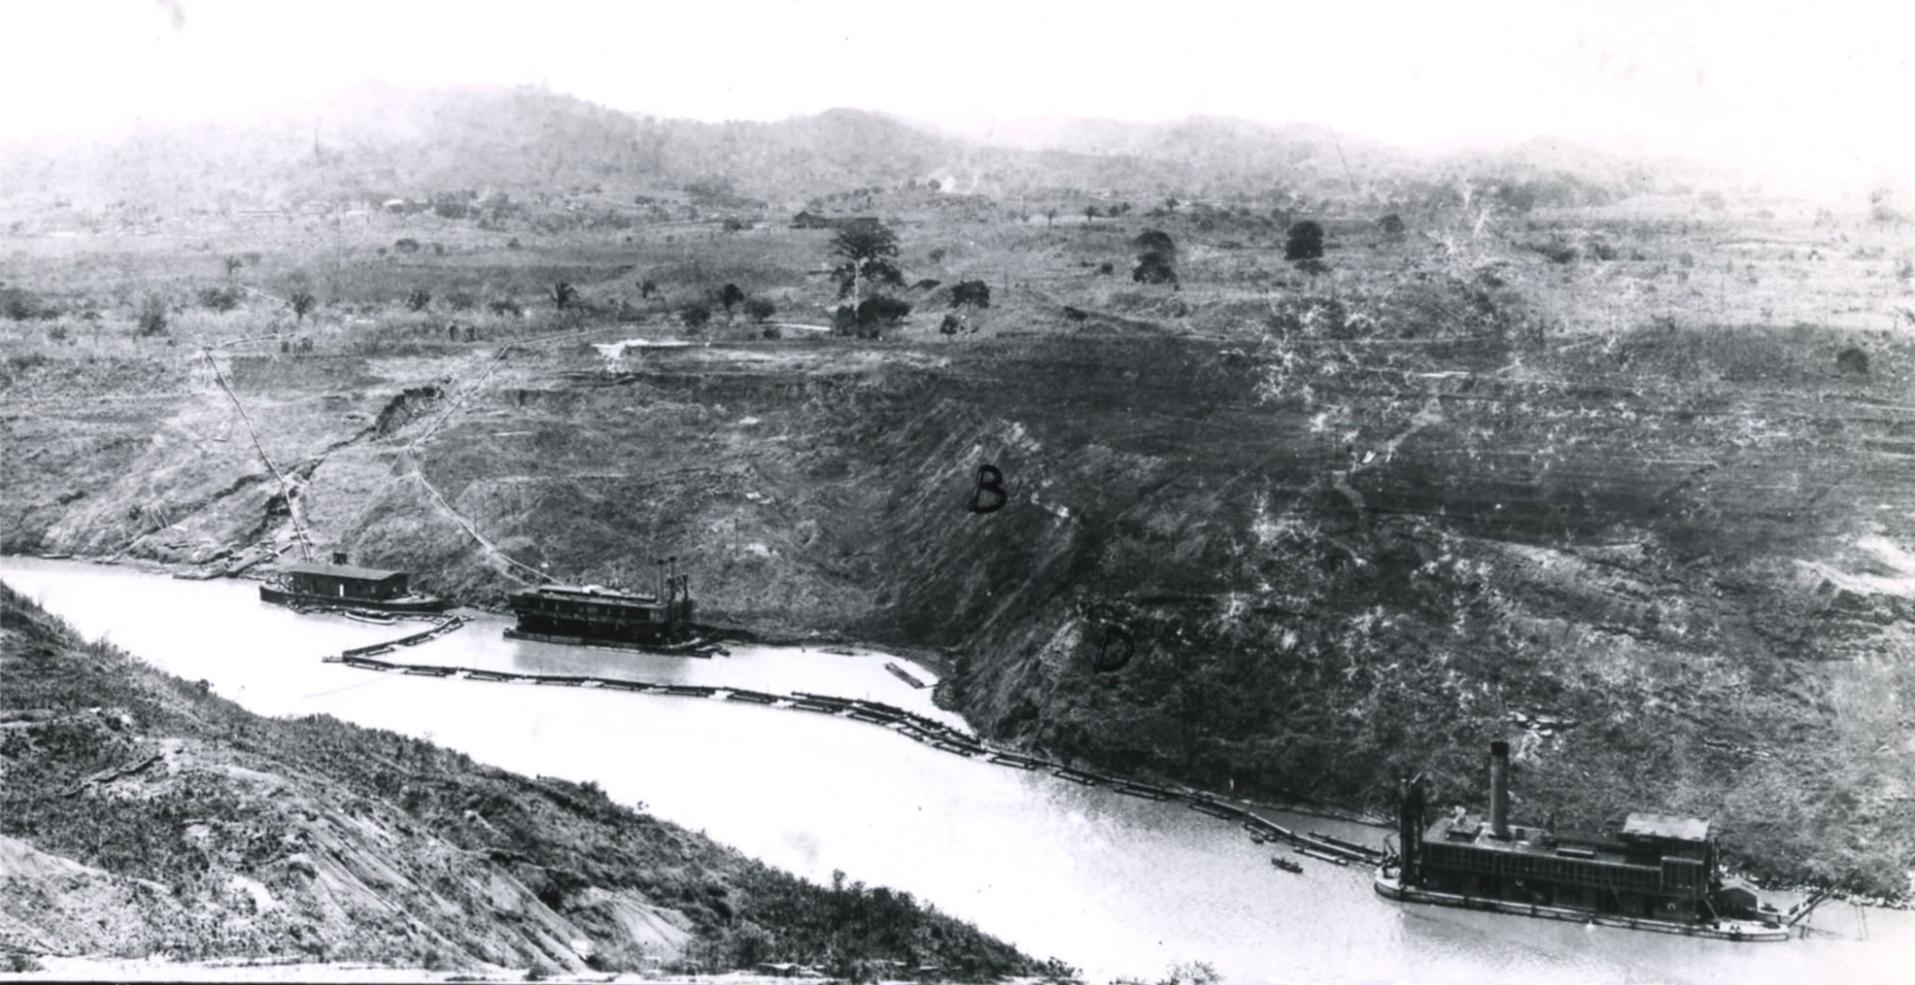
- Dredges continue to work the zone between Obispo and East Culebra on April 25, 1924, ten years after the canal opened
